## NOTICE TO BUYER: SELLER-PROCURED INSPECTION REPORT

**Robert and Suzanne Kingsley  
16934 NE 131<sup>st</sup> Pl  
Redmond WA 98052**

**Per the seller, the following items listed on the pre-sale inspection report dated 12/26/2023 have been corrected by the seller as part of preparation for sale in good faith.**

At your request, a visual inspection of the above referenced property was conducted on 12/18/2023. We have inspected the major structural components, plumbing, heating and electrical systems for signs of significant non-performance, excessive or unusual wear and general state of repair.

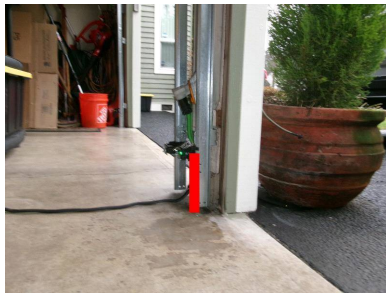
#### GARAGE DOOR OPENER

The Photo-eye beam was installed too high above the floor of the garage to adequately offer protection for small children and/or pets. We recommend that the photo-eye be lowered to within 4-6" of the floor.

Page 10 Garage door sensors relocated, and fire barriers installed. GFCI outlet installed.

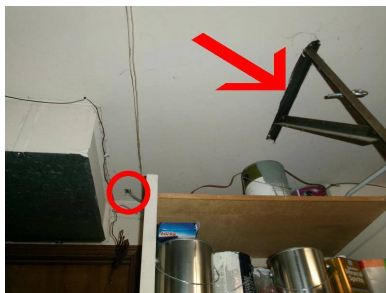
#### FIRE SEPARATION

There are voids in the fire resistive barrier between the living space and garage that will allow flames to penetrate. The gypsum barrier slows the spread of a fire from the garage to the structure and/or living space. Patching the voids with a fire retardant caulk is recommended.

Page 15 Installed fire putty and fire rated foam sealant in void above Sheetrock, installed metal flashing at penetration and sealed with fire caulk.

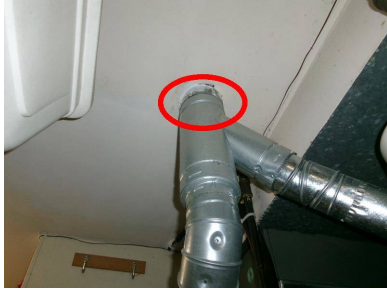
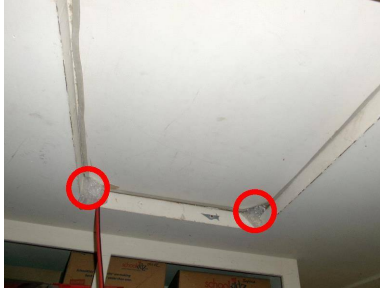
The installation of a furnace vent thimble is recommended to prevent flames from spreading to the structure.

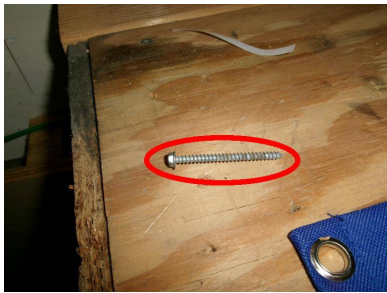
### SUBPANEL

Screws that secure the sub panel cover to the panel box are the wrong type. This is a potential hazard. Screws should be replaced with the original style blunt end screws.

Page 12 Panel screws replaced.

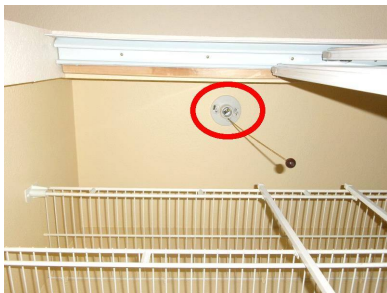
### LUMINARIES

The luminaries in the closet is a fire hazard. It should be replaced with luminaries identified for use within the closet storage space. Such as surface or recessed incandescent or LED luminaries with an enclosed light source. Surface or recessed fluorescent luminaries are also permitted.

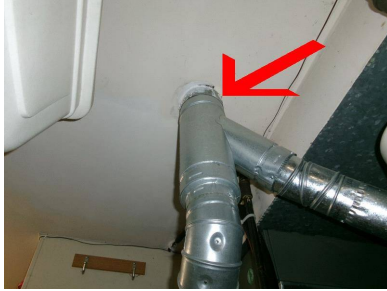
### *VENT*

The furnace vent connector is too close to a combustible material. This is a hazard. A minimum clearance of 6" is required between the single wall vent connector and the combustible material. The double wall type B vent requires only 1" of clearance. Repairs are recommended.

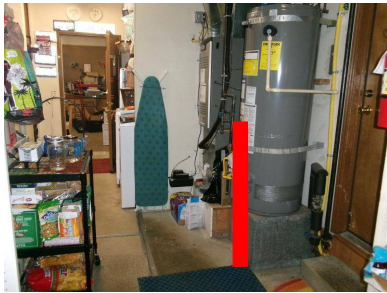
### *GAS PIPING*

The gas pipes in front of the furnace and water heater are not protected by a bumper stop. A vertical steel pipe, bolted to the floor, is typically installed in front of the water heater to prevent a car bumper from damaging the gas lines.

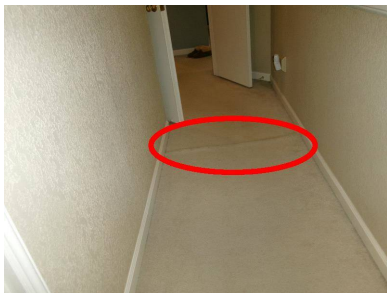
### *FLOORS*

The carpeting is loose and buckling. Re-stretching the carpet is recommended to avoid trip hazards.

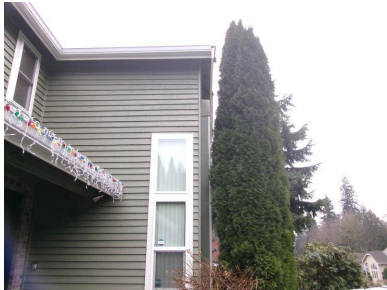
#### **VEGETATION**

Trees are nearly touching the building on both the south side. Low hanging tree branches can damage the roof, siding, doors and windows. Tree branches should be trimmed back where necessary.

Page 6 Trees trimmed back 12/23/23, done.

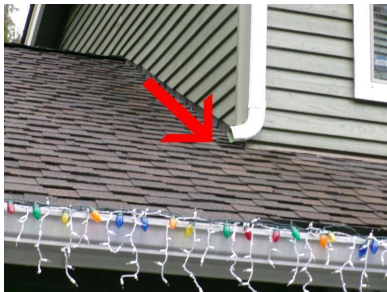
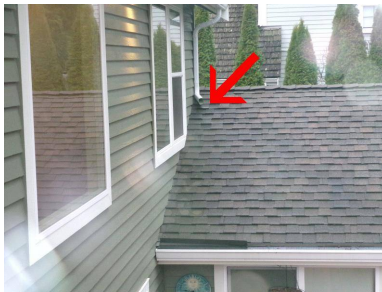
#### **GUTTERS AND DOWNSPOUTS**

Downspouts draining directly onto the asphalt shingle surface causes excessive wear of the roofing material. Downspout extensions to the lower gutters should be installed to prevent excessive wear and tear of the roofing.

Page 7 Downspouts extended, done.

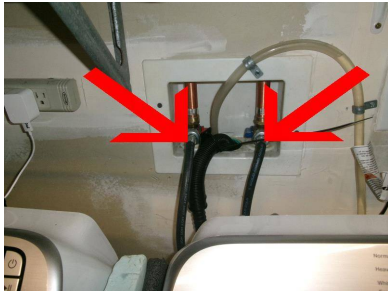
#### APPLIANCES

Upgrading the washer connections to high pressure (steel braided) lines is recommended.

Page 11 Appliances professionally installed recently, and they used UPC rated hoses.

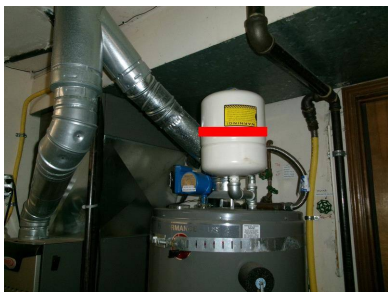
### EXPANSION TANK

The expansion tank is not adequately secured to the wall. As code requirements start to call for engineered expansion tank supports we recommend the installation of seismic restraints to secure the expansion tank instead of allowing it to simply depend on piping connections that could result in damage to the water pipe and leakage during an earthquake.

Page 18 Expansion tank has been supported to structure.

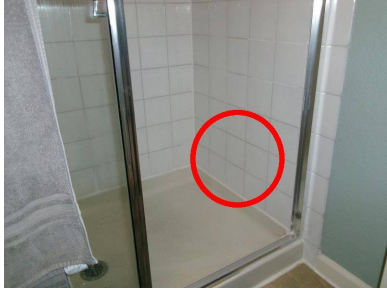
SHOWER

There are areas of the lower shower wall surround tiles where water may be penetrating into the wall. The grout in and around the shower wall tiles is in poor condition. The wall surround should be regouted to prevent moisture penetration into the surrounding materials and subsequent damage.

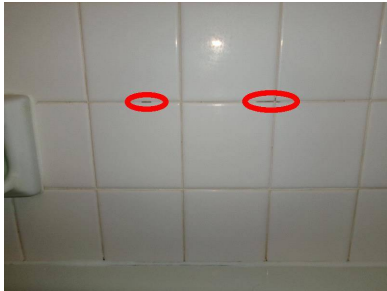
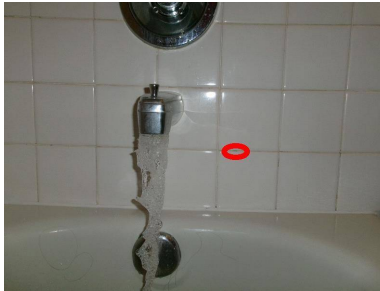
TUB WALLS

Grout is missing from between some of the wall tiles. This can allow water to enter through the tile and can damage the walls. Regrouting the wall tile is recommended.

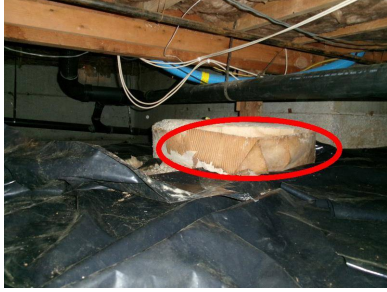
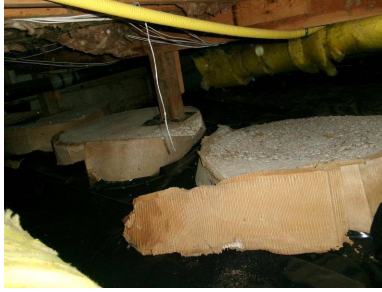
PEST CONTROL

Cellulose forms were left in place on the pier footings. This cellulose is conducive to the infestation of various wood destroying organisms. The removal of the cellulose is recommended.

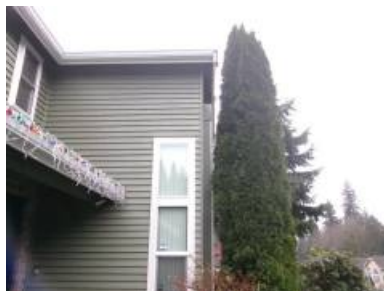
Trees are nearly touching the building on both the south side. Low hanging tree branches can damage the roof, siding, doors and windows. Tree branches should be trimmed back where necessary.

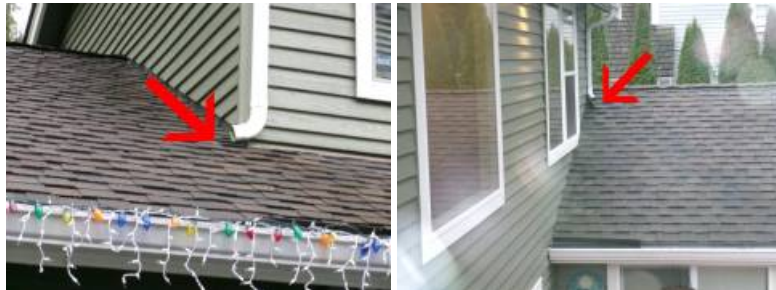
Downspouts draining directly onto the asphalt shingle surface causes excessive wear of the roofing material. Downspout extensions to the lower gutters should be installed to prevent excessive wear and tear of the roofing.

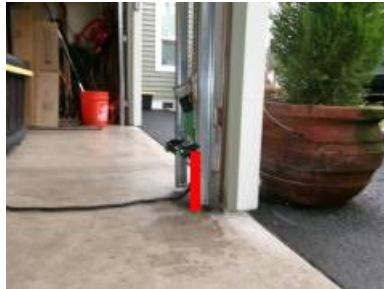
The Photo-eye beam was installed too high above the floor of the garage to adequately offer protection for small children and/or pets. We recommend that the photo-eye be lowered to within 4-6" of the floor.

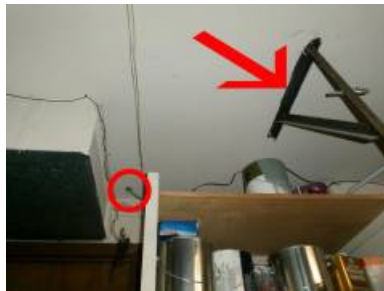
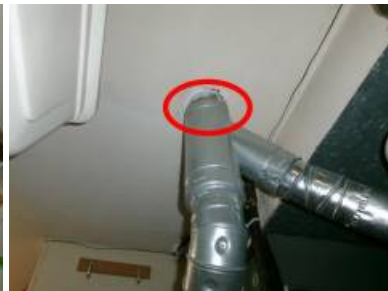
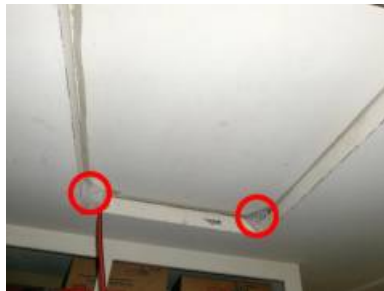
#### FIRE SEPARATION

There are voids in the fire resistive barrier between the living space and garage that will allow flames to penetrate. The gypsum barrier slows the spread of a fire from the garage to the structure and/or living space. Patching the voids with a fire retardant caulk is recommended.

The installation of a furnace vent thimble is recommended to prevent flames from spreading to the structure.

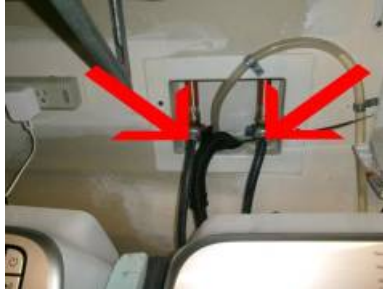
Upgrading the washer connections to high pressure (steel braided) lines is recommended.

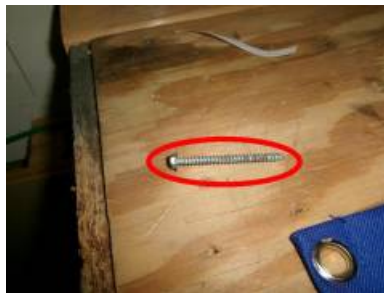
Screws that secure the sub panel cover to the panel box are the wrong type. This is a potential hazard. Screws should be replaced with the original style blunt end screws.

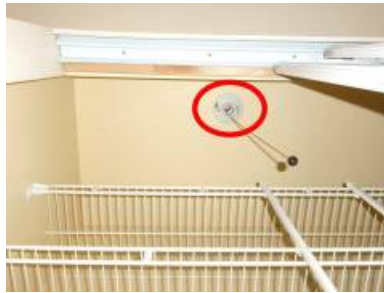
The luminaries in the closet is a fire hazard. It should be replaced with luminaries identified for use within the closet storage space. Such as surface or recessed incandescent or LED luminaries with an enclosed light source. Surface or recessed fluorescent luminaries are also permitted.

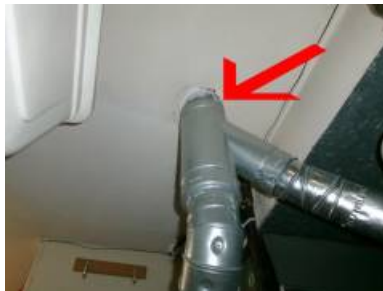
The furnace vent connector is too close to a combustible material. This is a hazard. A minimum clearance of 6" is required between the single wall vent connector and the combustible material. The double wall type B vent requires only 1" of clearance. Repairs are recommended.

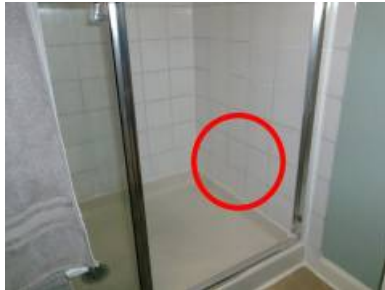
LOCATION	Primary Bedroom.
SHOWER	The shower walls are properly installed and are in serviceable condition.
	There are areas of the lower shower wall surround tiles where water may be penetrating into the wall. The grout in and around the shower wall tiles is in poor condition. The wall surround should be regouted to prevent moisture penetration into the surrounding materials and subsequent damage.

Page 20 Powder room faucet and drain stop replaced. Installed new GFCI-TR outlet and tested, primary bathroom grout was patched and properly sealed, new faucets and drain stops installed, backsplashes, sinks and countertops re-caulked and re-grouted.

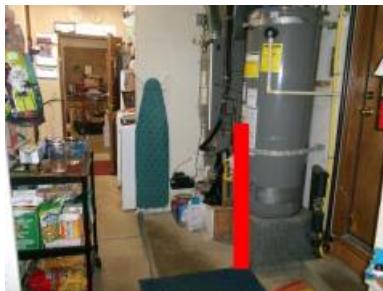
The gas pipes in front of the furnace and water heater are not protected by a bumper stop. A vertical steel pipe, bolted to the floor, is typically installed in front of the water heater to prevent a car bumper from damaging the gas lines.

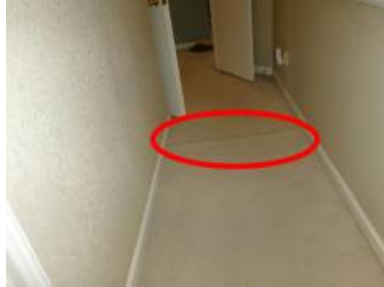
#### FLOORS

The carpeting is loose and buckling. Re-stretching the carpet is recommended to avoid trip hazards.

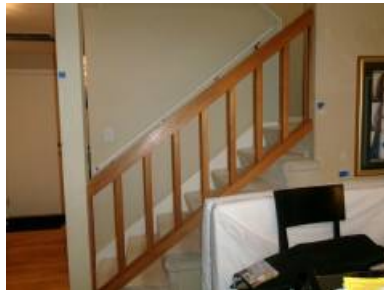
#### STAIRS

The stair railing baluster spacing is too wide. This is a hazard for small children. The baluster spacing should be reduced as a safety upgrade. Current standards require that a 4-3/8" sphere not pass through the railing.
