NOTICE TO BUYER: SELLER-PROCURED INSPECTION REPORT

**Douglas and MaryLou Sales
9808 NE 140th PI
Kirkland WA 98034**

At your request, a visual inspection of the above referenced property was conducted on 02/13/2024. We have inspected the major structural components, plumbing, heating and electrical systems for signs of significant non-performance, excessive or unusual wear and general state of repair.

DATE OF INSPECTION: 2/13/2024.
 INSPECTOR'S NAME: Terry Clark.
 CLIENT NAME: Mr. & Mrs. Doug & MaryLou Sales.
 MAILING ADDRESS: 9808 NE 142nd Pl.
 Kirkland WA.
 CLIENT E-MAIL ADDRESS: dmsalez@hoymail.com; extrahands@comcast.net.
 ADDRESS OF PROPERTY: 9808 NE 142nd Pl.
 INSPECTED: Kirkland, WA.

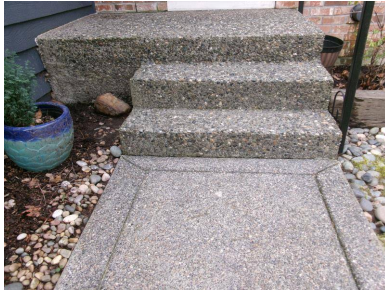
PORCH STEPS

The steps are non-conforming due to the variable and/or excessive rise. Stair design standards require that step risers do not exceed 8" and that the variation in rise not exceed 3/8" in order to reduce falls from tripping. To increase the margin of safety, consideration should be given to reconfiguring the steps so that rise and run do not vary by more than 3/8". If this proves to be too impractical or expensive, then we recommend exercising caution when using.

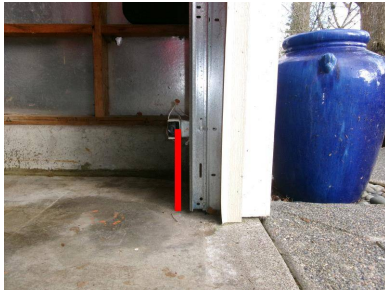
GARAGE DOOR OPENER

The Photo-eye beam was installed too high above the floor of the garage to adequately offer protection for small children and/or pets. We recommend that the photo-eye be lowered to within 4-6" of the floor.

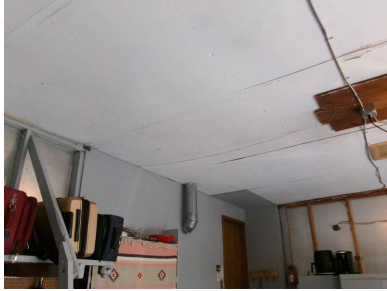
FIRE SEPARATION

The fire resistive barrier between the garage and the living space is properly installed and in good condition, however, several of the ceiling joints are not taped. Consideration should be given to "fire taping" the drywall as a safety upgrade.

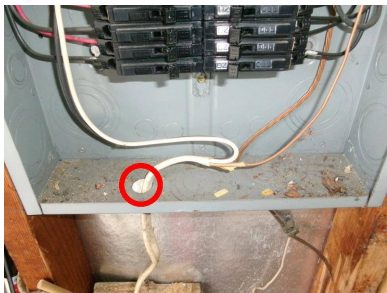
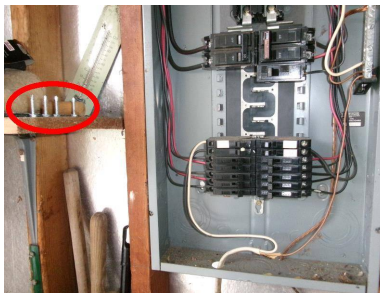
There is an electrical cable emanating from the service panel that is not clamped. The sharp edge of the panel box could cut through the wire insulation and cause a short circuit or fire. Clamping the cable to the panel box using an approved cable clamp is recommended.

Screws that secure the panel cover to the panel box are the wrong type. This is a potential hazard. Screws should be replaced with the original style blunt end screws.

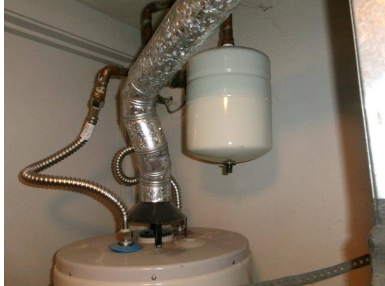
EXPANSION TANK

The expansion tank is not adequately secured to the wall. As code requirements begin to call for engineered expansion tank supports we recommend the installation of seismic restraints to secure the expansion tank instead of allowing it to simply depend on piping connections that could result in damage to the water pipe and leakage during an earthquake.

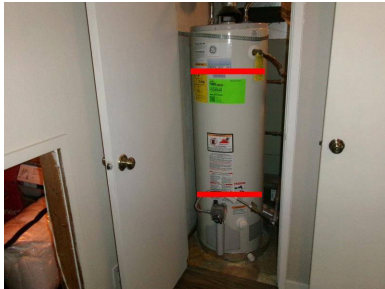
SEISMIC RESTRAINT

The seismic restraint for the water heater was minimal. Proper strapping is recommended to adequately secure the tank and provide potable water in the event of an earthquake.

- A. Strap water heater.
- B. Caulk tub/floor transition in upper bathroom.

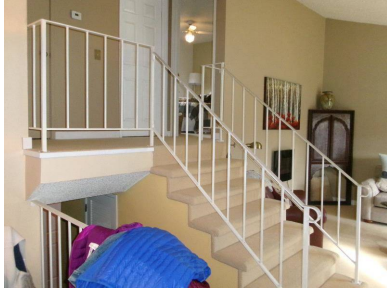
The stair railing baluster spacing is too wide. This is a hazard for small children. The baluster spacing should be

reduced as a safety upgrade. Current standards require that a 4-3/8" sphere not pass through the railing.

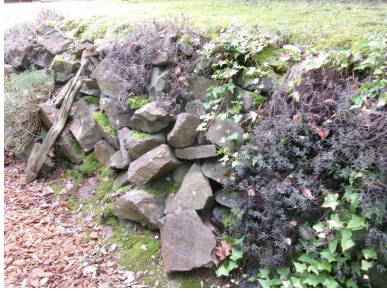
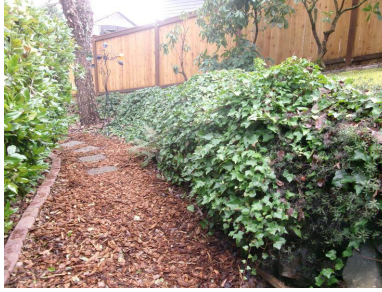
We observed displacement of numerous rocks and soils are migrating out from behind the rocks. Landscape foam adhesives can be strategically applied to block the soils movement and directing the drainage. Planting ground cover plants that anchor soil in place can be placed in the voids. Allowing for drainage at the base of the rockery is advised.

Poor construction or old age? Poor construction can come in many forms. Such as improper wall weight or anchor system to the soil load behind the wall, improper drainage system, incorrect base construction, or improper back fill techniques. Any one, or combination of these can result in wall failure.

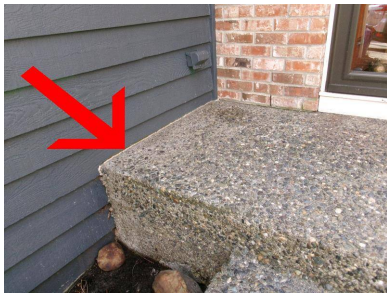
PEST CONTROL

Untreated wood in direct contact with concrete was observed along the stoop. Untreated wood should be raised 1-2" above the concrete. Treating the wood with a preservative sometimes will prevent wood destroy organism damage.

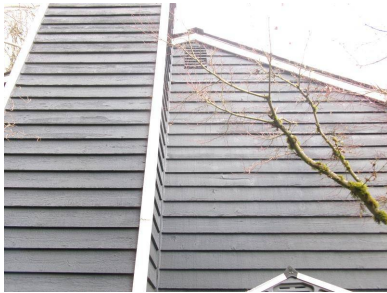
PAINT

The paint on the high exposure areas of the exterior is deteriorated. Paint protects the wood from cupping, checking, warping and rot. Repainting the exposed areas is recommended.

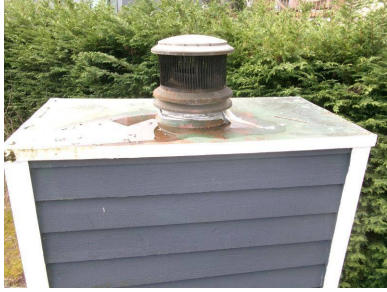
CHIMNEYS

The chase cover for the fireplace is concave and holds water. This has resulted in corrosion of the sheet metal. When rust holes form the cover will begin to leak. Chase cover replacement is recommended. The new chase cover should be sloped for drainage.

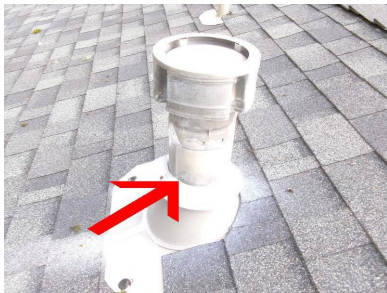
GAS APPLIANCE VENTS

The storm collar is not sealed. This is allowing leakage to occur. Sealing the storm collar is recommended.

- A. Reseat Upper Floor Toilet.
- B. Reseal storm collar on roof Gas Appliance Vent.
- C. Perform repairs per attached Wu Construction estimate dated 2/12/2024.

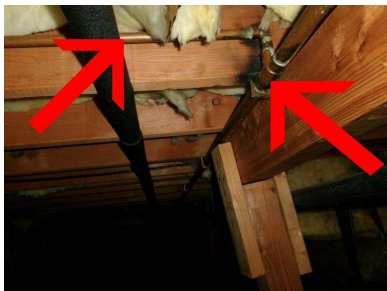
There are water pipes in the crawlspace that are not adequately insulated and could freeze. The installation of foam pipe insulation on all exposed water pipes is recommended.

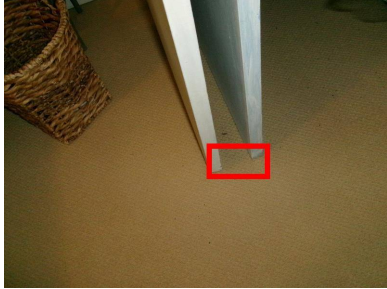
The floor guides are missing from the bypass closet doors in the bedroom. Missing floor guides could result in damage to the doors. The installation of floor guides is recommended.

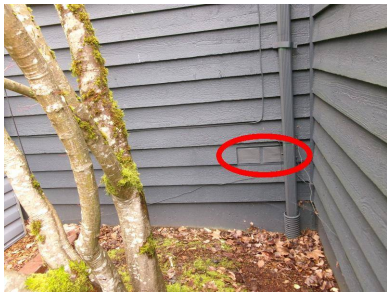
VENTILATION

The vents are covered with louvered vent covers. This type of vent cover blocks the flow of air and the screen behind the cover becomes easily clogged with dust and dirt. Better ventilation can be achieved by installing 1/4" wire mesh over the vents.

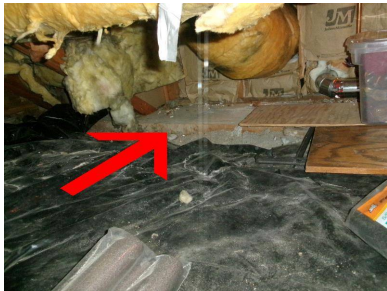
PEST CONTROL

Form wood was left in place on the concrete pad. This wood is conducive to the infestation of various wood destroying organisms. The removal of the form wood is recommended.

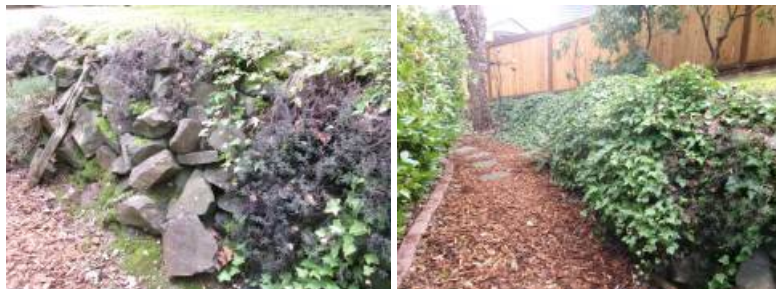
Poor construction or old age? Poor construction can come in many forms. Such as improper wall weight or anchor system to the soil load behind the wall, improper drainage system, incorrect base construction, or improper back fill techniques. Any one, or combination of these can result in wall failure.

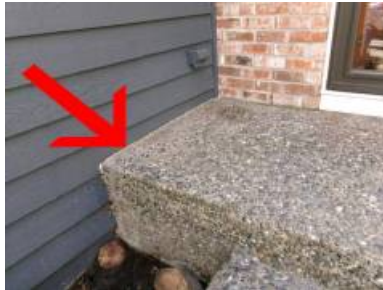
Untreated wood in direct contact with concrete was observed along the stoop. Untreated wood should be raised 1-2" above the concrete. Treating the wood with a preservative sometimes will prevent wood destroy organism damage.

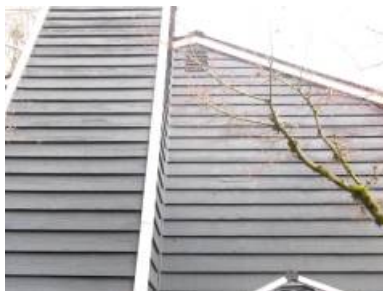
The paint on the high exposure areas of the exterior is deteriorated. Paint protects the wood from cupping, checking, warping and rot. Repainting the exposed areas is recommended.

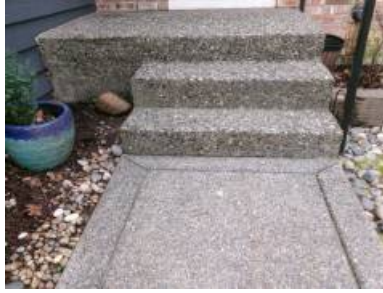
by more than 3/8". If this proves to be too impractical or expensive, then we recommend exercising caution when using.

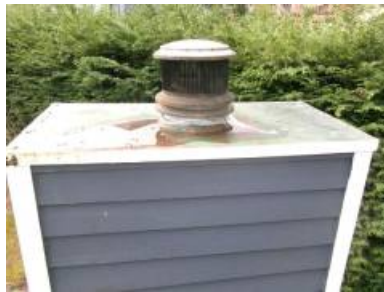
The chase cover for the fireplace is concave and holds water. This has resulted in corrosion of the sheet metal. When rust holes form the cover will begin to leak. Chase cover replacement is recommended. The new chase cover should be sloped for drainage.

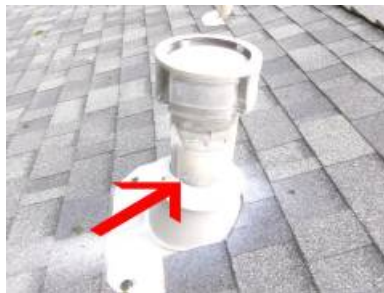
GAS APPLIANCE VENTS

The storm collar is not sealed. This is allowing leakage to occur. Sealing the storm collar is recommended.

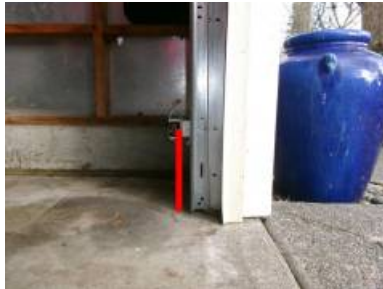
The Photo-eye beam was installed too high above the floor of the garage to adequately offer protection for small children and/or pets. We recommend that the photo-eye be lowered to within 4-6" of the floor.

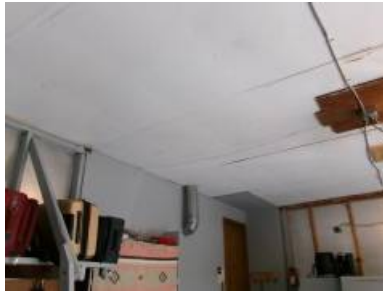
FIRE SEPARATION

The fire resistive barrier between the garage and the living space is properly installed and in good condition, however, several of the ceiling joints are not taped. Consideration should be given to "fire taping" the drywall as a safety upgrade.

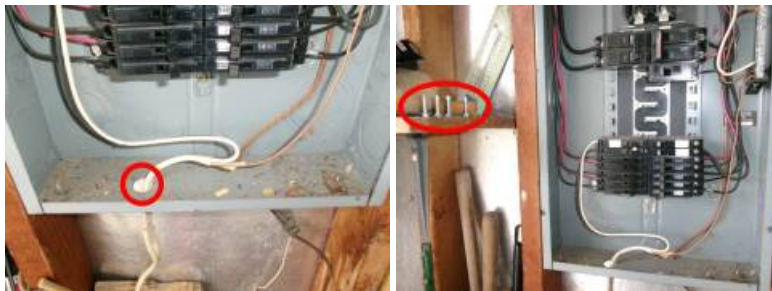
Screws that secure the panel cover to the panel box are the wrong type. This is a potential hazard. Screws should be replaced with the original style blunt end screws.

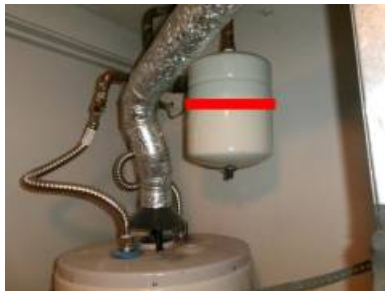
<i>LOCATION OF UNIT</i>	The water heater is located in the garage.
<i>GENERAL INFORMATION</i>	The water heater fuel is natural gas. The capacity of the water heater is 40 gallons. The input rating of the burner is approximately 38,000 BTU. The water heater is approximately 15 years old. Water heaters of this type typically last about 10-15 years.
<i>PRESSURE RELIEF VALVE</i>	The pressure relief valve is properly installed. The valve was not tested, as this could cause the valve to leak.
<i>SHUTOFF VALVE</i>	The shutoff valve for the water supply to the water heater is properly installed and is functioning as intended.
<i>WATER CONNECTIONS AT TANK</i>	The water connections at the tank are properly installed and are performing their intended function.
<i>EXPANSION TANK</i>	The expansion tank is not adequately secured to the wall. As code requirements begin to call for engineered expansion tank supports we recommend the installation of seismic restraints to secure the expansion tank instead of allowing it to simply depend on piping connections that could result in damage to the water pipe and leakage during an earthquake.

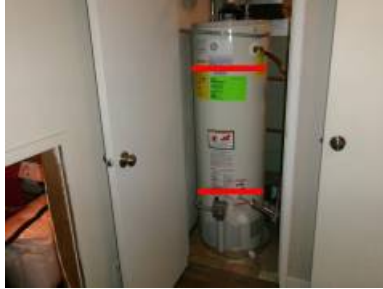
<i>SEISMIC RESTRAINT</i>	The seismic restraint for the water heater was minimal. Proper strapping is recommended to adequately secure the tank and provide potable water in the event of an earthquake.

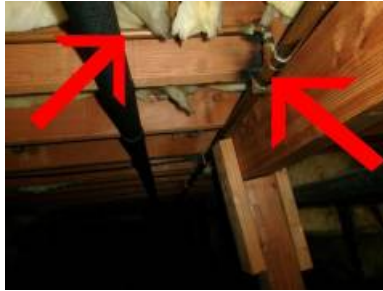
There are water pipes in the crawlspace that are not adequately insulated and could freeze. The installation of foam pipe insulation on all exposed water pipes is recommended.

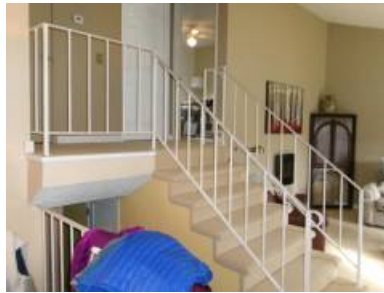
The stair railing baluster spacing is too wide. This is a hazard for small children. The baluster spacing should be reduced as a safety upgrade. Current standards require that a 4-3/8" sphere not pass through the railing.

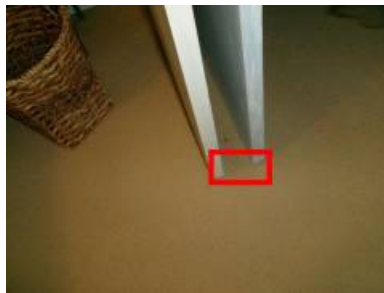
The floor guides are missing from the bypass closet doors in the bedroom. Missing floor guides could result in damage to the doors. The installation of floor guides is recommended.

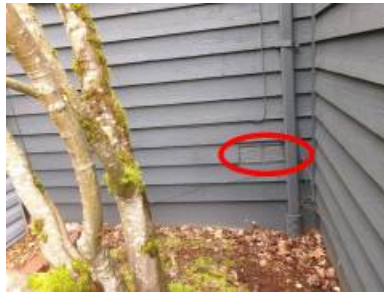
The vents are covered with louvered vent covers. This type of vent cover blocks the flow of air and the screen behind the cover becomes easily clogged with dust and dirt. Better ventilation can be achieved by installing 1/4" wire mesh over the vents.

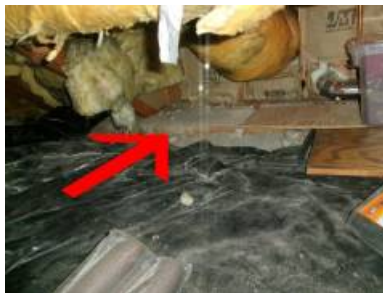
Good building practice requires that foundation walls or pier footings supporting wood frame construction, should extend at least 8" above the finish grade with at least a 6" clearance between the top of the soil and the bottom of the wood finish materials. Untreated wood should be raised 1-2" above surrounding flatwork and should have a moisture barrier such as 30 lb. asphalt impregnated felt installed between the concrete and wood. For additional information and treatment options, you should retain the services of a qualified pest control operator.
