NOTICE TO BUYER: SELLER-PROCURED INSPECTION REPORT

The following notice is given with respect to the Purchase and Sale Agreement dated _____ between _____ (“Buyer”) and **Estate of Mary K Howard** _____ (“Seller”) concerning **3671 225th Pl SE 1301 Issaquah WA 98029** (“the Property”).

CLIENT & SITE INFORMATION:

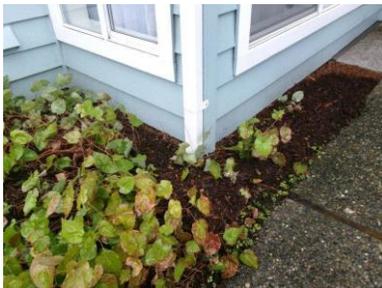
Soil is close to or in contact with siding in some areas around the building exterior. Good building practice requires that foundation walls or pier footings supporting wood frame construction, extend at least 8" above the finish grade with at least a 6" clearance between the top of the soil and the bottom of the wood finish materials. Soil in direct contact with wood creates a hospitable environment for wood destroying organisms. Establishing these minimum clearances is recommended.

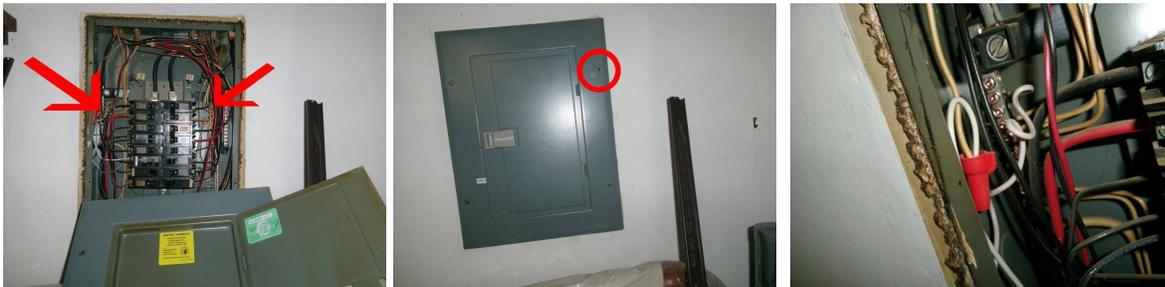
SERVICE PANEL

Several of the neutral wires are double tapped on the buss bar. Double tapping means that two conductors share a single terminal. Double tapped terminals can loosen and overheat and therefore are not permitted unless the terminal is specifically listed for multiple wires. This defect is easily repaired by connecting the two wires to a "pig tail", securing them with a wire cap, and then inserting the pig tail conductor under the terminal.

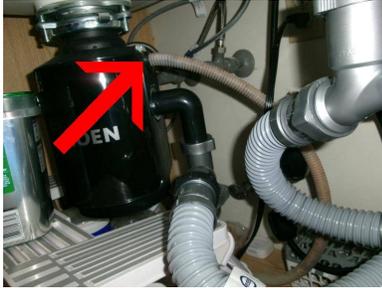
AIR GAP

The dishwasher drain lacks an air gap. The dishwasher will function without one, but there is a risk of contamination of the inside of the dishwasher by waste water. The installation of an air gap above the flood rim of the sink is recommended.

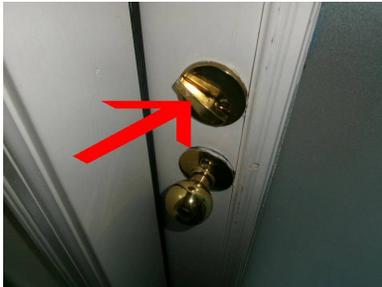
DOORS

The handle to the patio door deadbolt is loose. It should be repaired as necessary.

All locks on all outbound doors have been replaced and re-keyed to the same key.

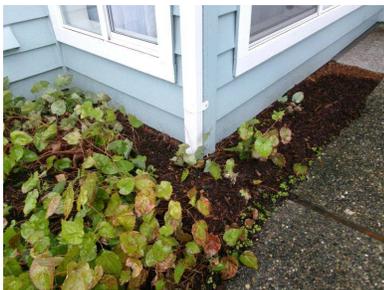
PEST CONTROL

Soil is close to or in contact with siding in some areas around the building exterior. Good building practice requires that foundation walls or pier footings supporting wood frame construction, extend at least 8" above the finish grade with at least a 6" clearance between the top of the soil and the bottom of the wood finish materials. Soil in direct contact with wood creates a hospitable environment for wood destroying organisms. Establishing these minimum clearances is recommended.

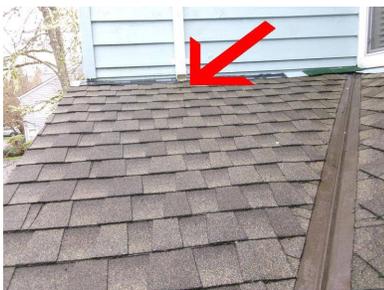
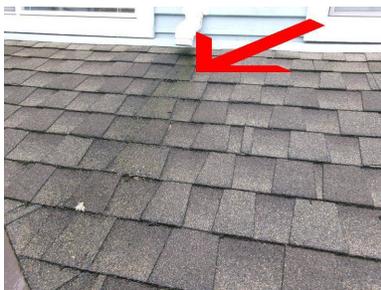
GUTTERS AND DOWNSPOUTS

Downspouts draining directly onto the asphalt shingle surface causes excessive wear of the roofing material. Downspout extensions to the lower gutters should be installed to prevent excessive wear and tear of the roofing.

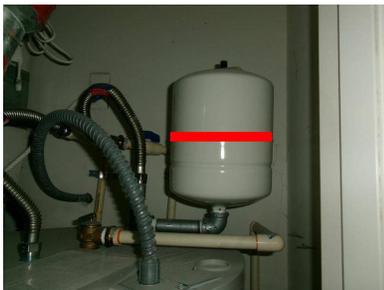
EXPANSION TANK

The expansion tank is not adequately secured to the wall. As code requirements start to call for engineered expansion tank supports we recommend the installation of seismic restraints to secure the expansion tank instead of allowing it to simply depend on piping connections that could result in damage to the water pipe and leakage during an earthquake.

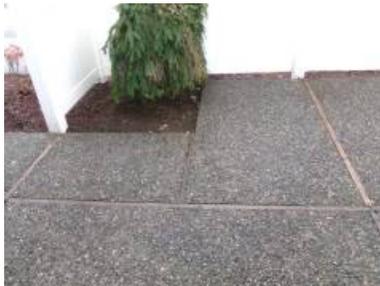
PATIO The wooden dividers separating the concrete patio sections will eventually deteriorate to a condition where the gaps would be a trip hazard. Replacement with mortar is recommended.

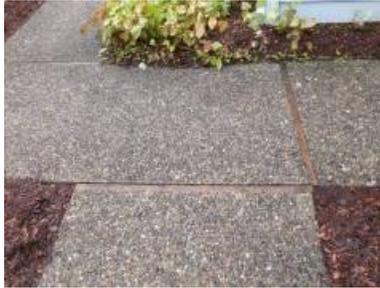
WALKWAY When the wooden dividers separating the concrete walkway sections have deteriorated to a point where they become a trip hazard. Replacement with mortar is recommended.

Many legal and public works departments have defined a trip hazard as an irregularity in a walking surface exceeding one inch (1") in height. All walking surfaces should maintain, free of a vertical surface change of 3/4" or more, in the interest of public and personal safety.

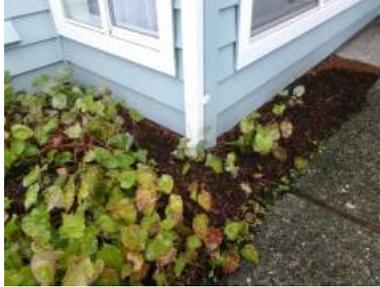
PEST CONTROL Soil is close to or in contact with siding in some areas around the building exterior. Good building practice requires that foundation walls or pier footings supporting wood frame construction, extend at least 8" above the finish grade with at least a 6" clearance between the top of the soil and the bottom of the wood finish materials. Soil in direct contact with wood creates a hospitable environment for wood destroying organisms. Establishing these minimum clearances is recommended.

Good building practice requires that foundation walls or pier footings supporting wood frame construction, extend at least 8" above the finish grade with at least a 6" clearance between the top of the soil and the bottom of the wood finish materials. Untreated wood should be raised 1-2" above surrounding flatwork and should have a moisture barrier installed between the concrete and wood.

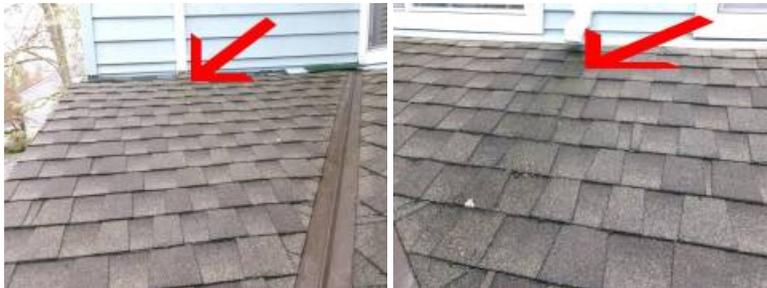
Downspouts draining directly onto the asphalt shingle surface causes excessive wear of the roofing material. Downspout extensions to the lower gutters should be installed to prevent excessive wear and tear of the roofing.

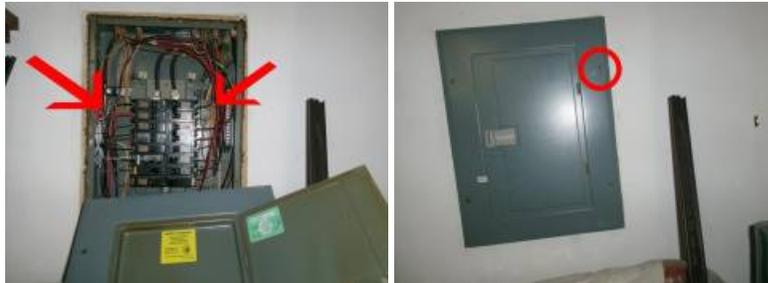
- SERVICE PANEL* The electrical service panel is properly installed and in serviceable condition except where noted below.

Several of the neutral wires are double tapped on the buss bar. Double tapping means that two conductors share a single terminal. Double tapped terminals can loosen and overheat and therefore are not permitted unless the terminal is specifically listed for multiple wires. This defect is easily repaired by connecting the two wires to a "pig tail", securing them with a wire cap, and then inserting the pig tail conductor under the terminal.

Screws that secure the panel cover to the panel box are missing. This is a potential hazard. Missing screws should be replaced with the original style blunt end screws.

Replaced screws

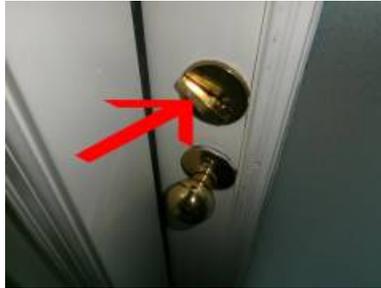
The handle to the patio door deadbolt is loose. It should be repaired as necessary.

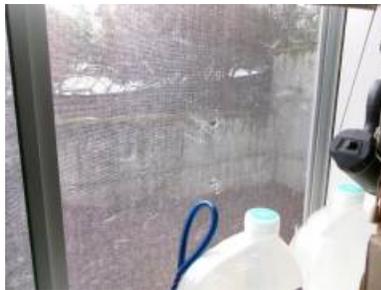
One of the window screens is damaged. Damaged screens should be repaired or replaced so that the window(s) can be left open for ventilation as designed.

Screen replaced.
