NOTICE TO BUYER: SELLER-PROCURED INSPECTION REPORT

19614 222nd Ave NE, Woodinville, WA 98077

At your request, a visual inspection of the above referenced property was conducted on 09/22/2020. We have inspected the major structural components, plumbing, heating and electrical systems for signs of significant non-performance, excessive or unusual wear and general state of repair.

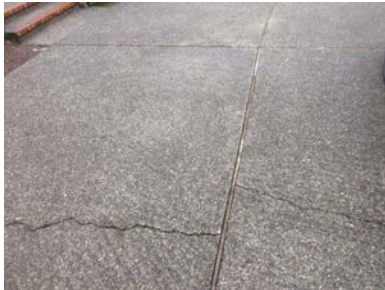
One or more of the wooden dividers separating the concrete driveway sections were infested by wood destroying organisms and have deteriorated to a point where they are becoming a trip hazard. Replacement with mortar is recommended.

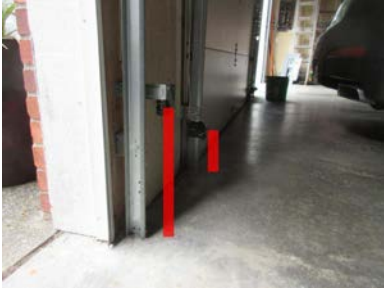
6.3 GARAGE DOOR OPENER

The Photo-eye beam was installed to high above the floor of the east garage to adequately offer protection for small children and/or pets. We recommend that the photo-eye be lowered to within 4-6" of the floor.

- 6.3: Garage door opener. Garage door photo-eye beam relocated to 4"-6" off floor.
 - 7.10 – sub panel breakers will be labelled clearly
 - 7.14 – Loose receptacles will be tightened and repaired, and cover plate will be added to receptacle in crawl space

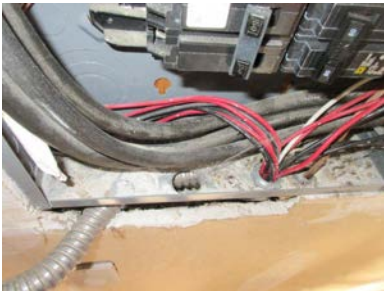
7.9 SERVICE PANEL

There are openings in the panel box where knock-outs have been removed. Missing knock-outs should be replaced with snap in metal plugs.

- 7.9 - Snap in plug installed in main circuit breaker box in garage where knock outs had been removed
- 7.10 - Snap in plug installed in sub panel box where knock outs had been removed
- 7.12 – An approved electrical connection box was installed in east attic area, and splices moved inside box per code.
- 8.2 – gas pipe in garage was secured with metal brackets on ceiling
- 9.10 – Approved water heater seismic restraint straps were installed to secure water heater to the wall
- 13.10 – gas pipe supply line in garage was secured with additional metal strap brackets on ceiling
- 14.7 – installed the additional smoke detector per code. There are smoke detectors in every bedroom, as well as in hallway outside bedrooms and hallway downstairs

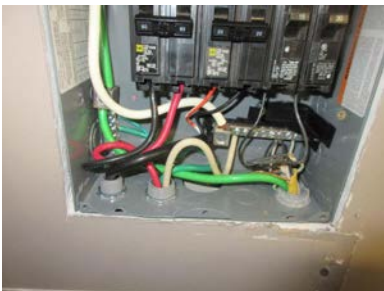
7.10 SUBPANEL

There are openings in the panel box where knock-outs have been removed. Missing knock-outs should be replaced with snap in metal plugs.

The circuits are not labeled. Each circuit breaker should be labeled to allow servicing and repair of electrical circuits and equipment without having to shut off power to all electrical circuits. The services of a qualified electrician should be retained to perform this service.

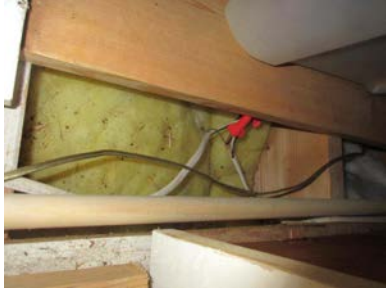
7.12 WIRING

Splices in cable made outside of a junction box were observed in the east attic. This is a fire hazard. The splices should be made inside an approved box with a cover.

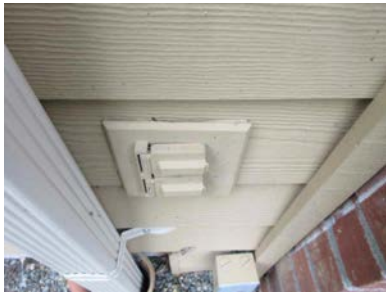
7.14 RECEPTACLES

The exterior receptacle adjacent the chimney is loose. This is a potential shock and a fire hazard. All loose receptacles should be repaired as necessary.

The receptacle adjacent the crawl space access is loose. This is a potential shock and a fire hazard. All loose receptacles should be repaired as necessary.

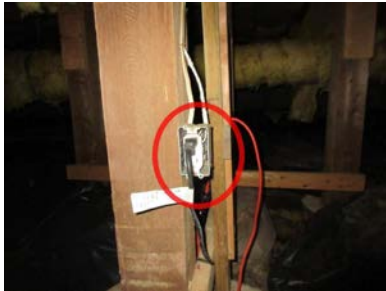
The cover plate is missing from a receptacle in the crawlspace. This is a shock and fire hazard. The installation of a cover plate is recommended.

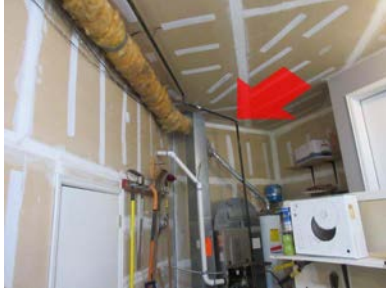
The vertical portion of the gas pipe is not adequately secured. Movement of the gas pipe could crack the flexible gas connector. The gas pipe should be secured in such a manner as to prevent lateral movement.

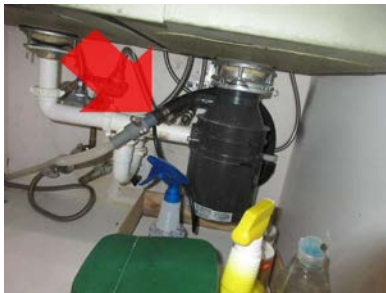
The dishwasher drain lacks an air gap. The dishwasher will function without one, but there is a risk of contamination of the inside of the dishwasher by waste water. The installation of an air gap is recommended.

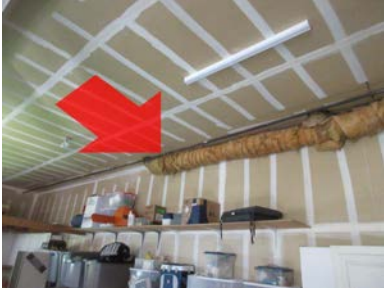
The gas pipe in the garage was not adequately secured. This can damage the pipe. The gas pipe should be secured in accordance with industry standards.

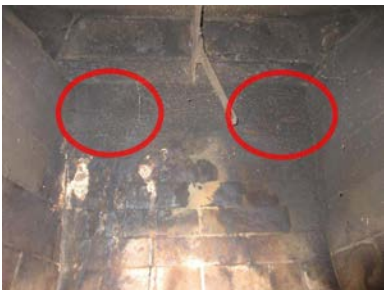
An examination of the inside of the chimney revealed an accumulation of creosote. Smoldering fires and the burning of green or wet wood are the primary contributors to creosote build-up. Creosote in a chimney flue is dangerous because it is the fuel for a chimney fire. Chimney fires produce intense heat and sparks. The intense heat can crack the flue tile, brick and mortar of a masonry chimney. After holes or cracks have developed, chimney fires can cause the wood framing or roof of the house to catch on fire. To avoid chimney fires, flues should be cleaned and inspected at least once a year with moderate use. More frequent cleaning may be required depending on amount of use and burning practice.

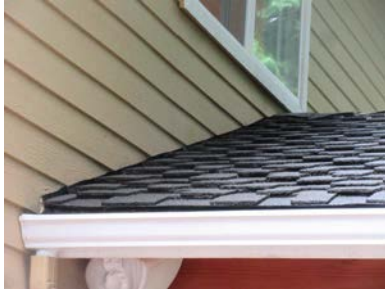
The siding is vulnerable to damage where it has been close to or in contact with the roofing material. The siding should be modified and a minimum of a 2" clearance should be maintained between the top of the roofing and bottom of the siding.

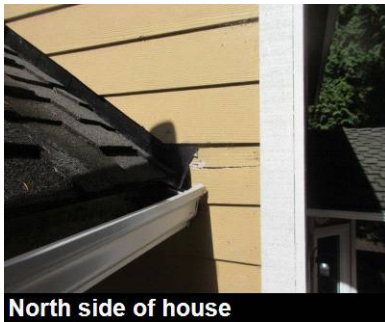
Sections of siding that have cracked should be replaced or flashing installed to prevent moisture or pest entry into these areas.

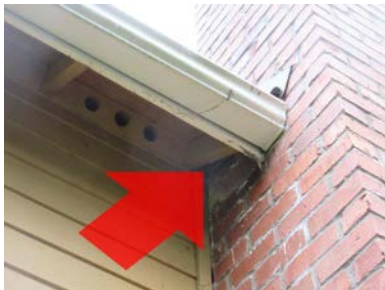
3.3 SOFFITS AND OVERHANGS

There are openings at the intersection between the overhang and the roof and adjacent the chimney through which birds and rodents can enter into the attic. These openings should be covered with wood, wire mesh or filled with aerosol foam.

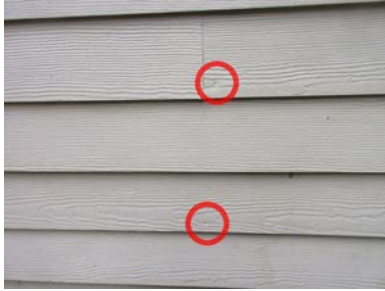
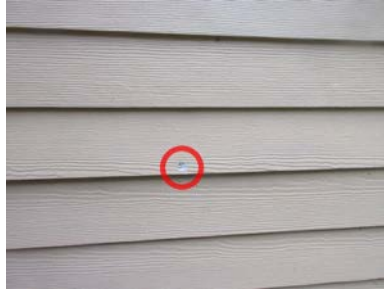
3.5 PAINT

The bottom edge of the lower sections of siding on the exterior are unprotected. Paint protects the siding from moisture absorption and its propensity to hold paint. Painting of the exposed edges is recommended.

Siding nails that have damaged the surface overlay need to be caulked. Caulking prevents water intrusion of

the siding. Consideration should be given to caulking the siding as necessary. Exterior caulking is recommended.

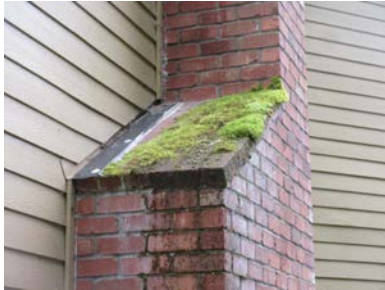
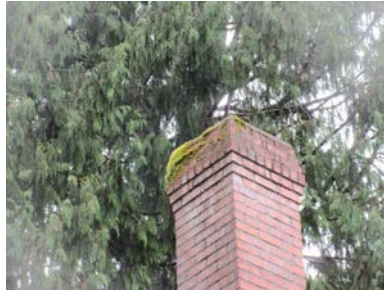
4.3 CHIMNEYS

Moss/vegetation was observed in several areas around the upper portions and at the corbeling of the chimney. This will lead to accelerated deterioration of the brick masonry mortar. We recommend removal of all organic growth. Damaged areas can be repaired by filling in cutout or defective mortar joints with fresh mortar. (Tuck pointing)

- 4.3 Moss will be removed from Chimney on south side of house
 - 5.4 – Issaquah Pest Control is scheduled to perform rodent inspection and all recommended service on October 7th.

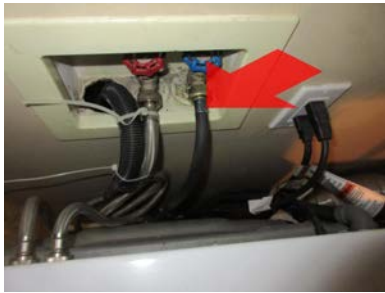
Upgrading all of the washer connections to high pressure (steel braided) lines is recommended.

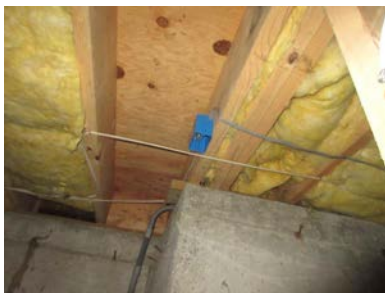
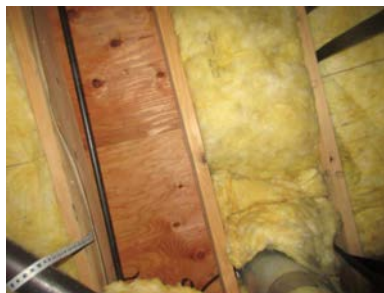
Some of the insulation batts were not properly secured and have falling down. The fallen batts should be reinstalled and secured.

- 10.1 – re-caulking as recommended
 - 11.18 and .33 – repair drain stops
 - 11.22, 31, 37, and 12.2 – re-caulking as recommended
 - 17.3 – repair fallen insulation in crawl space

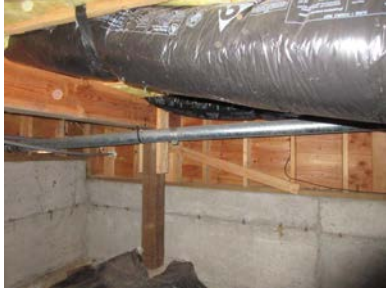
18.6 SHEAR PANELS

Shear panels are plywood or OSB panels that are mechanically fastened to both vertical and horizontal framing members in critical structural areas of the building. They prevent lateral movement of the structure during an earthquake. Shear panels are often visible in the crawlspace on cripple walls between the first floor and foundation. They may also be installed on interior walls that are covered with drywall. An examination of the crawlspace revealed the absence of shear panels on the cripple walls. The installation of shear panels on the cripple walls is recommended as an upgrade.

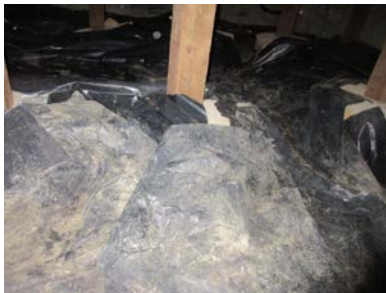
19.4 VAPOR RETARDER

The support post concrete piers are covered with the plastic vapor retarder. This allows the transmission of water vapor from the soil up and into the floor framing. The plastic vapor retarder should be removed from the pier so that it covers at least 85% of the entire surface of the soil only.

- 19.4 – vapor barrier will be adjusted around piers in crawl space
-
2. Seller has also purchased and scheduled installation of a brand-new custom front door and side panels (similar style to existing original door and side panels with glass), as well as replacement window for Kitchen (double pain seal was broken). These are being professionally installed by Washington Energy Services on October 22nd and paid for by seller as gift to buyers. Note buyers will be responsible for painting of the door and side panels after taking possession so they can pick color.

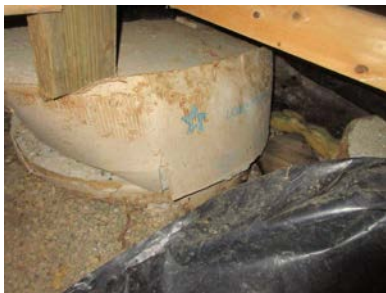
19.5 PEST CONTROL

Cellulose forms were left in place on the pier footings. This cellulose is conducive to the infestation of various wood destroying organisms. The removal of the cellulose is recommended.

Scrap-wood and other cellulose debris was observed on the crawl floor. This wood debris creates conducive conditions for wood boring insects. The removal of all cellulose debris is recommended.

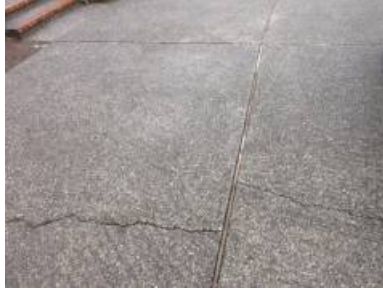
One or more of the wooden dividers separating the concrete driveway sections were infested by wood destroying organisms and have deteriorated to a point where they are becoming a trip hazard. Replacement with mortar is recommended.

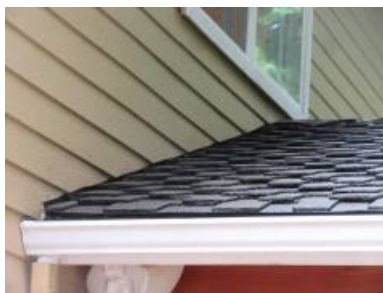
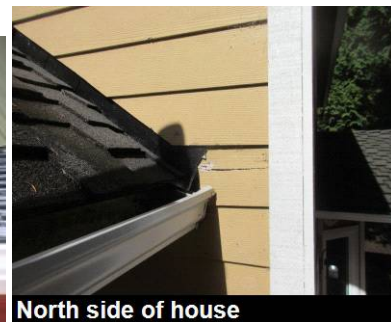
Sections of siding that have cracked should be replaced or flashing installed to prevent moisture or pest entry into these areas.

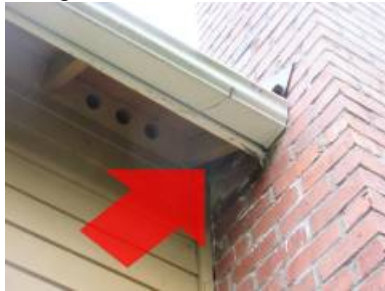
There are openings at the intersection between the overhang and the roof and adjacent the chimney through which birds and rodents can enter into the attic. These openings should be covered with wood, wire mesh or filled with aerosol foam.

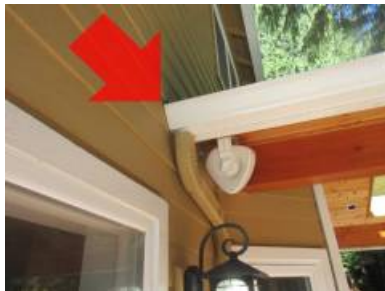
Gutter ends are too close to the siding. Gutter ends should be installed with a 1" clearance from cement fiber board siding.

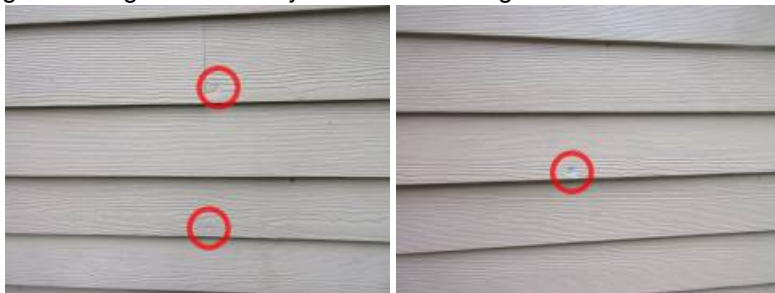
Siding nails that have damaged the surface overlay need to be caulked. Caulking prevents water intrusion of the siding. Consideration should be given to caulking the siding as necessary. Exterior caulking is recommended.

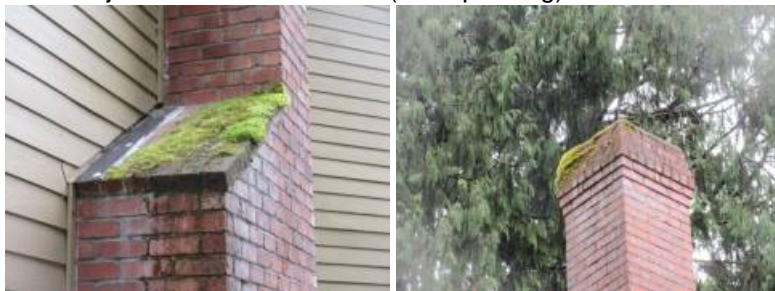
Moss/vegetation was observed in several areas around the upper portions and at the corbeling of the chimney. This will lead to accelerated deterioration of the brick masonry mortar. We recommend removal of all organic growth. Damaged areas can be repaired by filling in cutout or defective mortar joints with fresh mortar. (Tuck pointing)

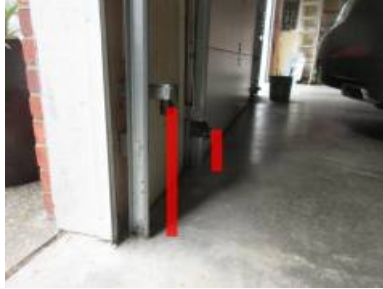
The Photo-eye beam was installed too high above the floor of the east garage to adequately offer protection for small children and/or pets. We recommend that the photo-eye be lowered to within 4-6" of the floor.

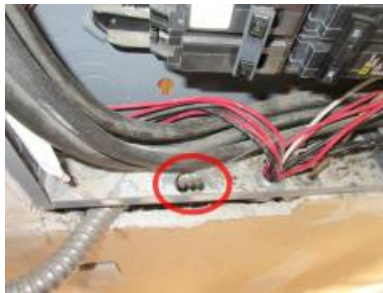
There are openings in the panel box where knock-outs have been removed. Missing knock-outs should be replaced with snap in metal plugs.

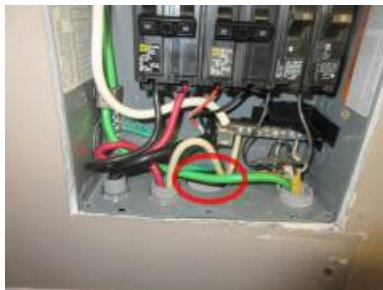
The circuits are not labeled. Each circuit breaker should be labeled to allow servicing and repair of electrical circuits and equipment without having to shut off power to all electrical circuits. The services of a qualified electrician should be retained to perform this service.

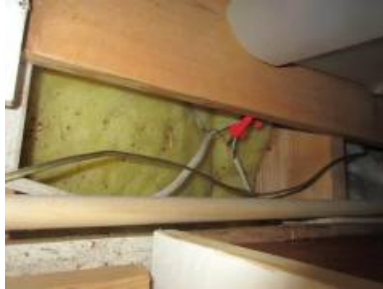
Splices in cable made outside of a junction box were observed in the east attic. This is a fire hazard. The splices should be made inside an approved box with a cover.

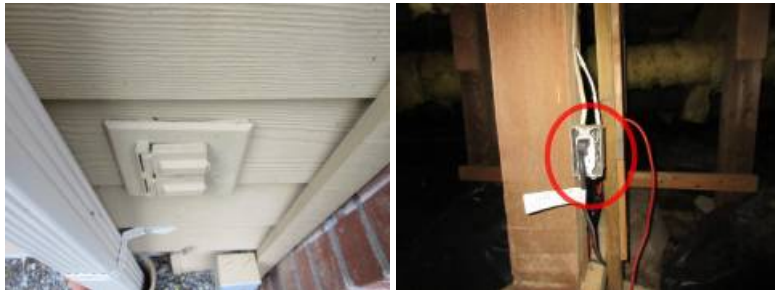
The cover plate is missing from a receptacle in the crawlspace. This is a shock and fire hazard. The installation of a cover plate is recommended.

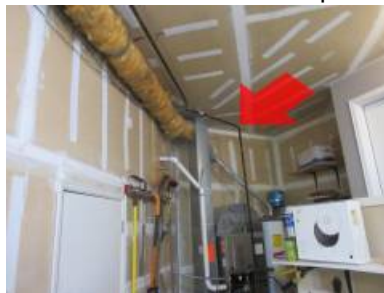
The vertical portion of the gas pipe is not adequately secured. Movement of the gas pipe could crack the flexible gas connector. The gas pipe should be secured in such a manner as to prevent lateral movement.

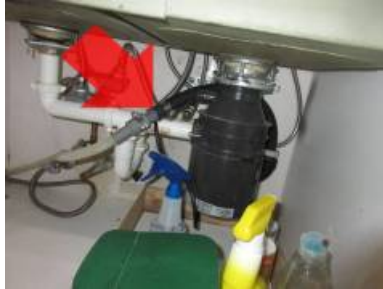
The dishwasher drain lacks an air gap. The dishwasher will function without one, but there is a risk of contamination of the inside of the dishwasher by waste water. The installation of an air gap is recommended.

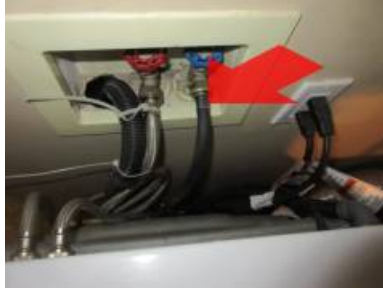
Upgrading all of the washer connections to high pressure (steel braided) lines is recommended.

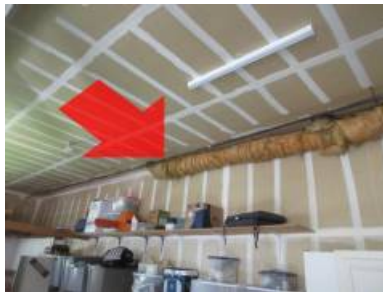
The gas pipe in the garage was not adequately secured. This can damage the pipe. The gas pipe should be secured in accordance with industry standards.

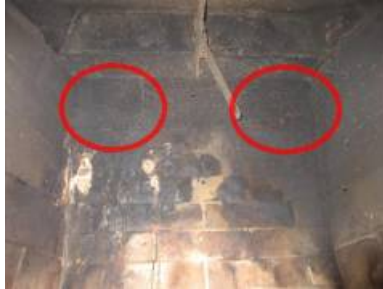
An examination of the inside of the chimney revealed an accumulation of creosote. Smoldering fires and the burning of green or wet wood are the primary contributors to creosote build-up. Creosote in a chimney flue is dangerous because it is the fuel for a chimney fire. Chimney fires produce intense heat and sparks. The intense heat can crack the flue tile, brick and mortar of a masonry chimney. After holes or cracks have developed, chimney fires can cause the wood framing or roof of the house to catch on fire. To avoid chimney fires, flues should be cleaned and inspected at least once a year with moderate use. More frequent cleaning may be required depending on amount of use and burning practice.

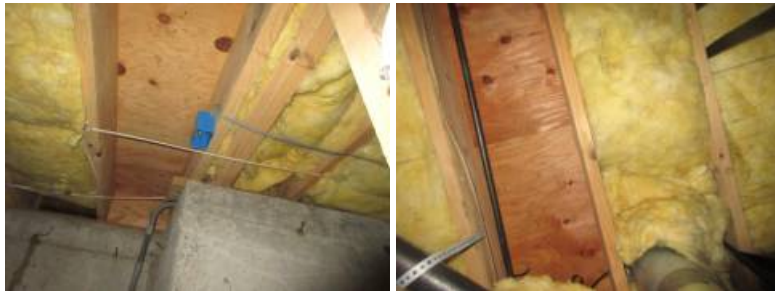
Some of the insulation batts were not properly secured and have falling down. The fallen batts should be reinstalled and secured.

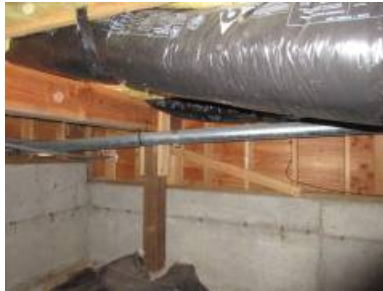
Shear panels are plywood or OSB panels that are mechanically fastened to both vertical and horizontal framing members in critical structural areas of the building. They prevent lateral movement of the structure during an earthquake. Shear panels are often visible in the crawlspace on cripple walls between the first floor and foundation. They may also be installed on interior walls that are covered with drywall. An examination of the crawlspace revealed the absence of shear panels on the cripple walls. The installation of shear panels on the cripple walls is recommended as an upgrade.

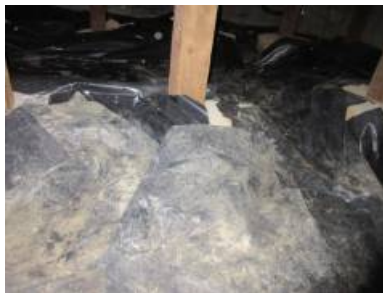
The support post concrete piers are covered with the plastic vapor retarder. This allows the transmission of water vapor from the soil up and into the floor framing. The plastic vapor retarder should be removed from the pier so that it covers at least 85% of the entire surface of the soil only.

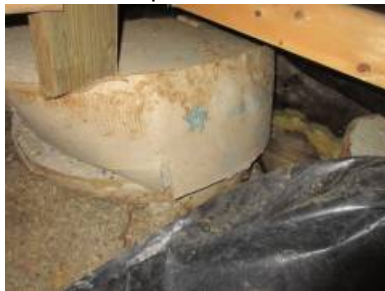
Good building practice requires that foundation walls or pier footings supporting wood frame construction, should extend at least 8" above the finish grade with at least a 6" clearance between the top of the soil and the bottom of the wood finish materials. Untreated wood should be raised 1-2" above surrounding flatwork and should have a moisture barrier such as 30 lb. asphalt impregnated felt installed between the concrete and wood. For additional information and treatment options, you should retain the services of a qualified pest control operator.
