NOTICE TO BUYER: SELLER-PROCURED INSPECTION REPORT

Linda and Roy McIntosh, Sellers
17617 NE 131st Street
Redmond, WA 98052

As of October 13, 2020 the following items listed on inspection summary for this property by Terry Clark have been corrected by the sellers:

At your request, a visual inspection of the above referenced property was conducted on 09/28/2020. We have inspected the major structural components, plumbing, heating and electrical systems for signs of significant non-performance, excessive or unusual wear and general state of repair.

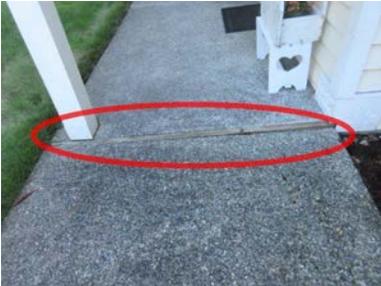
2.6 WALKWAY

The walkway has cracked and settled differentially. This was probably caused by inadequate preparation of the soil prior to the placement of the concrete. This condition can be repaired by pressure grouting the sunken portion of the walkway or by removing and replacing it. Grinding down the raised edges of the concrete will also mitigate the hazard. The walkway remains functional despite this condition. However, the raised edges of the concrete can be a trip hazard for some people. Repairs should be made as necessary.

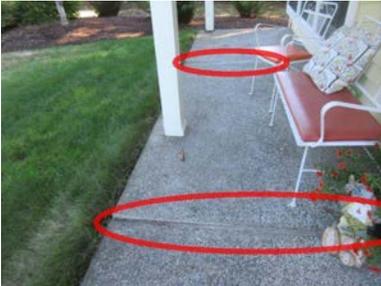
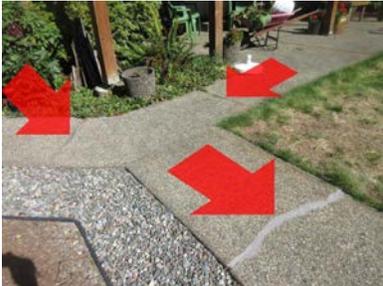
The wooden dividers separating the concrete walkway sections have deteriorated to a point where the gaps are a trip hazard. Replacement with mortar is recommended.

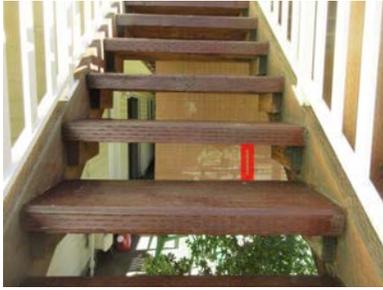
3.8 STAIRS

The stair rise spacing is too wide. This is a hazard for small children. The spacing should be reduced as a safety upgrade. Current standards require that a 4" sphere not pass through the opening.

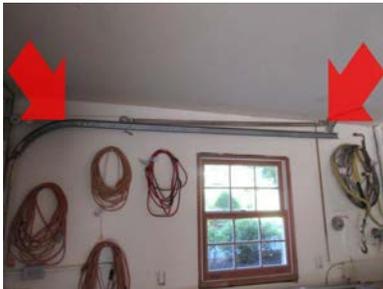
6.2 OVERHEAD GARAGE DOORS

Safeties are cables run through the center of the garage door springs that prevent broken springs from becoming projectiles that can cause injury. There are no safeties installed. The installation of safeties is recommended.

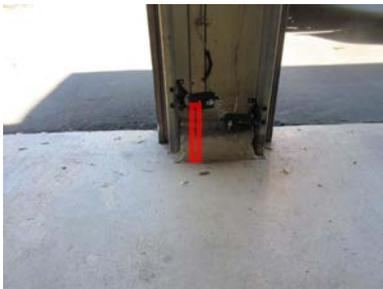
6.3 GARAGE DOOR OPENER

The Photo-eye beam was installed too high above the floor of the garage to adequately offer protection for small children and/or pets. We recommend that the photo-eye be lowered to within 4-6" of the floor.

- 6.3 **Garage Door Opener.** Photo-eye beams have been relocated to 4-6" off floor.
 - 6.4 **Fire Separation.** Voids indicated have been filled with fire resistant caulk.

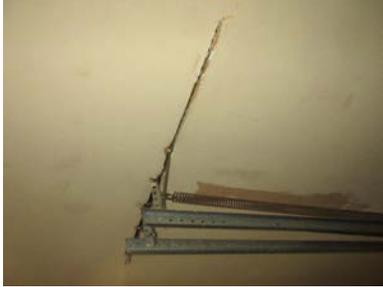
6.4 FIRE SEPARATION

There are voids in the fire resistive barrier between the living space and garage that will allow flames to penetrate. The gypsum barrier slows the spread of a fire from the garage to the structure and/or living space. Patching the voids with a fire retardant caulk is recommended.

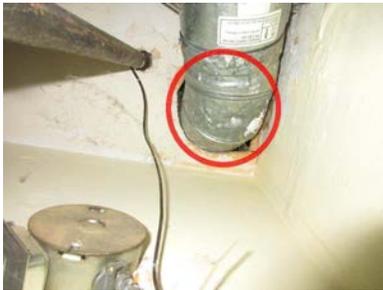
The installation of a furnace vent thimble is recommended to prevent flames to spread to the structure.

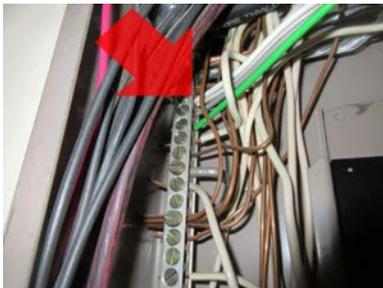
7.8 SERVICE PANEL

One of the neutral wires is double tapped on the buss bar. Double tapping means that two conductors share a single terminal. Double tapped terminals can loosen and overheat and therefore are not permitted unless the terminal is specifically listed for multiple wires. This defect is easily repaired by connecting the two wires to a "pig tail", securing them with a wire cap, and then inserting the pig tail conductor under the terminal.

- 7.8 **Electrical Service Panel.** Double tapped terminal has been modified to a single tap.
 - 7.13 **GFCI Receptacles.** Additional GFCI placed in kitchen
GFCI receptacle in main floor powder room has been replaced.

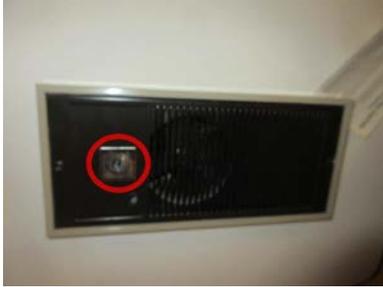
The control knob is missing. We recommend replacement of the heater control knob.

- 8.1 **Electrical Heating.** Control knob for wall heater has been installed.
 - 11.8 **Air Gap.** A ¼" hole has been drilled in the Johnson Tee.
 - 12.5 **Upper Floor Hallway Bathroom.** Recently installed toilet has been more firmly secured.

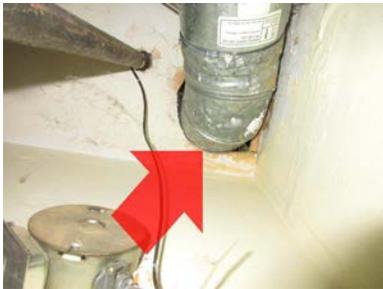
10.10 VENT

The water heater vent connector is too close to combustible material. The minimum clearance of 6" is required between the single wall vent connector and the combustible surface. The double wall type B vent requires only 1" of clearance.

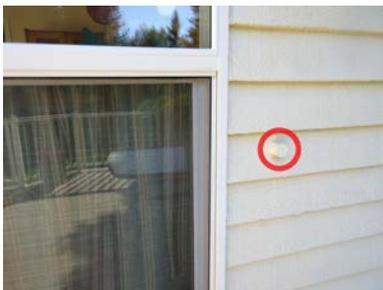
11.8 AIR GAP

An air gap called a Johnson Tee is installed in the kitchen wall. This air gap protects the dishwasher from contamination caused by a backflow of waste water. The cap protruding on the exterior wall opposite the dishwasher is not drilled. This renders the air gap non-functional. Drilling a 1/4" hole in the end of the cap will restore its function.

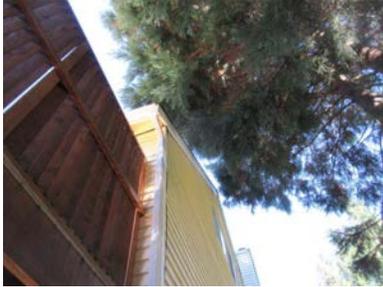
2.3 VEGETATION

Trees are touching the building on the east side. Low hanging tree branches can damage the roof, gutters, siding, doors and/or windows. Tree branches should be trimmed back where necessary.

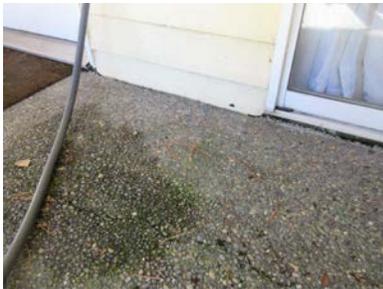
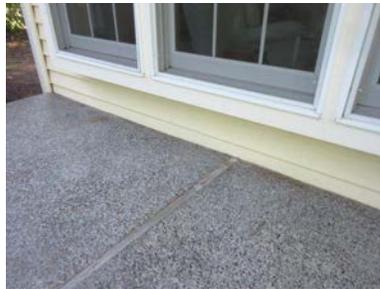
3.2 PEST CONTROL

Untreated wood in direct contact with concrete was observed along the patio and front stoop. Untreated wood should be raised 1-2" above the concrete. Treating the wood with a preservative sometimes will prevent wood destroy organism damage.

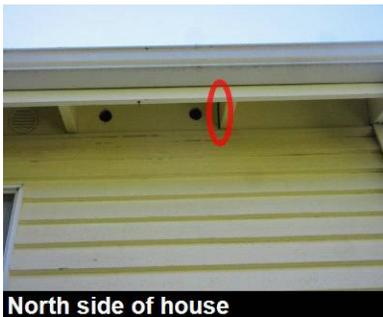
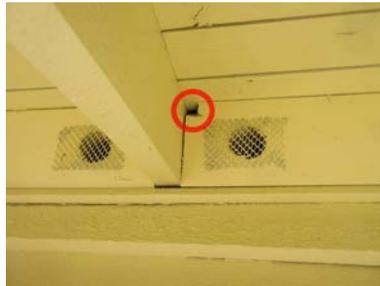
3.3 SOFFITS AND OVERHANGS

Gaps over 1/4" in size adjacent the soffit vent blocks will allow insects and rodents to enter the attic. Covering any gaps with screening, a strip of wood and/or caulking is recommended.

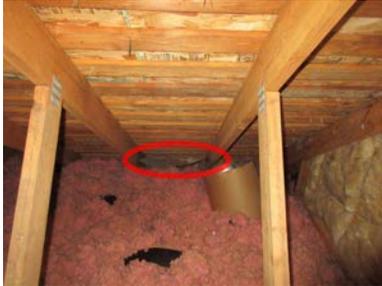
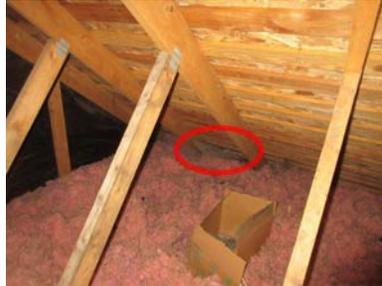
Wind baffles locations are compromised in some areas of the attic. The proper placement of wind baffles in front of all soffit vents is recommended.

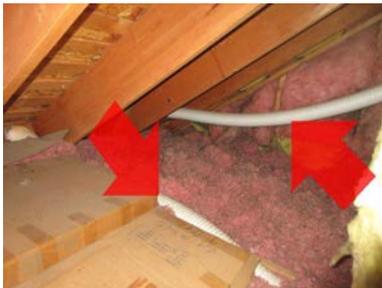
5.3 MECHANICAL VENTILATION SYSTEMS

Flexible plastic duct is used to direct air from the vent fans to the exterior. This type of material is unreliable. Replacing the plastic duct with 4" smooth-wall sheet metal duct is recommended.

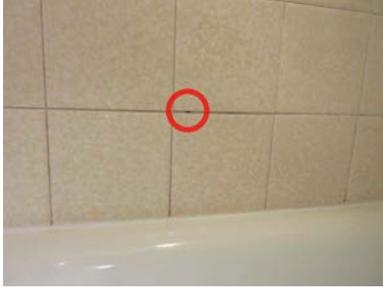
Grout is missing from between some of the wall tiles. This can allow water to enter through the tile and can damage the walls. Regrouting the wall tile is recommended.

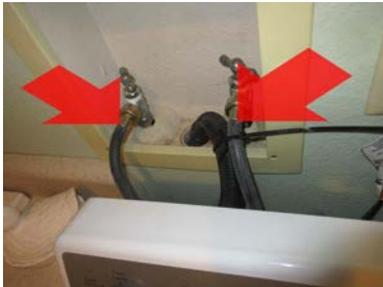
Upgrading the washer connections to high pressure (steel braided) lines is recommended.

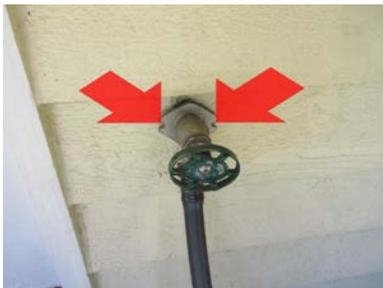
14.9 HOSE BIBBS AND EXTERIOR SUPPLY PIPES

The hose bibb on the rear of the house is loose. This could result in damage to the water pipe and leakage. The bibb should be securely fastened to the wall.

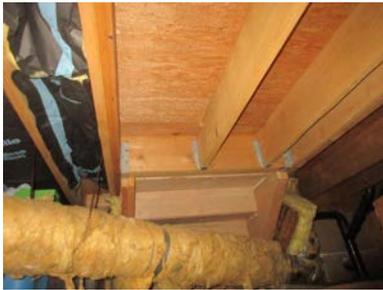
The entry floor is not insulated. This allows heat loss to occur through the floor. The installation of floor insulation is recommended.

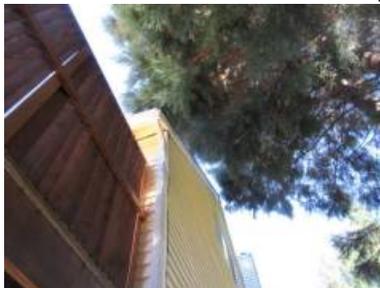
Trees are touching the building on the east side. Low hanging tree branches can damage the roof, gutters, siding, doors and/or windows. Tree branches should be trimmed back where necessary.

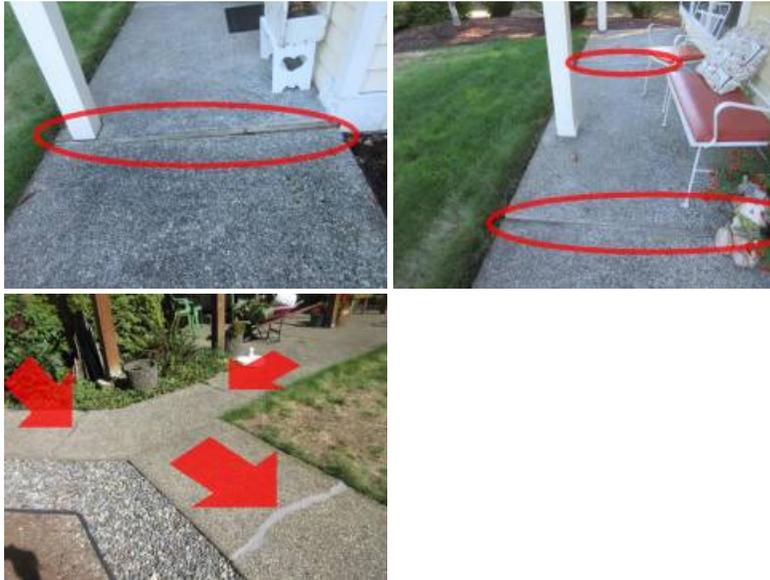
Many legal and public works departments have defined a trip hazard as an irregularity in a walking surface exceeding one inch (1") in height. All walking surfaces should maintain, free of a vertical surface change of 3/4" or more, in the interest of public and personal safety.

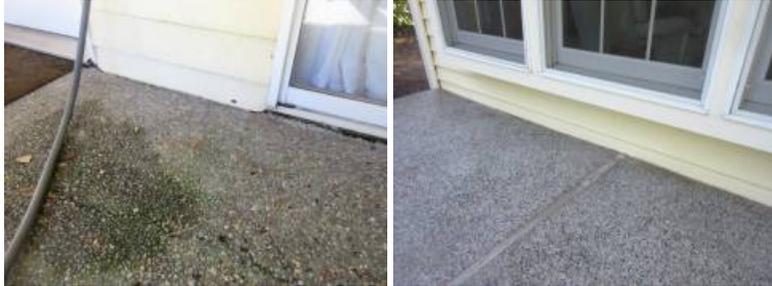
Untreated wood in direct contact with concrete was observed along the patio and front stoop. Untreated wood should be raised 1-2" above the concrete. Treating the wood with a preservative sometimes will prevent wood destroy organism damage.

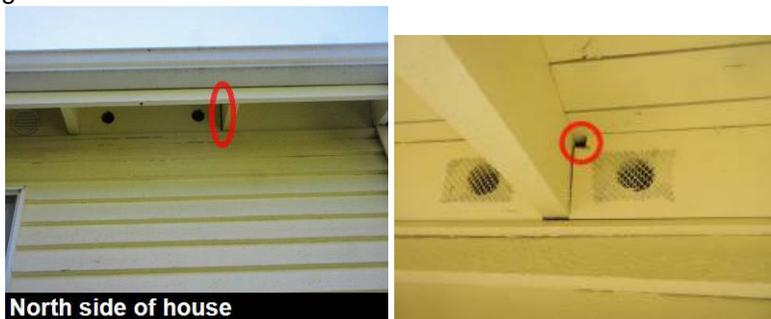
3.3 SOFFITS AND OVERHANGS

Gaps over 1/4" in size adjacent the soffit vent blocks will allow insects and rodents to enter the attic. Covering any gaps with screening, a strip of wood and/or caulking is recommended.

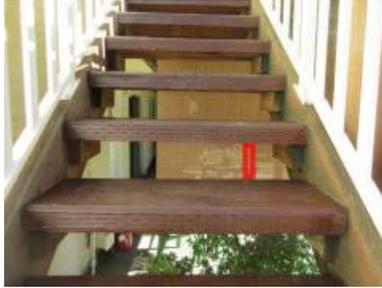
The stair rise spacing is too wide. This is a hazard for small children. The spacing should be reduced as a safety upgrade. Current standards require that a 4" sphere not pass through the opening.

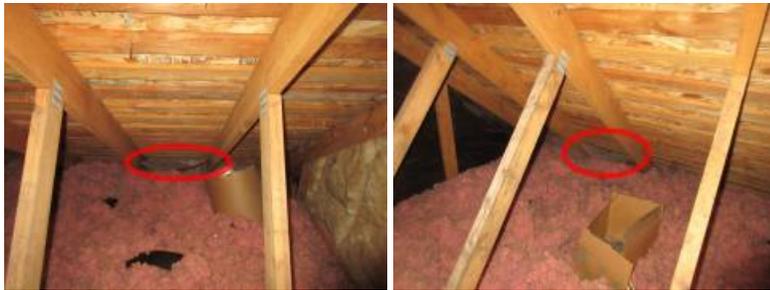
Wind baffles locations are compromised in some areas of the attic. The proper placement of wind baffles in front of all soffit vents is recommended.

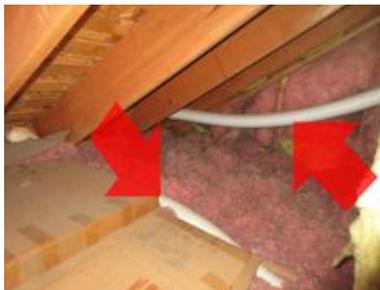
5.3 MECHANICAL VENTILATION SYSTEMS

Flexible plastic duct is used to direct air from the vent fans to the exterior. This type of material is unreliable. Replacing the plastic duct with 4" smooth-wall sheet metal duct is recommended.

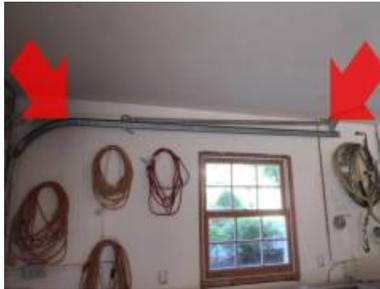
Safeties are cables run through the center of the garage door springs that prevent broken springs from becoming projectiles that can cause injury. There are no safeties installed. The installation of safeties is recommended.

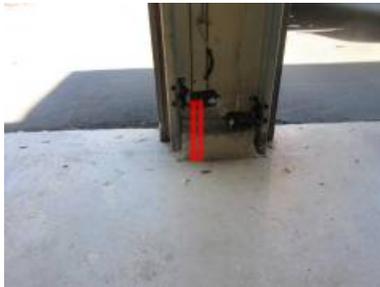
6.3 GARAGE DOOR OPENER

The Photo-eye beam was installed too high above the floor of the garage to adequately offer protection for small children and/or pets. We recommend that the photo-eye be lowered to within 4-6" of the floor.

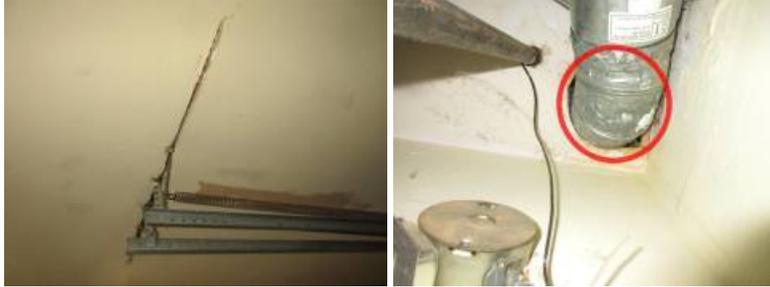
6.4 FIRE SEPARATION

There are voids in the fire resistive barrier between the living space and garage that will allow flames to penetrate. The gypsum barrier slows the spread of a fire from the garage to the structure and/or living space. Patching the voids with a fire retardant caulk is recommended.

The installation of a furnace vent thimble is recommended to prevent flames to spread to the structure.

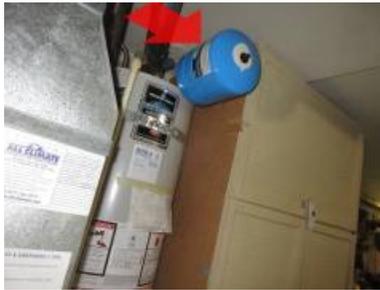
The expansion tank is not adequately secured to the framing. This could result in damage to the water pipe and leakage during an earth quake. A seismic restraint should be installed to secure the expansion tank.

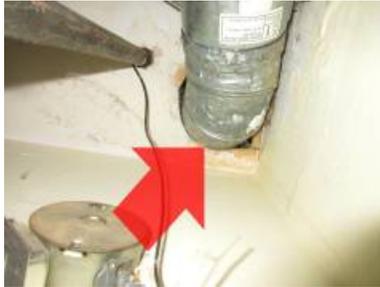
The water heater vent connector is too close to combustible material. The minimum clearance of 6" is required between the single wall vent connector and the combustible surface. The double wall type B vent requires only 1" of clearance.

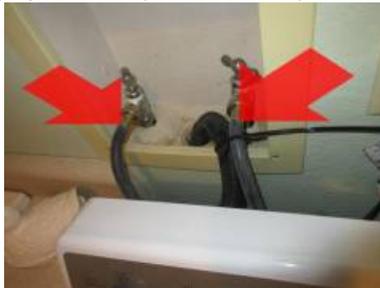
Upgrading the washer connections to high pressure (steel braided) lines is recommended.

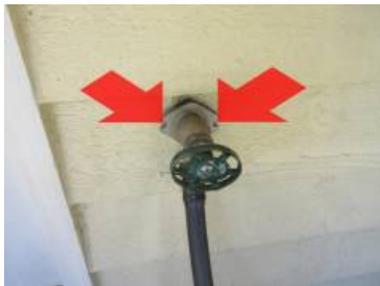
The hose bibb on the rear of the house is loose. This could result in damage to the water pipe and leakage. The bibb should be securely fastened to the wall.

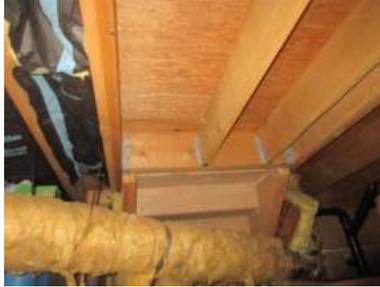
The entry floor is not insulated. This allows heat loss to occur through the floor. The installation of floor insulation is recommended.
