**NOTICE TO BUYER: SELLER-PROCURED INSPECTION REPORT**

**Lola Ball**  
**14153 176<sup>th</sup> Ave NE**  
**Redmond, WA 98052**

May 15, 2020

14153 176th Ave. NE  
Redmond WA.

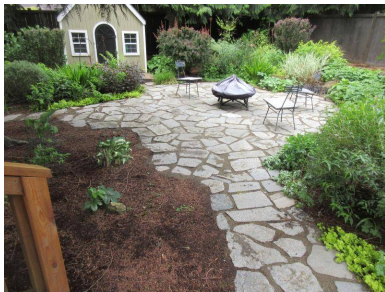
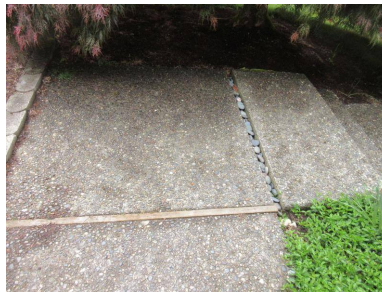
#### 2.5 PATIO

The gaps separating the patio stones are a trip hazard. We recommend all walking surfaces be maintained free of trip hazards.

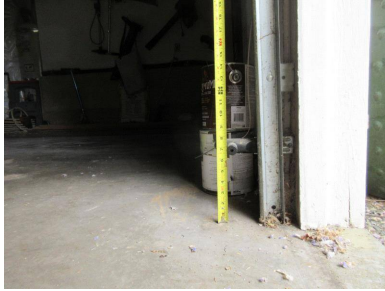
#### 6.4 GARAGE DOOR OPENER

One of the Photo-eye beams was installed to high above the floor of the garage to adequately offer protection for small children and/or pets. We recommend that the photo-eye be lowered to within 4-6" of the floor.

**6.4 Garage door opener** Relocate garage door photo-eye beam to within 4"-6" of the floor

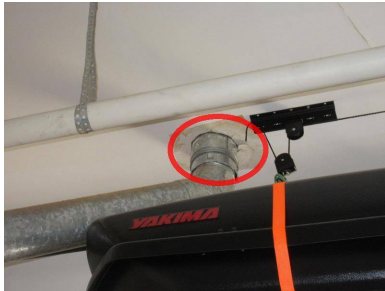
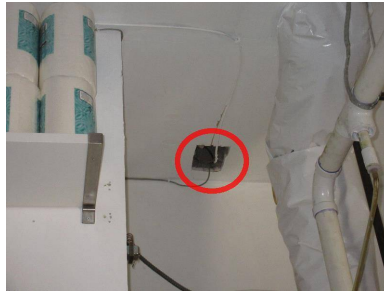
#### 6.5 FIRE SEPARATION

There are voids in the fire resistive barrier between the living space and garage that will allow flames to penetrate. The gypsum barrier slows the spread of a fire from the garage to the structure and/or living space. Patching the voids with a fire retardant caulk is recommended.

**6.5 Fire Separation** Patch voids with fire-resistant caulk

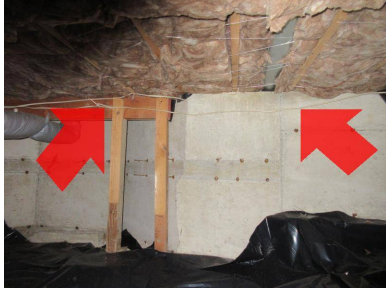
A loose electrical cable was observed in the crawlspace. Loose cables are vulnerable to damage. All loose cables should be secured at 4' intervals using approved cable staples.

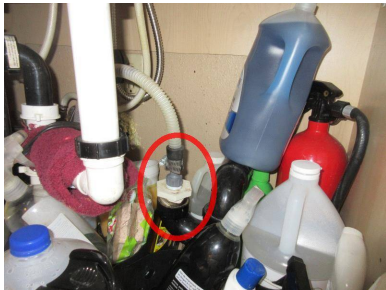
The dishwasher drain lacks an air gap. The dishwasher will function without one, but there is a risk of contamination of the inside of the dishwasher by waste water. The installation of an air gap is recommended.

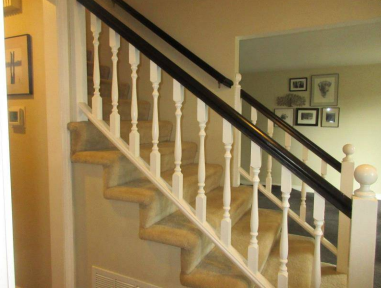
The stair railing baluster spacing is too wide. This is a hazard for small children. The baluster spacing should be reduced as a safety upgrade. Current standards require that a 4" sphere not pass through the railing.

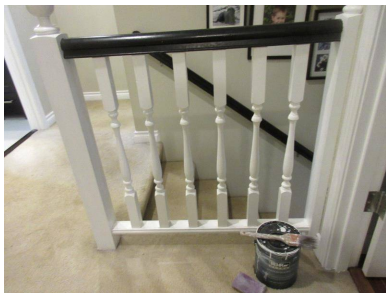
#### **14.3 GUARD RAILINGS**

The spacing between the balusters is too wide. This is a hazard to small children. The balusters should be spaced close enough together so that a 4" sphere cannot pass through. Upgrading the guard railing is recommended if small children are present.

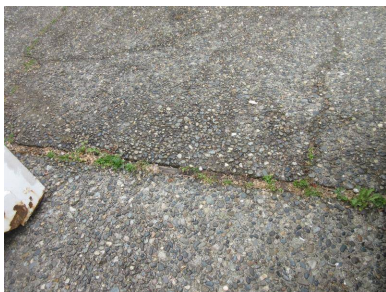
One or more of the wooden dividers separating the concrete driveway sections were infested by wood destroying organisms and have deteriorated to a point where they are becoming a trip hazard. Replacement with mortar is recommended.

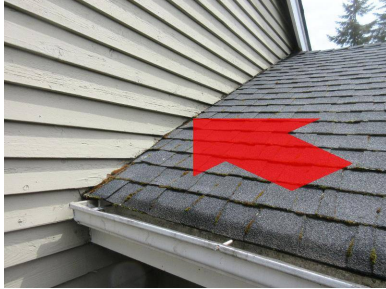
##### **3.1 PRIMARY EXTERIOR WALL CLADDING**

The siding is rotted where it has been in contact with the roofing material. The rot damaged siding should be repaired and a minimum of a 2" clearance should be maintained between the top of the roofing and bottom of the siding.

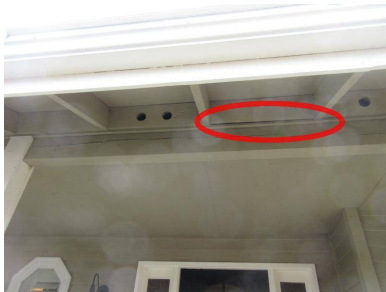
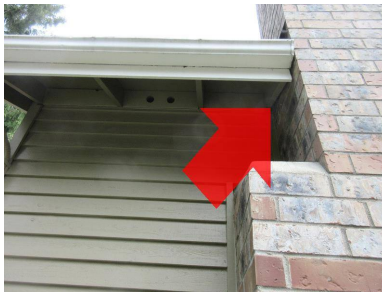
There are large gaps over 1/4" in size adjacent the soffit vent blocks and adjacent the chimney. These gaps allow insects and rodents to enter the attic. Covering the gaps with screening, a strip of wood and/or caulking is recommended.

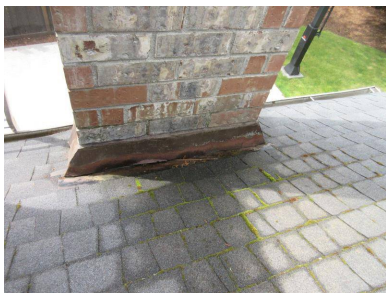
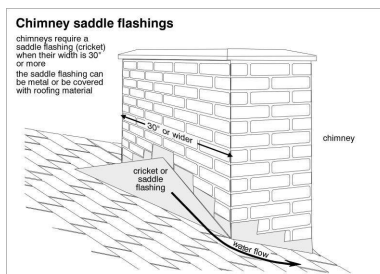
### 4.4 CHIMNEYS

There is no cricket on the up-slope side of the living room fireplace chimney. This is conducive to leakage. Consideration should be given to installing a cricket to divert water around the chimney.

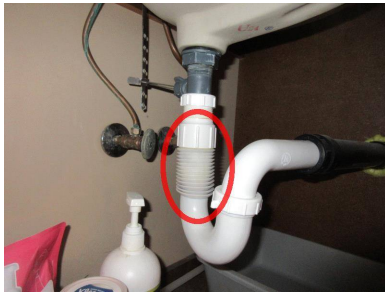
Improper, non-conforming material has been used for the drain pipe fitting. This material will not function reliably. Replacement with industry standard fittings is recommended.

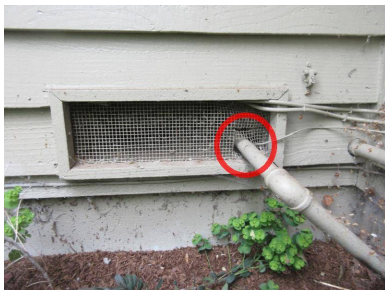
One of the crawlspace vent screens is damaged on the west side of the house. This will allow rodent entry into the crawlspace. The damaged screen should be repaired.

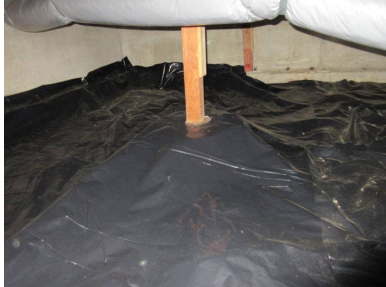
#### 19.4 VAPOR RETARDER

The support post concrete piers are covered with the plastic vapor retarder. This allows the transmission of water vapor from the soil up and into the floor framing. The plastic vapor retarder should be removed from the pier so that it covers at least 85% of the entire surface of the soil only.

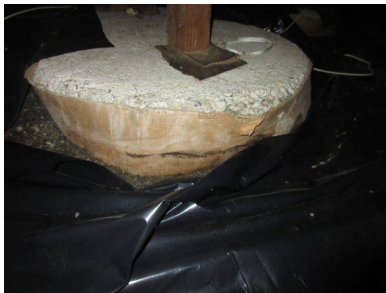
#### 19.5 PEST CONTROL

Cellulose forms were left in place on the pier footings. This cellulose is conducive to the infestation of various wood destroying organisms. The removal of the cellulose is recommended.

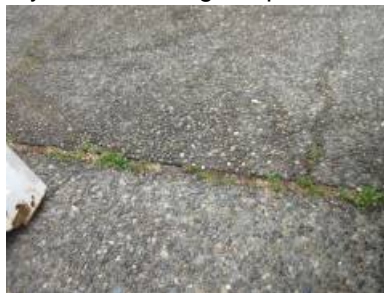
One or more of the wooden dividers separating the concrete driveway sections were infested by wood destroying organisms and have deteriorated to a point where they are becoming a trip hazard. Replacement with mortar is recommended.

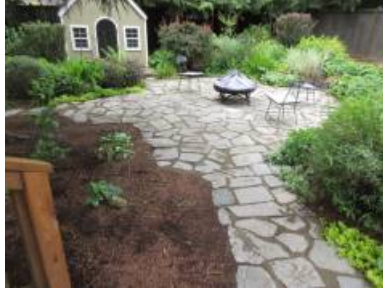
## **2.5 PATIO**

There are minor cracks in the concrete patio but it remains in serviceable condition.

The gaps separating the patio stones are a trip hazard. We recommend all walking surfaces be maintained free of trip hazards.

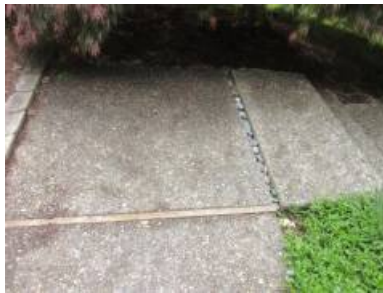
## 2.6 WALKWAY

When the wooden dividers separating the concrete walkway sections have deteriorated to a point where they become a trip hazard. Replacement with mortar is recommended.

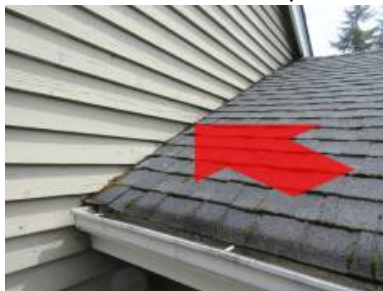
The siding is rotted where it has been in contact with the roofing material. The rot damaged siding should be repaired and a minimum of a 2" clearance should be maintained between the top of the roofing and bottom of the siding.

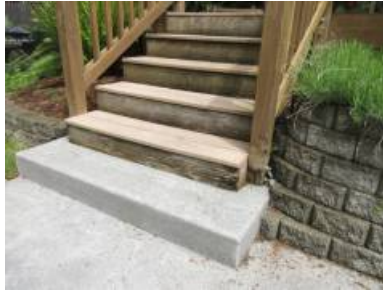
### 3.2 PEST CONTROL

Rot damage was observed in some of the deck stair framing. Wood rot commonly referred to as "Dry Rot" occurs when untreated wood is allowed to retain moisture for extended periods of time. Wood rot is caused by fungi which grow in the cell structure and spread like a root system through the wood. Fungi can also develop from spores which are present in the soil and are transferred through the air. Rotted wood creates an environment that is conducive to various types of wood boring insects (e.g. carpenter ants, moisture ants, dampwood termites, etc.) Wood rot can be prevented by keeping the wood dry, or if this is not possible, such as in the case of outdoor wood, by using pressure treated wood, by treating exposed wood with semi-transparent stain and/or wood preservative, and by keeping untreated wood out of and 6" above the soil.

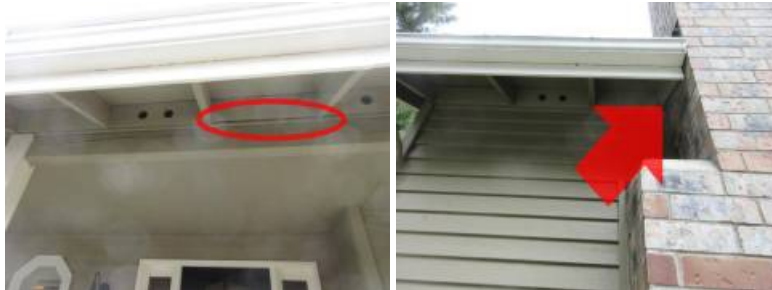
### 3.3 SOFFITS AND OVERHANGS

There are large gaps over 1/4" in size adjacent the soffit vent blocks and adjacent the chimney. These gaps allow insects and rodents to enter the attic. Covering the gaps with screening, a strip of wood and/or caulking is recommended.

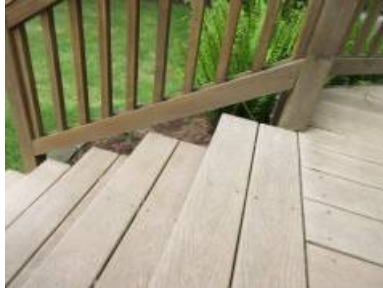
The spacing under stair railing is too wide. This is a hazard for small children. The spacing should be reduced as a safety upgrade. Current standards require that a 4" sphere not pass under the railing.

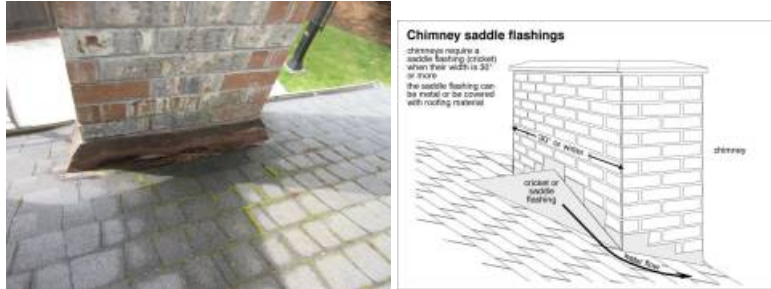
There is no cricket on the up-slope side of the living room fireplace chimney. This is conducive to leakage. Consideration should be given to installing a cricket to divert water around the chimney.

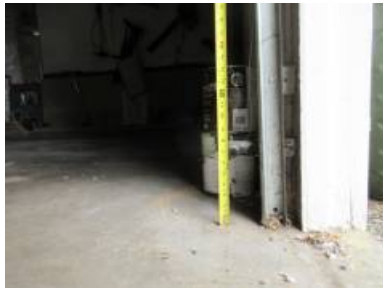
One of the Photo-eye beams was installed to high above the floor of the garage to adequately offer protection for small children and/or pets. We recommend that the photo-eye be lowered to within 4-6" of the floor.

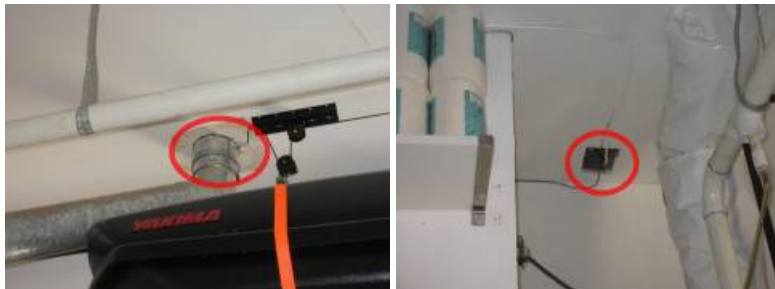
### 6.5 FIRE SEPARATION

There are voids in the fire resistive barrier between the living space and garage that will allow flames to penetrate. The gypsum barrier slows the spread of a fire from the garage to the structure and/or living space. Patching the voids with a fire retardant caulk is recommended.

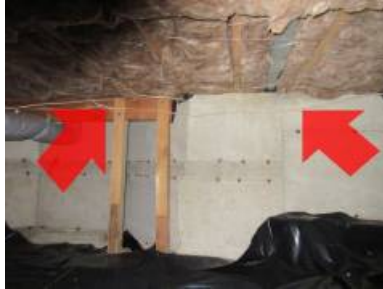
A loose electrical cable was observed in the crawlspace. Loose cables are vulnerable to damage. All loose cables should be secured at 4' intervals using approved cable staples.

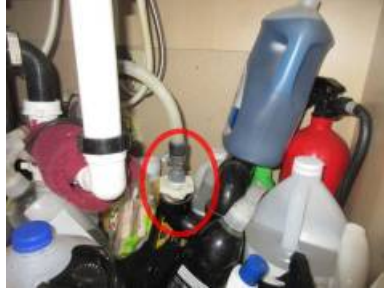
The dishwasher drain lacks an air gap. The dishwasher will function without one, but there is a risk of contamination of the inside of the dishwasher by waste water. The installation of an air gap is recommended.

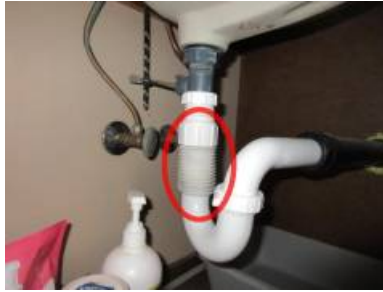
Replacement with industry standard fittings is recommended.

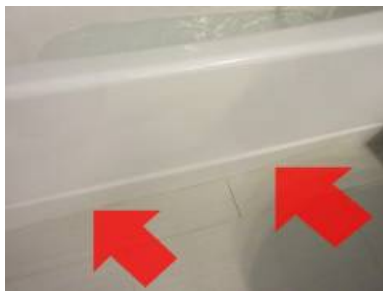
The caulking is cracked at the intersection between the tub/shower and floor. This can lead to water damage to the flooring and substrate. Caulking this area with a flexible caulk is recommended.

**11.14 Flooring material** Caulked between tub and floor

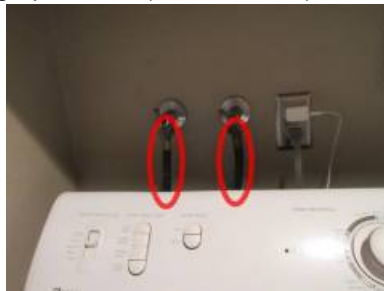
Upgrading the washer connections to high pressure (steel braided) lines is recommended.

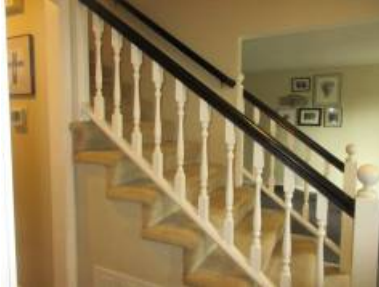
The stair railing baluster spacing is too wide. This is a hazard for small children. The baluster spacing should be reduced as a safety upgrade. Current standards require that a 4" sphere not pass through the railing.

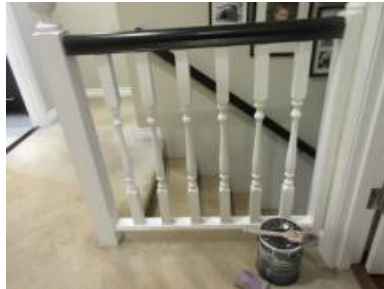
#### 14.3 GUARD RAILINGS

The spacing between the balusters is too wide. This is a hazard to small children. The balusters should be spaced close enough together so that a 4" sphere cannot pass through. Upgrading the guard railing is recommended if small children are present.

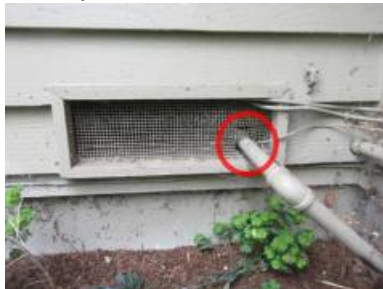
One of the crawlspace vent screens is damaged on the west side of the house. This will allow rodent entry into the crawlspace. The damaged screen should be repaired.

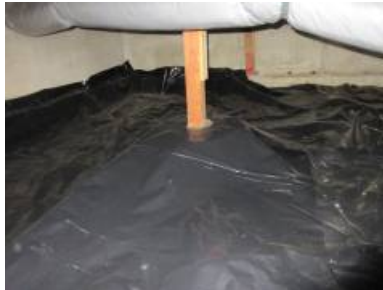
#### 19.4 VAPOR RETARDER

The support post concrete piers are covered with the plastic vapor retarder. This allows the transmission of water vapor from the soil up and into the floor framing. The plastic vapor retarder should be removed from the pier so that it covers at least 85% of the entire surface of the soil only.

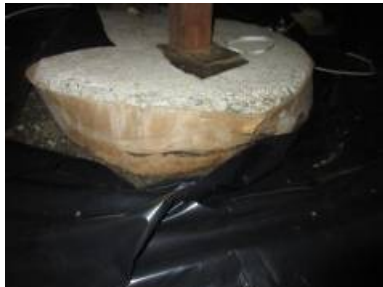
Good building practice requires that foundation walls or pier footings supporting wood frame construction, should extend at least 8" above the finish grade with at least a 6" clearance between the top of the soil and the bottom of the wood finish materials. Untreated wood should be raised 1-2" above surrounding flatwork and should have a moisture barrier such as 30 lb. asphalt impregnated felt installed between the concrete and wood. For additional information and treatment options, you should retain the services of a qualified pest control operator.
