NOTICE TO BUYER: SELLER-PROCURED INSPECTION REPORT

17633 NE 129th Pl

Redmond, WA 98052

At your request, a visual inspection of the above referenced property was conducted on 03/01/2021. We have inspected the major structural components, plumbing, heating and electrical systems for signs of significant non-performance, excessive or unusual wear and general state of repair.

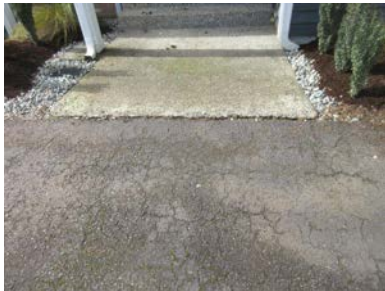
The large gap separating the concrete walkway and driveway is a trip hazard. Grinding down the raised edge of the concrete and filling the gap with mortar is recommended.

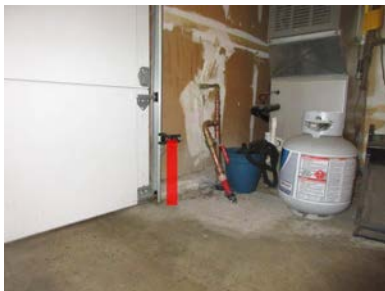
The Photo-eye beam was installed to high above the floor of the garage to adequately offer protection for small children and/or pets. We recommend that the photo-eye be lowered to within 4-6" of the floor.

6.3 – Photo-eye beam was lowered to 6" off the floor.

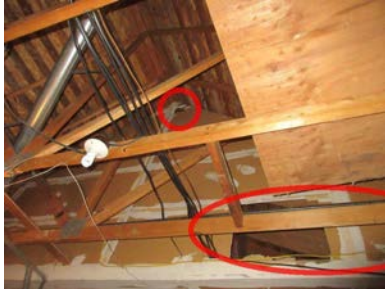
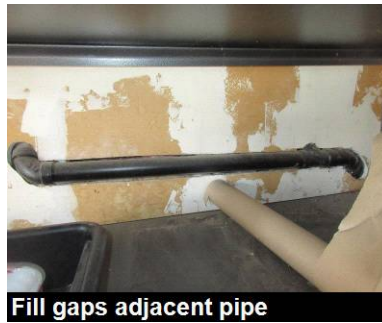
6.4 FIRE SEPARATION

There are voids in the fire resistive barrier between the living space and garage that will allow flames to penetrate. The gypsum barrier slows the spread of a fire from the garage to the structure and/or living space.

6.4 – Gap around black pipe sealed with fire retardant caulk.

Patching the voids with a fire retardant caulk is recommended.

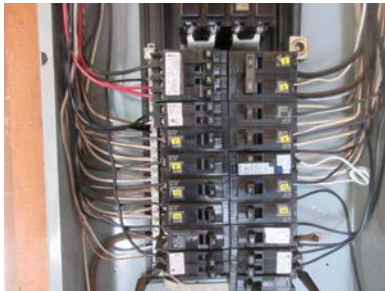
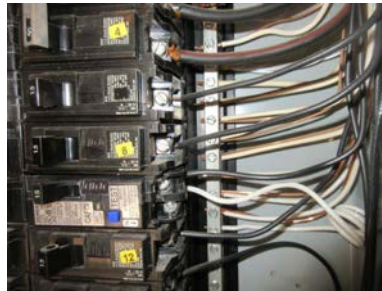
Neutral (white wire) and equipment grounding conductors (bare wire) terminate under the same lug. An individual terminal should be provided for the connection of each branch-circuit neutral conductor. When the neutral is disconnected, the objective is to still have the equipment ground connected. If both the neutral and grounded conductor is under the same terminal, this cannot be accomplished. The services of a qualified electrical contractor should be retained to repair the circuit(s).

Some of the circuits are not labeled. Each circuit breaker should be labeled to allow servicing and repair of electrical circuits and equipment without having to shut off power to all electrical circuits. The services of a qualified electrician should be retained to perform this service.

6.7 – All circuits are labelled.

7.8 – Will hire a qualified electrical contractor to repair circuit panel.

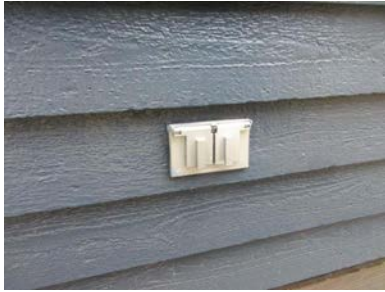
The cover plate is loose from the exterior receptacle. This is a shock and fire hazard. The weather tight cover

should be secured.

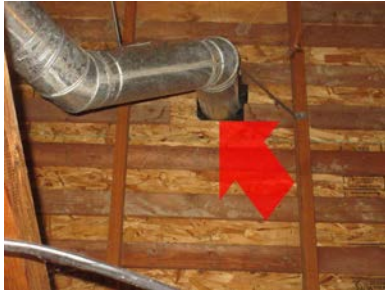
The furnace vent connector is too close to a combustible material. This is a hazard. A minimum clearance of 6" is required between the single wall vent connector and the combustible material. The double wall type B vent requires only 1" of clearance. Repairs are recommended.

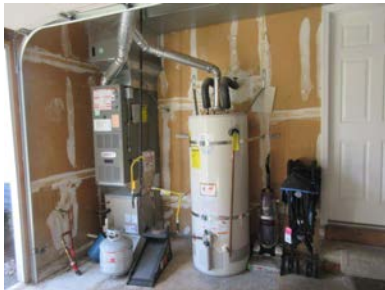
10.12 ELEVATION ABOVE GARAGE FLOOR

The water heater is not elevated above the garage floor in accordance with industry standards. This is a hazard. Elevating the water heater so that the burner is at least 18" above the garage floor prevents ignition of gasoline fumes.

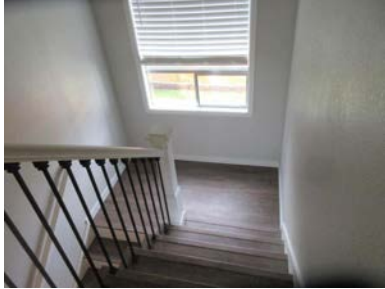
The stairway landing window glass is not labeled as tempered safety glass. The existing glass is nonconforming by current building standards and would be hazardous if broken. The installation of safety glass is recommended as a safety upgrade.

15.7 – Larger landing window is tempered glass.

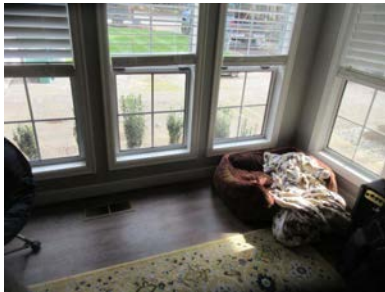
The lower window glass is not labeled as tempered safety glass. The existing glass is nonconforming by current building standards and would be hazardous if broken. The installation of safety glass is recommended as a safety upgrade for all windows less than 18" from the walking surface.

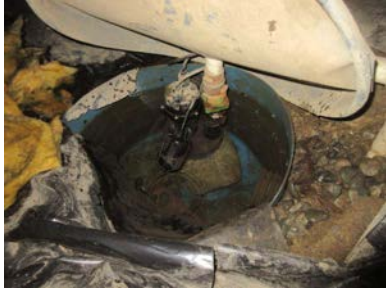
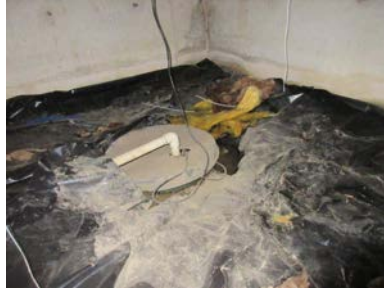
20.2 MOISTURE

A sump pump has been installed to remove incoming ground water. The sump pump is not working correctly and will not function reliably. The services of a qualified plumbing contractor should be retained to repair or replace the sump pump.

20.2 – The sump pump functions normally. During our ownership we have not had standing water or mold. In addition, we have replaced the vapor barrier and insulation to improve this area.

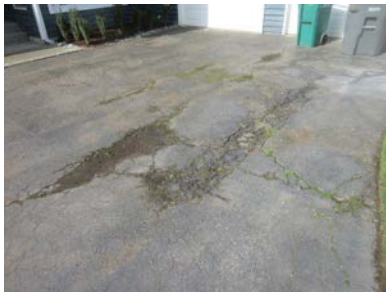
Portions of the asphalt driveway are damaged. The damaged areas are not adversely affecting the function of the driveway, therefore patching or resurfacing is optional. Seal coating the surface of the asphalt is recommended to maximize the service life of the paving. Asphalt sealers are available at most home improvement stores.

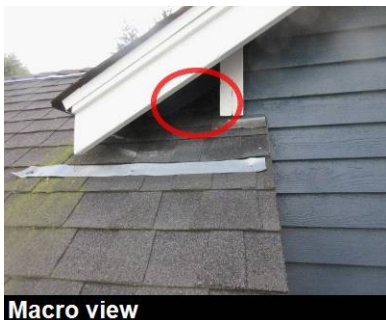
There are openings adjacent the ends of the outlook boards under the overhang through which insects and rodents can enter into the attic. These openings should be covered with wood, wire mesh or filled with aerosol foam.

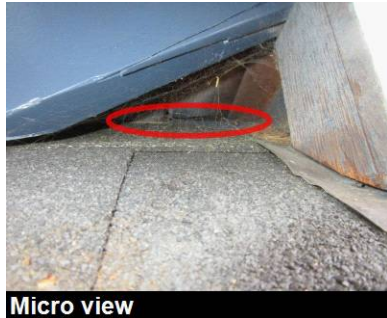
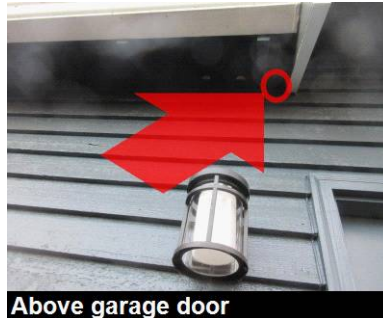
There are openings at the intersection between the overhang and the roof through which rodents and pests can enter into the structure. These openings should be covered with wood, wire mesh or filled with aerosol foam.

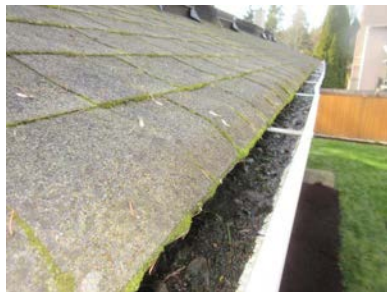
There is a build-up of organic debris inside the gutters. Proper maintenance of gutters and downspouts is essential and should be performed routinely in order to prevent clogging. Maintenance consists primarily of keeping leaves and other organic debris out of the system. Failure to clean the gutters will result in water splash on the building when they overflow. Gutters can be damaged under the weight of the water and organic matter inside the gutter. Gutters should be cleaned as necessary to maintain a free flow of water into the downspouts.

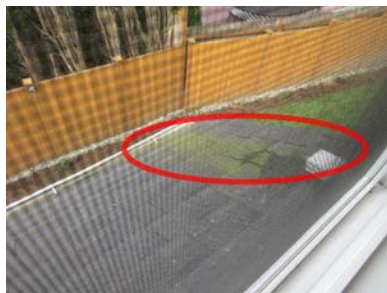
Downspouts draining directly onto the asphalt shingle surface causes excessive wear of the roofing material. Downspout extensions to the lower gutters should be installed to prevent excessive wear and tear of the roofing.

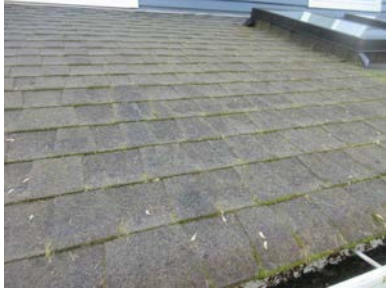
The roof is in need of routine maintenance. The surface should be blown off or washed with a high volume low pressure garden hose to remove moss and organic debris. Performing this maintenance will improve the appearance and increase the life expectancy of the roof.

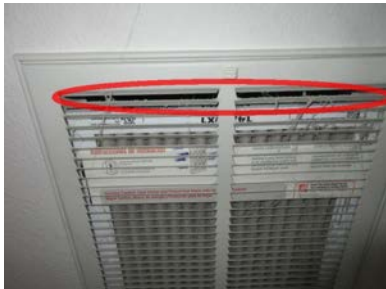
The air filter behind the return air grille in the hallway is redundant. Removal of one, of the two filters is recommended.

The air filter behind the return air grille is clogged with dust. This reduces air flow and furnace efficiency. Removal and replacement of the air filter is recommended. Pleated style air filters are recommended as they offer better filtration of dust than the coarser hogs hair or fiberglass filters.

The air filter behind the return air grille is ill-fitting. This allows air to bypass the filter. This filter should be removed.

Maintenance 8.12 – Air filter replaced

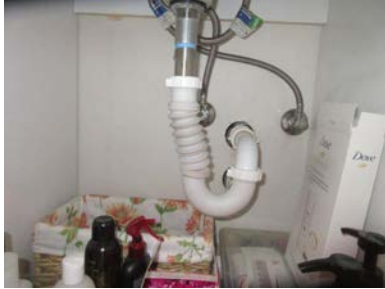
Improper, non-conforming material has been used for the drain pipe fitting. This material will not function reliably. Replacement with industry standard fittings is recommended.

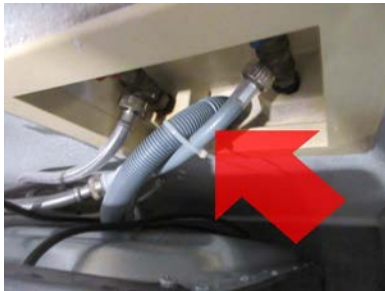
The laundry tub cabinet was not secured to the floor or wall. Attachment is recommended to prevent damage or leakage to the attached plumbing.

Upgrading the washer connections to high pressure (steel braided) lines is recommended.

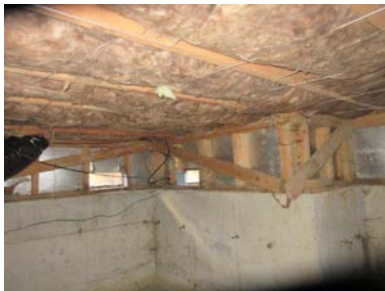
19.6 SHEAR PANELS

Shear panels are plywood or OSB panels that are mechanically fastened to both vertical and horizontal framing members in critical structural areas of the building. They prevent lateral movement of the structure during an earthquake. Shear panels are often visible in the crawlspace on cripple walls between the first floor and foundation. They may also be installed on interior walls that are covered with drywall. An examination of the crawlspace revealed the absence of shear panels on the cripple walls. The installation of shear panels on the cripple walls is recommended as an upgrade.

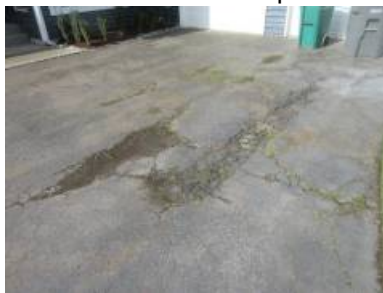
Portions of the asphalt driveway are damaged. The damaged areas are not adversely affecting the function of the driveway, therefore patching or resurfacing is optional. Seal coating the surface of the asphalt is recommended to maximize the service life of the paving. Asphalt sealers are available at most home improvement stores.

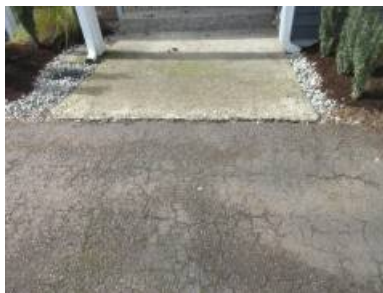
2.5 WALKWAY

The large gap separating the concrete walkway and driveway is a trip hazard. Grinding down the raised edge of the concrete and filling the gap with mortar is recommended.

Many legal and public works departments have defined a trip hazard as an irregularity in a walking surface exceeding one inch (1") in height. All walking surfaces should maintain, free of a vertical surface change of 3/4" or more, in the interest of public and personal safety.

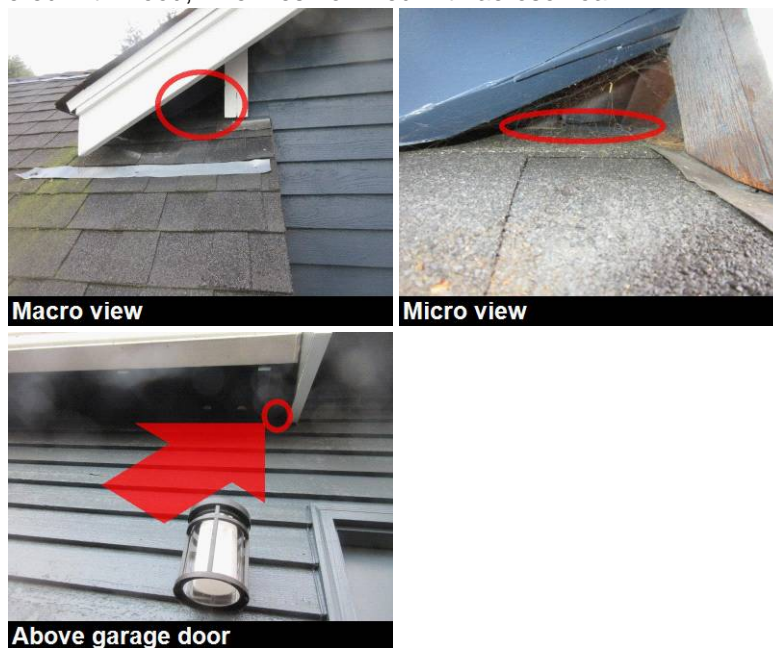
There are openings at the intersection between the overhang and the roof through which rodents and pests can enter into the structure. These openings should be covered with wood, wire mesh or filled with aerosol foam.

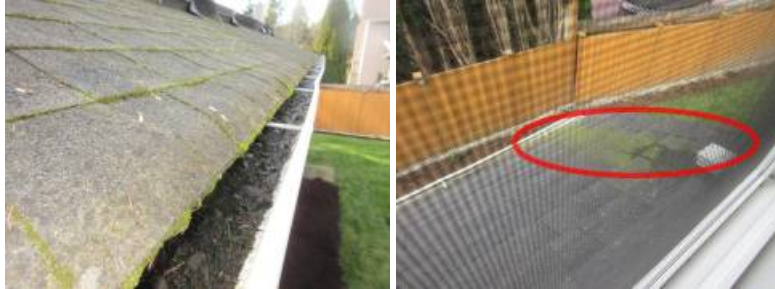
Downspouts draining directly onto the asphalt shingle surface causes excessive wear of the roofing material. Downspout extensions to the lower gutters should be installed to prevent excessive wear and tear of the roofing.

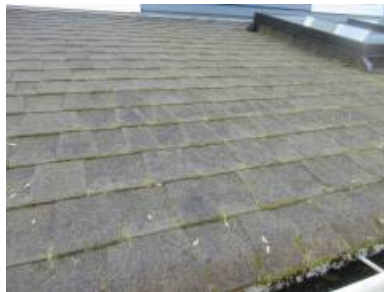
The roof is in need of routine maintenance. The surface should be blown off or washed with a high volume low pressure garden hose to remove moss and organic debris. Performing this maintenance will improve the appearance and increase the life expectancy of the roof.

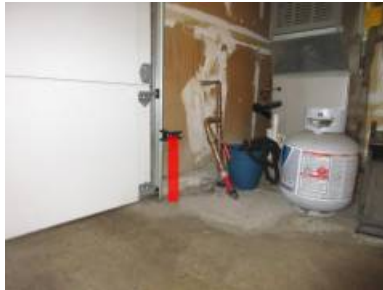
The Photo-eye beam was installed to high above the floor of the garage to adequately offer protection for small children and/or pets. We recommend that the photo-eye be lowered to within 4-6" of the floor.

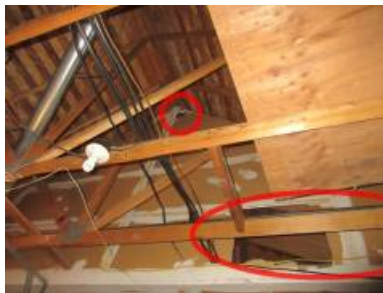
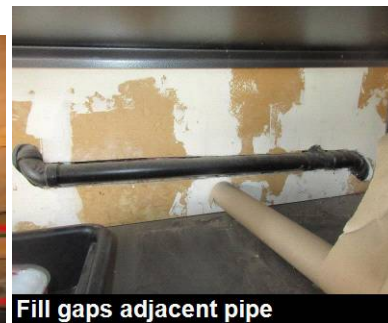
6.4 FIRE SEPARATION

There are voids in the fire resistive barrier between the living space and garage that will allow flames to penetrate. The gypsum barrier slows the spread of a fire from the garage to the structure and/or living space. Patching the voids with a fire retardant caulk is recommended.

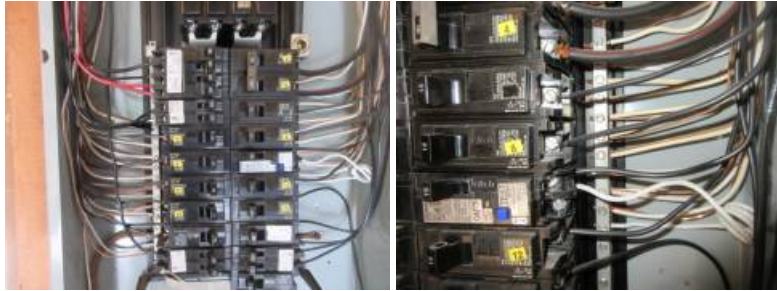
Some of the circuits are not labeled. Each circuit breaker should be labeled to allow servicing and repair of electrical circuits and equipment without having to shut off power to all electrical circuits. The services of a qualified electrician should be retained to perform this service.

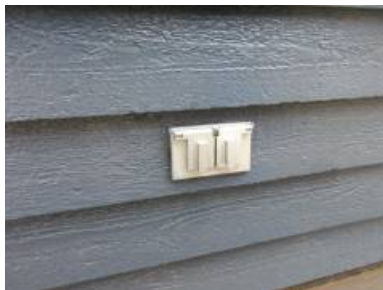
The cover plate is loose from the exterior receptacle. This is a shock and fire hazard. The weather tight cover should be secured.

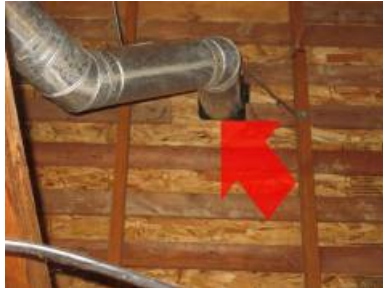
The furnace vent connector is too close to a combustible material. This is a hazard. A minimum clearance of 6" is required between the single wall vent connector and the combustible material. The double wall type B vent requires only 1" of clearance. Repairs are recommended.

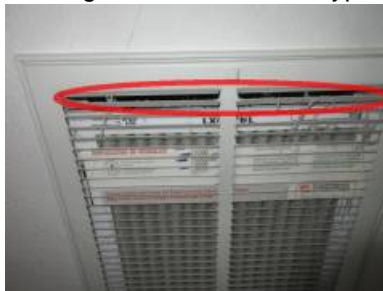
The air filter behind the return air grille is ill-fitting. This allows air to bypass the filter. This filter should be removed.

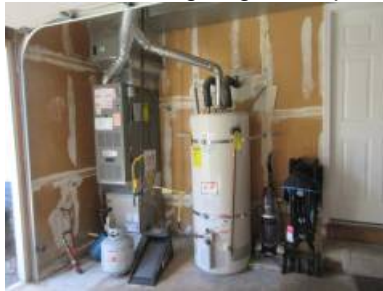
The water heater is not elevated above the garage floor in accordance with industry standards. This is a hazard. Elevating the water heater so that the burner is at least 18" above the garage floor prevents ignition of gasoline fumes.

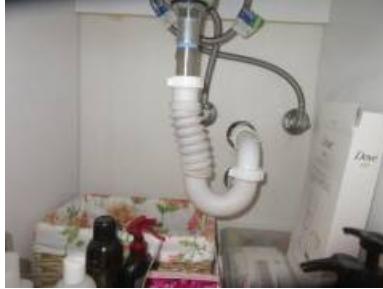
Improper, non-conforming material has been used for the drain pipe fitting. This material will not function reliably. Replacement with industry standard fittings is recommended.

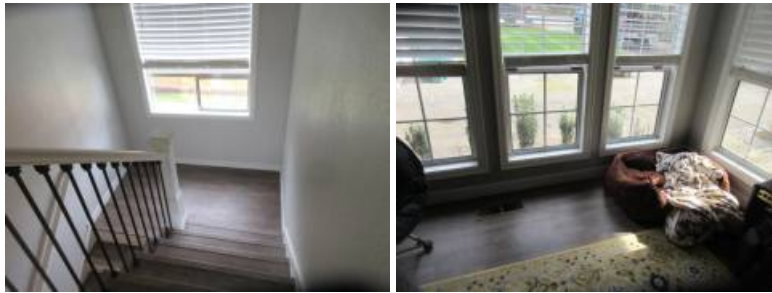
The lower window glass is not labeled as tempered safety glass. The existing glass is nonconforming by current building standards and would be hazardous if broken. The installation of safety glass is recommended as a safety upgrade for all windows less than 18" from the walking surface.

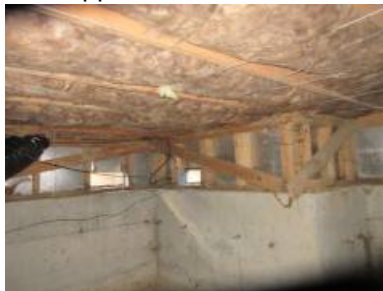
Shear panels are plywood or OSB panels that are mechanically fastened to both vertical and horizontal framing members in critical structural areas of the building. They prevent lateral movement of the structure during an earthquake. Shear panels are often visible in the crawlspace on cripple walls between the first floor and foundation. They may also be installed on interior walls that are covered with drywall. An examination of the crawlspace revealed the absence of shear panels on the cripple walls. The installation of shear panels on the cripple walls is recommended as an upgrade.

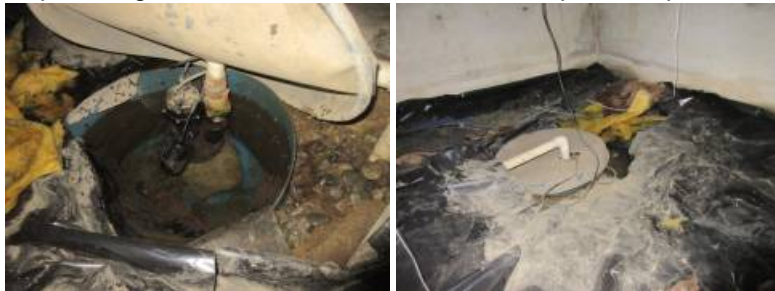
A sump pump has been installed to remove incoming ground water. The sump pump is not working correctly and will not function reliably. The services of a qualified plumbing contractor should be retained to repair or replace the sump pump.

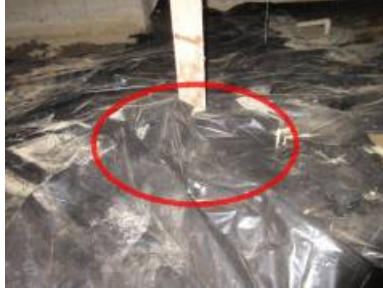
The support post concrete piers are covered with the plastic vapor retarder. This allows the transmission of water vapor from the soil up and into the floor framing. The plastic vapor retarder should be removed from the pier so that it covers at least 85% of the entire surface of the soil only.
