NOTICE TO BUYER: SELLER-PROCURED INSPECTION REPORT

13506 174th Ave NE

Redmond, WA 98052

At your request, a visual inspection of the above referenced property was conducted on 03/25/2021. We have inspected the major structural components, plumbing, heating and electrical systems for signs of significant non-performance, excessive or unusual wear and general state of repair.

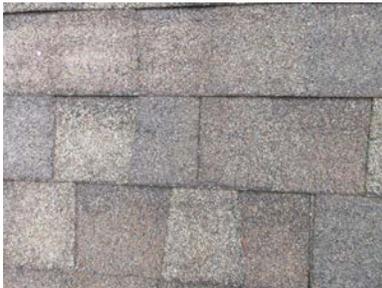
4.5 GENERAL COMMENTS

The roof is nearing the end of its service life. Significant wear and deterioration was observed. The need for replacement should be anticipated within 3-5 years.

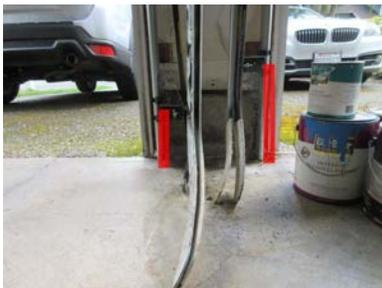
6.3 GARAGE DOOR OPENER

The Photo-eye beam was installed to high above the floor of the garage to adequately offer protection for small children and/or pets. We recommend that the photo-eye be lowered to within 4-6" of the floor.

- 6.3 – Garage Door Opener – adjusted photo-eye beam per recommendation
- 6.4 – Voids in the fire barrier have been corrected
- 7.8 – Completed service panel recommendations

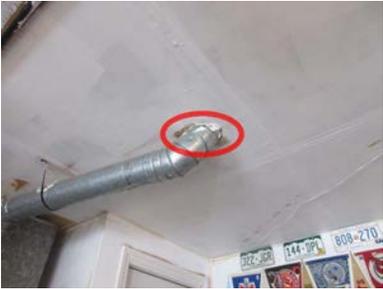
6.4 FIRE SEPARATION

The installation of a furnace vent thimble is recommended to prevent flames to spread to the structure.

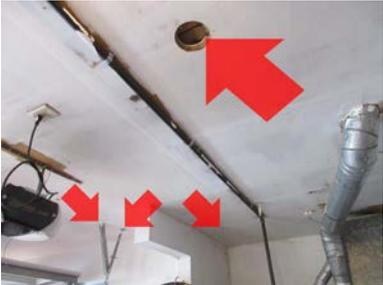
There are voids in the fire resistive barrier between the living space and garage that will allow flames to penetrate. The gypsum barrier slows the spread of a fire from the garage to the structure and/or living space. Patching the voids with a fire retardant caulk is recommended.

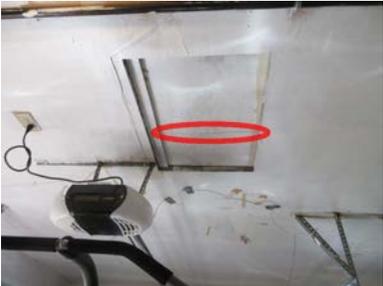
The broken drywall cover for the attic access is a breach in the fire resistive barrier in the garage. This is a safety concern. The broken joint can be taped. Consideration should be given to "fire taping" the drywall access cover as a safety upgrade.

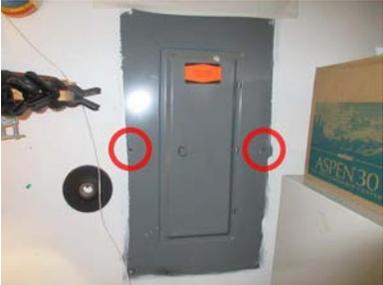
7.8 SERVICE PANEL

Screws that secure the panel cover to the panel box are missing. This is a potential hazard. Missing screws should be replaced with the original style blunt end screws.

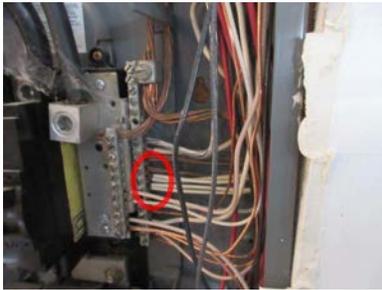
Several of the neutral wires are double tapped on the buss bar. Double tapping means that two conductors

share a single terminal. Double tapped terminals can loosen and overheat and therefore are not permitted unless the terminal is specifically listed for multiple wires. This defect is easily repaired by connecting the two wires to a "pig tail", securing them with a wire cap, and then inserting the pig tail conductor under the terminal.

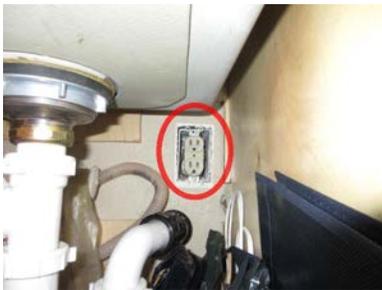
7.12 RECEPTACLES

There are several loose receptacles throughout the home. This is a potential shock and a fire hazard. All loose receptacles should be repaired as necessary.

The cover plate is missing from a receptacle in the kitchen sink cabinet. This is a shock and fire hazard. The installation of a cover plate is recommended.

- 7.12 – Secured receptacle and installed cover plate
- 8.10 – Clearance to B vent have been corrected
- 8.13 – Replaced heating ducks in crawlspace and secured in accordance to code

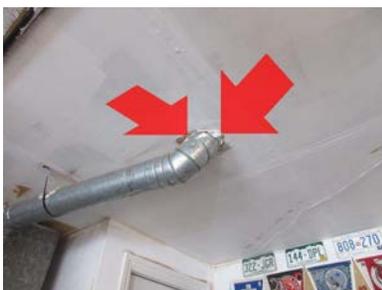
8.10 VENT

The furnace vent connector is too close to a combustible material. This is a hazard. A minimum clearance of 6" is required between the single wall vent connector and the combustible material. The double wall type B vent requires only 1" of clearance. Repairs are recommended.

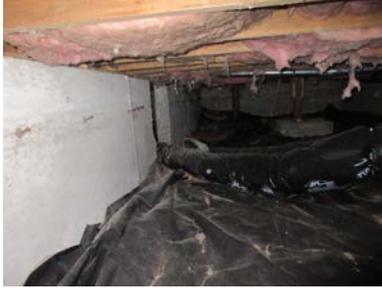
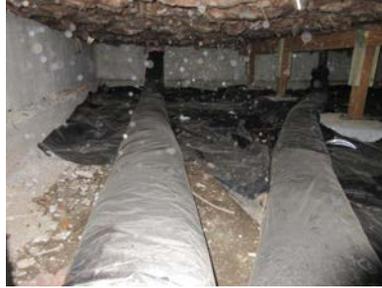
8.13 DUCTS

Heating ducts are in direct contact with the soil in the crawlspace under the house extension and have water in them. This will cause the ducts to corrode and will adversely affect the performance and efficiency of the heating system. The ducting should be drained, cleaned then reattached and secured in accordance with the manufacturer's specifications. Proper clearances should be established under the air ducts.

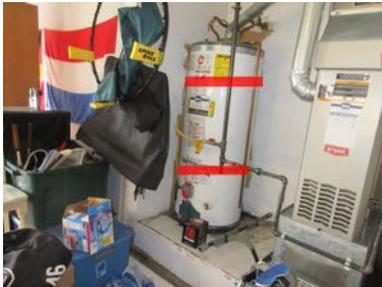
9.11 SEISMIC RESTRAINT

The nipples sticking out of the top of the water heater are corroded and are leaking. The nipples should be replaced as necessary. Installing brass nipples will eliminate the corrosion that occurs when two dissimilar metals are joined together in the presence of water.

The seismic restraint for the water heater was minimal. Proper strapping is recommended to adequately secure the tank and provide potable water in the event of an earthquake.

The water heater is leaking. The services of a qualified plumbing contractor should be retained to replace the water heater.

- 9.5, 9.11, 9.13 – Installed new water heater which addresses the recommendations in these sections
- 11.8 – Caulked back splash in main floor bathroom

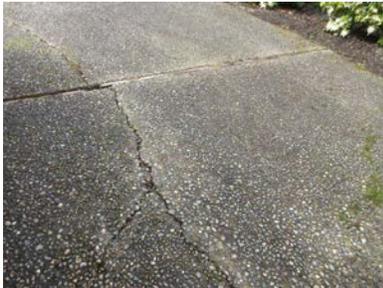
The driveway has cracked and settled differentially. This was probably caused by inadequate preparation of the soil prior to the placement of the concrete. This condition can be repaired by pressure grouting the sunken portion of the driveway or by removing and replacing it. The driveway remains functional despite this condition.

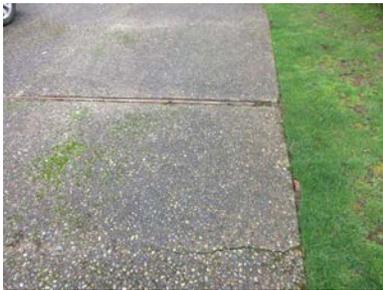
One or more of the wooden dividers separating the concrete driveway sections were infested by wood destroying organisms and have deteriorated to a point where they are becoming a trip hazard. Replacement with mortar is recommended.

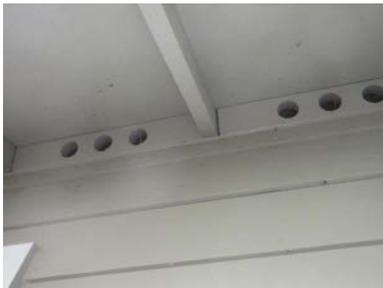
3.3 SOFFITS AND OVERHANGS

There are large gaps over 1/4" in size adjacent the soffit vent blocks. These gaps allow insects and rodents to enter the attic. Covering the gaps with screening, a strip of wood and/or caulking is recommended.

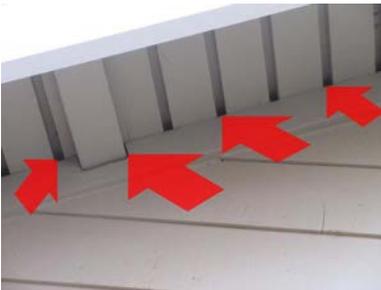
There are openings adjacent the ends of the outlook boards under the overhang through which insects and rodents can enter into the attic. These openings should be covered with wood, wire mesh or filled with aerosol

foam.

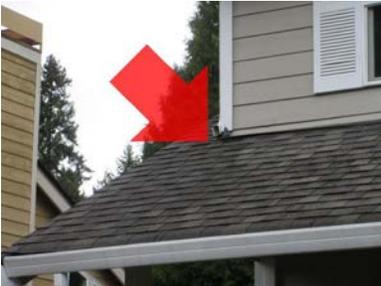
3.4 GUTTERS AND DOWNSPOUTS

Downspouts draining directly onto the asphalt shingle surface causes excessive wear of the roofing material. Downspout extensions to the lower gutters should be installed to prevent excessive wear and tear of the roofing.

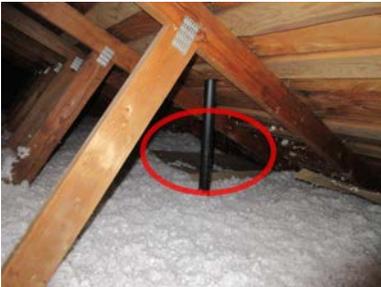
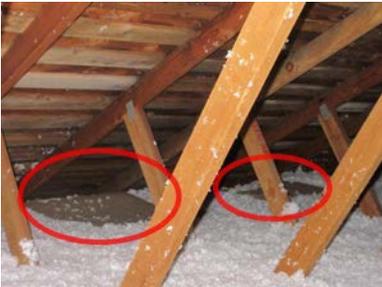
5.2 VENTILATION

The attic space is only minimally vented. The installation of some additional attic ventilation is recommended,

Wind baffles locations are compromised in some areas of the attic. The proper placement of wind baffles in front of all soffit vents is recommended.

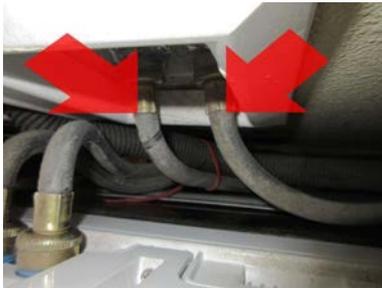
Upgrading the washer connections to high pressure (steel braided) lines is recommended.

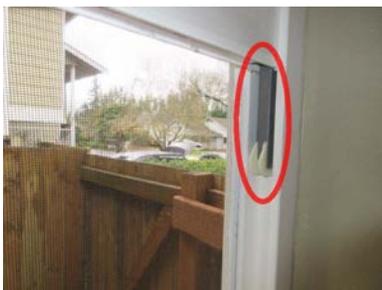
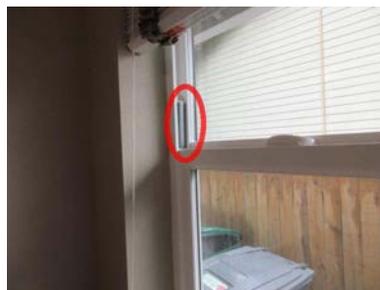
14.7 WINDOWS

The lift assist mechanism for the window in the laundry room is in need of repair. The window should not be used until repairs are completed.

- 11.16 – Fixed drain stop in master bedroom bath
- 12.2 – Caulked countertop and wall intersection
- 14.7 – Fixed lift assist in laundry room window
- 17.3 – Reinstalled and secured fallen insulation

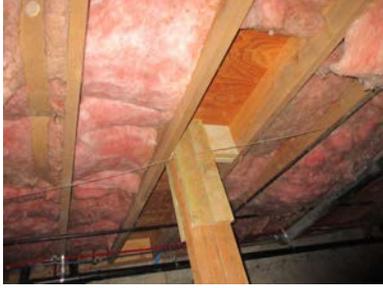
17.3 FLOOR INSULATION

Some of the insulation batts were not properly secured and have falling down. The fallen batts should be reinstalled and secured.

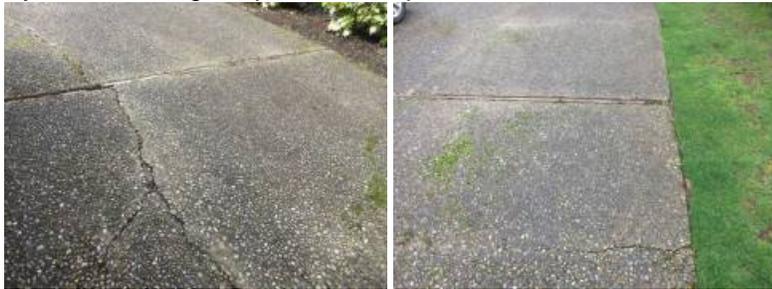
One or more of the wooden dividers separating the concrete driveway sections were infested by wood destroying organisms and have deteriorated to a point where they are becoming a trip hazard. Replacement with mortar is recommended.

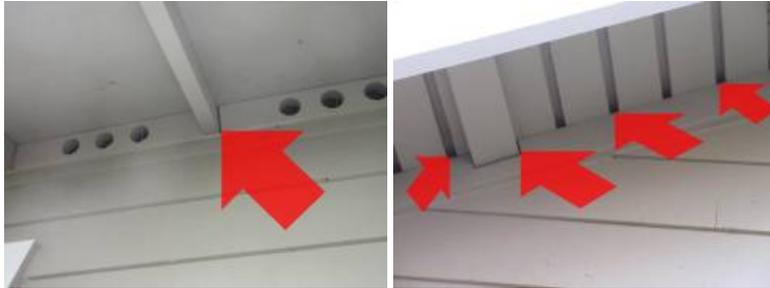
There are openings adjacent the ends of the outlook boards under the overhang through which insects and rodents can enter into the attic. These openings should be covered with wood, wire mesh or filled with aerosol foam.

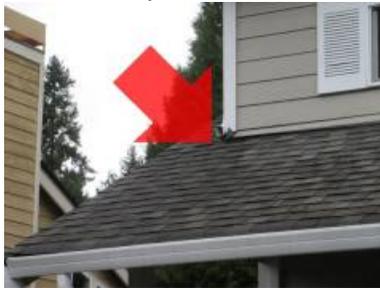
Downspouts draining directly onto the asphalt shingle surface causes excessive wear of the roofing material. Downspout extensions to the lower gutters should be installed to prevent excessive wear and tear of the roofing.

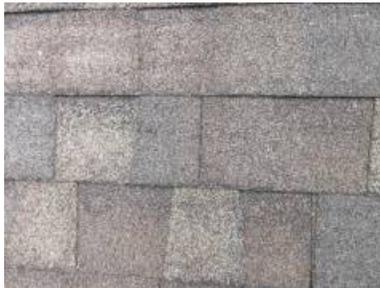
The roof is nearing the end of its service life. Significant wear and deterioration was observed. The need for replacement should be anticipated within 3-5 years.

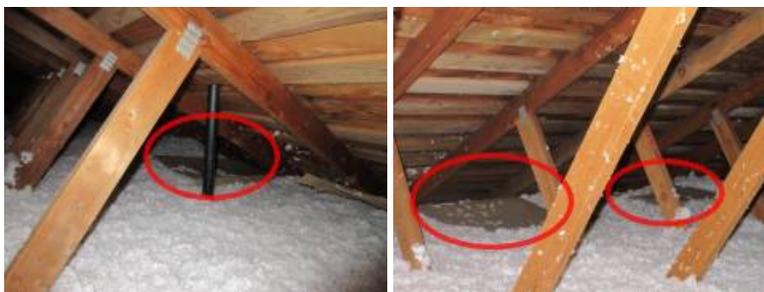
Wind baffles locations are compromised in some areas of the attic. The proper placement of wind baffles in front of all soffit vents is recommended.

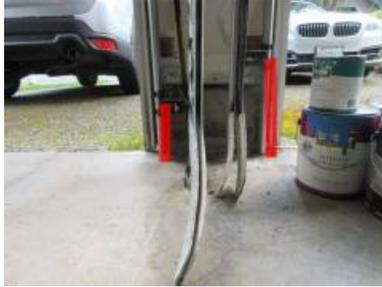
The Photo-eye beam was installed to high above the floor of the garage to adequately offer protection for small children and/or pets. We recommend that the photo-eye be lowered to within 4-6" of the floor.

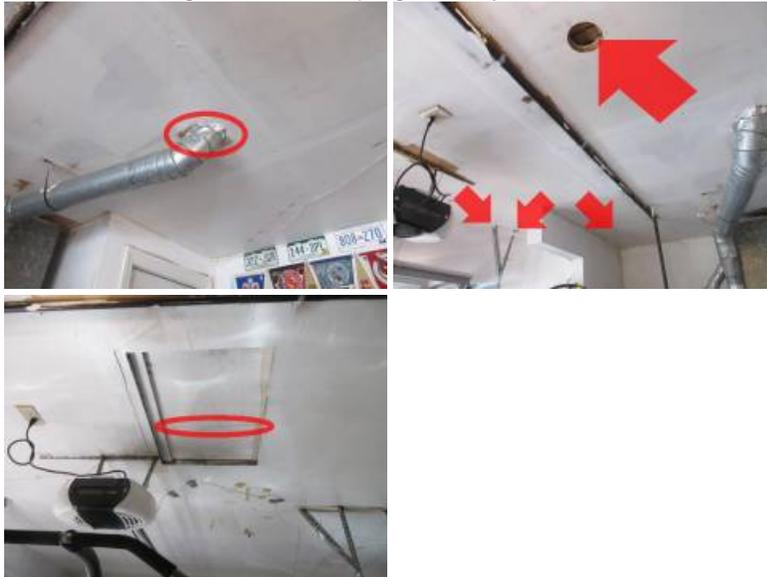
The broken drywall cover for the attic access is a breach in the fire resistive barrier in the garage. This is a safety concern. The broken joint can be taped. Consideration should be given to "fire taping" the drywall access cover as a safety upgrade.

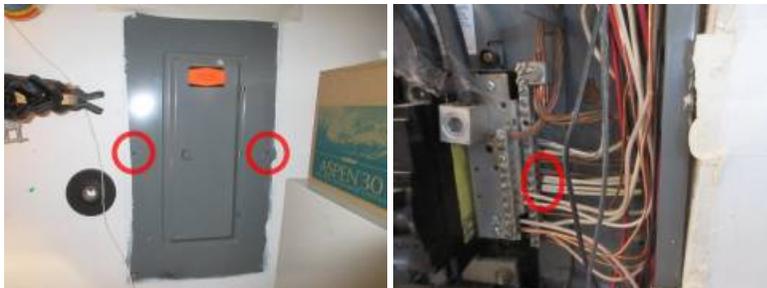
Several of the neutral wires are double tapped on the buss bar. Double tapping means that two conductors share a single terminal. Double tapped terminals can loosen and overheat and therefore are not permitted unless the terminal is specifically listed for multiple wires. This defect is easily repaired by connecting the two wires to a "pig tail", securing them with a wire cap, and then inserting the pig tail conductor under the terminal.

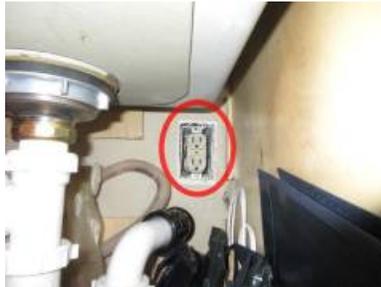
The cover plate is missing from a receptacle in the kitchen sink cabinet. This is a shock and fire hazard. The installation of a cover plate is recommended.

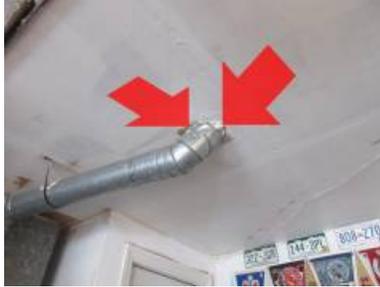
The furnace vent connector is too close to a combustible material. This is a hazard. A minimum clearance of 6" is required between the single wall vent connector and the combustible material. The double wall type B vent requires only 1" of clearance. Repairs are recommended.

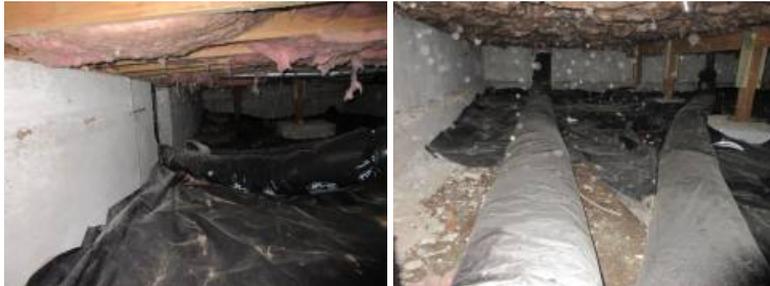
Heating ducts are in direct contact with the soil in the crawlspace under the house extension and have water in them. This will cause the ducts to corrode and will adversely affect the performance and efficiency of the heating system. The ducting should be drained, cleaned then reattached and secured in accordance with the manufacturer's specifications. Proper clearances should be established under the air ducts.

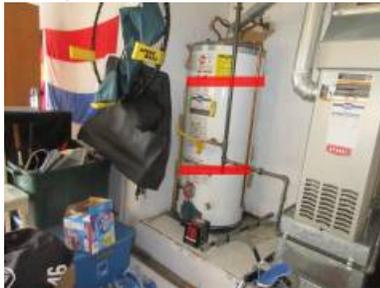
The seismic restraint for the water heater was minimal. Proper strapping is recommended to adequately secure the tank and provide potable water in the event of an earthquake.

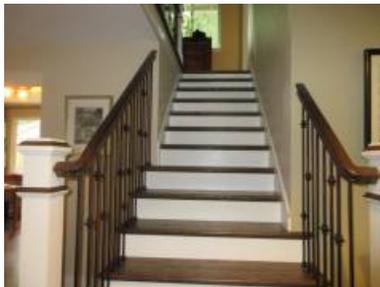
There is no continuous handrail in the stairwell. This is a safety hazard. The installation of a graspable handrail that conforms to present industry standards is recommended.

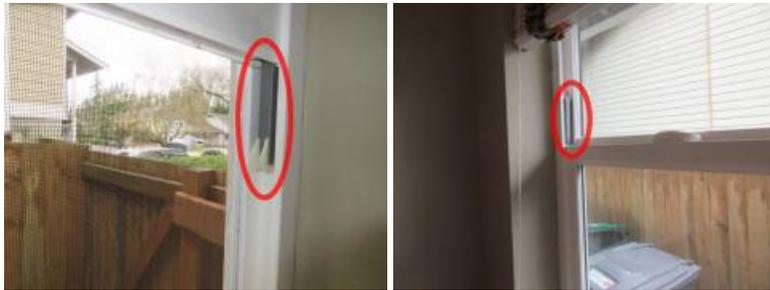
The lift assist mechanism for the window in the laundry room is in need of repair. The window should not be used until repairs are completed.

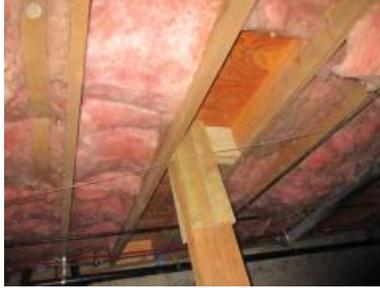
Some of the insulation batts were not properly secured and have falling down. The fallen batts should be reinstalled and secured.
