### NOTICE TO BUYER: SELLER-PROCURED INSPECTION REPORT

**Christopher and Rebekah Eldridge**

**13843 174<sup>th</sup> PL NE**

At your request, a visual inspection of the above referenced property was conducted on 04/20/2021. We have inspected the major structural components, plumbing, heating and electrical systems for signs of significant non-performance, excessive or unusual wear and general state of repair.

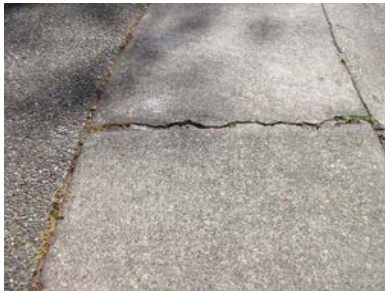
Cracks were observed in the concrete walkway. Minor cracks can be sealed to minimize moisture entry and further settlement of the concrete.

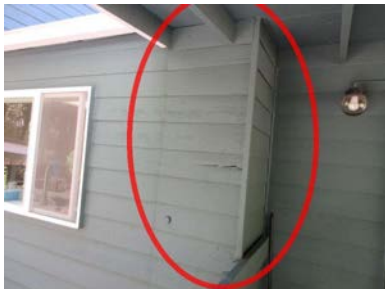
#### 3.1 PRIMARY EXTERIOR WALL CLADDING

The exterior wall adjacent the deck is rotted where there has been chronic contact with moisture from roof leakage. Rot damaged material should be replaced and protected from chronic contact with moisture. The damaged sections of wall sheathing and associated wall framing should be removed and replaced as needed.

**3.1, 3.9 – Seller will have rear (west) porch roof repaired (estimate attached)**

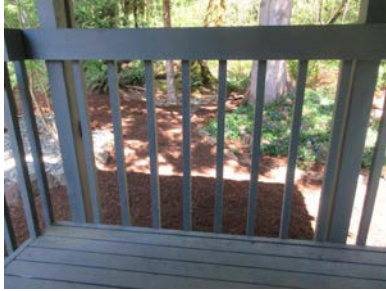
#### 3.8 DECK RAILINGS

The spacing between the balusters is too wide. This is a hazard to small children. The balusters should be

spaced close enough together so that a 4" sphere cannot pass through. Upgrading the deck railing is recommended if small children are present.

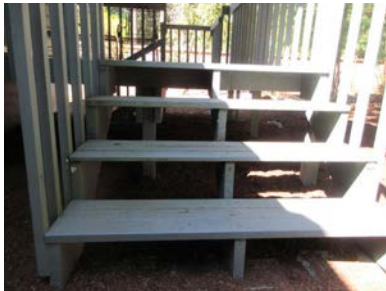
The stair rise spacing is too wide. This is a hazard for small children. The spacing should be reduced as a safety upgrade. Current standards require that a 4" sphere not pass through the opening.

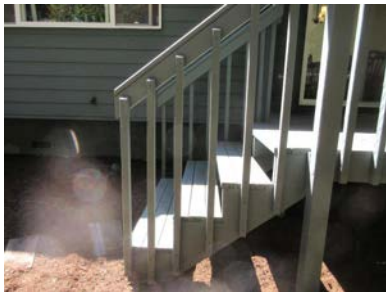
The stair railing baluster spacing is too wide. This is a hazard for small children. The baluster spacing should be reduced as a safety upgrade. Current standards require that a 4" sphere not pass through the railing.

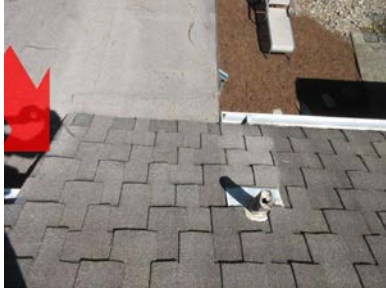
### 4.7 MAINTENANCE AND REPAIRS

The deck awning roof is not properly sloped. This has allowed water to pond on the surface of the roof and water damage was observed below the intersection of the deck roof to house roof. Repairs are recommended.

When reroofing, the surface of the roof should be sloped a minimum of a 1/4" per foot towards the drains. Consult with a qualified roofing contractor for additional information and replacement cost estimates.

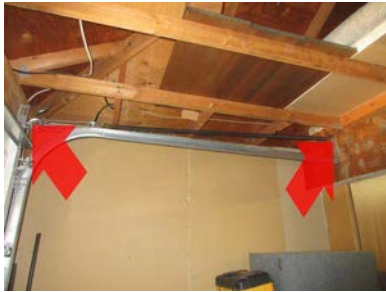
Safeties are cables run through the center of the garage door springs that prevent broken springs from becoming projectiles that can cause injury. There are no safeties installed. The installation of safeties is recommended.

**6.2 – Safety cables installed on garage door springs.**

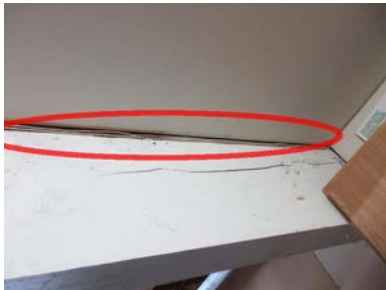
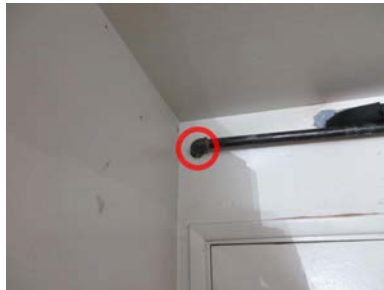
#### 6.4 FIRE SEPARATION

There are voids in the fire resistive barrier between the living space and garage that will allow flames to penetrate. The gypsum barrier slows the spread of a fire from the garage to the structure and/or living space. Patching the voids with a fire retardant caulk is recommended.

**6.4 – Voids in the fire barrier have been corrected.**

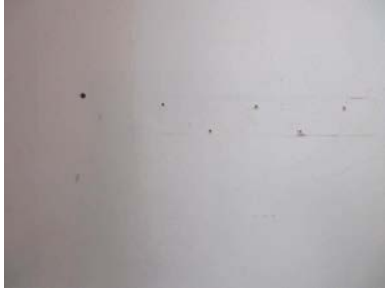
The fire resistive barrier between the garage and the living space is properly installed and in good condition, however, there are several holes that are not taped. Consideration should be given to "fire taping" the holes in the drywall as a safety upgrade.

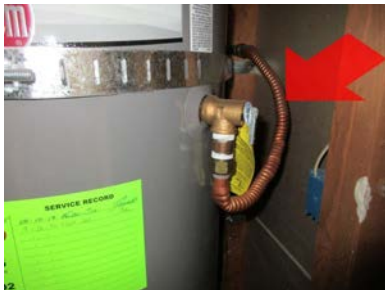
The pressure relief valve drain pipe has a reverse slope which traps water in the pipe. This can result in failure of the pressure relief valve. The drain pipe should be reconfigured so that it slopes 1/4" per foot to the drain outlet. If this is not possible or practical, a small (1/16") drain hole can be drilled in the bottom of the pipe at the lowest point.

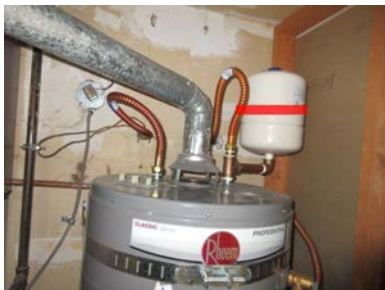
### ***10.5 EXPANSION TANK***

The expansion tank is not adequately secured to the wall. This could result in damage to the water pipe and leakage during an earth quake. A seismic restraint should be installed to secure the expansion tank.

**10.5 – Expansion tank secured to wall**

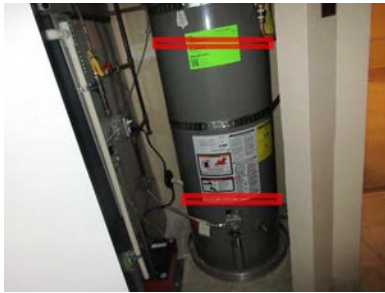
### ***10.11 SEISMIC RESTRAINT***

The seismic restraint for the water heater was minimal. Proper strapping is recommended to adequately secure the tank and provide potable water in the event of an earthquake.

**10.11 – Water Heater seismic restraints added to adequately secure to wall**

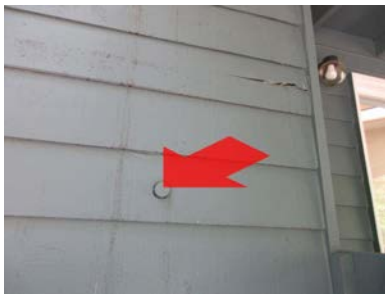
### 11.9 AIR GAP

An air gap called a Johnson Tee is installed in the kitchen wall. This air gap protects the dishwasher from contamination caused by a backflow of waste water. The cap protruding on the exterior wall opposite the dishwasher is not drilled. This renders the air gap non-functional. Drilling a 1/4" hole in the end of the cap will restore its function. The remaining visible portions of the Johnson Tee were properly installed and functioning as intended.

**11.9 – Johnson Tee drilled for proper venting.**

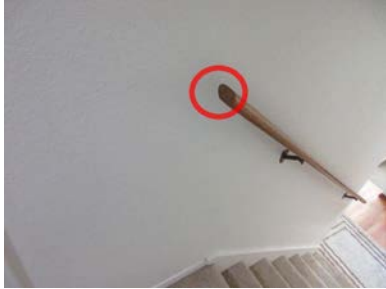
The railing ends in the stairwell does not return to the wall. This is a safety hazard. The installation of a continuous handrail should be considered as a safety upgrade.

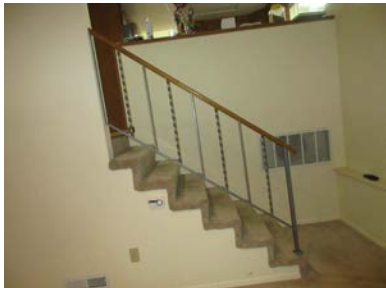
The lower stair railing baluster spacing is too wide. This is a hazard for small children. The baluster spacing should be reduced as a safety upgrade. Current standards require that a 4" sphere not pass through the railing.

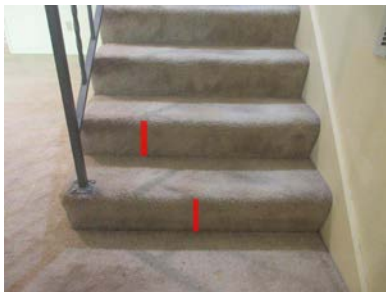
The stairs are non-conforming due to the variable and/or excessive rise. Stair design standards require that stair risers do not exceed 8" and that the variation in rise not exceed 3/8" in order to reduce falls from tripping. To increase the margin of safety, consideration should be given to reconfiguring the stairs so that rise and run do not vary by more than 3/8". If this proves to be too impractical or expensive, then we recommend exercising caution when using these stairs.

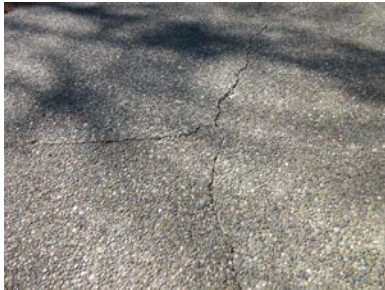
Cracks were observed in the concrete surface of the driveway. Minor cracks can be sealed to minimize moisture entry and further settlement of the concrete. Minor cracks are common and do not affect the serviceability of the concrete.

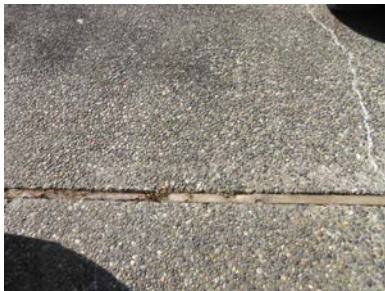
One or more of the wooden dividers separating the concrete driveway sections were infested by wood destroying organisms and have deteriorated to a point where they are becoming a trip hazard. Replacement with mortar is recommended.

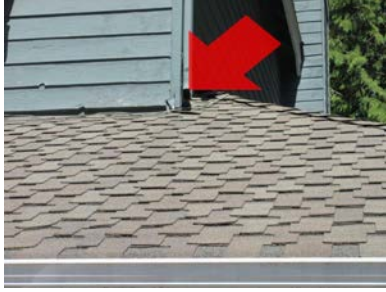
Downspouts draining directly onto the asphalt shingle surface causes excessive wear of the roofing material. Downspout extensions to the lower gutters should be installed to prevent excessive wear and tear of the roofing.

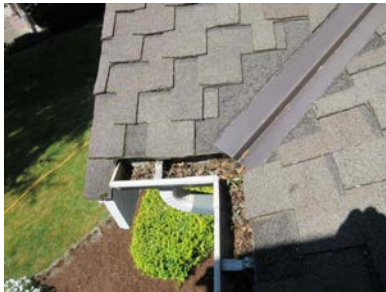
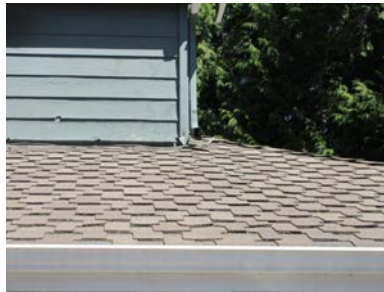
There is a build-up of organic debris inside the gutters. Proper maintenance of gutters and downspouts is essential and should be performed routinely in order to prevent clogging. Maintenance consists primarily of keeping leaves and other organic debris out of the system. Failure to clean the gutters will result in water splash on the building when they overflow. Gutters can be damaged under the weight of the water and organic matter inside the gutter. Gutters should be cleaned as necessary to maintain a free flow of water into the downspouts.

**3.5 – Gutters cleaned and debris removed on 4/26 by Ned Stevens**

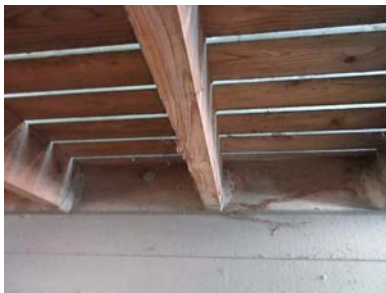
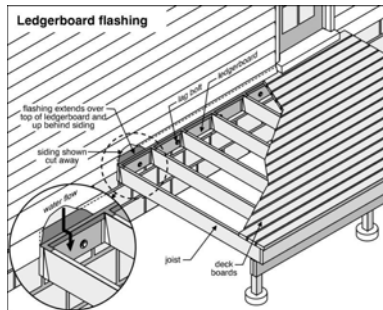
### 3.7 DECK

There is no flashing at the intersection between the deck and house. This will allow water to enter behind the siding. The installation of flashing in this area is recommended.

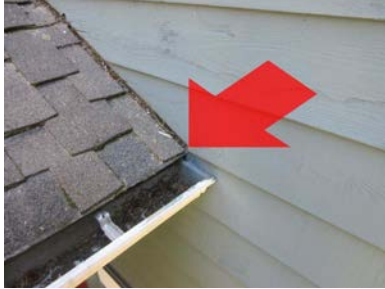
### 4.6 FLASHINGS

There is no kick out flashing at the roof edge to wall intersection above the gutter. This will allow water to enter the wall behind the siding. The installation of a kick-out flashing is recommended.

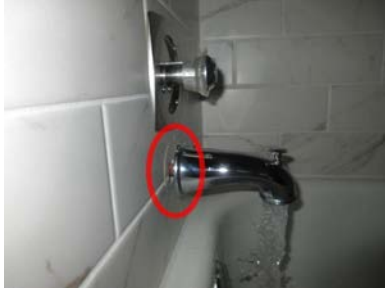
The tub spout is not mounted flush to the wall. This can result in leaks. The spout should be made flush to the wall in accordance with industry standards.

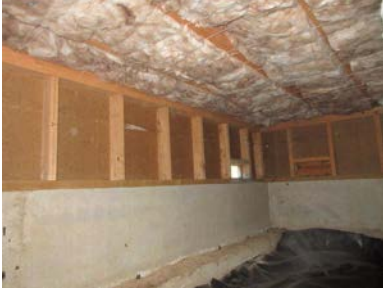
Shear panels are plywood or OSB panels that are mechanically fastened to both vertical and horizontal framing members in critical structural areas of the building. They prevent lateral movement of the structure during an earthquake. Shear panels are often visible in the crawlspace on cripple walls between the first floor and foundation. They may also be installed on interior walls that are covered with drywall. An examination of the crawlspace revealed the absence of shear panels on the cripple walls. The installation of shear panels on the cripple walls is recommended as an upgrade.

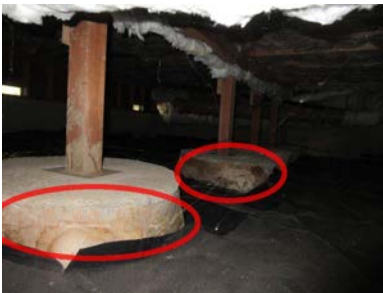
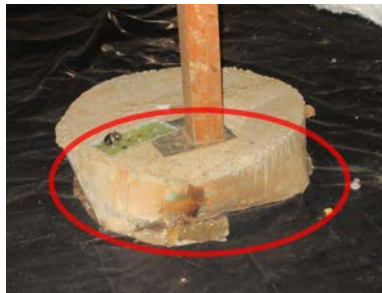
Cellulose forms were left in place on the pier footings. This cellulose is conducive to the infestation of various wood destroying organisms. The removal of the cellulose is recommended.

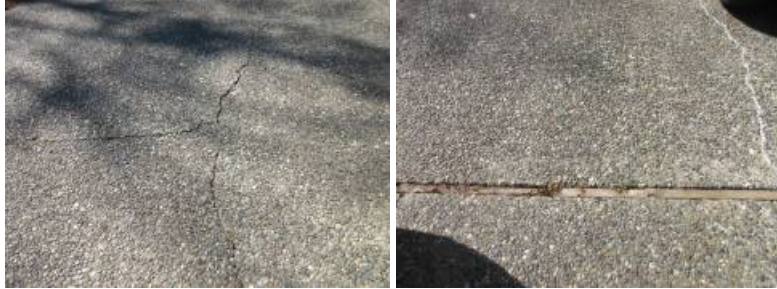
One or more of the wooden dividers separating the concrete driveway sections were infested by wood destroying organisms and have deteriorated to a point where they are becoming a trip hazard. Replacement with mortar is recommended.

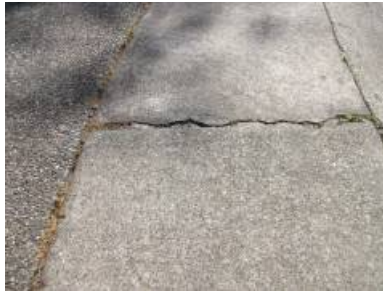
Many legal and public works departments have defined a trip hazard as an irregularity in a walking surface exceeding one inch (1") in height. All walking surfaces should maintain, free of a vertical surface change of 3/4" or more, in the interest of public and personal safety.

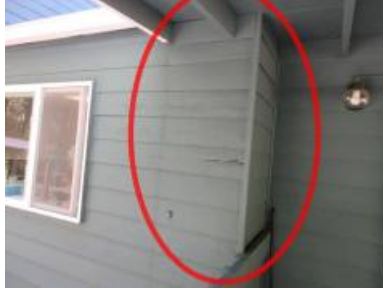
The exterior wall adjacent the deck is rotted where there has been chronic contact with moisture from roof leakage. Rot damaged material should be replaced and protected from chronic contact with moisture. The damaged sections of wall sheathing and associated wall framing should be removed and replaced as needed.

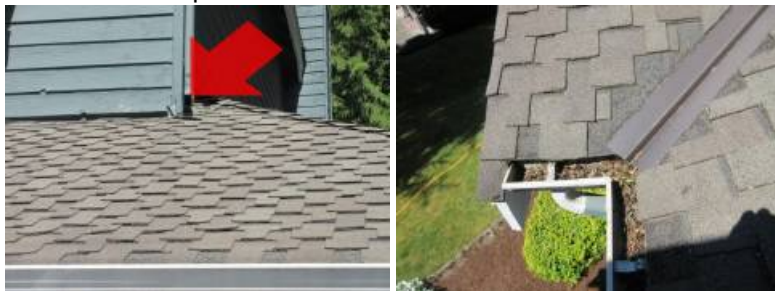
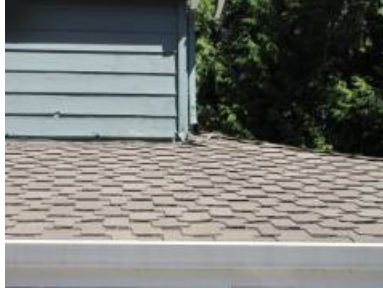
There is a build-up of organic debris inside the gutters. Proper maintenance of gutters and downspouts is essential and should be performed routinely in order to prevent clogging. Maintenance consists primarily of keeping leaves and other organic debris out of the system. Failure to clean the gutters will result in water splash on the building when they overflow. Gutters can be damaged under the weight of the water and organic matter inside the gutter. Gutters should be cleaned as necessary to maintain a free flow of water into the downspouts.

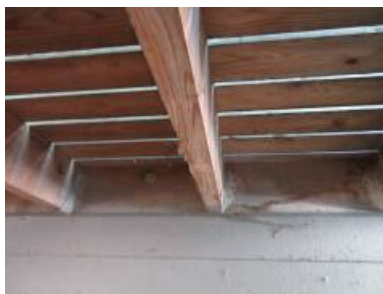
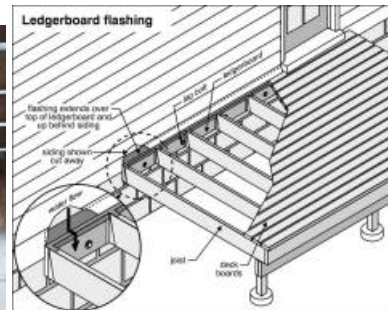
There is no flashing at the intersection between the deck and house. This will allow water to enter behind the siding. The installation of flashing in this area is recommended.

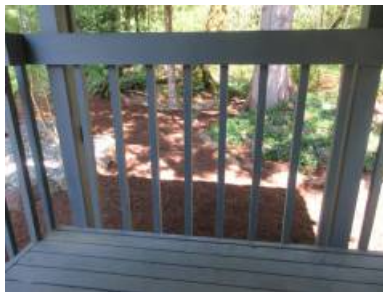
### 3.8 DECK RAILINGS

The spacing between the balusters is too wide. This is a hazard to small children. The balusters should be spaced close enough together so that a 4" sphere cannot pass through. Upgrading the deck railing is recommended if small children are present.

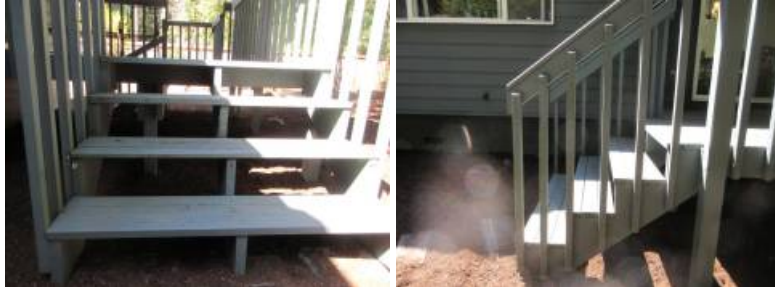
The stair railing baluster spacing is too wide. This is a hazard for small children. The baluster spacing should be reduced as a safety upgrade. Current standards require that a 4" sphere not pass through the railing.

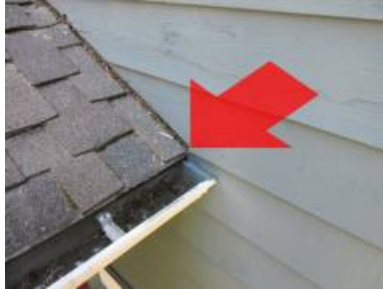
There is no kick out flashing at the roof edge to wall intersection above the gutter. This will allow water to enter the wall behind the siding. The installation of a kick-out flashing is recommended.

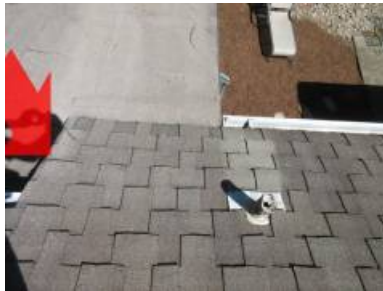
When reroofing, the surface of the roof should be sloped a minimum of a 1/4" per foot towards the drains. Consult with a qualified roofing contractor for additional information and replacement cost estimates.

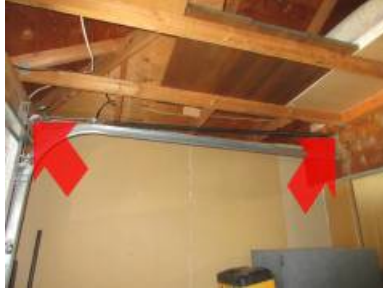
Safeties are cables run through the center of the garage door springs that prevent broken springs from becoming projectiles that can cause injury. There are no safeties installed. The installation of safeties is recommended.

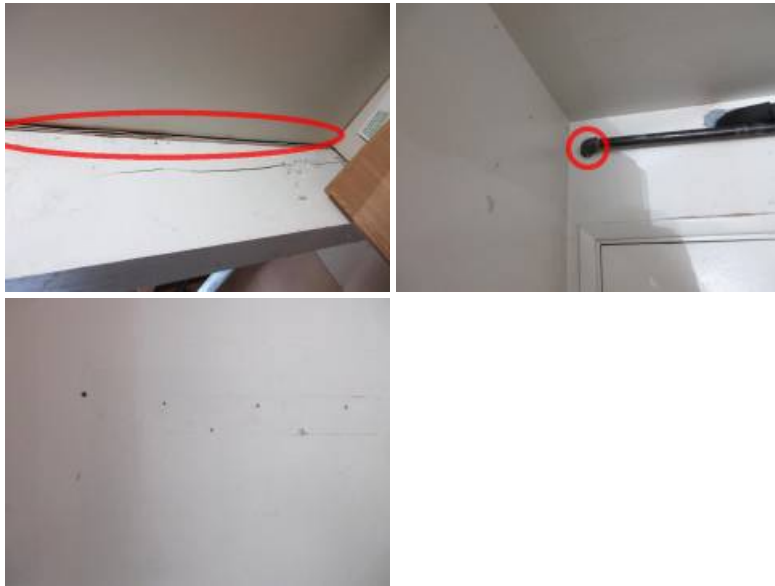
The fire resistive barrier between the garage and the living space is properly installed and in good condition, however, there are several holes that are not taped. Consideration should be given to "fire taping" the holes in the drywall as a safety upgrade.

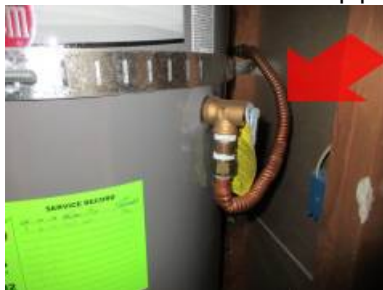
The pressure relief valve drain pipe has a reverse slope which traps water in the pipe. This can result in failure of the pressure relief valve. The drain pipe should be reconfigured so that it slopes 1/4" per foot to the drain outlet. If this is not possible or practical, a small (1/16") drain hole can be drilled in the bottom of the pipe at the lowest point.

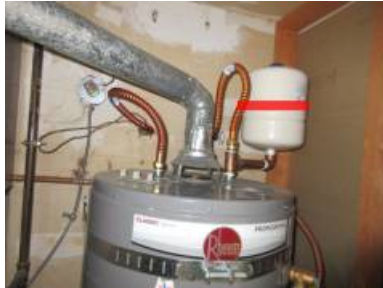
The expansion tank is not adequately secured to the wall. This could result in damage to the water pipe and leakage during an earth quake. A seismic restraint should be installed to secure the expansion tank.

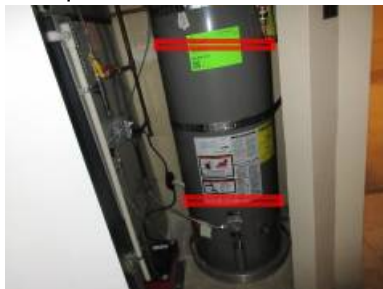
The seismic restraint for the water heater was minimal. Proper strapping is recommended to adequately secure the tank and provide potable water in the event of an earthquake.

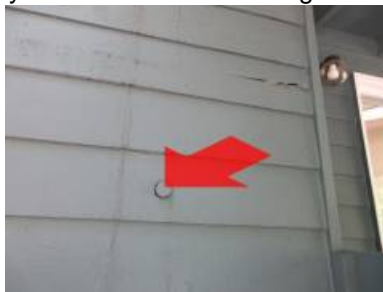
An air gap called a Johnson Tee is installed in the kitchen wall. This air gap protects the dishwasher from contamination caused by a backflow of waste water. The cap protruding on the exterior wall opposite the dishwasher is not drilled. This renders the air gap non-functional. Drilling a 1/4" hole in the end of the cap will restore its function. The remaining visible portions of the Johnson Tee were properly installed and functioning as intended.

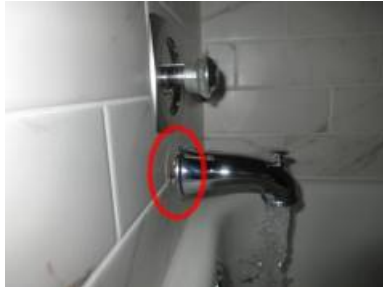
The tub spout is not mounted flush to the wall. This can result in leaks. The spout should be made flush to the wall in accordance with industry standards.

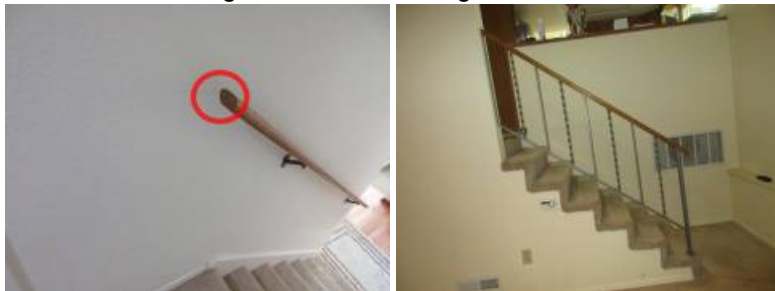
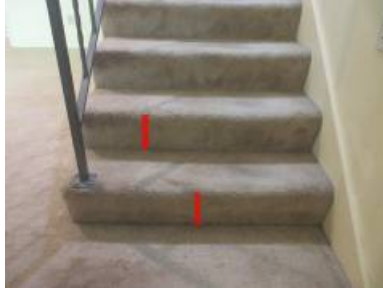
The stairs are non-conforming due to the variable and/or excessive rise. Stair design standards require that stair risers do not exceed 8" and that the variation in rise not exceed 3/8" in order to reduce falls from tripping. To increase the margin of safety, consideration should be given to reconfiguring the stairs so that rise and run do not vary by more than 3/8". If this proves to be too impractical or expensive, then we recommend exercising caution when using these stairs.

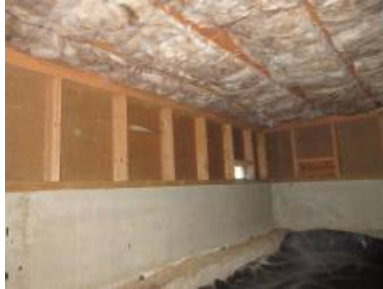
often visible in the crawlspace on cripple walls between the first floor and foundation. They may also be installed on interior walls that are covered with drywall. An examination of the crawlspace revealed the absence of shear panels on the cripple walls. The installation of shear panels on the cripple walls is recommended as an upgrade.

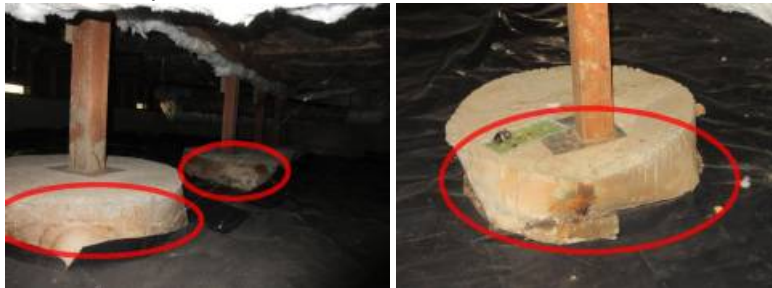
Good building practice requires that foundation walls or pier footings supporting wood frame construction, should extend at least 8" above the finish grade with at least a 6" clearance between the top of the soil and the bottom of the wood finish materials. Untreated wood should be raised 1-2" above surrounding flatwork and should have a moisture barrier such as 30 lb. asphalt impregnated felt installed between the concrete and wood. For additional information and treatment options, you should retain the services of a qualified pest control operator.
