NOTICE TO BUYER: SELLER-PROCURED INSPECTION REPORT

The following notice is given with respect to the Purchase and Sale Agreement dated _____
between _____ ("Buyer")
and **Chantal L Porter** **Kevin D Porter** ("Seller")
concerning **1048 215th Pl SE Bothell WA 98021** ("the Property").

**Chantal and Kevin Porter
1048 215th PL SE
Bothell, WA 98021**

At your request, a visual inspection of the above referenced property was conducted on 10/14/2021. We have inspected the major structural components, plumbing, heating and electrical systems for signs of significant non-performance, excessive or unusual wear and general state of repair.

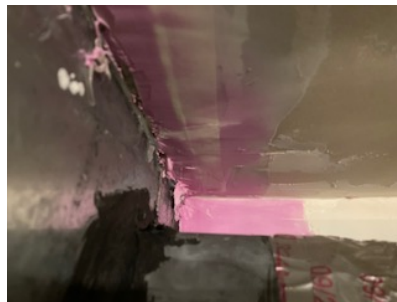
6.4 Attached Garage Fire Separation – Repaired: The penetrations have been fire caulked and the un-taped joint fire taped. No further action needed.

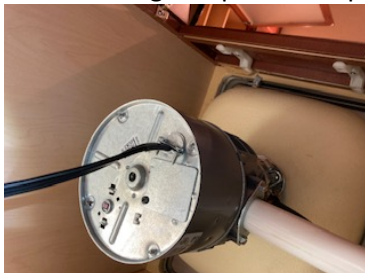
11.14 Garbage Disposer - Repaired: Broken wire-clamp is replaced. No further action needed.

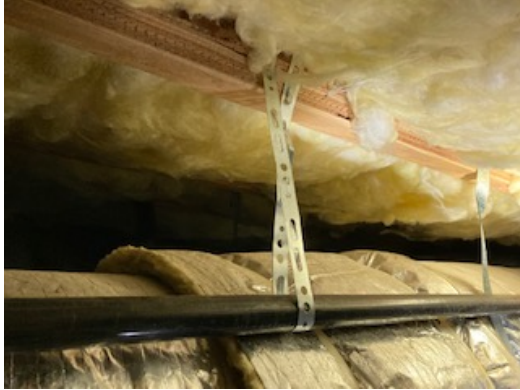
14.10 Gas Piping – Repaired: Supports added. No further action needed.

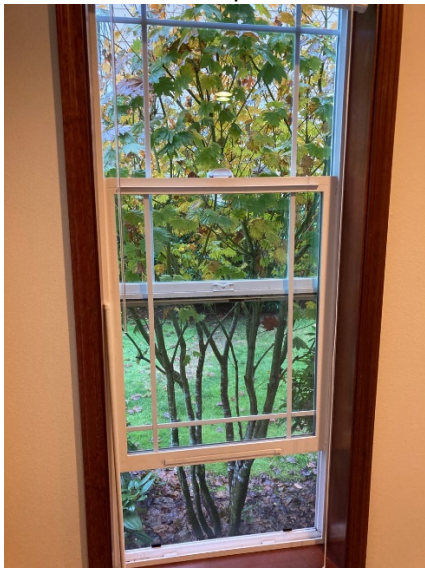
15.6 Windows – Repaired.

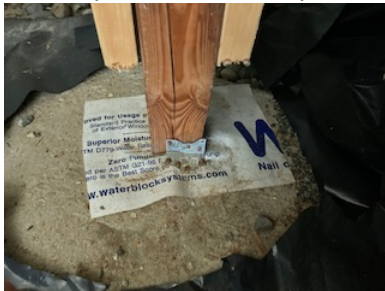
20.4 Vapor retarder – Repaired: Cut back plastic 1 ft from wood posts. No further action needed.

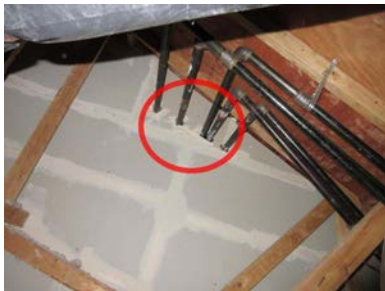
5.5 FIREWALL

Further inspection of the visible portions of the fire wall revealed no protection around the piping. This defeats the purpose of the firewall. The fire wall slows the spread of a fire from one unit to the next. Consideration should be given to "sealing" the drywall around the ducting as a safety upgrade.

5.5 Firewall – The firewall is fire taped per code, as are the pipe penetrations. No action needed.

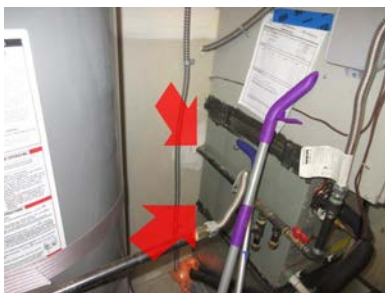
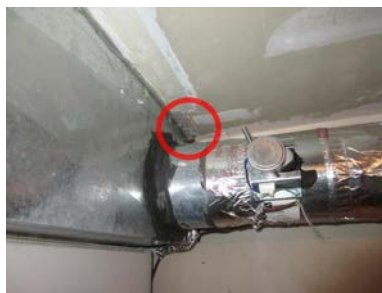
6.4 FIRE SEPARATION

There are voids adjacent the pipe penetrations in the fire resistive barrier between the living space and garage that will allow flames to penetrate. The gypsum barrier slows the spread of a fire from the garage to the structure and/or living space. Patching the voids with a fire retardant caulk is recommended.

The joints are not taped above the ducting. Consideration should be given to "fire taping" the drywall as a

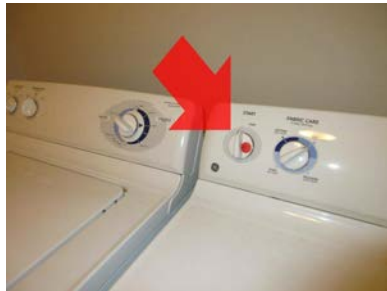
13.3 APPLIANCES

The dryer start cycle control switch is not working. It should be repaired or replaced as necessary.

13.3 Dryer start cycle switch – Dryer functions without the momentary contact start switch. It appears to be permanently in the on position. Simply use the cycle selector/timer. Automatically turns off when cycle completed. (Seller will have this fixed prior to closing). No further action needed.

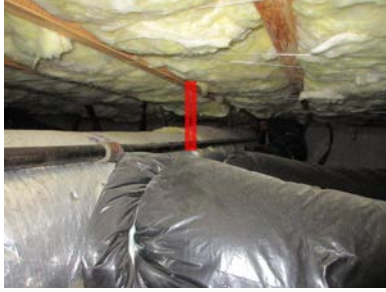
14.10 GAS PIPING

The gas pipe in crawlspace was not adequately secured to the framing. This can damage the pipe. The gas pipe should be secured in accordance with industry standards.

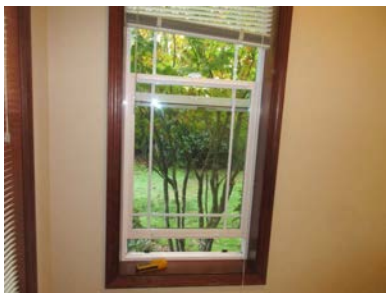
15.6 WINDOWS

The lift assist mechanism for the west window in the living room is in need of repair. The window should not be used until repairs are completed.

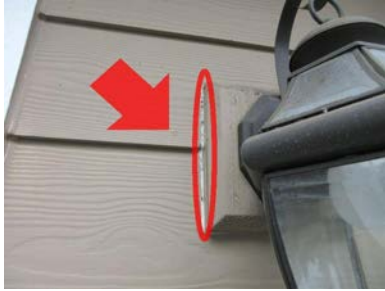
The caulking is cracked and deteriorated. Caulking prevents water intrusion into the wall. Removing and replacing deteriorated caulk is recommended.

- Caulking of the edge of outside lamp base is repaired. No further action needed.

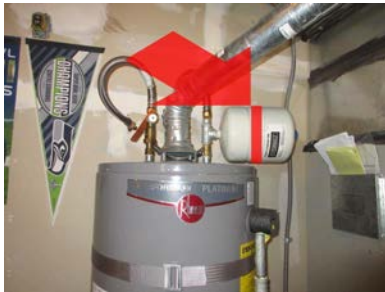
10.6 EXPANSION TANK

The expansion tank is not adequately secured to the wall. As code requirements start to call for engineered expansion tank supports we recommend the installation of seismic restraints to secure the expansion tank instead of allowing it to simply depend on piping connections that could result in damage to the water pipe and leakage during an earthquake.

10.6 Water Heater expansion tank – Repaired: seismic strap has been added to secure the tank. No further action needed.

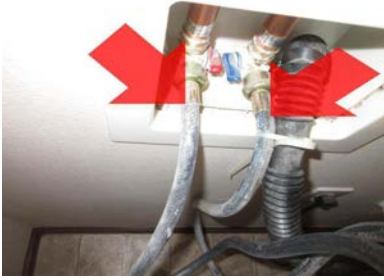
13.3 APPLIANCES

Upgrading the washer connections to high pressure (steel braided) lines is recommended.

13.3 Washer water supply hoses – inspected for signs of bulging or rusting and found none. No further action is needed. Recommendation regarding braided hoses noted.

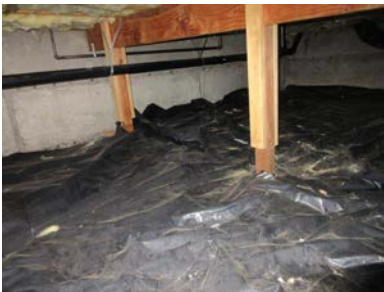
20.4 VAPOR RETARDER

The support post concrete piers are covered with the plastic vapor retarder. This allows the transmission of water vapor from the soil up and into the floor framing. The plastic vapor retarder should be removed from the pier so that it covers at least 85% of the entire surface of the soil only.

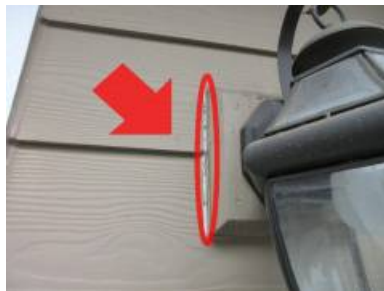
The caulking is cracked and deteriorated. Caulking prevents water intrusion into the wall. Removing and replacing deteriorated caulk is recommended.

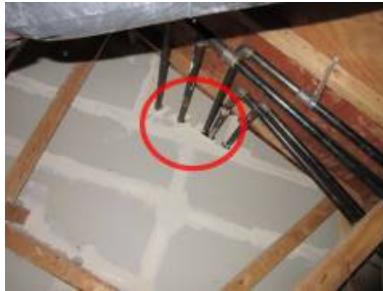
5.5 FIREWALL

Further inspection of the visible portions of the fire wall revealed no protection around the piping. This defeats the purpose of the firewall. The fire wall slows the spread of a fire from one unit to the next. Consideration should be given to "sealing" the drywall around the ducting as a safety upgrade.

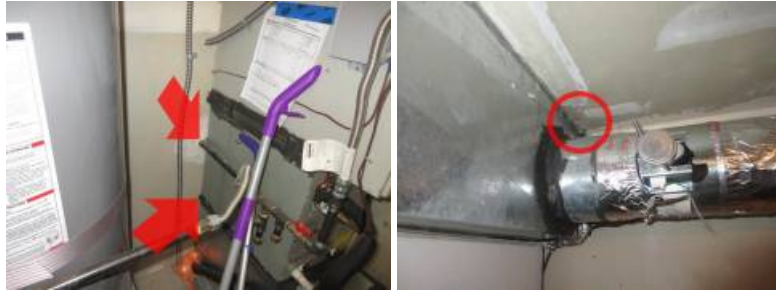
There are voids adjacent the pipe penetrations in the fire resistive barrier between the living space and garage that will allow flames to penetrate. The gypsum barrier slows the spread of a fire from the garage to the structure and/or living space. Patching the voids with a fire retardant caulk is recommended.

The joints are not taped above the ducting. Consideration should be given to "fire taping" the drywall as a safety upgrade.

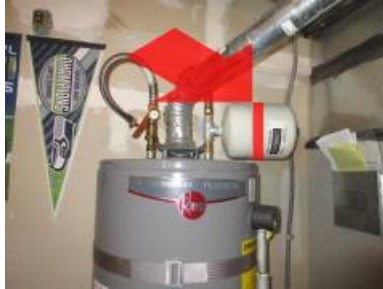
10.6 EXPANSION TANK

The expansion tank is not adequately secured to the wall. As code requirements start to call for engineered expansion tank supports we recommend the installation of seismic restraints to secure the expansion tank instead of allowing it to simply depend on piping connections that could result in damage to the water pipe and leakage during an earthquake.

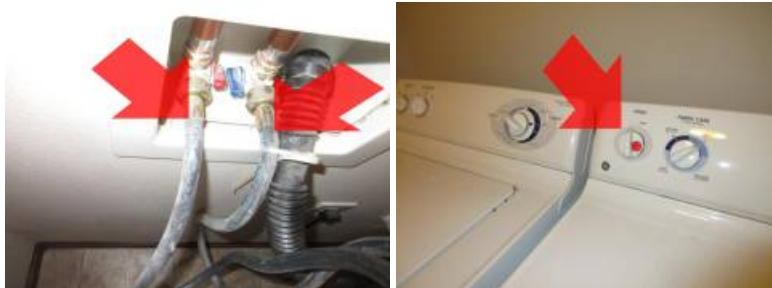
The dryer start cycle control switch is not working. It should be repaired or replaced as necessary.

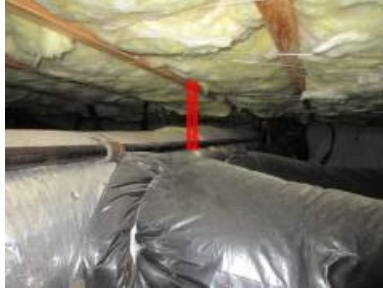
The gas pipe in crawlspace was not adequately secured to the framing. This can damage the pipe. The gas pipe should be secured in accordance with industry standards.

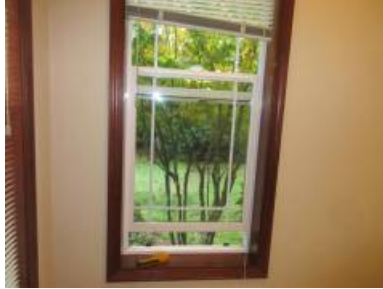
The lift assist mechanism for the west window in the living room is in need of repair. The window should not be used until repairs are completed.

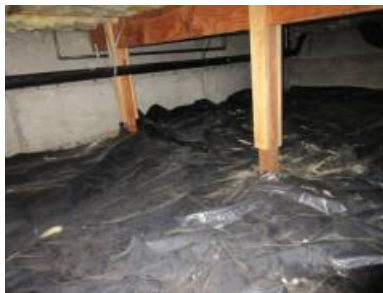
The support post concrete piers are covered with the plastic vapor retarder. This allows the transmission of water vapor from the soil up and into the floor framing. The plastic vapor retarder should be removed from the pier so that it covers at least 85% of the entire surface of the soil only.
