NOTICE TO BUYER: SELLER-PROCURED INSPECTION REPORT

The following notice is given with respect to the Purchase and Sale Agreement dated _____ between _____ ("Buyer") and **Taylor Trust** _____ ("Seller") concerning **31780 Ne 171st St Duvall WA 98019** ("the Property").

March 9, 2022

Re: 31780 NE171st St.
Duvall, WA.

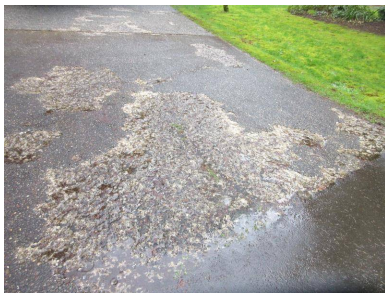
Severe aggregate loss and degradation of the surface of the driveway was observed. This may have been caused by an admixture or overworking of the material at the time of installation. The driveway remains functional despite this condition. Removing and replacing the degraded portion of the driveway should be considered.

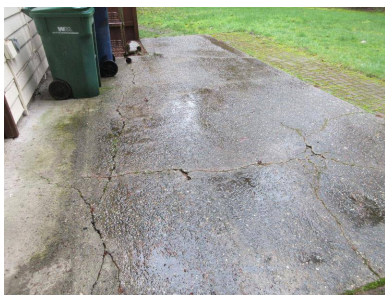
2.5 PATIO

The patio has settled differentially. This was probably caused by inadequate preparation of the soil prior to the placement of the concrete. This condition can be repaired by pressure grouting the sunken portion of the patio or by removing and replacing it. The patio remains functional despite this condition. However, the raised edges of the concrete can be a trip hazard for some people. Repairs should be made as necessary.

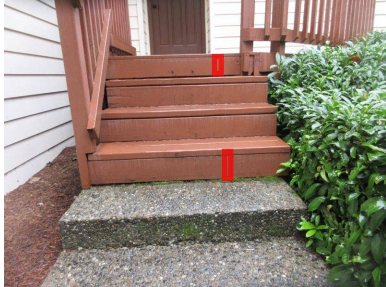
3.9 PORCH STEPS

The steps are non-conforming due to the variable and/or excessive rise. Stair design standards require that step risers do not exceed 8" and that the variation in rise not exceed 3/8" in order to reduce falls from tripping. To increase the margin of safety, consideration should be given to reconfiguring the steps so that rise and run do not vary by more than 3/8". If this proves to be too impractical or expensive, then we recommend exercising caution when using.

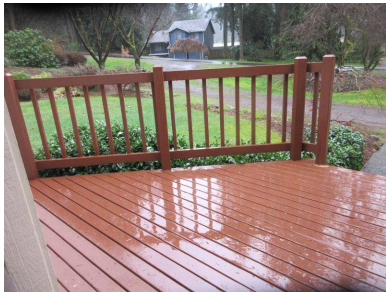
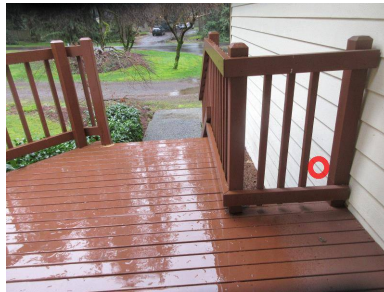
3.10 PORCH RAILING

The spacing between the balusters is too wide. This is a hazard to small children. The balusters should be spaced close enough together so that a 4" sphere cannot pass through. Upgrading the porch railing is recommended if small children are present.

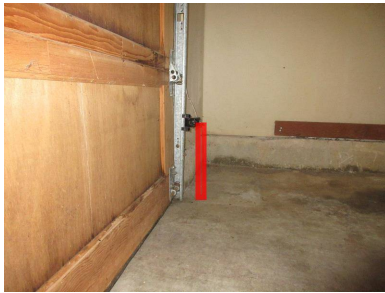
There was no photo-eye sensor installed for the east garage door to offer protection for small children and/or pets. We recommend that a photo-eye sensor be installed for the garage door at a height of within 4-6" of the floor.

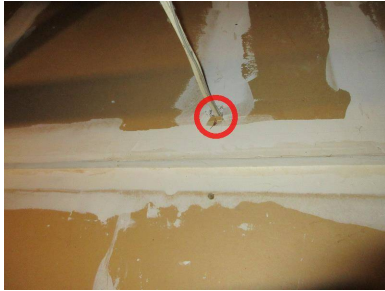
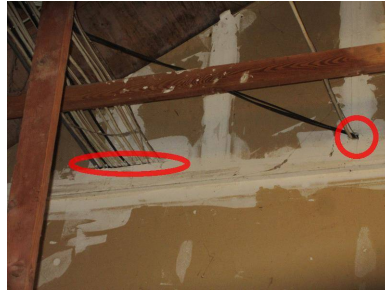
6.4 FIRE SEPARATION

There are voids in the fire resistive barrier between the living space and garage that will allow flames to penetrate. The gypsum barrier slows the spread of a fire from the garage to the structure and/or living space. Patching the voids with a fire retardant caulk is recommended.

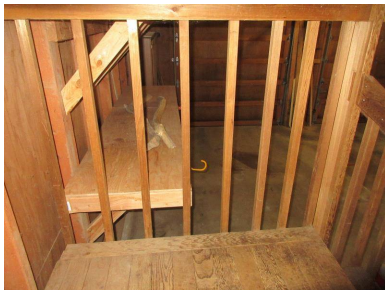
The stair landing and railing baluster spacing is too wide. This is a hazard for small children. The baluster spacing should be reduced as a safety upgrade. Current standards require that a 4" sphere not pass through the railing.

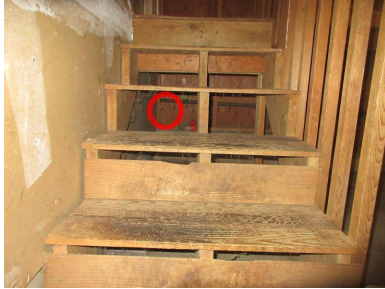
The stair rise spacing is too wide. This is a hazard for small children. The spacing should be reduced as a safety upgrade. Current standards require that a 4" sphere not pass through the opening.

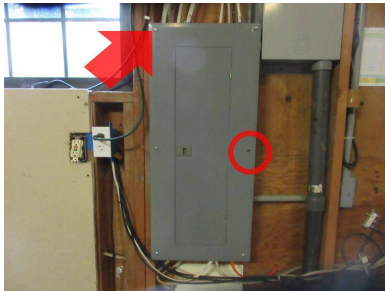
7.8 SERVICE PANEL

One of the screws that secure the panel cover to the panel box is missing. This is a potential hazard. Missing screws should be replaced with the original style blunt end screws.

One of the screws that secure the panel cover to the panel box is stripped. This is a potential hazard. Properly fitted screws with blunt ends should be installed.

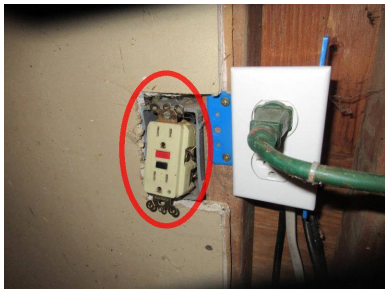
The GFCI receptacle in the garage does not trip when a ground fault is introduced. This is caused by an improperly wired or defective GFCI. Repair or replacement of this GFCI is recommended.

The installation of additional GFCI protection in all of the garage receptacles is recommended.

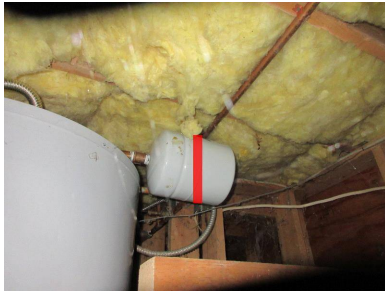
The expansion tank is not adequately secured to the wall. As code requirements start to call for engineered expansion tank supports we recommend the installation of seismic restraints to secure the expansion tank instead of allowing it to simply depend on piping connections that could result in damage to the water pipe and leakage during an earthquake.

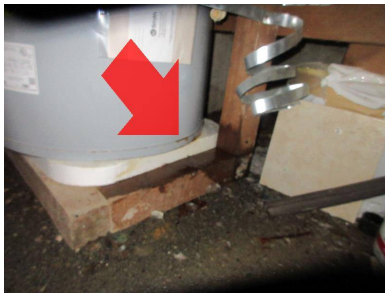
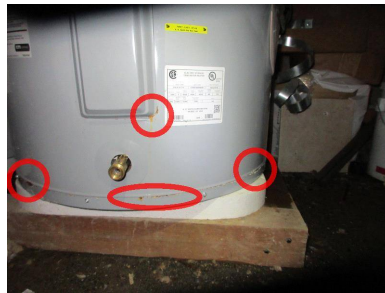
9.8 GENERAL COMMENTS

The west water heater is leaking. The services of a qualified plumbing contractor should be retained to replace the water heater.

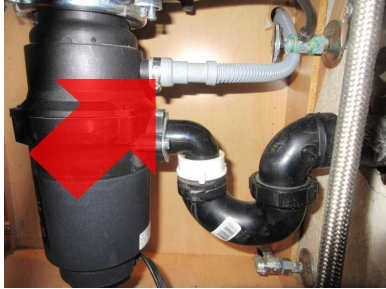
The dishwasher drain lacks an air gap. The dishwasher will function without one, but there is a risk of contamination of the inside of the dishwasher by waste water. The installation of an air gap is recommended.

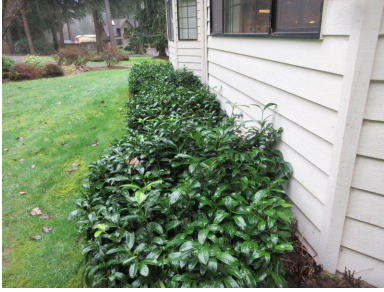
Dense shrubbery and trees planted too close to the building can damage siding and the roof overhang and interfere with drainage and air movement, thus promoting fungus growth and accelerated deterioration of exterior finishes and wood. Trees and shrubs in contact with the building also provide carpenter ants with a route into walls or attics. Trees and shrubs should be trimmed back, where required. When landscaping, trees and shrubs should be planted back away from the building so that they have room to grow.

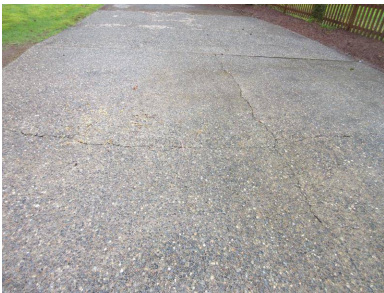
2.4 DRIVEWAY

Cracks were observed in the concrete surface of the driveway. Minor cracks can be sealed to minimize moisture entry and further settlement of the concrete. Minor cracks are common and do not affect the serviceability of the concrete.

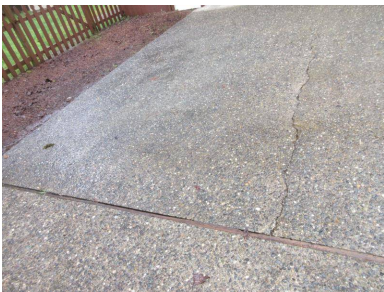
One or more of the wooden dividers separating the concrete driveway sections were infested by wood destroying organisms and have deteriorated to a point where they are becoming a trip hazard. Replacement with mortar is recommended.

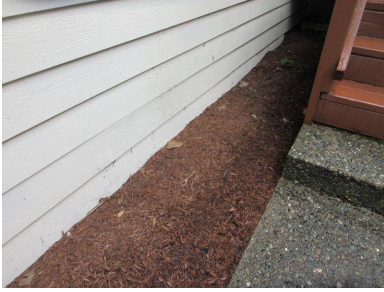
Soil is close to or in contact with siding in some areas around the building exterior. Good building practice requires that foundation walls or pier footings supporting wood frame construction, extend at least 8" above the finish grade with at least a 6" clearance between the top of the soil and the bottom of the wood finish materials. Soil in direct contact with wood creates a hospitable environment for wood destroying organisms. Establishing these minimum clearances is recommended.

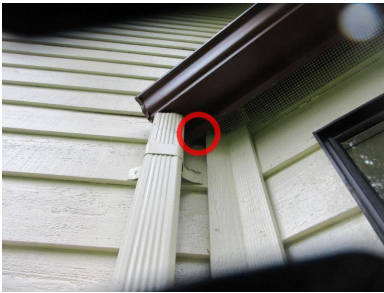
3.3 SOFFITS AND OVERHANGS

Gaps over 1/4" in size adjacent the gutters will allow insects and rodents to enter the attic. Covering any gaps with aerosol foam, a strip of wood and/or caulking is recommended.

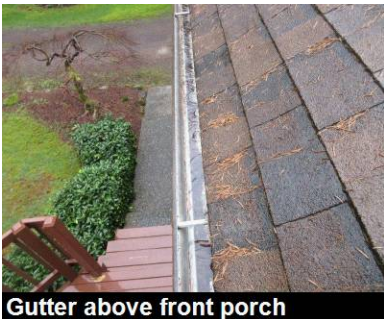
3.4 GUTTERS AND DOWNSPOUTS

The gutters are not properly sloped on the front side of the building. The gutters should be sloped properly to prevent water splash on the siding.

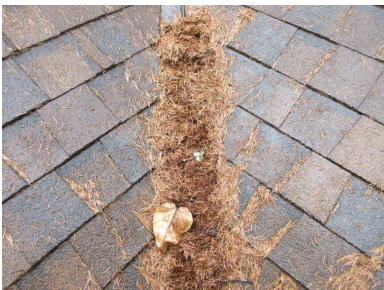
4.5 MAINTENANCE AND REPAIRS

The roof is in need of routine maintenance. The surface should be blown off or washed with a high volume low pressure garden hose to remove moss and organic debris. Performing this maintenance will improve the appearance and increase the life expectancy of the roof.

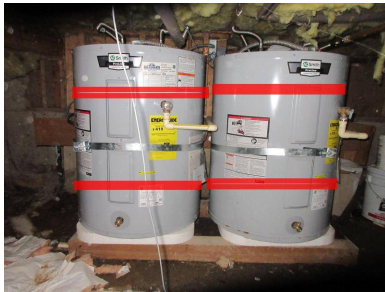
The seismic restraint for the water heaters was minimal. Proper strapping is recommended to adequately secure the tank and provide potable water in the event of an earthquake.

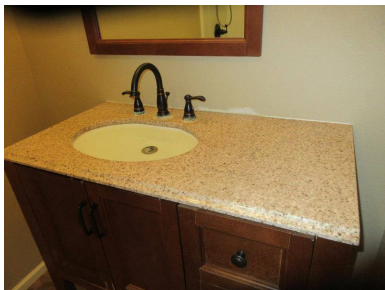
The backsplash is missing. The installation of a backsplash is recommended.

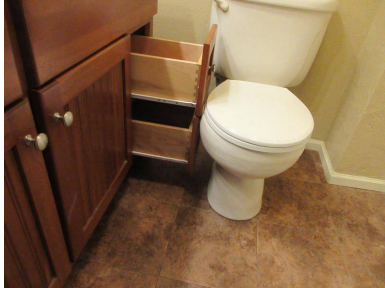
The bathroom cabinet proximity prevented two of the drawers to fully open otherwise the cabinet is in good condition.

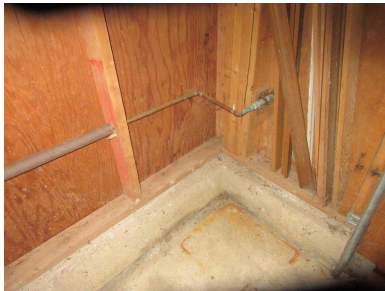
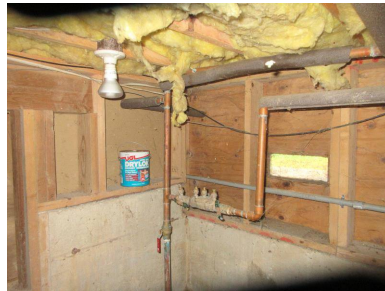
There are water pipes in the garage and crawlspace that are not adequately insulated and could freeze. The installation of foam pipe insulation on all exposed water pipes is recommended.

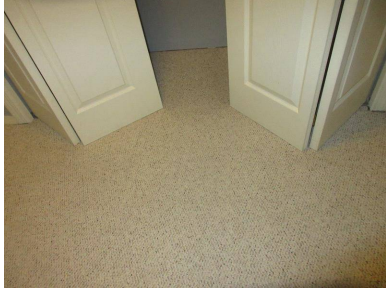
The bedroom bifold closet doors rub on the carpet. Doors should be adjusted as necessary.

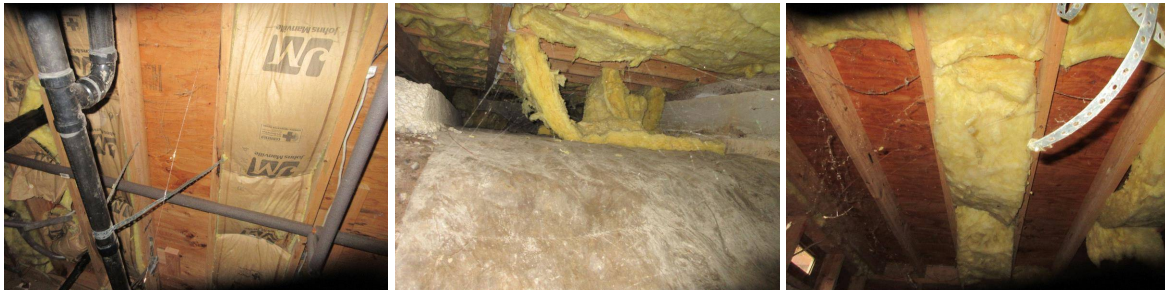
Some of the insulation batts were not properly secured and have falling down. The fallen batts should be reinstalled and secured.

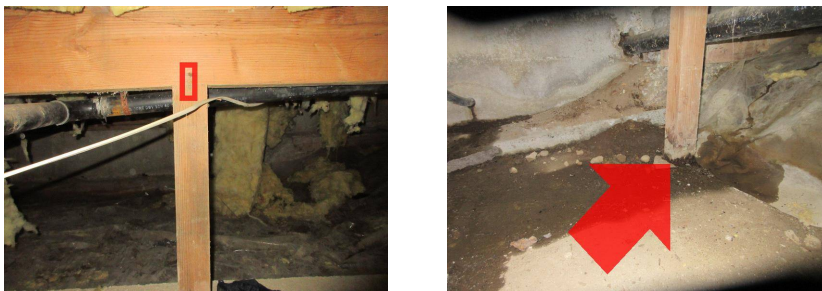
There are missing gusset plates tying the beams and posts together. The installation of gusset plates for all post and beam connections is recommend to reduce the likelihood of damage during an earthquake.

The beam support post adjacent the west foundation wall sits on the reatproofing. Water seeping into the crawlspace over the footing saturates the bottom of the support post. This has caused the bottom of the post to rot. Damaged posts should be replaced. The remaining posts should be treated with wood preservative.

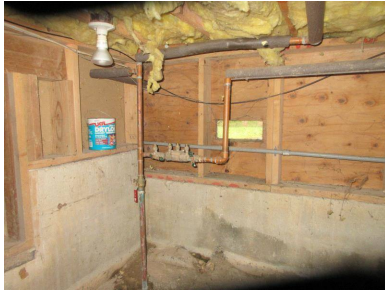
18.6 SHEAR PANELS

Shear panels are plywood or OSB panels that are mechanically fastened to both vertical and horizontal framing members in critical structural areas of the building. They prevent lateral movement of the structure during an earthquake. Shear panels are often visible in the crawlspace on cripple walls between the first floor and foundation. They may also be installed on interior walls that are covered with drywall. An examination of the crawlspace revealed the absence of shear panels on the cripple walls. The installation of shear panels on the cripple walls is recommended as an upgrade.

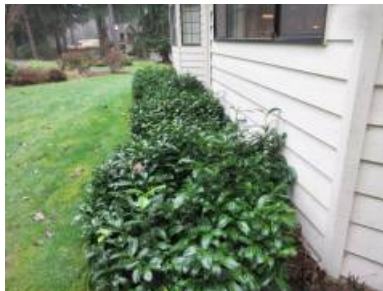
Dense shrubbery and trees planted too close to the building can damage siding and the roof overhang and interfere with drainage and air movement, thus promoting fungus growth and accelerated deterioration of exterior finishes and wood. Trees and shrubs in contact with the building also provide carpenter ants with a route into walls or attics. Trees and shrubs should be trimmed back, where required. When landscaping, trees and shrubs should be planted back away from the building so that they have room to grow.

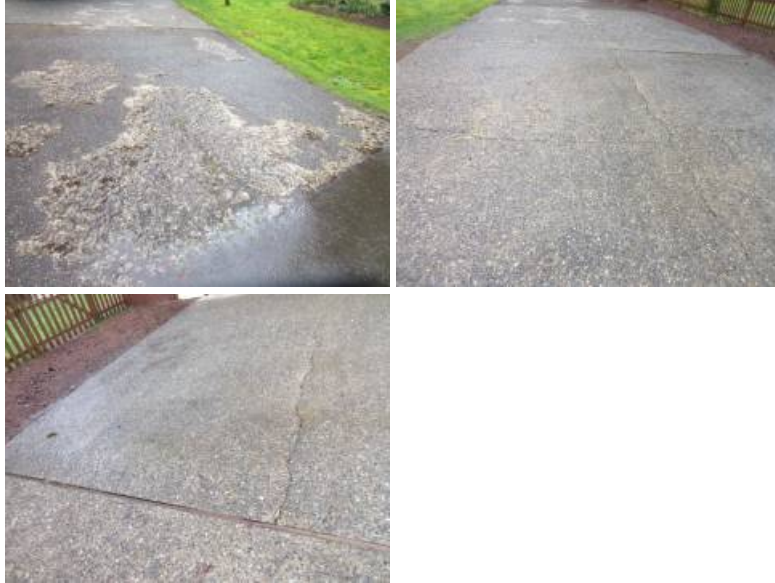
One or more of the wooden dividers separating the concrete driveway sections were infested by wood destroying organisms and have deteriorated to a point where they are becoming a trip hazard. Replacement with mortar is recommended.

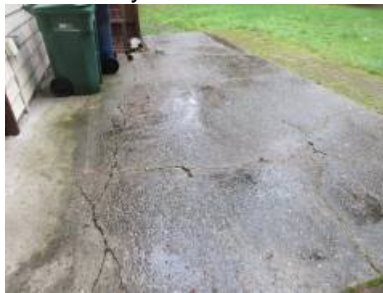
2.5 PATIO

The patio has settled differentially. This was probably caused by inadequate preparation of the soil prior to the placement of the concrete. This condition can be repaired by pressure grouting the sunken portion of the patio or by removing and replacing it. The patio remains functional despite this condition. However, the raised edges of the concrete can be a trip hazard for some people. Repairs should be made as necessary.

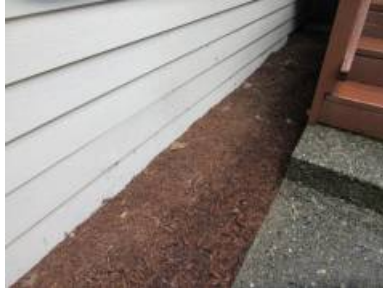
Soil is close to or in contact with siding in some areas around the building exterior. Good building practice requires that foundation walls or pier footings supporting wood frame construction, extend at least 8" above the finish grade with at least a 6" clearance between the top of the soil and the bottom of the wood finish materials. Soil in direct contact with wood creates a hospitable environment for wood destroying organisms. Establishing these minimum clearances is recommended.

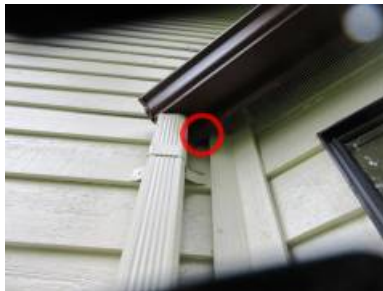
Gaps over 1/4" in size adjacent the gutters will allow insects and rodents to enter the attic. Covering any gaps with aerosol foam, a strip of wood and/or caulking is recommended.

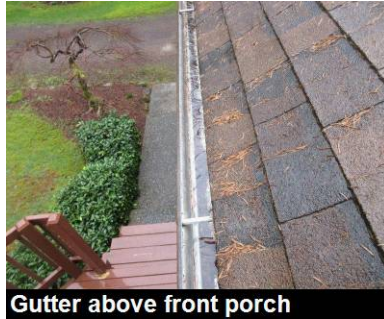
The gutters are not properly sloped on the front side of the building. The gutters should be sloped properly to prevent water splash on the siding.

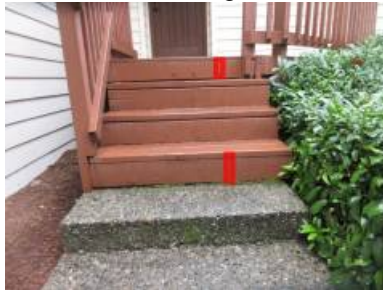
The steps are non-conforming due to the variable and/or excessive rise. Stair design standards require that step risers do not exceed 8" and that the variation in rise not exceed 3/8" in order to reduce falls from tripping. To increase the margin of safety, consideration should be given to reconfiguring the steps so that rise and run do not vary by more than 3/8". If this proves to be too impractical or expensive, then we recommend exercising caution when using.

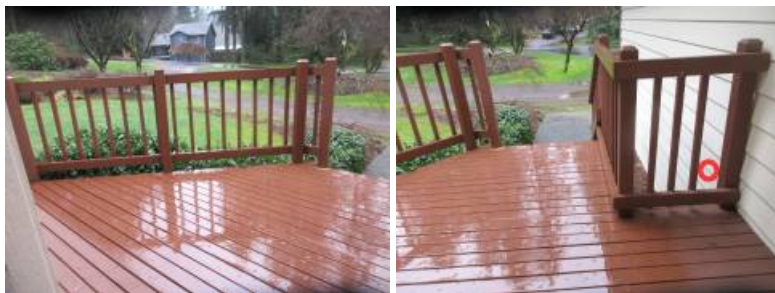
3.10 PORCH RAILING

The spacing between the balusters is too wide. This is a hazard to small children. The balusters should be spaced close enough together so that a 4" sphere cannot pass through. Upgrading the porch railing is recommended if small children are present.

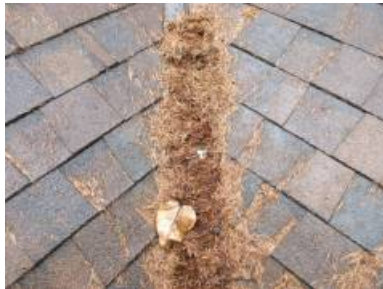
The roof is in need of routine maintenance. The surface should be blown off or washed with a high volume low pressure garden hose to remove moss and organic debris. Performing this maintenance will improve the appearance and increase the life expectancy of the roof.

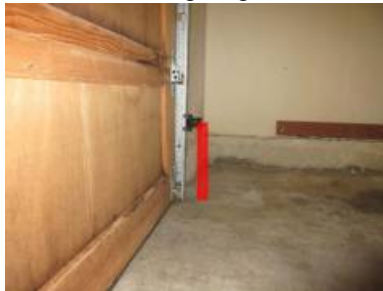
There was no photo-eye sensor installed for the east garage door to offer protection for small children and/or pets. We recommend that a photo-eye sensor be installed for the garage door at a height of within 4-6" of the floor.

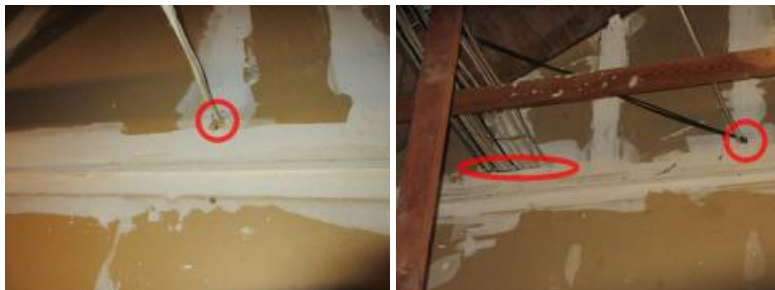
6.4 FIRE SEPARATION

There are voids in the fire resistive barrier between the living space and garage that will allow flames to penetrate. The gypsum barrier slows the spread of a fire from the garage to the structure and/or living space. Patching the voids with a fire retardant caulk is recommended.

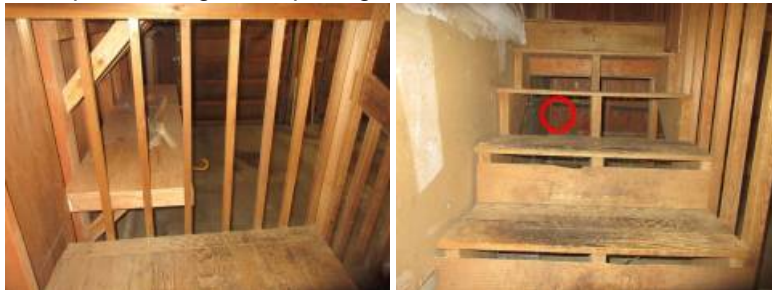
The stair rise spacing is too wide. This is a hazard for small children. The spacing should be reduced as a safety upgrade. Current standards require that a 4" sphere not pass through the opening.

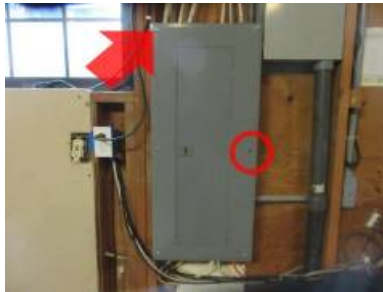
One of the screws that secure the panel cover to the panel box is stripped. This is a potential hazard. Properly fitted screws with blunt ends should be installed.

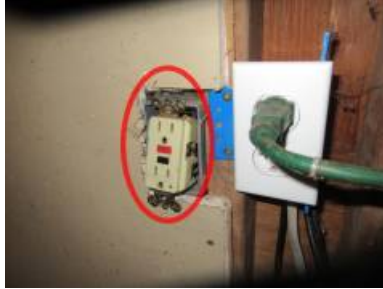
The installation of additional GFCI protection in all of the garage receptacles is recommended.

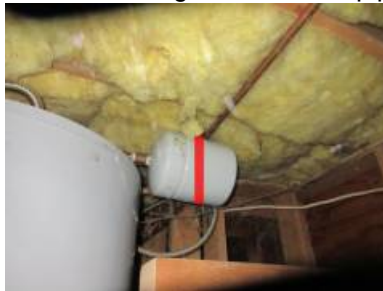
The expansion tank is not adequately secured to the wall. As code requirements start to call for engineered expansion tank supports we recommend the installation of seismic restraints to secure the expansion tank instead of allowing it to simply depend on piping connections that could result in damage to the water pipe and leakage during an earthquake.

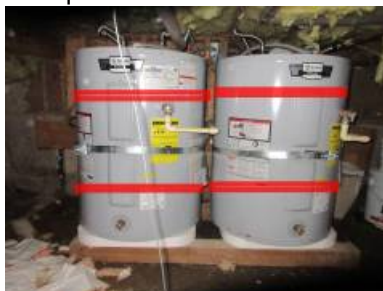
9.7 SEISMIC RESTRAINT

The seismic restraint for the water heaters was minimal. Proper strapping is recommended to adequately secure the tank and provide potable water in the event of an earthquake.

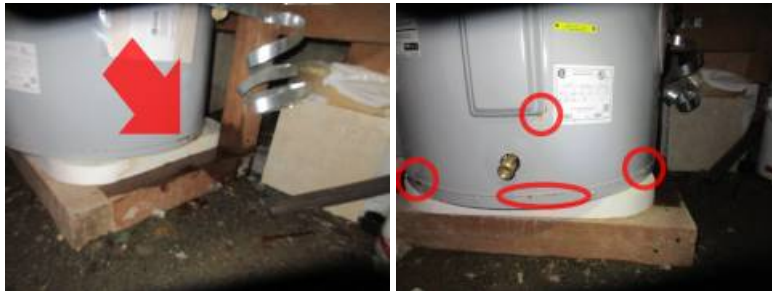
9.8 GENERAL COMMENTS

The west water heater is leaking. The services of a qualified plumbing contractor should be retained to replace the water heater.

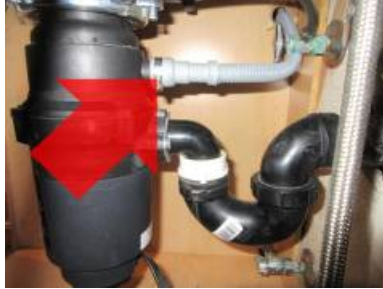
The dishwasher drain lacks an air gap. The dishwasher will function without one, but there is a risk of contamination of the inside of the dishwasher by waste water. The installation of an air gap is recommended.

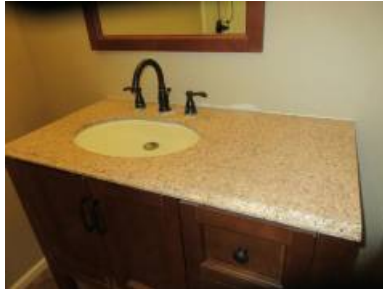
The backsplash is missing. The installation of a backsplash is recommended.

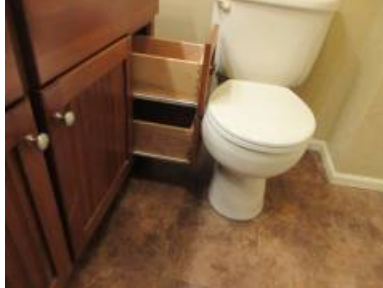
The bathroom cabinet proximity prevented two of the drawers to fully open otherwise the cabinet is in good condition.

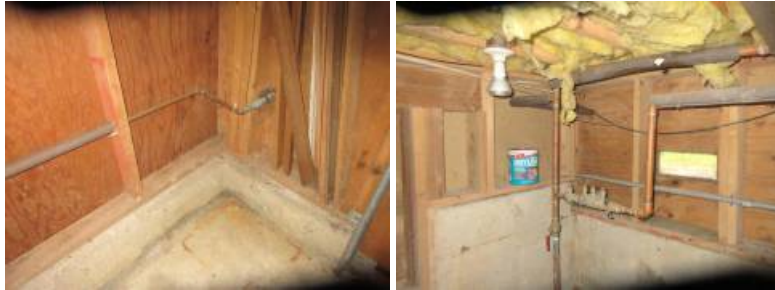
There are water pipes in the garage and crawlspace that are not adequately insulated and could freeze. The installation of foam pipe insulation on all exposed water pipes is recommended.

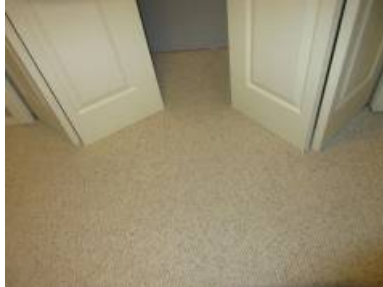
The bedroom bifold closet doors rub on the carpet. Doors should be adjusted as necessary.

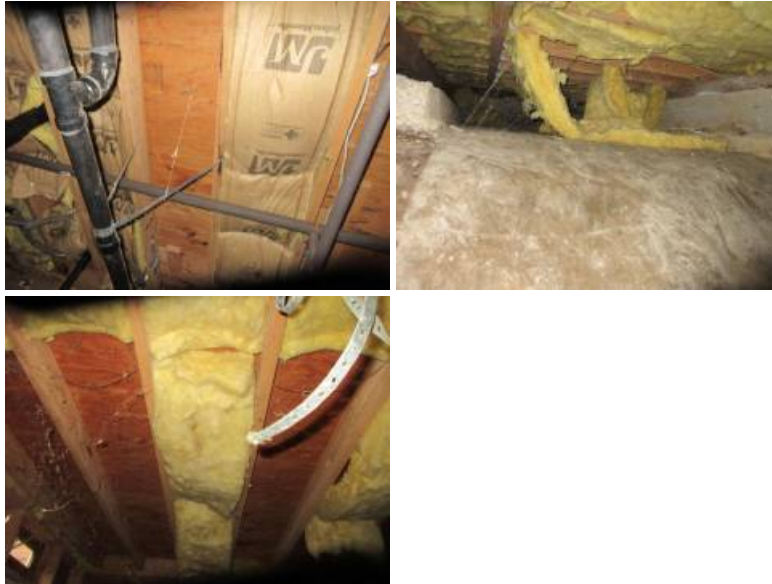
Some of the insulation batts were not properly secured and have falling down. The fallen batts should be reinstalled and secured.

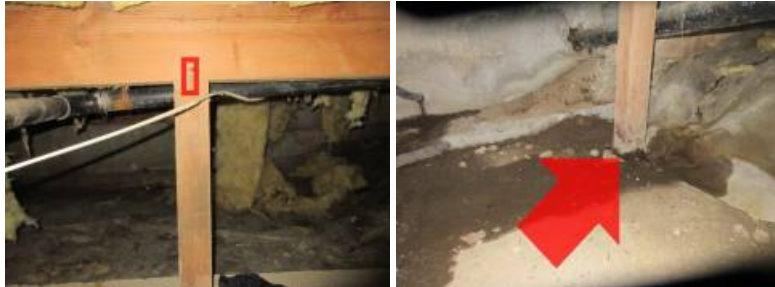
The beam support post adjacent the west foundation wall sits on the reatproofing. Water seeping into the crawlspace over the footing saturates the bottom of the support post. This has caused the bottom of the post to rot. Damaged posts should be replaced. The remaining posts should be treated with wood preservative.
