## NOTICE TO BUYER: SELLER-PROCURED INSPECTION REPORT

April 20, 2022

**Re: 13716 175th Court NE**  
**Redmond, WA.**

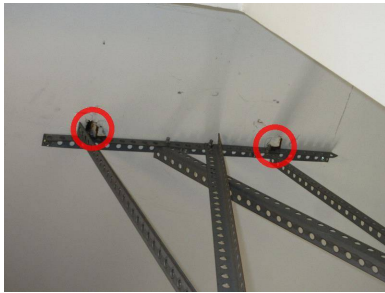
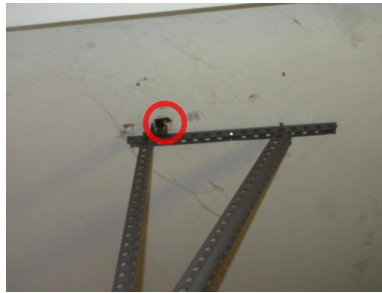
##### 6.4 FIRE SEPARATION

There are voids in the fire resistive barrier between the living space and garage that will allow flames to penetrate. The gypsum barrier slows the spread of a fire from the garage to the structure and/or living space. Patching the voids with a fire retardant caulk is recommended.

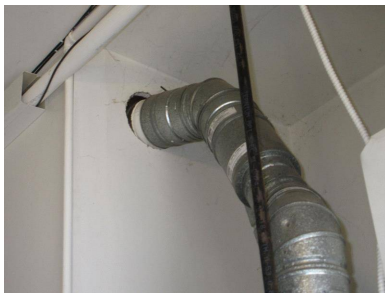
The installation of a furnace vent thimble is recommended to prevent flames to spread to the structure.

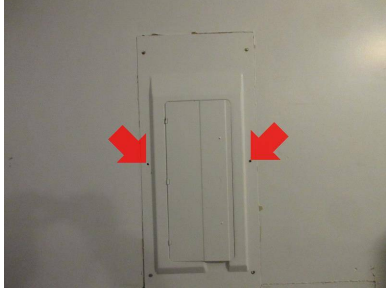
#### 7.8 SERVICE PANEL

Screws that secure the panel cover to the panel box are missing. This is a potential hazard. Missing screws should be replaced with the original style blunt end screws.

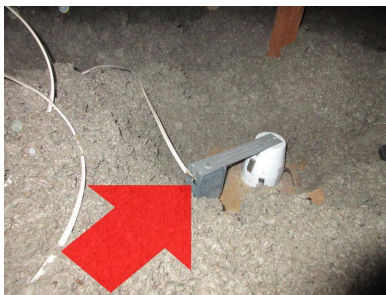
#### 7.10 WIRING

The Romex cables are not clamped where they enter the light fixture chassis in the attic. This could result in a short circuit or fire. A Romex clamp should be installed at the point where the cable enters each of the light fixtures.

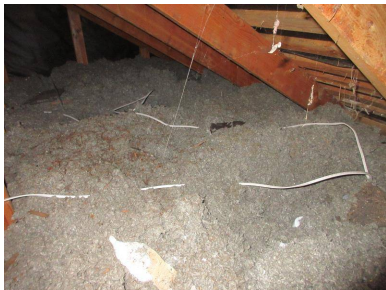
Loose electrical cables were observed in the attic. Loose cables are vulnerable to damage. All loose cables should be secured at 4' intervals using approved cable staples.

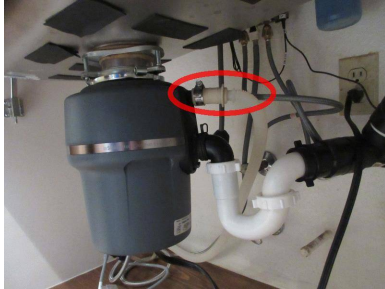
#### 11.8 AIR GAP

The dishwasher drain lacks an air gap. The dishwasher will function without one, but there is a risk of contamination of the inside of the dishwasher by waste water. The installation of an air gap is recommended.

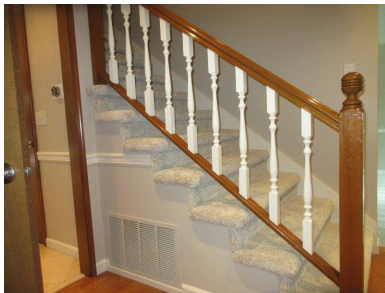
### 15.2 STAIRS

The stair railing baluster spacing is too wide. This is a hazard for small children. The baluster spacing should be reduced as a safety upgrade. Current standards require that a 4" sphere not pass through the railing.

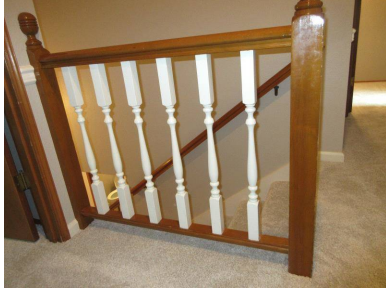
### 15.3 GUARD RAILINGS

The spacing between the balusters is too wide. This is a hazard to small children. The balusters should be spaced close enough together so that a 4" sphere cannot pass through. Upgrading the guard railing is recommended if small children are present.

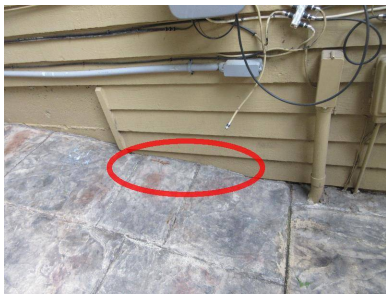
Untreated wood in direct contact with concrete was observed along the patio and walkway. Untreated wood should be raised 1-2" above the concrete. Treating the wood with a preservative sometimes will prevent wood destroy organism damage.

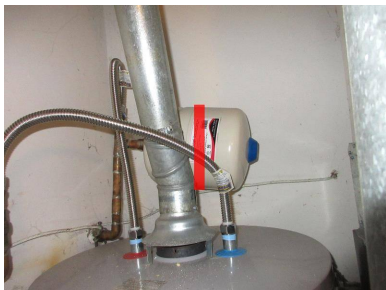
The expansion tank is not adequately secured to the wall. As code requirements start to call for engineered expansion tank supports we recommend the installation of seismic restraints to secure the expansion tank instead of allowing it to simply depend on piping connections that could result in damage to the water pipe and leakage during an earthquake.

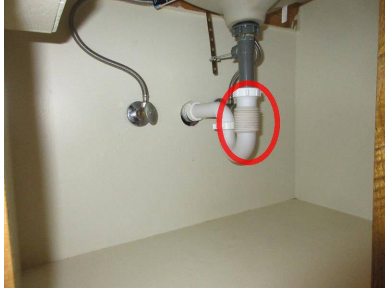
Improper, non-conforming material has been used for the drain pipe fitting. This material will not function reliably. Replacement with industry standard fittings is recommended.

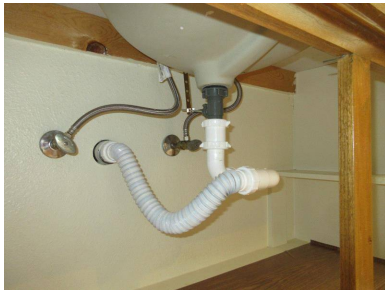
Improper, non-conforming material has been used for the drain pipe fitting. This material will not function reliably. Replacement with industry standard fittings is recommended.

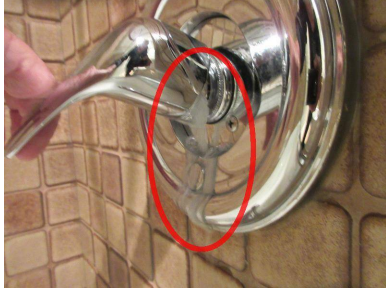
#### *12.32 FAUCET FIXTURES*

The bathtub faucet handle is leaking at its base. Leaking faucets should be rebuilt or replaced.

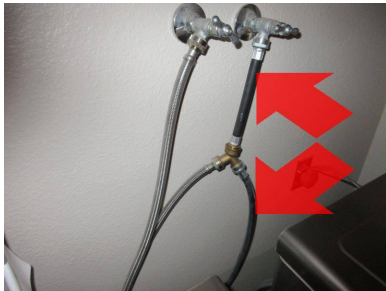
Upgrading the washer connections to high pressure (steel braided) lines is recommended.

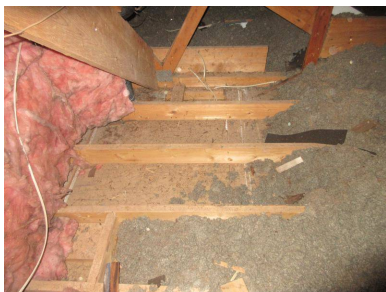
There are thermal bypasses in the attic. A thermal bypass is an opening between an insulated and uninsulated part of the house through which heated air can escape. As air is heated, it rises and pulls cool air in to the space to replace it. This condition will result in significant heat loss. Sealing up all thermal bypass routes is recommended.

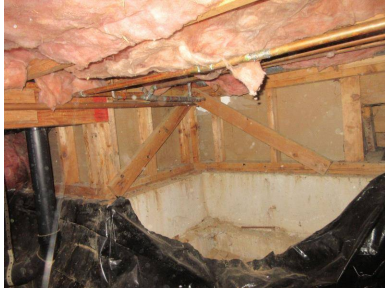
#### **19.6 SHEAR PANELS**

framing members in critical structural areas of the building. They prevent lateral movement of the structure during an earthquake. Shear panels are often visible in the crawlspace on cripple walls between the first floor and foundation. They may also be installed on interior walls that are covered with drywall. An examination of the crawlspace revealed the absence of shear panels on the cripple walls. The installation of shear panels on the cripple walls is recommended as an upgrade.

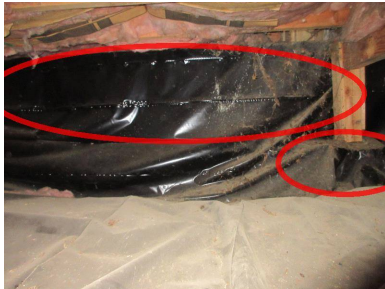
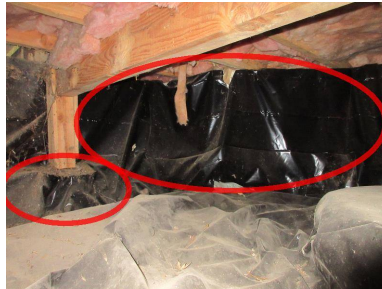
### 20.4 VAPOR RETARDER

The foundation walls are covered with the plastic vapor retarder. This allows the transmission of water vapor from the soil up and into the exterior wall framing. The plastic vapor retarder should be removed from the foundation.

The support post concrete piers are covered with the plastic vapor retarder. This allows the transmission of water vapor from the soil up and into the floor framing. The plastic vapor retarder should be removed from the piers.

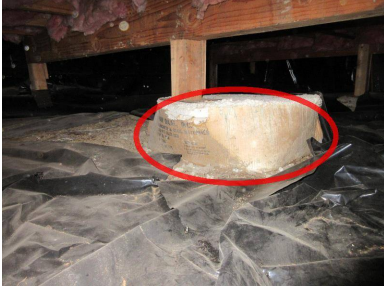
### 20.5 PEST CONTROL

There is evidence of rodent activity in the crawlspace. The first step in eliminating rodents from the crawlspace is to seal all possible entry points using wire mesh, caulking, wood, stainless steel wool, aerosol foam or mortar. Careful work sealing cracks, holes, gaps, and covering ground water drain inlets will discourage rodent activity. Once this work is completed, snap traps baited with peanut butter should be installed and monitored. The absence of rodents in the traps typically means that the rodents have been excluded from the area.

Scrap-wood and other cellulose debris was observed on the crawl floor. This wood debris creates conducive conditions for wood boring insects. The removal of all cellulose debris is recommended.

Cellulose forms were left in place on the pier footings. This cellulose is conducive to the infestation of various wood destroying organisms. The removal of the cellulose is recommended.

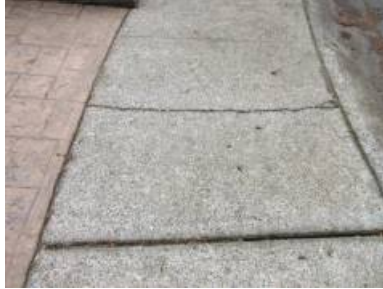
There are minor cracks in the walkway, however, they do not affect its functionality and it remains in serviceable condition.

Many legal and public works departments have defined a trip hazard as an irregularity in a walking surface exceeding one inch (1") in height. All walking surfaces should maintain, free of a vertical surface change of 3/4" or more, in the interest of public and personal safety.

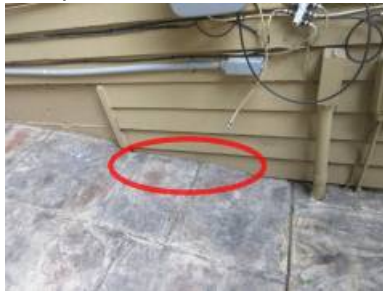
Untreated wood in direct contact with concrete was observed along the walkway. Untreated wood should be raised 1-2" above the concrete. Treating the wood with a preservative sometimes will prevent wood destroy organism damage.

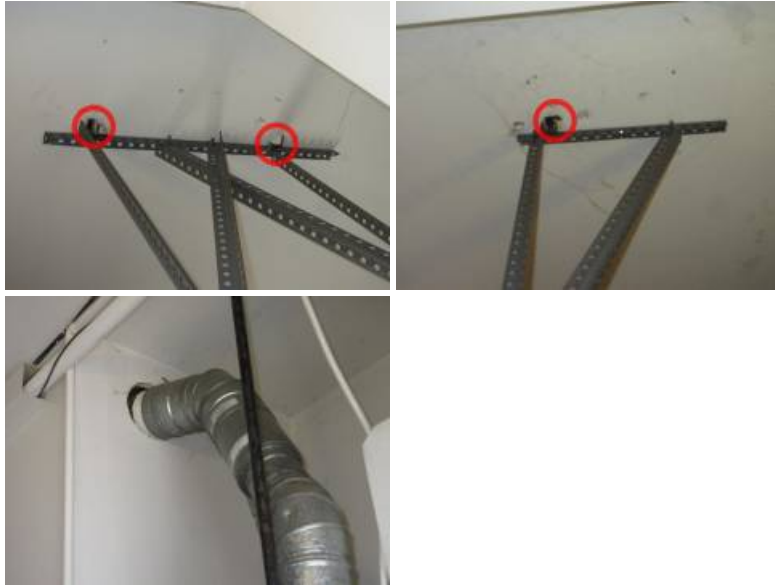
The installation of a furnace vent thimble is recommended to prevent flames to spread to the structure.

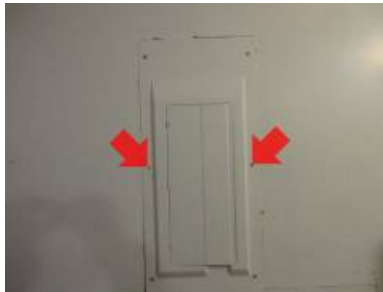
Screws that secure the panel cover to the panel box are missing. This is a potential hazard. Missing screws should be replaced with the original style blunt end screws.

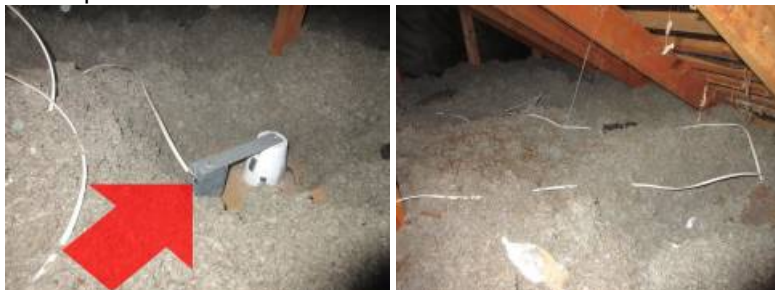
Loose electrical cables were observed in the attic. Loose cables are vulnerable to damage. All loose cables should be secured at 4' intervals using approved cable staples.

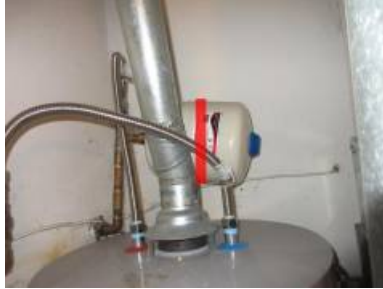
The expansion tank is not adequately secured to the wall. As code requirements start to call for engineered expansion tank supports we recommend the installation of seismic restraints to secure the expansion tank instead of allowing it to simply depend on piping connections that could result in damage to the water pipe and leakage during an earthquake.

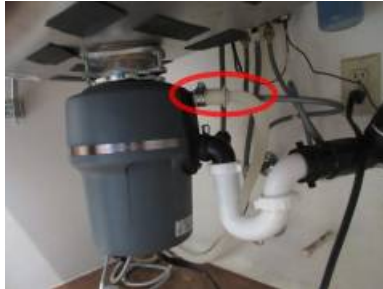
The dishwasher drain lacks an air gap. The dishwasher will function without one, but there is a risk of contamination of the inside of the dishwasher by waste water. The installation of an air gap is recommended.

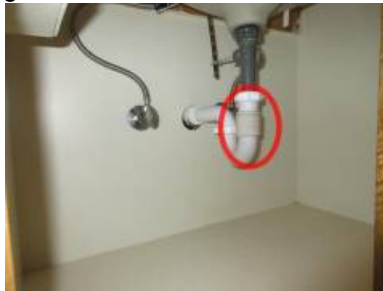
Improper, non-conforming material has been used for the drain pipe fitting. This material will not function reliably. Replacement with industry standard fittings is recommended.

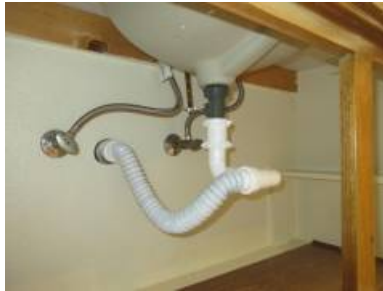
Improper, non-conforming material has been used for the drain pipe fitting. This material will not function reliably. Replacement with industry standard fittings is recommended.

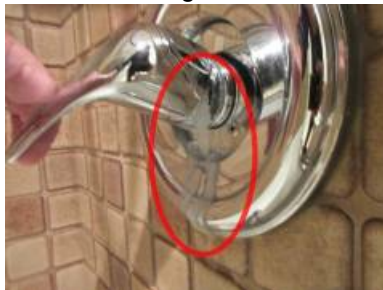
The bathtub faucet handle is leaking at its base. Leaking faucets should be rebuilt or replaced.

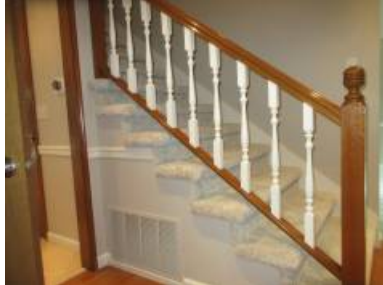
The stair railing baluster spacing is too wide. This is a hazard for small children. The baluster spacing should be reduced as a safety upgrade. Current standards require that a 4" sphere not pass through the railing.

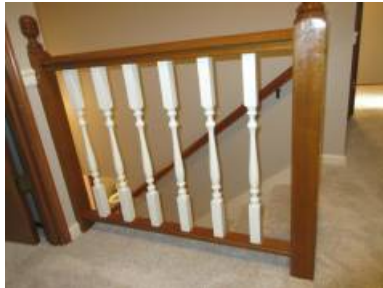
**15.3 GUARD RAILINGS**

The spacing between the balusters is too wide. This is a hazard to small children. The balusters should be spaced close enough together so that a 4" sphere cannot pass through. Upgrading the guard railing is recommended if small children are present.

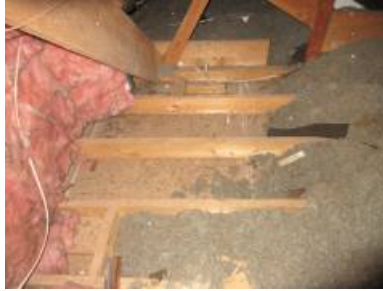
There are thermal bypasses in the attic. A thermal bypass is an opening between an insulated and uninsulated part of the house through which heated air can escape. As air is heated, it rises and pulls cool air in to the space to replace it. This condition will result in significant heat loss. Sealing up all thermal bypass routes is recommended.

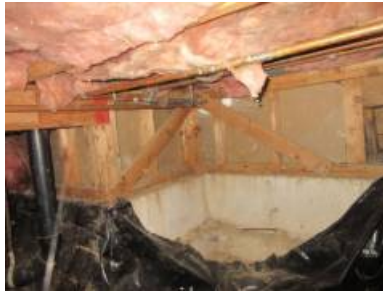
Shear panels are plywood or OSB panels that are mechanically fastened to both vertical and horizontal framing members in critical structural areas of the building. They prevent lateral movement of the structure during an earthquake. Shear panels are often visible in the crawlspace on cripple walls between the first floor and foundation. They may also be installed on interior walls that are covered with drywall. An examination of the crawlspace revealed the absence of shear panels on the cripple walls. The installation of shear panels on the cripple walls is recommended as an upgrade.

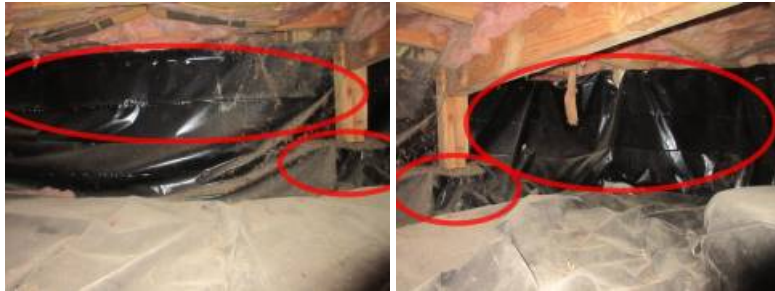
The support post concrete piers are covered with the plastic vapor retarder. This allows the transmission of water vapor from the soil up and into the floor framing. The plastic vapor retarder should be removed from the piers.

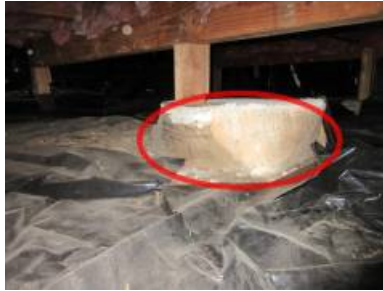
Good building practice requires that foundation walls or pier footings supporting wood frame construction, should extend at least 8" above the finish grade with at least a 6" clearance between the top of the soil and the bottom of the wood finish materials. Untreated wood should be raised 1-2" above surrounding flatwork and should have a moisture barrier such as 30 lb. asphalt impregnated felt installed between the concrete and wood. For additional information and treatment options, you should retain the services of a qualified pest control operator.
