NOTICE TO BUYER: SELLER-PROCURED INSPECTION REPORT

Thomas & Suzan Leever
13814 176th PL NE
Redmond, WA 98052

April 19, 2022

13814 176th Pl. NE
Redmond WA.

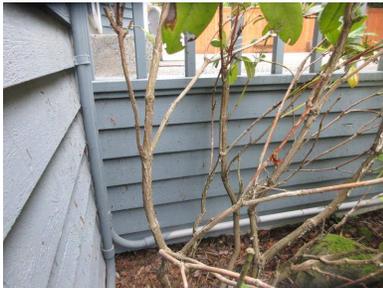
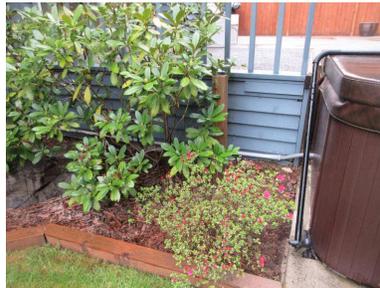
2.3 RETAINING WALLS

Untreated wood retaining walls are used adjacent the patio to stabilize and contain the soil under the patio. The wood is rotted and the retaining wall will fail. The need for replacement should be anticipated.

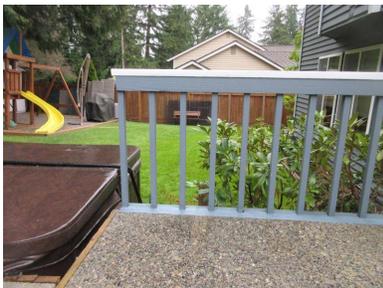
2.6 PATIO

The spacing between the railing balusters is too wide. This is a hazard to small children. The balusters should be spaced close enough together so that a 4" sphere cannot pass through. Upgrading the deck railing is recommended if small children are present.

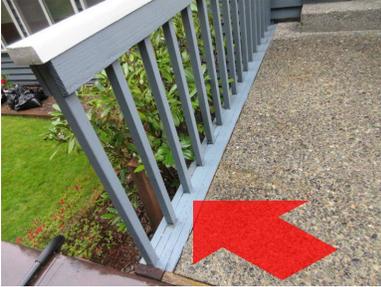
The patio railing is rotted at its base. This is a hazard. The deck railing should be repaired or replaced.

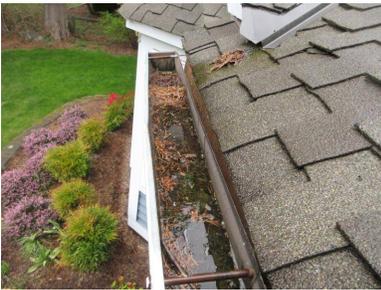
3.5 GUTTERS AND DOWNSPOUTS

The gutter is loose and pulling away from the eave at the west side of the building. The gutter should be cleaned and then secured to the rafter tails or fascia board.

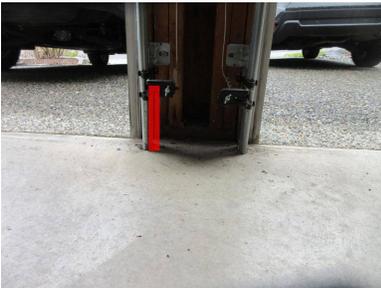
6.3 GARAGE DOOR OPENER

The Photo-eye beam was installed too high above the floor of the garage to adequately offer protection for small children and/or pets. We recommend that the photo-eye be lowered to within 4-6" of the floor.

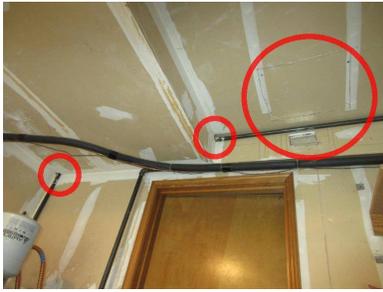
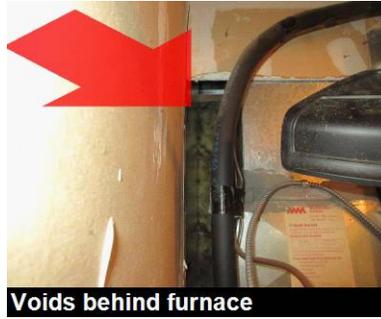
6.4 FIRE SEPARATION

There are voids in the fire resistive barrier between the living space and garage that will allow flames to penetrate. The gypsum barrier slows the spread of a fire from the garage to the structure and/or living space. Patching the voids with a fire retardant caulk is recommended.

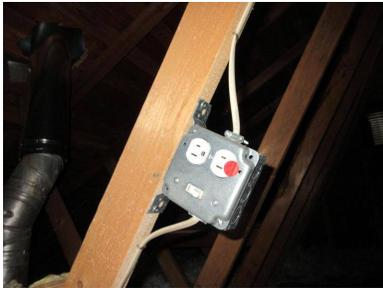
Testing revealed open grounds (ungrounded receptacles) in the attic. Open grounds are a potential hazard and could damage some electronic equipment. All receptacles with open grounds should be repaired in accordance with applicable electrical codes.

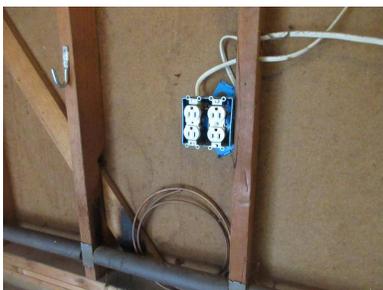
The receptacle on the west wall of the garage (adjacent the overhead door) is loose. This is a potential shock and a fire hazard. All loose receptacles should be repaired as necessary.

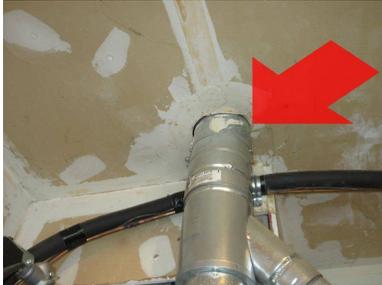
8.10 VENT

The furnace vent connector is too close to a combustible material. This is a hazard. A minimum clearance of 6" is required between the single wall vent connector and the combustible material. The double wall type B vent requires only 1" of clearance. The installation of a furnace vent thimble is recommended.

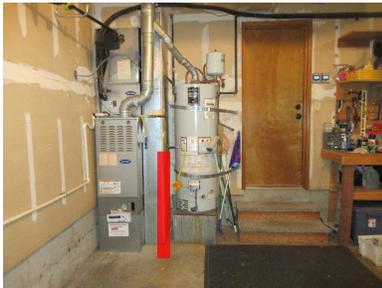
13.10 GAS PIPING

The gas pipes in front of the furnace and water heater are not protected by a bumper stop. A vertical steel pipe, bolted to the floor, is typically installed in front of the water heater to prevent a car bumper from damaging the gas lines.

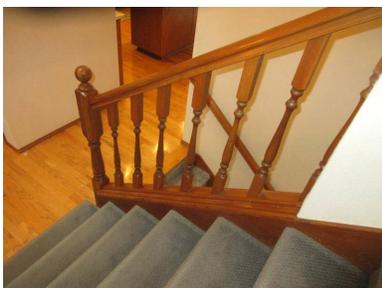
14.2 STAIRS

The stair railing baluster spacing is too wide. This is a hazard for small children. The baluster spacing should be reduced as a safety upgrade. Current standards require that a 4" sphere not pass through the railing.

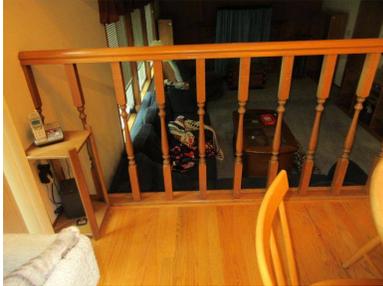
14.3 GUARD RAILINGS

The spacing between the balusters is too wide. This is a hazard to small children. The balusters should be spaced close enough together so that a 4" sphere cannot pass through. Upgrading the guard railing is recommended if small children are present.

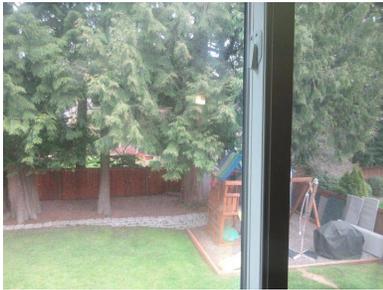
14.7 WINDOWS

There is condensation or mineral deposits between the panes of glass in one of the primary bedroom insulated glass window panes. This indicates a failed seal. The glass assembly should be replaced, which is the only method for correcting this deficiency.

- 14.7 Interior master bedroom windows replacement/repair

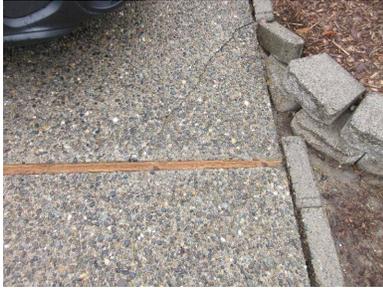
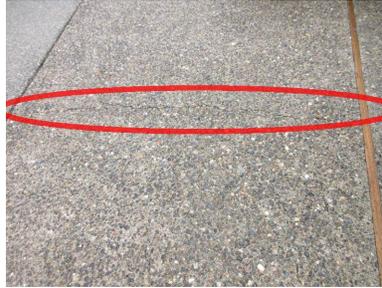
A small portion of the driveway has cracked and settled differentially. This was probably caused by inadequate

preparation of the soil prior to the placement of the concrete. This condition can be repaired by pressure grouting the sunken portion of the driveway or by removing and replacing it. The driveway remains functional despite this condition.

Cracks were observed in the concrete surface of the driveway. Minor cracks can be sealed to minimize moisture entry and further settlement of the concrete. Minor cracks are common and do not affect the serviceability of the concrete.

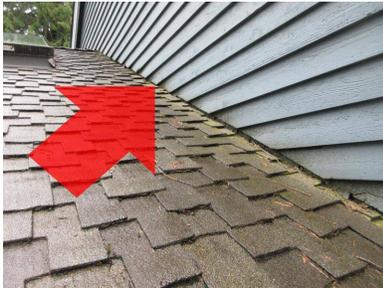
3.1 PRIMARY EXTERIOR WALL CLADDING

The siding is vulnerable to damage where it has been close to or in contact with the roofing material. The siding should be modified and a minimum of a 2" clearance should be maintained between the top of the roofing and bottom of the siding.

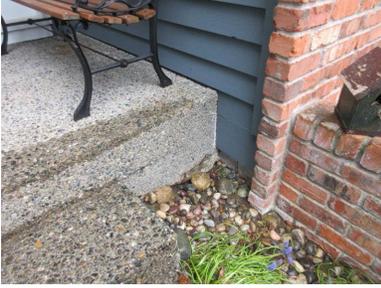
3.3 PEST CONTROL

Soil is close to or in contact with siding in some areas around the building exterior. Good building practice requires that foundation walls or pier footings supporting wood frame construction, extend at least 8" above the finish grade with at least a 6" clearance between the top of the soil and the bottom of the wood finish materials. Soil in direct contact with wood creates a hospitable environment for wood destroying organisms. Establishing these minimum clearances is recommended.

Untreated wood in direct contact with concrete was observed along the patio and stoop. Rot damage was observed in the retaining wall adjacent the patio. Wood rot commonly referred to as "Dry Rot" occurs when untreated wood is allowed to retain moisture for extended periods of time. Wood rot is caused by fungi which grow in the cell structure and spread like a root system through the wood. Fungi can also develop from spores which are present in the soil and are transferred through the air. Rotted wood creates an environment that is conducive to various types of wood boring insects (e.g. carpenter ants, moisture ants, dampwood termites, etc.) Wood rot can be prevented by keeping the wood dry, or if this is not possible, such as in the case of outdoor wood, by using pressure treated wood, by treating exposed wood with semi-transparent stain and/or wood preservative, and by keeping untreated wood out of and 6" above the soil.

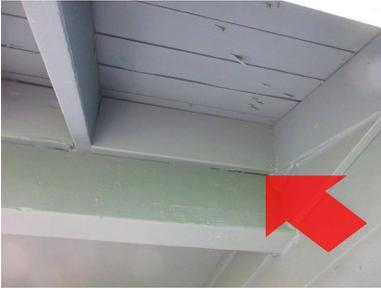
3.4 SOFFITS AND OVERHANGS

Gaps over 1/4" in size adjacent the soffit vent blocks will allow insects and rodents to enter the attic. Covering any gaps with screening, a strip of wood and/or caulking is recommended.

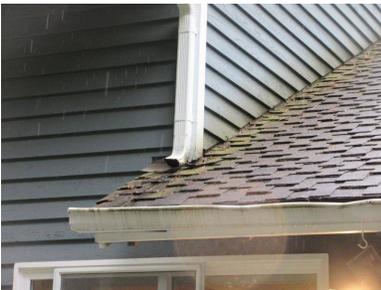
3.5 GUTTERS AND DOWNSPOUTS

Downspouts draining directly onto the asphalt shingle surface causes excessive wear of the roofing material. Downspout extensions to the lower gutters should be installed to prevent excessive wear and tear of the roofing.

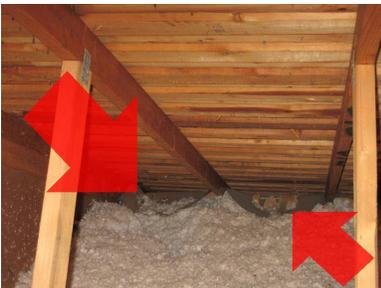
5.2 VENTILATION

Wind baffles locations are compromised in some areas of the attic. The proper placement of wind baffles in front of all soffit vents is recommended.

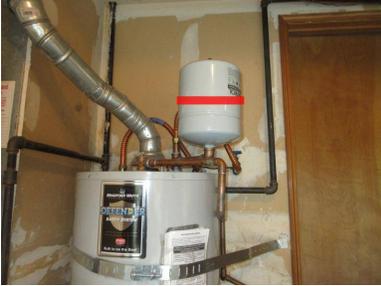
9.6 EXPANSION TANK

The expansion tank is not adequately secured to the wall. As code requirements start to call for engineered expansion tank supports we recommend the installation of seismic restraints to secure the expansion tank instead of allowing it to simply depend on piping connections that could result in damage to the water pipe and leakage during an earthquake.

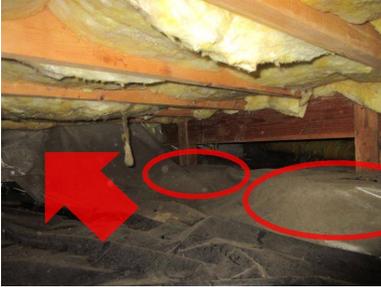
The foundation walls are covered with the plastic vapor retarder. This allows the transmission of water vapor from the soil up and into the exterior wall framing. The plastic vapor retarder should be removed from the foundation.

The support post concrete piers are covered with the plastic vapor retarder. This allows the transmission of water vapor from the soil up and into the floor framing. The plastic vapor retarder should be removed from the piers.

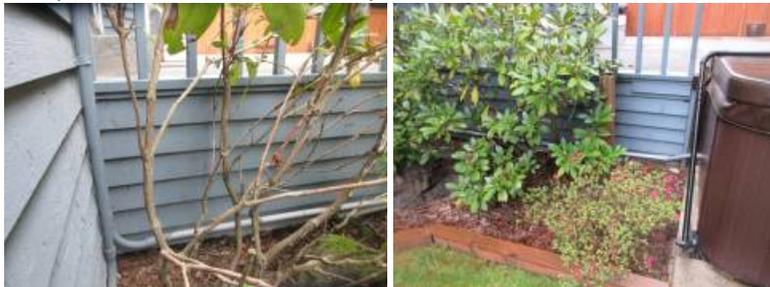
Untreated wood retaining walls are used adjacent the patio to stabilize and contain the soil under the patio. The wood is rotted and the retaining wall will fail. The need for replacement should be anticipated.

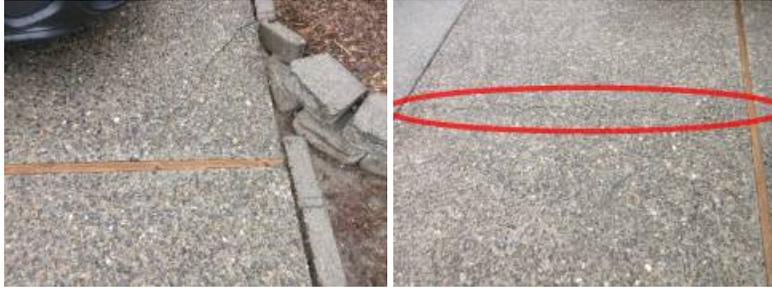
Cracks were observed in the concrete surface of the driveway. Minor cracks can be sealed to minimize moisture entry and further settlement of the concrete. Minor cracks are common and do not affect the serviceability of the concrete.

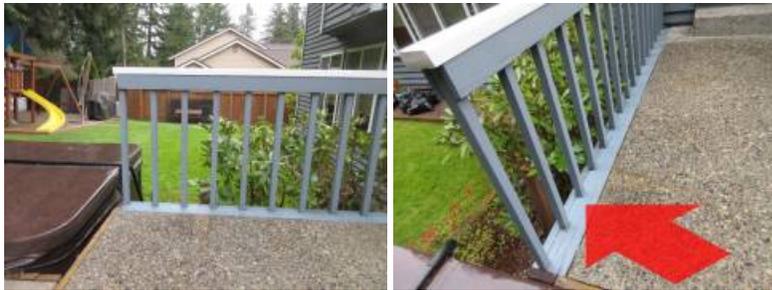
2.6 PATIO

The spacing between the railing balusters is too wide. This is a hazard to small children. The balusters should be spaced close enough together so that a 4" sphere cannot pass through. Upgrading the deck railing is recommended if small children are present.

The patio railing is rotted at its base. This is a hazard. The deck railing should be repaired or replaced.

Cracks were observed in the concrete surface of the patio. Minor cracks can be sealed to minimize moisture entry and further settlement of the concrete.

- 19.5 Pest control in crawl space – In progress – Pest control service has completed initial review & actions on 5/3 and will return 5/11 to complete.
- 2.6 Building Site Patio railing to be repaired/replaced
- 7.13 Electrical system GFCI receptacles to be added to garage and kitchen

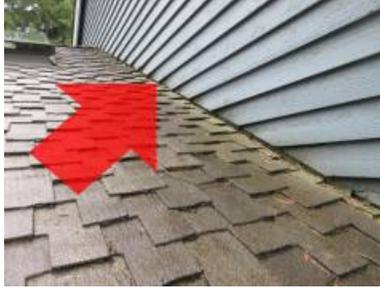
The siding is vulnerable to damage where it has been close to or in contact with the roofing material. The siding should be modified and a minimum of a 2" clearance should be maintained between the top of the roofing and bottom of the siding.

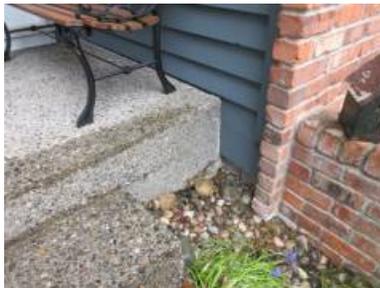
Untreated wood in direct contact with concrete was observed along the patio and stoop. Rot damage was observed in the retaining wall adjacent the patio. Wood rot commonly referred to as "Dry Rot" occurs when untreated wood is allowed to retain moisture for extended periods of time. Wood rot is caused by fungi which grow in the cell structure and spread like a root system through the wood. Fungi can also develop from spores which are present in the soil and are transferred through the air. Rotted wood creates an environment that is conducive to various types of wood boring insects (e.g. carpenter ants, moisture ants, dampwood termites, etc.) Wood rot can be prevented by keeping the wood dry, or if this is not possible, such as in the case of outdoor wood, by using pressure treated wood, by treating exposed wood with semi-transparent stain and/or wood preservative, and by keeping untreated wood out of and 6" above the soil.

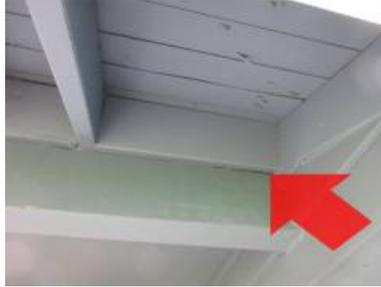
Gaps over 1/4" in size adjacent the soffit vent blocks will allow insects and rodents to enter the attic. Covering any gaps with screening, a strip of wood and/or caulking is recommended.

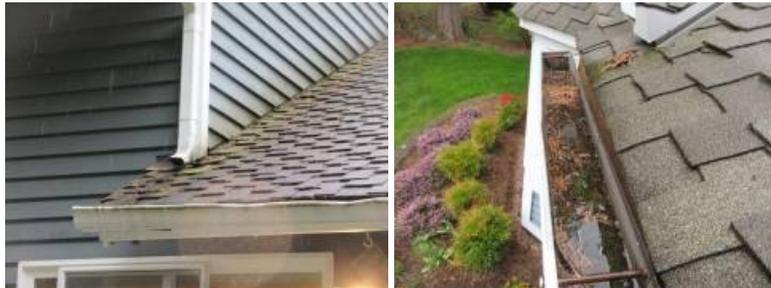
The gutter is loose and pulling away from the eave at the west side of the building. The gutter should be cleaned and then secured to the rafter tails or fascia board.

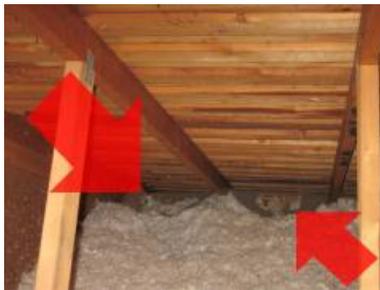
Wind baffles locations are compromised in some areas of the attic. The proper placement of wind baffles in front of all soffit vents is recommended.

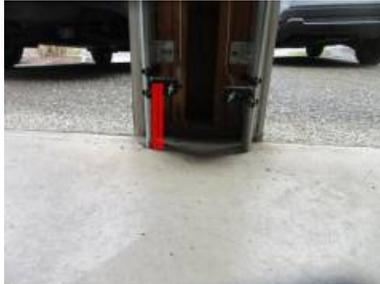
The Photo-eye beam was installed to high above the floor of the garage to adequately offer protection for small children and/or pets. We recommend that the photo-eye be lowered to within 4-6" of the floor.

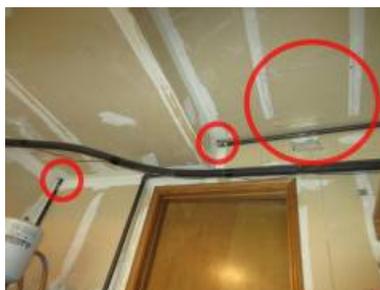
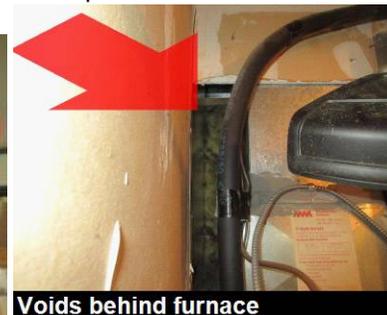
The installation of a furnace vent thimble is recommended to prevent flames to spread to the structure.

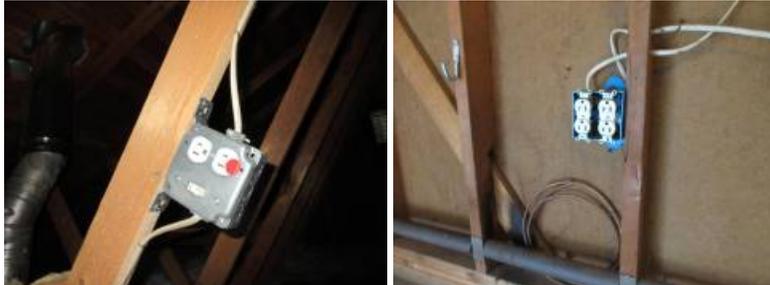
The receptacle on the west wall of the garage (adjacent the overhead door) is loose. This is a potential shock and a fire hazard. All loose receptacles should be repaired as necessary.

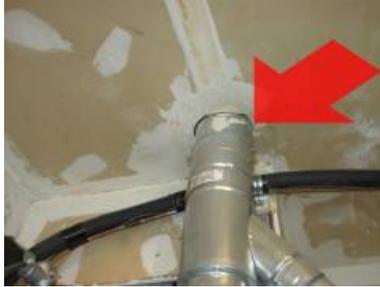
The furnace vent connector is too close to a combustible material. This is a hazard. A minimum clearance of 6" is required between the single wall vent connector and the combustible material. The double wall type B vent requires only 1" of clearance. The installation of a furnace vent thimble is recommended.

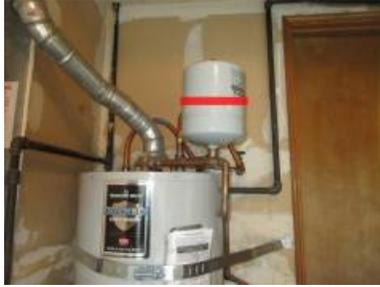
supports we recommend the installation of seismic restraints to secure the expansion tank instead of allowing it to simply depend on piping connections that could result in damage to the water pipe and leakage during an earthquake.

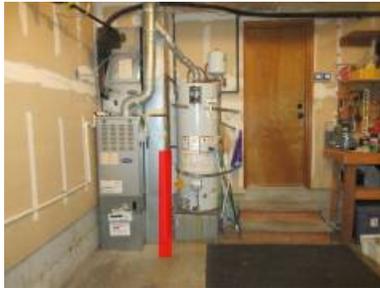
The gas pipes in front of the furnace and water heater are not protected by a bumper stop. A vertical steel pipe, bolted to the floor, is typically installed in front of the water heater to prevent a car bumper from damaging the gas lines.

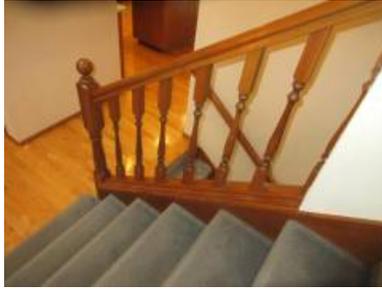
safety upgrade. Current standards require that a 4" sphere not pass through the railing.

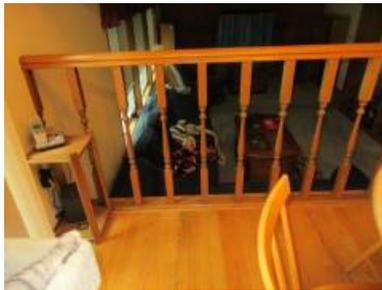
14.3 GUARD RAILINGS

The spacing between the balusters is too wide. This is a hazard to small children. The balusters should be spaced close enough together so that a 4" sphere cannot pass through. Upgrading the guard railing is recommended if small children are present.

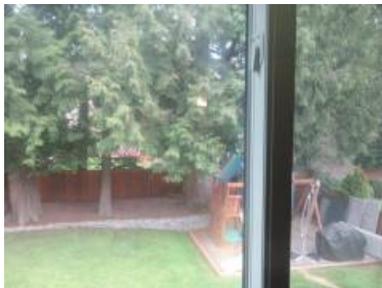
There is condensation or mineral deposits between the panes of glass in one of the primary bedroom insulated glass window panes. This indicates a failed seal. The glass assembly should be replaced, which is the only method for correcting this deficiency.

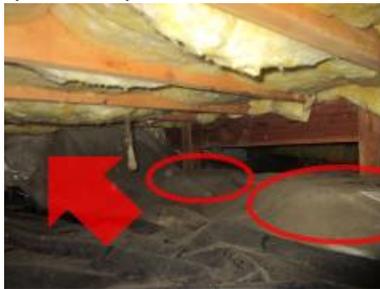
The support post concrete piers are covered with the plastic vapor retarder. This allows the transmission of water vapor from the soil up and into the floor framing. The plastic vapor retarder should be removed from the piers.

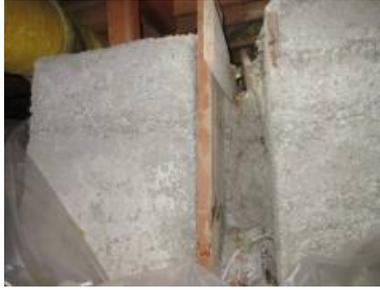
Good building practice requires that foundation walls or pier footings supporting wood frame construction, should extend at least 8" above the finish grade with at least a 6" clearance between the top of the soil and the bottom of the wood finish materials. Untreated wood should be raised 1-2" above surrounding flatwork and should have a moisture barrier such as 30 lb. asphalt impregnated felt installed between the concrete and wood. For additional information and treatment options, you should retain the services of a qualified pest control operator.
