NOTICE TO BUYER: SELLER-PROCURED INSPECTION REPORT

**Jonathan and Jessica Van Horn
14145 174th PI Ne
Redmond, WA 98052**

April 25, 2022

**Re: 14145 174th Pl. NE
Redmond, WA.**

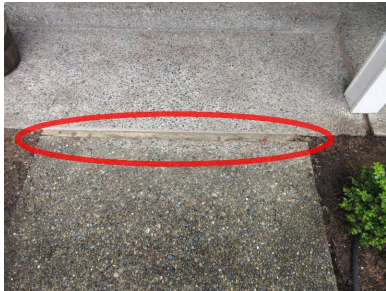
2.6 WALKWAY

The walkway has settled differentially. The walkway remains functional despite this condition. However, the raised edges of the concrete can be a trip hazard for some people. Grinding down the raised edges of the concrete will mitigate the hazard. Repairs should be made as necessary.

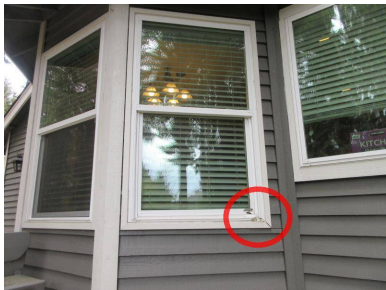
3.8 EXTERIOR WINDOWS

One of the window frames is damaged. Repair or replacement of the damaged window is recommended.

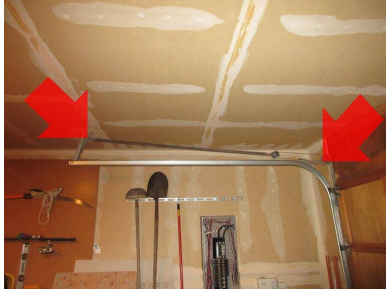
Safeties are cables run through the center of the garage door springs that prevent broken springs from

becoming projectiles that can cause injury. There are no safeties installed. The installation of safeties is recommended.

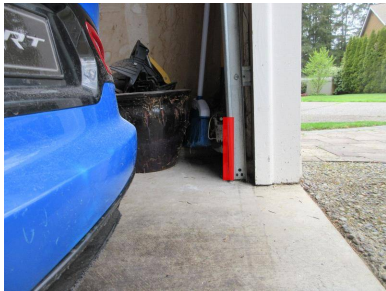
6.3 GARAGE DOOR OPENER

The Photo-eye beam was installed to high above the floor of the garage to adequately offer protection for small children and/or pets. We recommend that the photo-eye be lowered to within 4-6" of the floor.

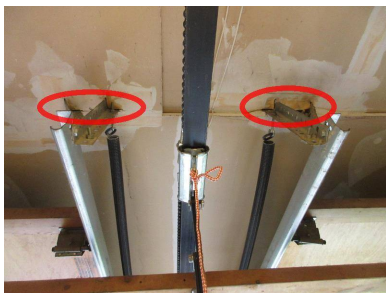
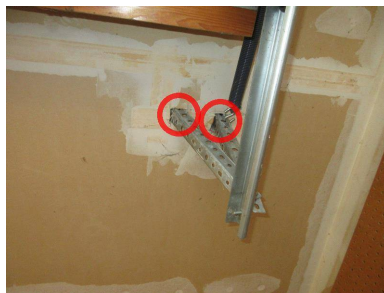
6.4 FIRE SEPARATION

There are voids in the fire resistive barrier between the living space and garage that will allow flames to penetrate. The gypsum barrier slows the spread of a fire from the garage to the structure and/or living space. Patching the voids with a fire retardant caulk is recommended.

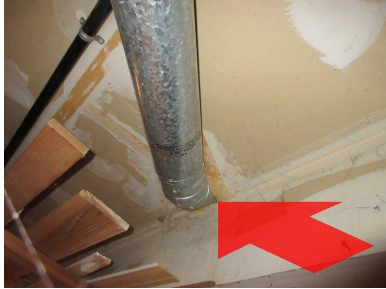
The installation of a furnace vent thimble is recommended to prevent flames to spread to the structure.

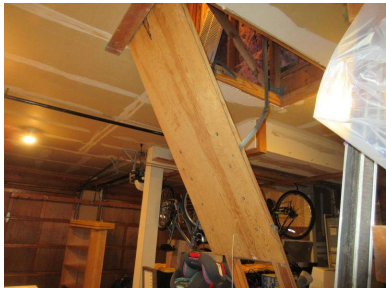
The pull down ladder is a breach in the fire resistive barrier in the garage. This is a safety concern. The gypsum barrier on the ceiling slows the spread of a fire from the garage to the attic. The installation of a layer of 5/8" gypsum type X board over the 1/4" plywood is recommended.

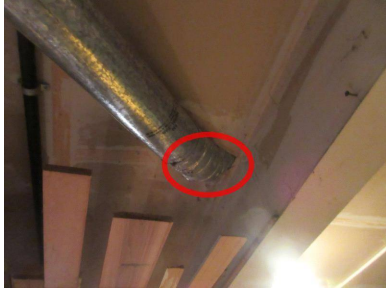
The furnace vent connector is too close to a combustible material. This is a hazard. A minimum clearance of 6" is required between the single wall vent connector and the combustible material. The double wall type B vent requires only 1" of clearance. Repairs are recommended.

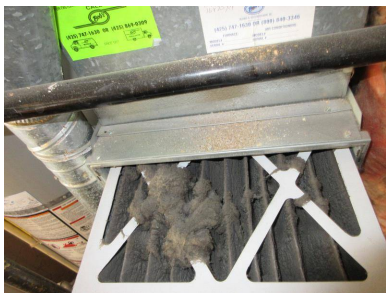
8.12 AIR FILTER

The air filter is clogged with dust. This reduces air flow and furnace efficiency. Removal and replacement of the air filter is recommended. Pleated style air filters are recommended as they offer better filtration of dust than the coarser hogs hair or fiberglass filters.

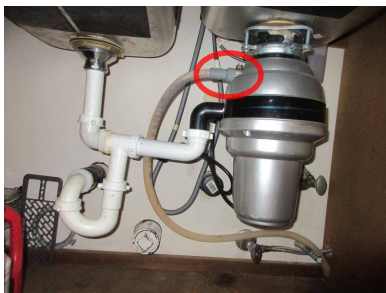
The dishwasher drain lacks an air gap. The dishwasher will function without one, but there is a risk of contamination of the inside of the dishwasher by waste water. The installation of an air gap is recommended.

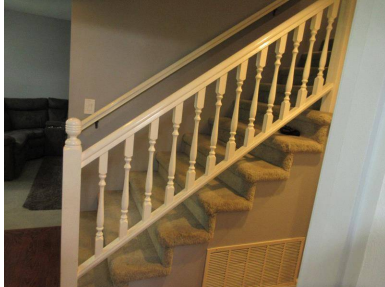
The stair railing baluster spacing is too wide. This is a hazard for small children. The baluster spacing should be reduced as a safety upgrade. Current standards require that a 4" sphere not pass through the railing.

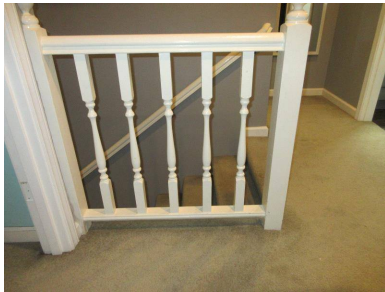
14.3 GUARD RAILINGS

The spacing between the balusters is too wide. This is a hazard to small children. The balusters should be spaced close enough together so that a 4" sphere cannot pass through. Upgrading the guard railing is recommended if small children are present.

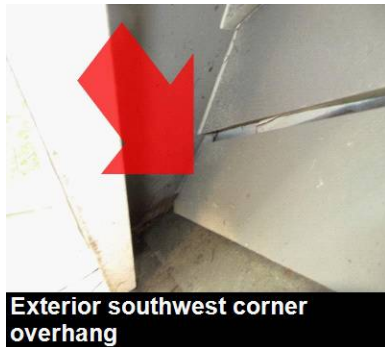
Sections of siding are loose under the southwest corner overhang. Consideration should be given to re-securing the loose siding to prevent moisture or pest entry into the attic.

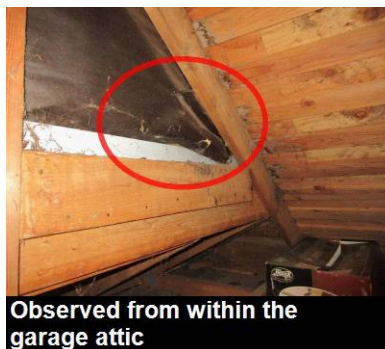
Replacing the damaged building paper to prevent moisture or pest entry into the attic is recommended.

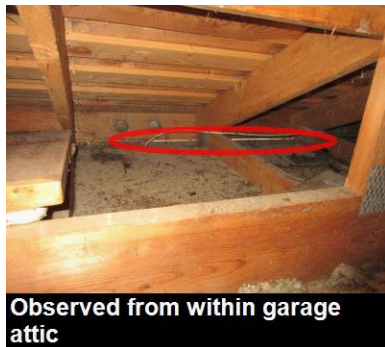
3.3 SOFFITS AND OVERHANGS

There are large gaps over 1/4" in size adjacent the soffit vent blocks. These gaps allow insects and rodents to enter the attic. Covering the gaps with screening, a strip of wood and/or caulking is recommended.

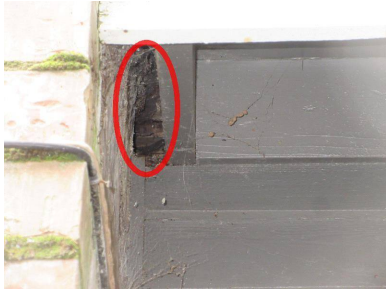
There are openings at the intersection between the overhang and the chimney through which birds and rodents can enter into the attic. These openings should be covered with wood, wire mesh or filled with aerosol foam.

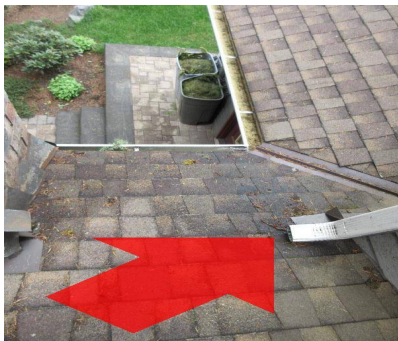
3.4 GUTTERS AND DOWNSPOUTS

Downspouts draining directly onto the asphalt shingle surface causes excessive wear of the roofing material. Downspout extensions to the lower gutters should be installed to prevent excessive wear and tear of the roofing.

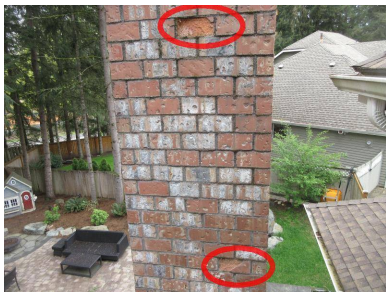
The brick is spalling on the exposed portion of the chimney. Spalling occurs during the winter when the surface of the soft brick absorbs moisture and freezes. The water expands as it freezes causing the surface of the brick to flake off. Spalling can be prevented by applying a sealer to the surface of the brick. For maximum protection, the sealer should be reapplied every 2-3 years.

There is no cricket on the up-slope side of the living room fireplace chimney. This is conducive to leakage. Consideration should be given to installing a cricket to divert water around the chimney.

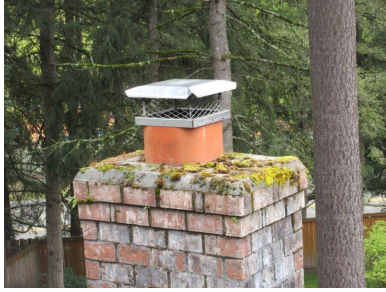
Moss/vegetation was observed in several areas around the upper portion of the chimney. This will lead to accelerated deterioration of the brick masonry mortar. We recommend removal of all organic growth. Damaged areas can be repaired by filling in cutout or defective mortar joints with fresh mortar. (Tuck pointing)

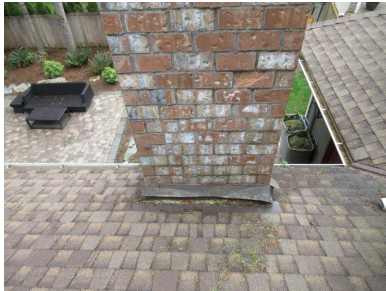
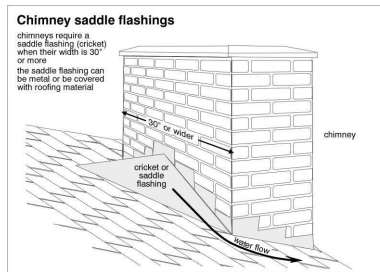
There is no cricket on the up-slope side of the living room fireplace chimney. This is conducive to leakage. Consideration should be given to installing a cricket to divert water around the chimney.

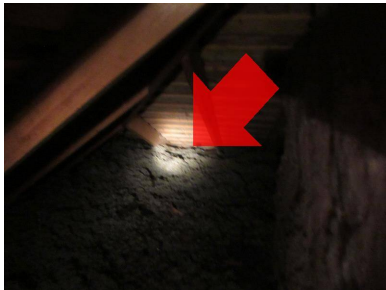
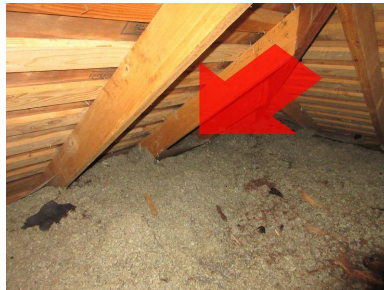
5.2 VENTILATION

Wind baffles locations are compromised in some areas of the attic. The proper placement of wind baffles in front of all soffit vents is recommended.

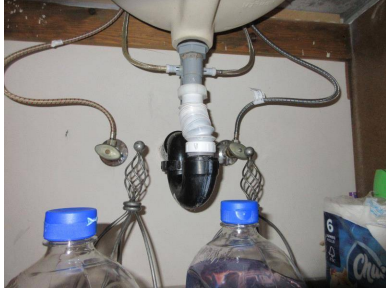
Improper, non-conforming material has been used for the drain pipe fitting. This material will not function reliably. Replacement with industry standard fittings is recommended.

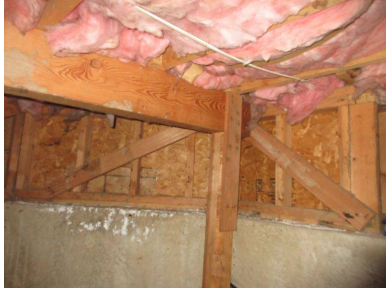
Shear panels are plywood or OSB panels that are mechanically fastened to both vertical and horizontal framing members in critical structural areas of the building. They prevent lateral movement of the structure during an earthquake. Shear panels are often visible in the crawlspace on cripple walls between the first floor and foundation. They may also be installed on interior walls that are covered with drywall. An examination of the crawlspace revealed the absence of shear panels on the cripple walls. The installation of shear panels on the cripple walls is recommended as an upgrade.

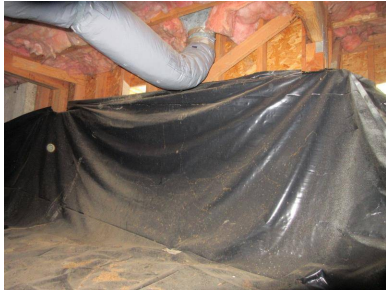
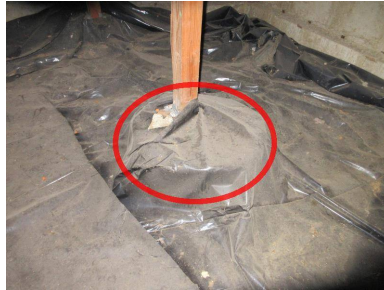
19.4 VAPOR RETARDER

The foundation walls are covered with the plastic vapor retarder. This allows the transmission of water vapor from the soil up and into the exterior wall framing. The plastic vapor retarder should be removed from the foundation.

The support post concrete piers are covered with the plastic vapor retarder. This allows the transmission of water vapor from the soil up and into the floor framing. The plastic vapor retarder should be removed from the piers.

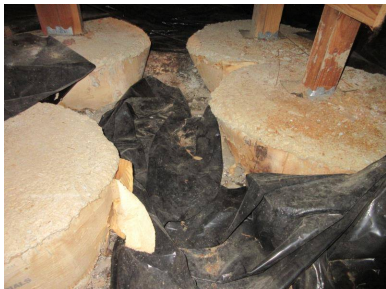
19.5 PEST CONTROL

Cellulose forms were left in place on the pier footings. This cellulose is conducive to the infestation of various wood destroying organisms. The removal of the cellulose is recommended.

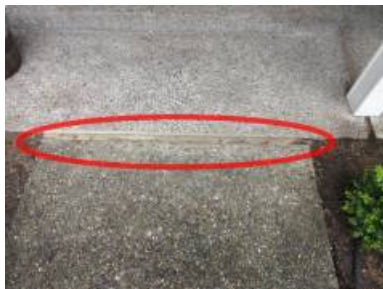
Many legal and public works departments have defined a trip hazard as an irregularity in a walking surface exceeding one inch (1") in height. All walking surfaces should maintain, free of a vertical surface change of 3/4" or more, in the interest of public and personal safety.

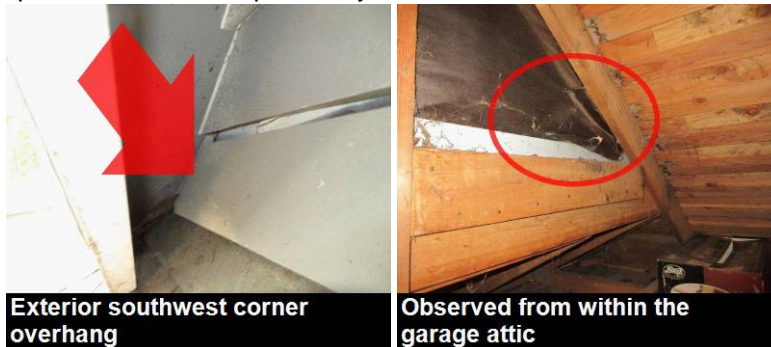
Replacing the damaged building paper to prevent moisture or pest entry into the attic is recommended.

Exterior southwest corner overhang

Observed from within the garage attic

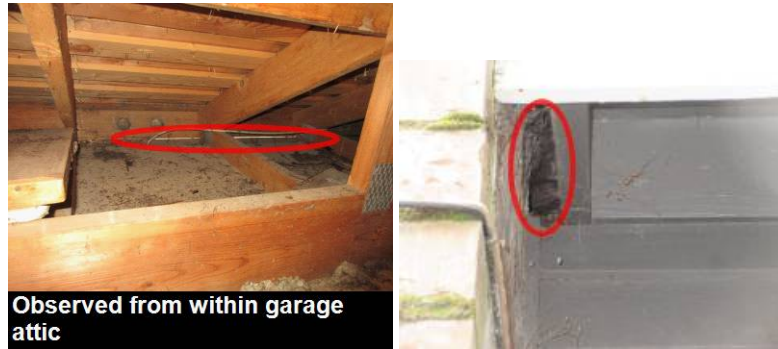
There are openings at the intersection between the overhang and the chimney through which birds and rodents can enter into the attic. These openings should be covered with wood, wire mesh or filled with aerosol foam.

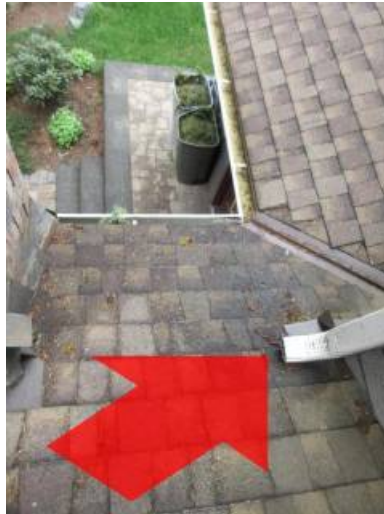
Downspouts draining directly onto the asphalt shingle surface causes excessive wear of the roofing material. Downspout extensions to the lower gutters should be installed to prevent excessive wear and tear of the roofing.

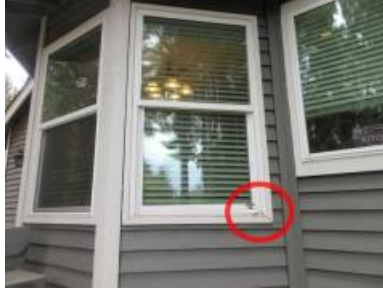
One of the window frames is damaged. Repair or replacement of the damaged window is recommended.

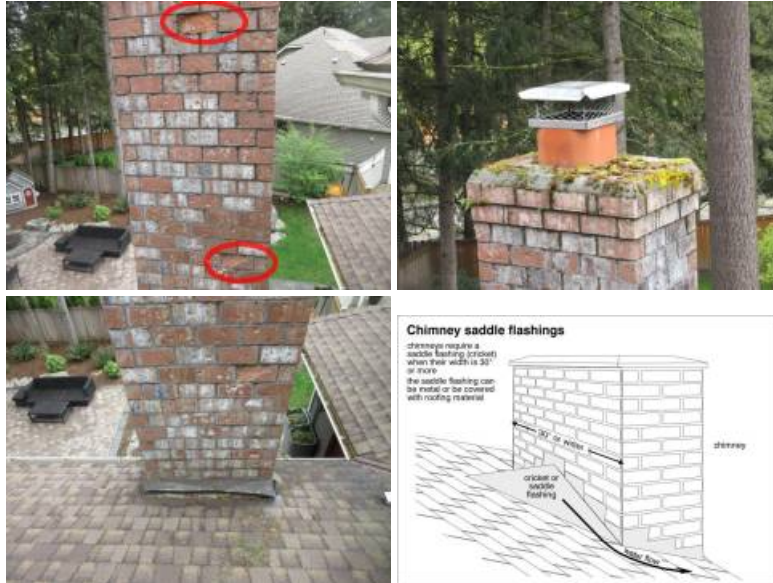
There is no cricket on the up-slope side of the living room fireplace chimney. This is conducive to leakage. Consideration should be given to installing a cricket to divert water around the chimney.

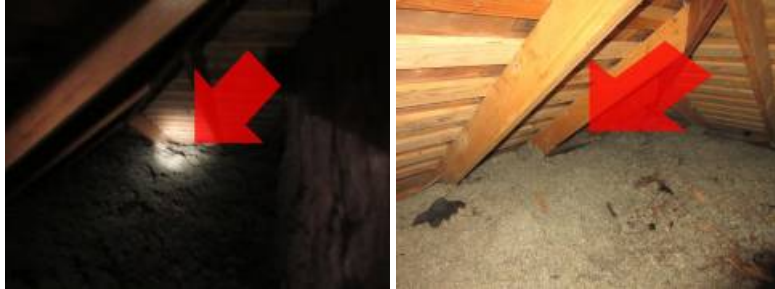
Pressure induced attic ventilation ie: attic fans, solar fans or other systems that mitigate moisture amounts may be necessary due to certain conditions found within some buildings. However the pressure increase or decrease of the ambient air of the living space may affect the performance of and/or venting of gas appliances or fireplaces when in use creating conditions may be hazardous to your health. These are designed systems that should be installed by a qualified contractor.

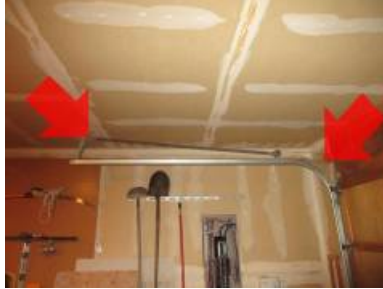
Safeties are cables run through the center of the garage door springs that prevent broken springs from becoming projectiles that can cause injury. There are no safeties installed. The installation of safeties is recommended.

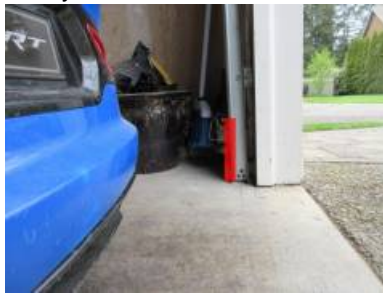
The Photo-eye beam was installed to high above the floor of the garage to adequately offer protection for small children and/or pets. We recommend that the photo-eye be lowered to within 4-6" of the floor.

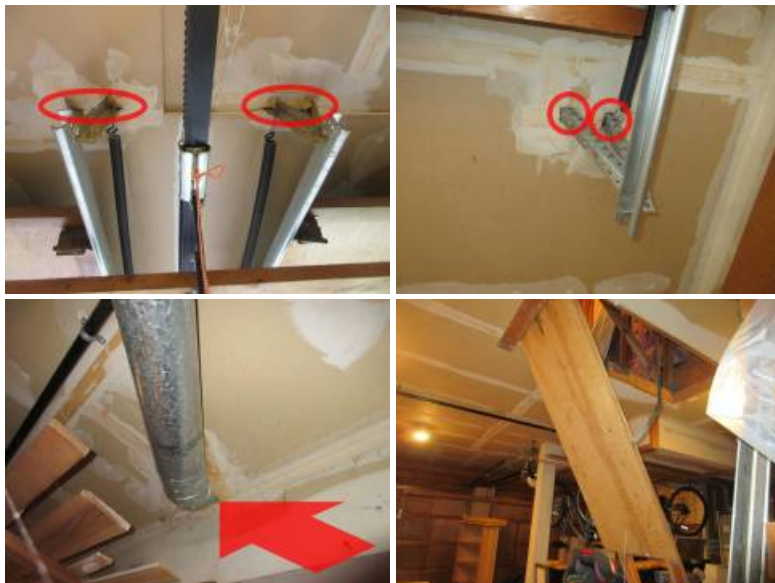
The pull down ladder is a breach in the fire resistive barrier in the garage. This is a safety concern. The gypsum barrier on the ceiling slows the spread of a fire from the garage to the attic. The installation of a layer of 5/8" gypsum type X board over the 1/4" plywood is recommended.

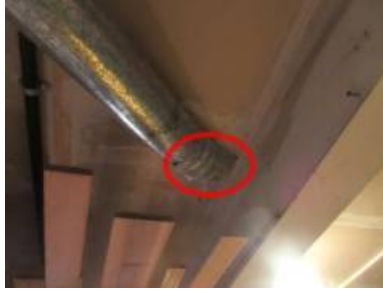
The furnace vent connector is too close to a combustible material. This is a hazard. A minimum clearance of 6" is required between the single wall vent connector and the combustible material. The double wall type B vent requires only 1" of clearance. Repairs are recommended.

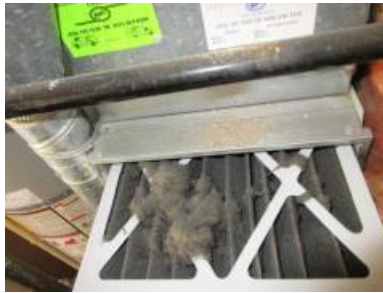
The air filter is clogged with dust. This reduces air flow and furnace efficiency. Removal and replacement of the air filter is recommended. Pleated style air filters are recommended as they offer better filtration of dust than the coarser hogs hair or fiberglass filters.

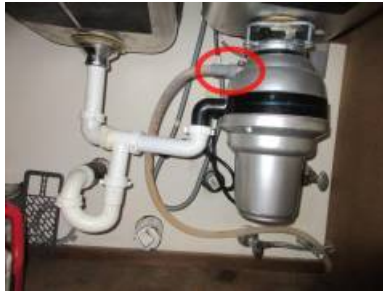
The dishwasher drain lacks an air gap. The dishwasher will function without one, but there is a risk of contamination of the inside of the dishwasher by waste water. The installation of an air gap is recommended.

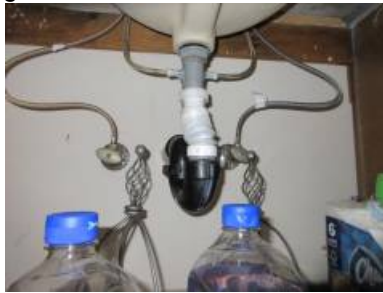
Improper, non-conforming material has been used for the drain pipe fitting. This material will not function reliably. Replacement with industry standard fittings is recommended.

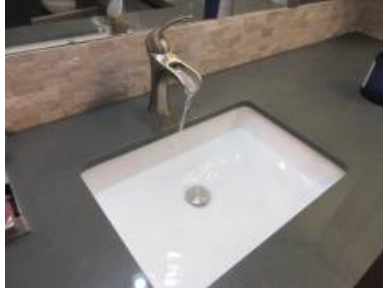
We observed low flow from the cold water direction of the left sink faucet. The faucet should be adjusted, repaired or replaced.

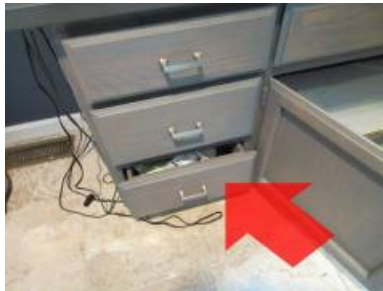
The bathroom cabinet bottom drawer slide hardware is damaged and in need of repair. The finish on the bathroom cabinet is slightly worn. The cabinet is otherwise in serviceable condition.

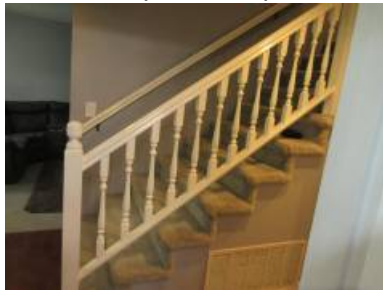
The stair railing baluster spacing is too wide. This is a hazard for small children. The baluster spacing should be reduced as a safety upgrade. Current standards require that a 4" sphere not pass through the railing.

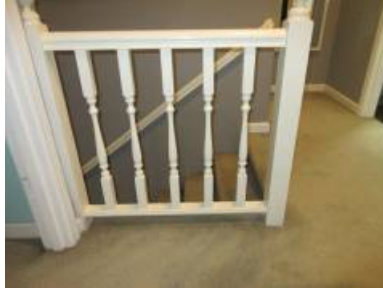
**14.3 GUARD RAILINGS**

The spacing between the balusters is too wide. This is a hazard to small children. The balusters should be spaced close enough together so that a 4" sphere cannot pass through. Upgrading the guard railing is recommended if small children are present.

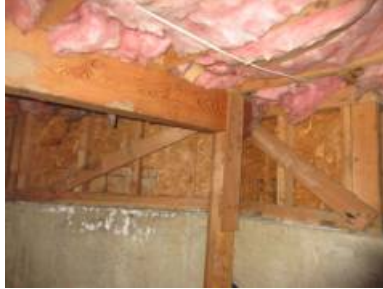
Shear panels are plywood or OSB panels that are mechanically fastened to both vertical and horizontal framing members in critical structural areas of the building. They prevent lateral movement of the structure during an earthquake. Shear panels are often visible in the crawlspace on cripple walls between the first floor and foundation. They may also be installed on interior walls that are covered with drywall. An examination of the crawlspace revealed the absence of shear panels on the cripple walls. The installation of shear panels on the cripple walls is recommended as an upgrade.

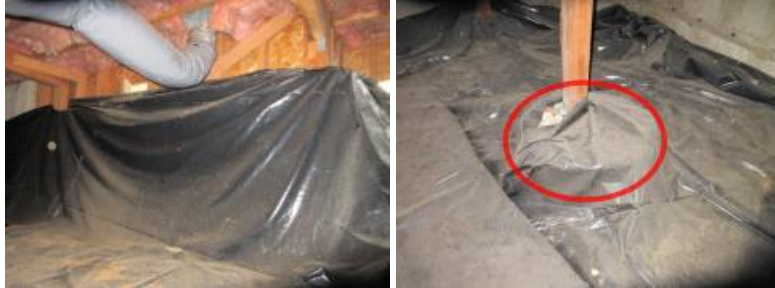
The support post concrete piers are covered with the plastic vapor retarder. This allows the transmission of water vapor from the soil up and into the floor framing. The plastic vapor retarder should be removed from the piers.

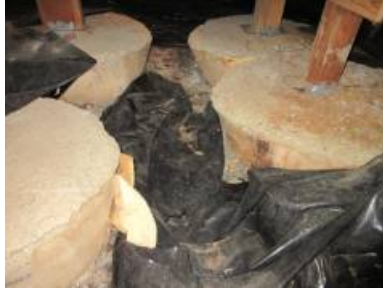
Good building practice requires that foundation walls or pier footings supporting wood frame construction, should extend at least 8" above the finish grade with at least a 6" clearance between the top of the soil and the bottom of the wood finish materials. Untreated wood should be raised 1-2" above surrounding flatwork and should have a moisture barrier such as 30 lb. asphalt impregnated felt installed between the concrete and wood. For additional information and treatment options, you should retain the services of a qualified pest control operator.
