NOTICE TO BUYER: SELLER-PROCURED INSPECTION REPORT

**Tom and Carolynne Joyce
16815 NE 117th Street
Redmond, WA 98052**

**Mr. & Mrs. Tom & Caroline Joyce
16815 NE 117th St.
Redmond, WA.**

**Re: 16815 NE 117th St.
Redmond, WA.**

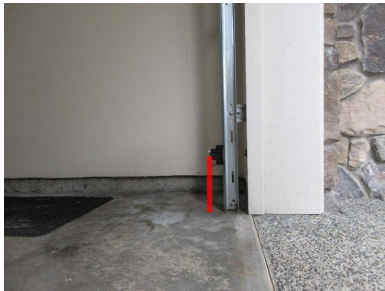
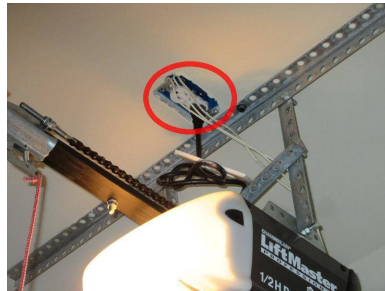
6.3 GARAGE DOOR OPENER

The Photo-eye beam was installed to high above the floor of the garage to adequately offer protection for small children and/or pets. We recommend that the photo-eye be lowered to within 4-6" of the floor.

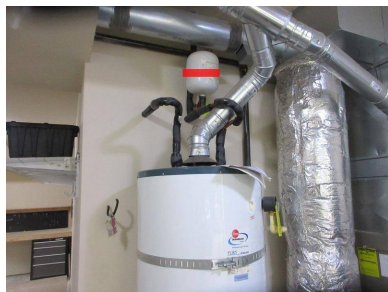
9.6 EXPANSION TANK

The expansion tank is not adequately secured to the wall. As code requirements start to call for engineered expansion tank supports we recommend the installation of seismic restraints to secure the expansion tank instead of allowing it to simply depend on piping connections that could result in damage to the water pipe and leakage during an earthquake.

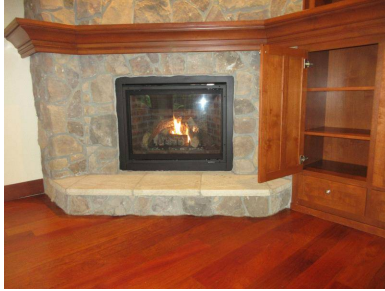
The gas valve was not observed. The gas supply for the fireplace should be located on the wall or floor adjacent to the hearth. The key that turns on this valve should be kept out of the reach of children.

Equipment shutoff valves separate from the appliance should be located in the same room as the appliance, not further than 6 feet from the appliance, and shall be installed upstream from the union, connector or quick disconnect device it serves. Such shutoff valves shall be provided with access.

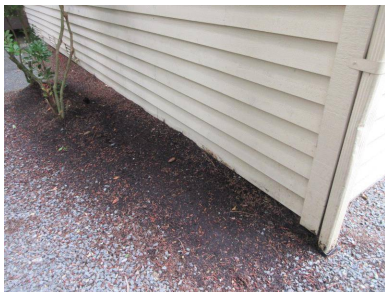
3.3 PEST CONTROL

Soil is close to or in contact with siding at the southeast corner of the building exterior. Good building practice requires that foundation walls or pier footings supporting wood frame construction, extend at least 8" above the finish grade with at least a 6" clearance between the top of the soil and the bottom of the wood finish materials. Soil in direct contact with wood creates a hospitable environment for wood destroying organisms. Establishing these minimum clearances is recommended.

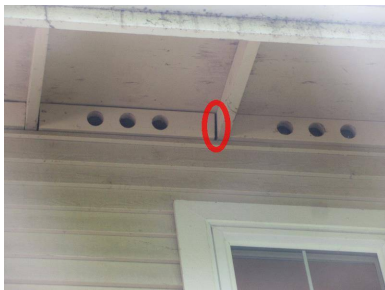
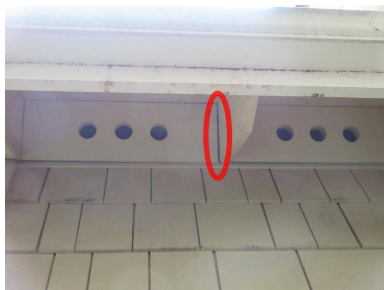
3.4 SOFFITS AND OVERHANGS

There are large gaps over 1/4" in size adjacent the soffit vent blocks. These gaps allow insects and rodents to enter the attic. Covering the gaps with screening, a strip of wood and/or caulking is recommended.

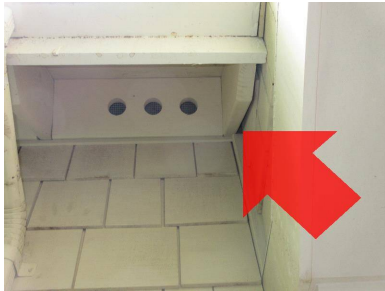
Gaps over 1/4" in size will allow insects and rodents to enter the attic. Covering any gaps with screening, a strip of wood and/or caulking is recommended.

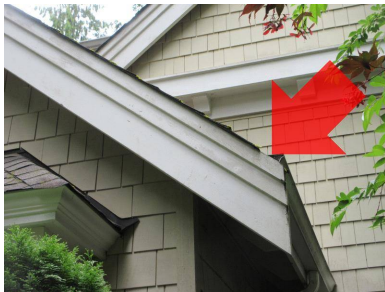
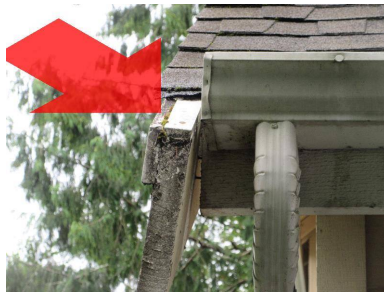
The ends of the barge boards are exposed to the weather and are vulnerable to rot damage. To prevent damage to the barge board ends, they should be covered with roofing material or flashing.

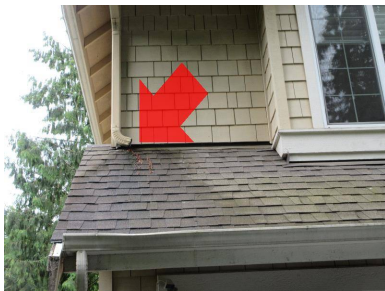
3.5 GUTTERS AND DOWNSPOUTS

Downspouts draining directly onto the asphalt shingle surface causes excessive wear of the roofing material. Downspout extensions to the lower gutters should be installed to prevent excessive wear and tear of the roofing.

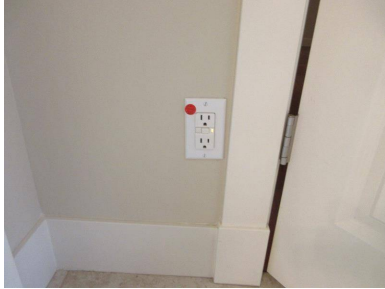
7.12 GFCI RECEPTACLES

The GFCI receptacle adjacent the primary bedroom bathroom door does not reset when a ground fault is introduced. This is caused by a redundant GFCI. The installation of just one GFCI outlet for protection of each circuit is recommended.

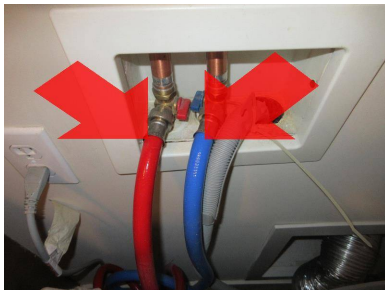
12.5 APPLIANCES

Upgrading the washer connections to high pressure (steel braided) lines is recommended.

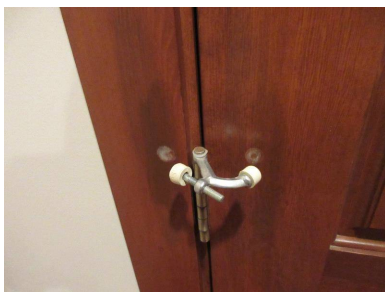
14.4 DOORS

Doors that are equipped with hinge mounted door stops can damage the door skin or surface, tear out hinge screws, and damage the door trim and frame. The removal and replacement with wall or floor mounted door stops is recommended.

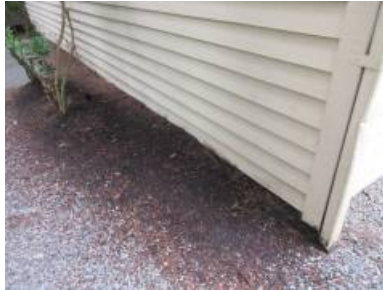
3.3 PEST CONTROL

Soil is close to or in contact with siding at the southeast corner of the building exterior. Good building practice requires that foundation walls or pier footings supporting wood frame construction, extend at least 8" above the finish grade with at least a 6" clearance between the top of the soil and the bottom of the wood finish materials. Soil in direct contact with wood creates a hospitable environment for wood destroying organisms. Establishing these minimum clearances is recommended.

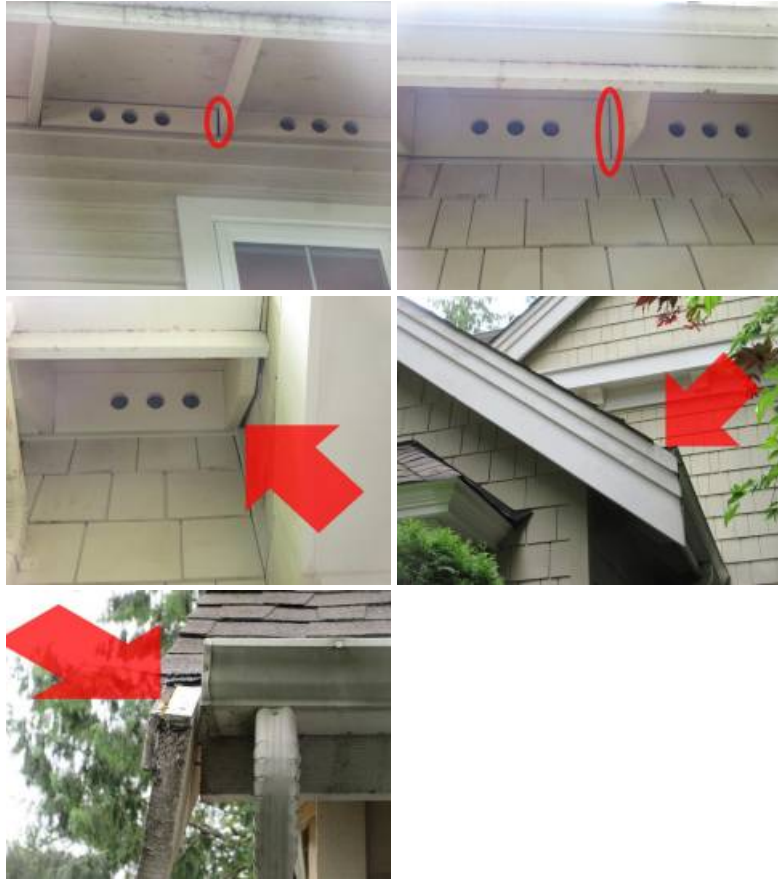
Gaps over 1/4" in size will allow insects and rodents to enter the attic. Covering any gaps with screening, a strip of wood and/or caulking is recommended.

The ends of the barge boards are exposed to the weather and are vulnerable to rot damage. To prevent damage to the barge board ends, they should be covered with roofing material or flashing.

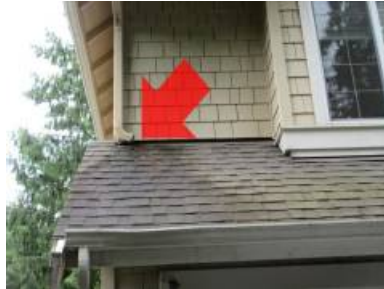
3.5 GUTTERS AND DOWNSPOUTS

Downspouts draining directly onto the asphalt shingle surface causes excessive wear of the roofing material. Downspout extensions to the lower gutters should be installed to prevent excessive wear and tear of the roofing.

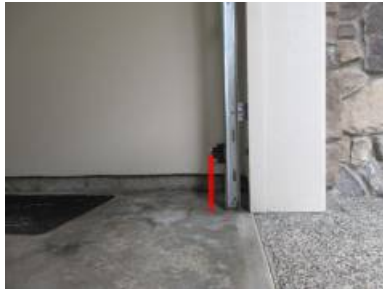
The Photo-eye beam was installed to high above the floor of the garage to adequately offer protection for small children and/or pets. We recommend that the photo-eye be lowered to within 4-6" of the floor.

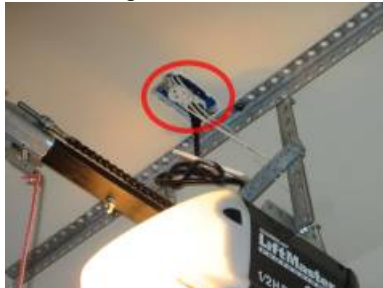
6.4 FIRE SEPARATION

The cover plate is missing from a receptacle in the garage. The void in the fire resistive barrier adjacent the receptacle and between the living space and garage will allow flames to penetrate. The gypsum barrier slows the spread of a fire from the garage to the structure and/or living space. Patching the voids with a fire retardant caulk is recommended.

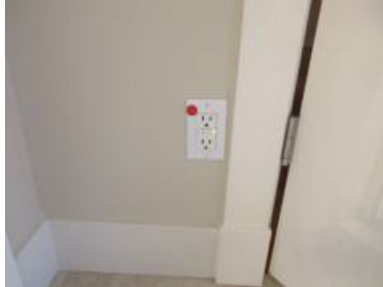
The GFCI receptacle adjacent the primary bedroom bathroom door does not reset when a ground fault is introduced. This is caused by a redundant GFCI. The installation of just one GFCI outlet for protection of each circuit is recommended.

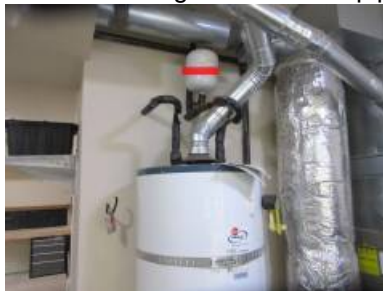
9.6 EXPANSION TANK

The expansion tank is not adequately secured to the wall. As code requirements start to call for engineered expansion tank supports we recommend the installation of seismic restraints to secure the expansion tank instead of allowing it to simply depend on piping connections that could result in damage to the water pipe and leakage during an earthquake.

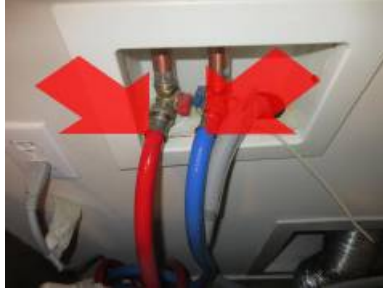
Upgrading the washer connections to high pressure (steel braided) lines is recommended.

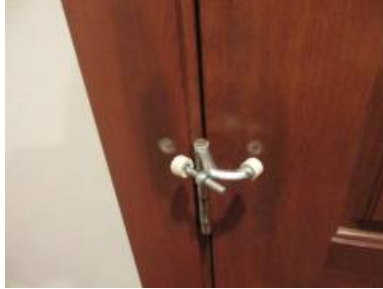
Doors that are equipped with hinge mounted door stops can damage the door skin, surface, tear out hinge screws, and damage the door trim and frame. The removal and replacement with wall or floor mounted door stops is recommended.

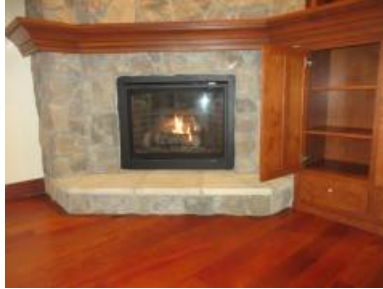
Equipment shutoff valves separate from the appliance should be located in the same room as the appliance, not further than 6 feet from the appliance, and shall be installed upstream from the union, connector or quick disconnect device it serves. Such shutoff valves shall be provided with access.

Exception: Shutoff valves for vented decorative appliances and decorative appliances for installation in vented fireplaces shall not be prohibited from being installed in an area remote from the appliance where such valves are provided with ready access. Such valves shall be permanently identified and shall serve no other equipment.
