NOTICE TO BUYER: SELLER-PROCURED INSPECTION REPORT

**Russell & Linda Morris
4112 169th Ct NE
Redmond WA 98052**

July 16, 2022

**Mr. Russel Morris
4112 169th Ct. NE
Redmond, WA.**

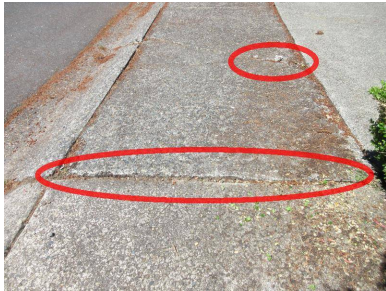
2.5 WALKWAY

Tree root damage was observed in the walkway and the concrete has cracked and settled differentially. The walkway can be repaired by removing and replacing it. Consultation of a qualified arborist should be considered prior to the removal of tree roots. The walkway remains functional despite this condition.

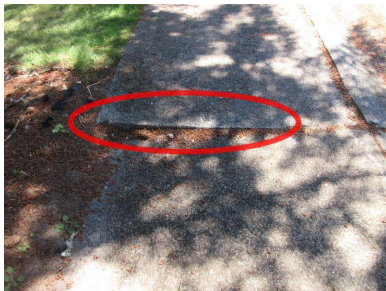
The walkway has cracked and settled differentially. This was probably caused by inadequate preparation of the soil prior to the placement of the concrete. This condition can be repaired by pressure grouting the sunken portion of the walkway or by removing and replacing it. Grinding down the raised edges of the concrete will also mitigate the hazard. The walkway remains functional despite this condition. However, the raised edges of the concrete can be a trip hazard for some people. Repairs should be made as necessary.

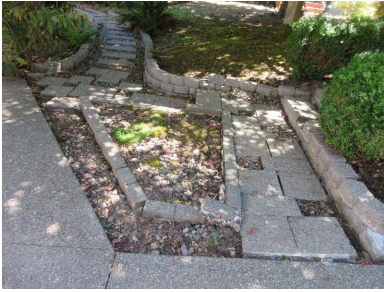
The walking surface was not even and trip hazards were present. We recommend all walking surfaces be maintained free of trip hazards.

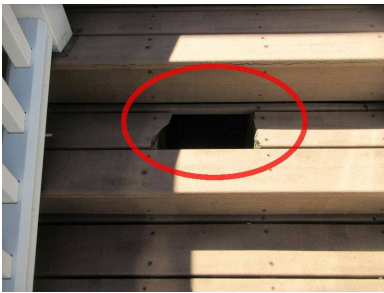
3.8 STAIRS

One of the deck steps is damaged. This is a hazard. Replacing the step is recommended.

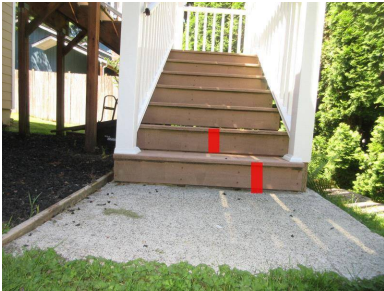
The deck stairs are non-conforming due to the variable and/or excessive rise. Deck stair/step design standards require that step risers do not exceed 8" and that the variation in rise not exceed 3/8" in order to reduce falls from tripping. To increase the margin of safety, consideration should be given to reconfiguring the steps so that rise and run do not vary by more than 3/8". If this proves to be too impractical or expensive, then we recommend exercising caution when using these steps.

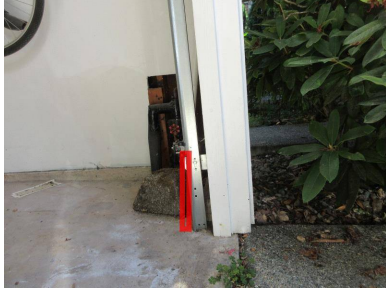
The Photo-eye beam was installed to high above the floor of the garage to adequately offer protection for small children and/or pets. We recommend that the photo-eye be lowered to within 4-6" of the floor.

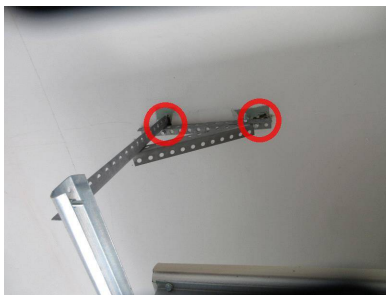
6.4 FIRE SEPARATION

There are voids in the fire resistive barrier between the living space and garage that will allow flames to penetrate. The gypsum barrier slows the spread of a fire from the garage to the structure and/or living space. Patching the voids with a fire retardant caulk is recommended.

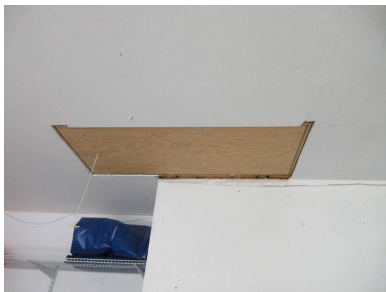
The pull down ladder is a breach in the fire resistive barrier in the garage. This is a safety concern. The gypsum barrier on the ceiling slows the spread of a fire from the garage to the attic. The installation of a layer of 5/8" gypsum type X board over the 1/4" plywood is recommended.

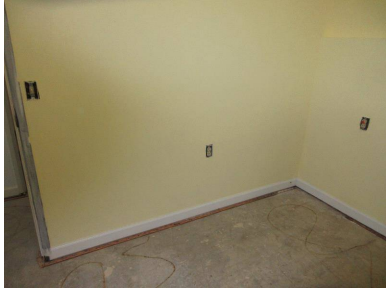
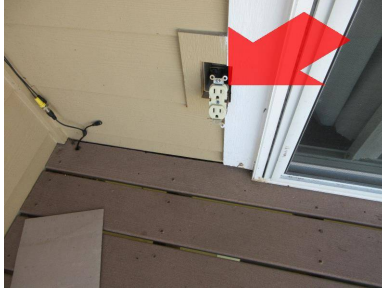
The receptacle on the wall adjacent the deck is loose. This is a potential shock and a fire hazard. All loose receptacles should be repaired as necessary. The installation of a weather tight cover plate is recommended.

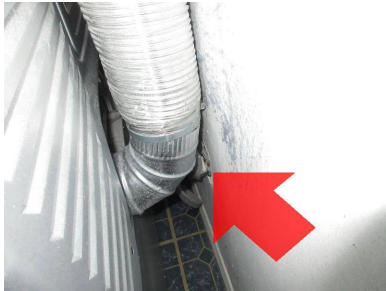
The cover plate is missing from the dryer receptacle in the laundry room. This is a shock and fire hazard. The installation of a cover plate is recommended.

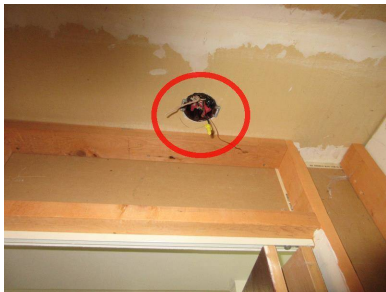
The closet luminaries is missing. A luminaries should be installed to provide proper lighting in this area.

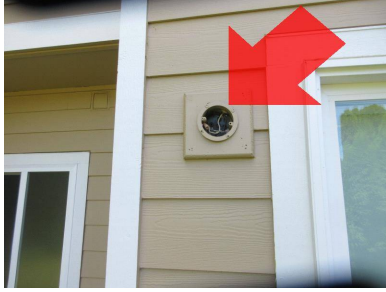
One of the exterior luminaries is missing. A luminaries should be installed to provide proper lighting in this area.

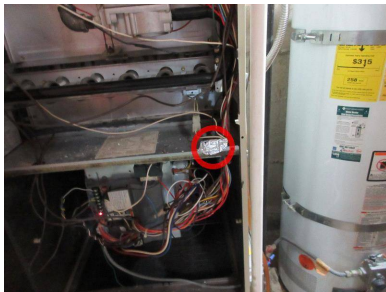
8.10 BLOWER

The blower door cut-out switch has been disabled. This is a potential hazard. The cut-out switch should be unrestricted.

- 8.10 Cost of door cutout switch – the current system works – Bobs Heating took care of this equipment and did the work on the system twice a year (spring and late fall). Willing to discuss

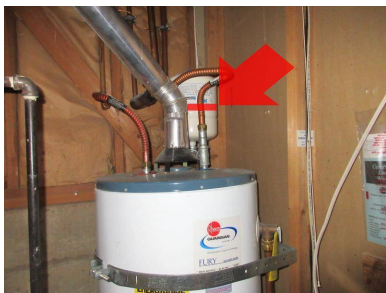
10.6 EXPANSION TANK

The expansion tank is not adequately secured to the wall. As code requirements start to call for engineered expansion tank supports we recommend the installation of seismic restraints to secure the expansion tank instead of allowing it to simply depend on piping connections that could result in damage to the water pipe and leakage during an earthquake.

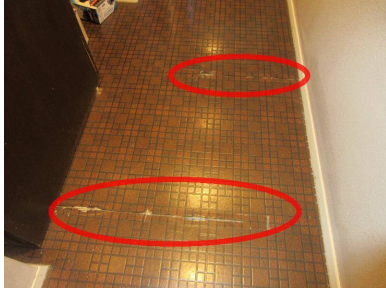
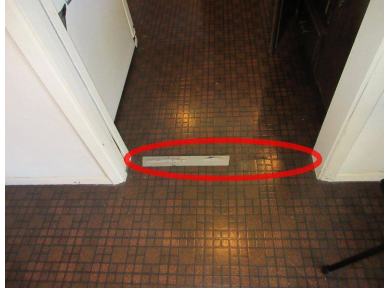
The vinyl flooring is worn and is nearing the end of its service life. Flooring replacement should be considered.

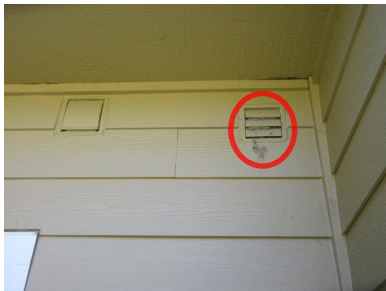
13.3 DRYER VENT

The dryer vent has become clogged with lint. This is a fire hazard and reduces dryer efficiency. The duct should be disassembled and cleaned.

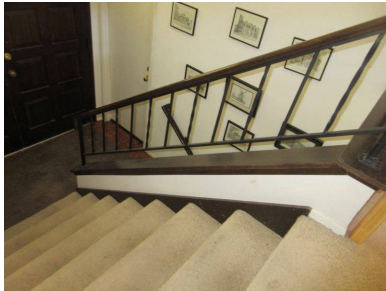
15.2 STAIRS

The stair railing baluster spacing is too wide. This is a hazard for small children. The baluster spacing should be reduced as a safety upgrade. Current standards require that a 4" sphere not pass through the railing.

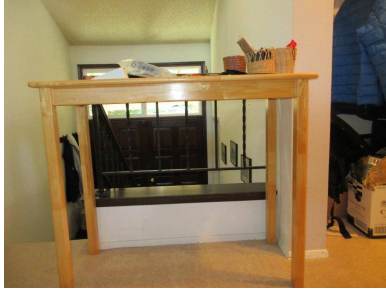
15.3 GUARD RAILINGS

The spacing between the balusters is too wide. This is a hazard to small children. The balusters should be spaced close enough together so that a 4" sphere cannot pass through. Upgrading the guard railing is recommended if small children are present.

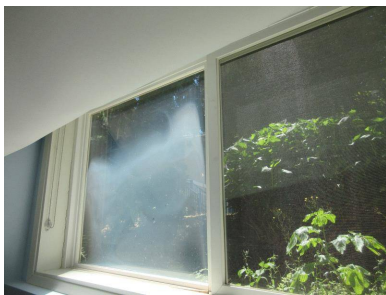
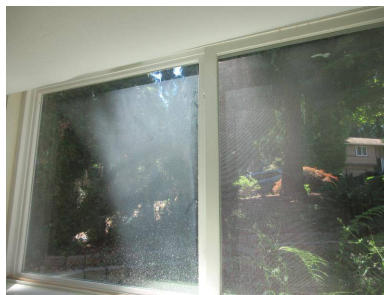
15.7 WINDOWS

There is condensation or mineral deposits between the panes of glass in two of the insulated glass windows. This indicates failed seals. The glass assemblies should be replaced, which is the only method for correcting this deficiency.

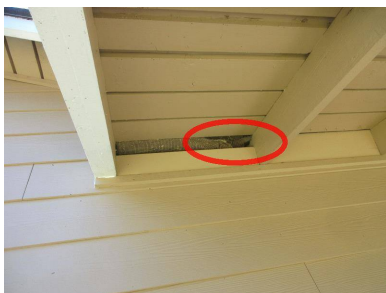
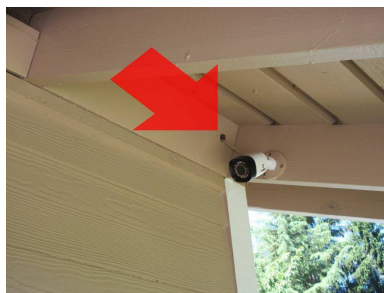
Gaps over 1/4" in size adjacent the soffit vent blocks will allow insects and rodents to enter the attic. Covering any gaps with screening, a strip of wood and/or caulking is recommended.

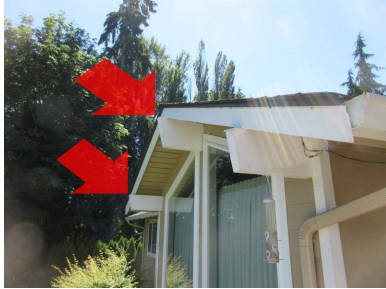
The beams that stick out beyond the drip edge of the roof are vulnerable to rot damage. They should be covered with a metal cap flashing or cut off flush with the edge of the overhang.

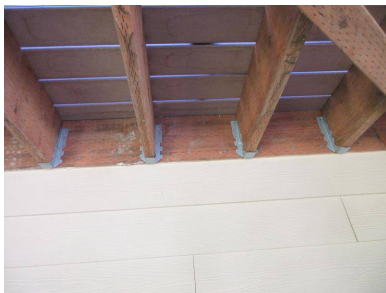
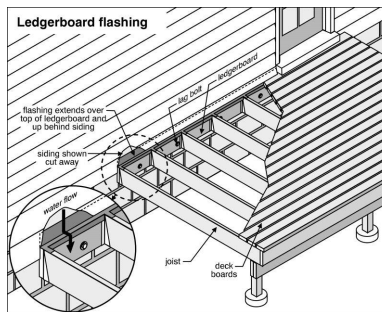
There is no flashing at the intersection between the deck and house. This will allow water to enter behind the siding. The installation of flashing in this area is recommended.

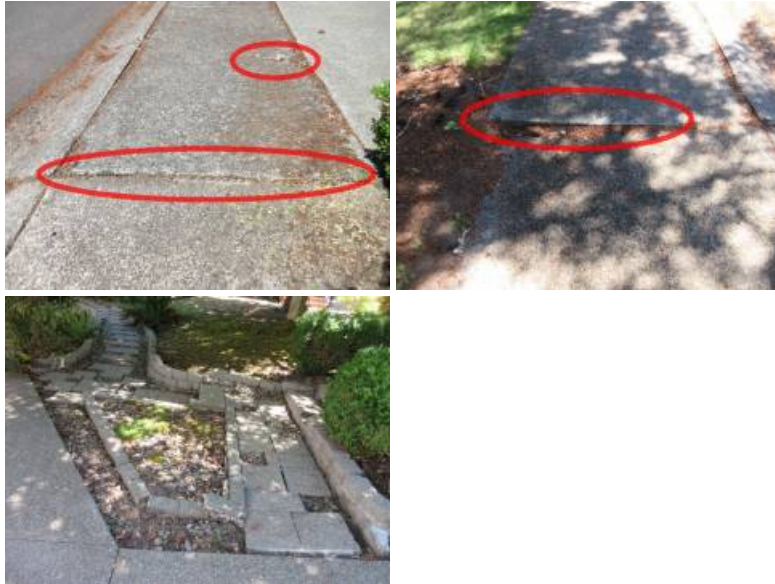
The walking surface was not even and trip hazards were present. We recommend all walking surfaces be maintained free of trip hazards.

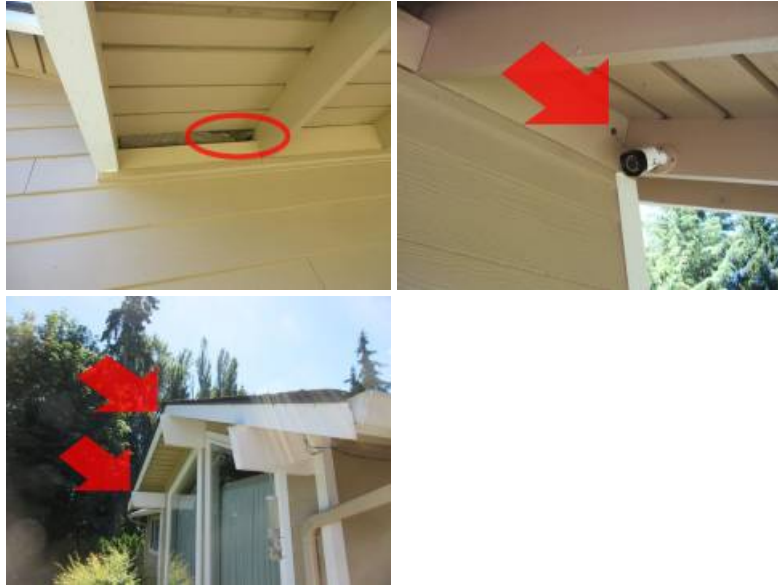
The beams that stick out beyond the drip edge of the roof are vulnerable to rot damage. They should be covered with a metal cap flashing or cut off flush with the edge of the overhang.

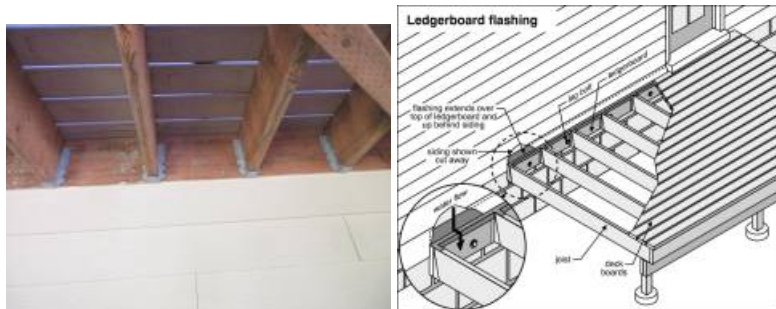
There is no flashing at the intersection between the deck and house. This will allow water to enter behind the siding. The installation of flashing in this area is recommended.

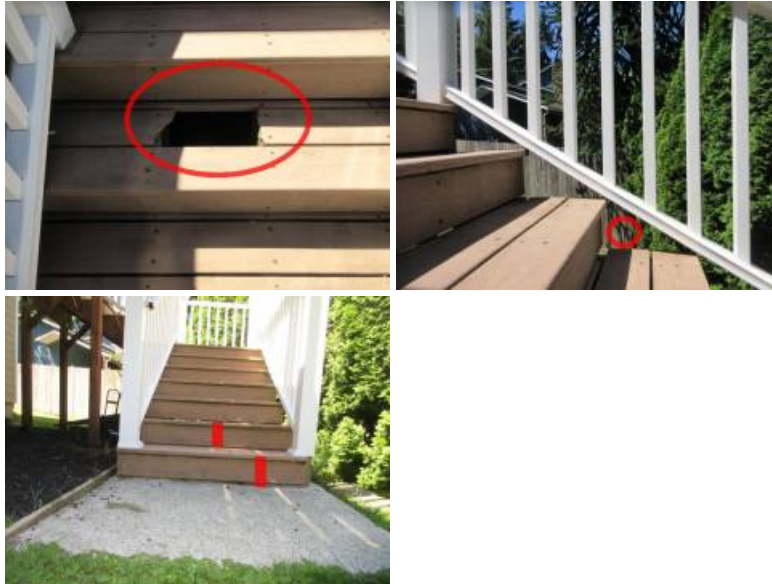
The deck stairs are non-conforming due to the variable and/or excessive rise. Deck stair/step design standards require that step risers do not exceed 8" and that the variation in rise not exceed 3/8" in order to reduce falls from tripping. To increase the margin of safety, consideration should be given to reconfiguring the steps so that rise and run do not vary by more than 3/8". If this proves to be too impractical or expensive, then we recommend exercising caution when using these steps.

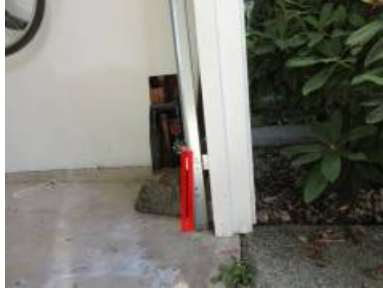
The Photo-eye beam was installed too high above the floor of the garage to adequately offer protection for small children and/or pets. We recommend that the photo-eye be lowered to within 4-6" of the floor.

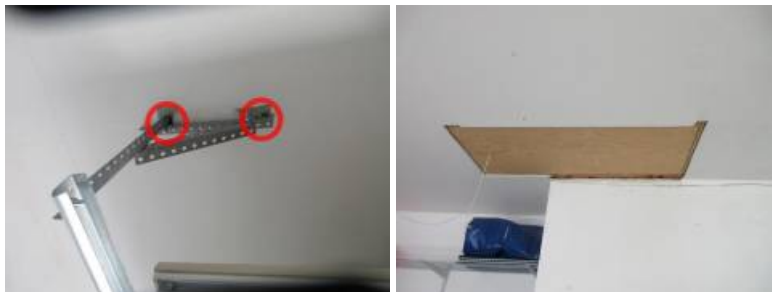
6.4 FIRE SEPARATION

There are voids in the fire resistive barrier between the living space and garage that will allow flames to penetrate. The gypsum barrier slows the spread of a fire from the garage to the structure and/or living space. Patching the voids with a fire retardant caulk is recommended.

The pull down ladder is a breach in the fire resistive barrier in the garage. This is a safety concern. The gypsum barrier on the ceiling slows the spread of a fire from the garage to the attic. The installation of a layer of 5/8" gypsum type X board over the 1/4" plywood is recommended.

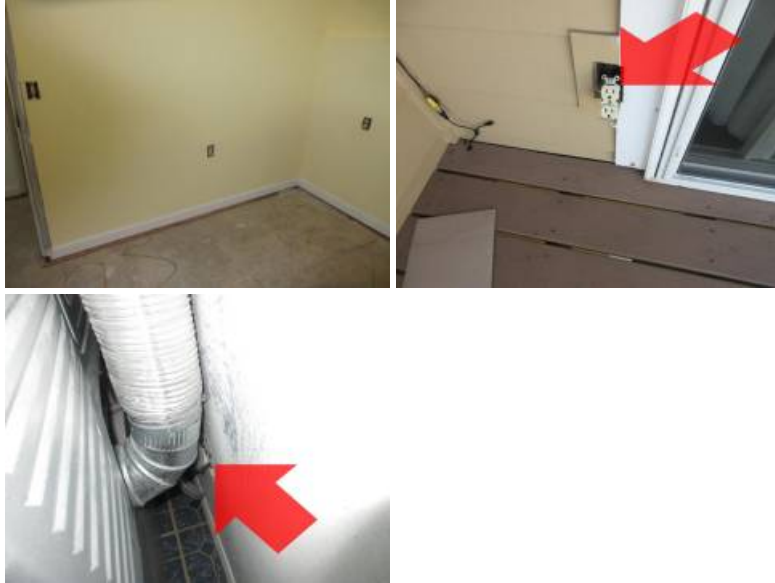
The cover plate is missing from the dryer receptacle in the laundry room. This is a shock and fire hazard. The installation of a cover plate is recommended.

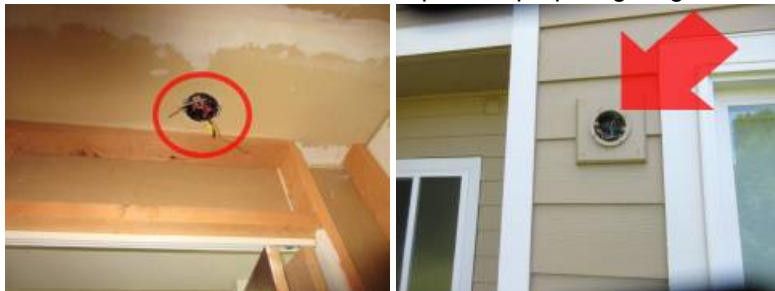
One of the exterior luminaries is missing. A luminaries should be installed to provide proper lighting in this area.

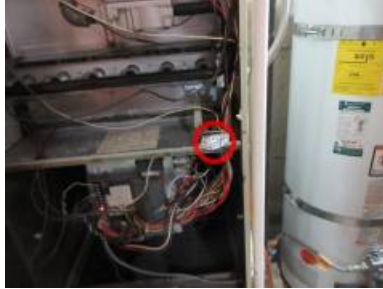
The blower door cut-out switch has been disabled. This is a potential hazard. The cut-out switch should be unrestricted.

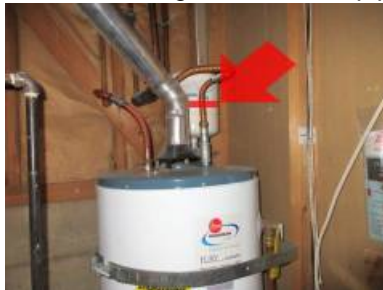
The expansion tank is not adequately secured to the wall. As code requirements start to call for engineered expansion tank supports we recommend the installation of seismic restraints to secure the expansion tank instead of allowing it to simply depend on piping connections that could result in damage to the water pipe and leakage during an earthquake.

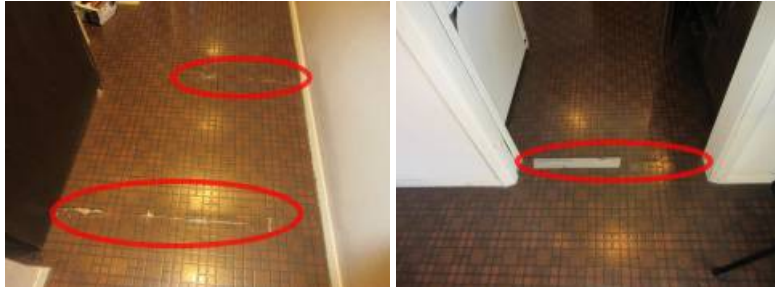
The vinyl flooring is worn and is nearing the end of its service life. Flooring replacement should be considered.

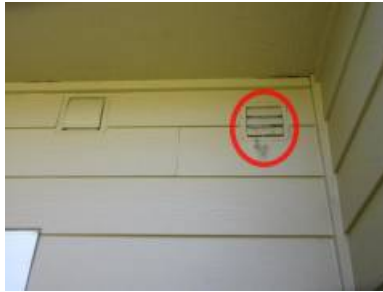
**13.3 DRYER VENT**

The dryer vent has become clogged with lint. This is a fire hazard and reduces dryer efficiency. The duct should be

disassembled and cleaned.

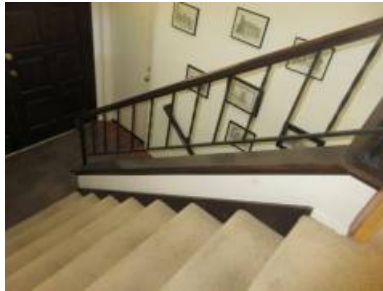
The stair railing baluster spacing is too wide. This is a hazard for small children. The baluster spacing should be reduced as a safety upgrade. Current standards require that a 4" sphere not pass through the railing.

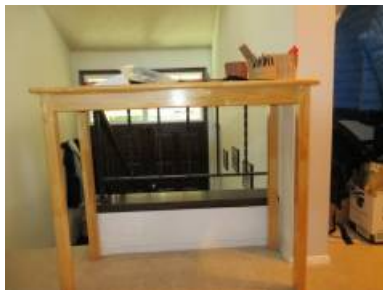
**15.3 GUARD RAILINGS**

The spacing between the balusters is too wide. This is a hazard to small children. The balusters should be spaced close enough together so that a 4" sphere cannot pass through. Upgrading the guard railing is recommended if small children are present.

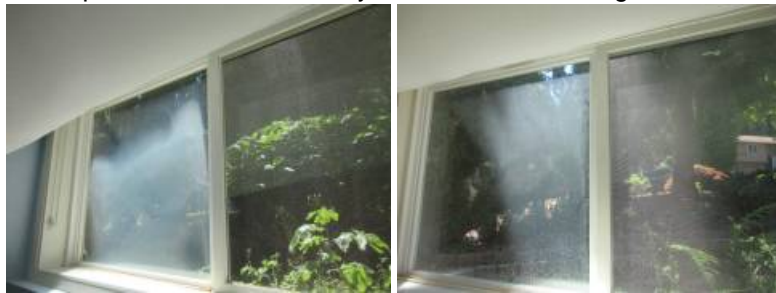
There is condensation or mineral deposits between the panes of glass in two of the insulated glass windows. This indicates failed seals. The glass assemblies should be replaced, which is the only method for correcting this deficiency.
