August 11, 2022

**Re: 14366 109th Ave. NE**  
**Kirkland, WA.**

At your request, a visual inspection of the above referenced property was conducted on 08/11/2022. We have inspected the major structural components, plumbing, heating and electrical systems for signs of significant non-performance, excessive or unusual wear and general state of repair.

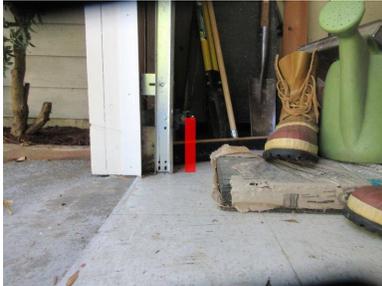
#### *6.3 GARAGE DOOR OPENER*

The Photo-eye beam was installed to high above the floor of the garage to adequately offer protection for small children and/or pets. We recommend that the photo-eye be lowered to within 4-6" of the floor.

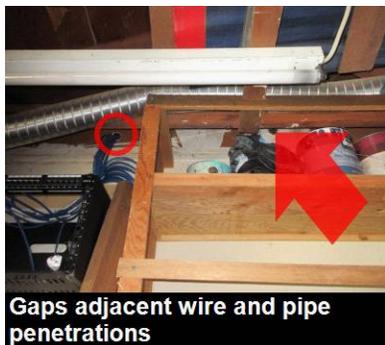
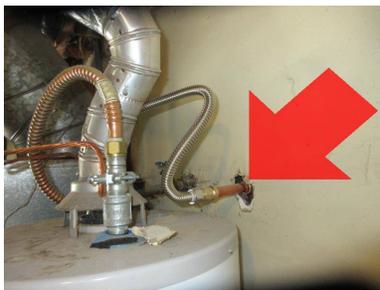
#### *6.4 FIRE SEPARATION*

There are voids in the fire resistive barrier between the living space and garage (adjacent pipe and wire penetrations) that will allow flames to penetrate. The gypsum barrier slows the spread of a fire from the garage to the structure and/or living space. Patching the voids with a fire retardant caulk is recommended.

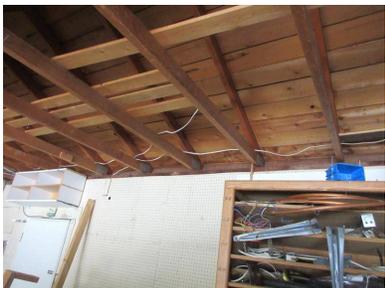
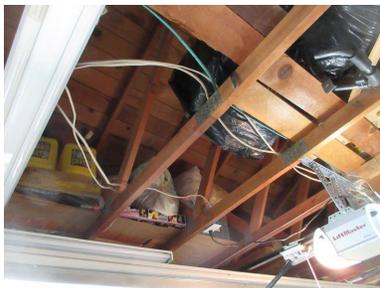
### 7.10 WIRING

Loose electrical cables were observed in the garage. Loose cables are vulnerable to damage. All loose cables should be secured at 4' intervals using approved cable staples.

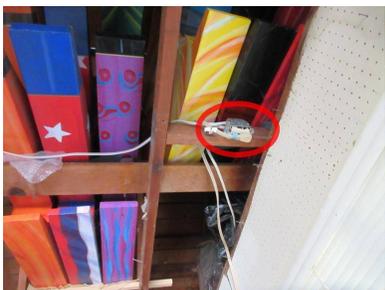
### 7.11 RECEPTACLES

The polarity is reversed in at least one receptacle in the primary bedroom. Reversed polarity means that the hot and neutral wires are reversed at the back of the receptacle. This defect is a shock hazard and can damage some electronic equipment. All receptacles exhibiting reversed polarity should be rewired.

The receptacle on the back wall of the garage is loose. This is a potential shock and a fire hazard. All loose receptacles should be repaired as necessary.

The cover plate is missing from a receptacle in the garage. This is a shock and fire hazard. The installation of a cover plate is recommended.

7.11 Polarity of bedroom receptacle is fixed; Receptacle on back wall of garage is fixed.

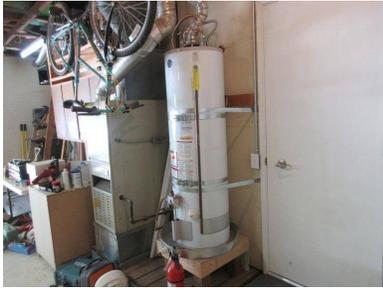
### 9.11 GENERAL COMMENTS

The water heater is at the end of its service life. The services of a qualified plumbing contractor should be retained to replace the water heater.

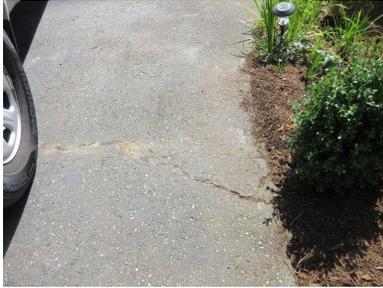
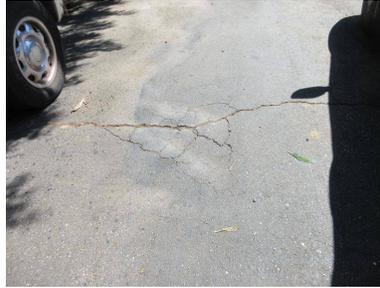
There is minor tree root damage visible in the asphalt driveway. The damage is not affecting the function of

the driveway. Seal coating the surface of the asphalt is recommended to maximize the service life of the paving. Asphalt sealers are available at most home improvement stores.

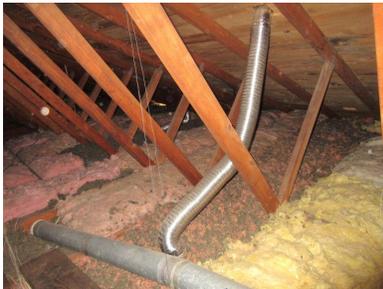
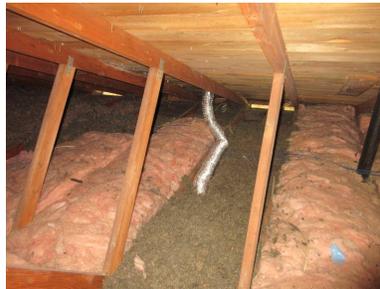
### 5.3 MECHANICAL VENTILATION SYSTEMS

Flexible plastic duct is used to direct air from the vent fans to the exterior. This type of material is unreliable. Replacing the plastic duct with 4" smooth-wall sheet metal duct is recommended.

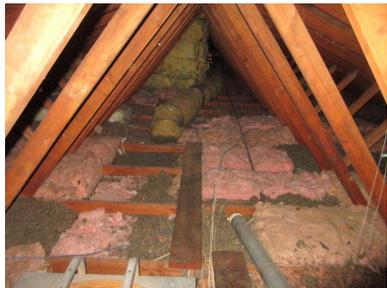
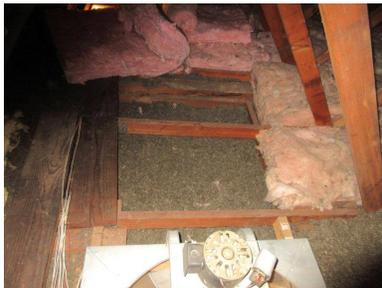
The attic has significantly less than the required amount of insulation, particularly in the areas not covered by

the added batt insulation. Adding additional insulation to achieve an R value of 30 is recommended to reduce heat loss through the ceilings.

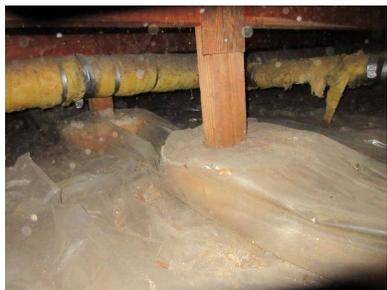
### 19.4 VAPOR RETARDER

The support post concrete piers are covered with the plastic vapor retarder. This allows the transmission of water vapor from the soil up and into the floor framing. The plastic vapor retarder should be removed from the pier so that it covers at least 85% of the entire surface of the soil only.

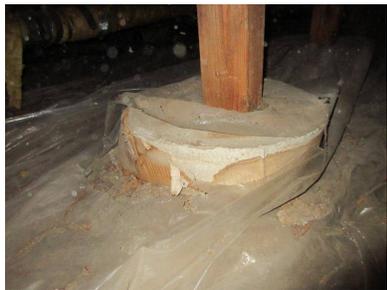
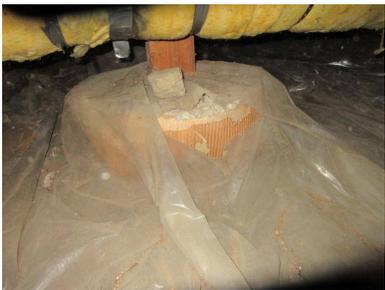
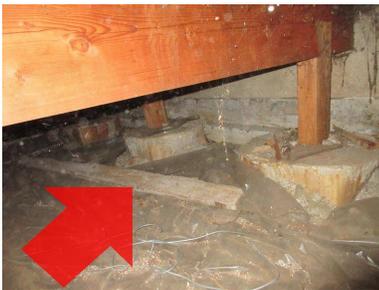
### 19.5 PEST CONTROL

Cellulose forms were left in place on the pier footings. This cellulose is conducive to the infestation of various wood destroying organisms. The removal of the cellulose is recommended.

Scrap-wood and other cellulose debris was observed on the crawl floor. This wood debris creates conducive conditions for wood boring insects. The removal of all cellulose debris is recommended.

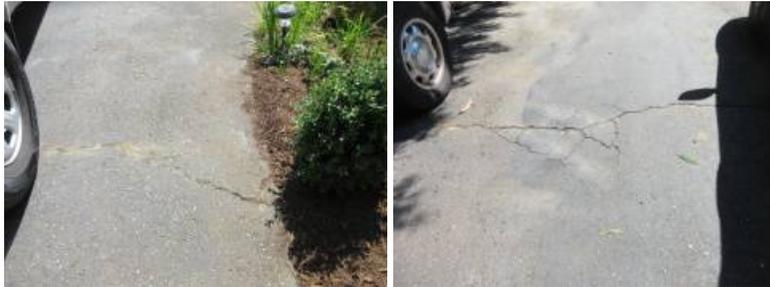
## 2.4 DRIVEWAY

There is minor tree root damage visible in the asphalt driveway. The damage is not affecting the function of the driveway. Seal coating the surface of the asphalt is recommended to maximize the service life of the paving. Asphalt sealers are available at most home improvement stores.

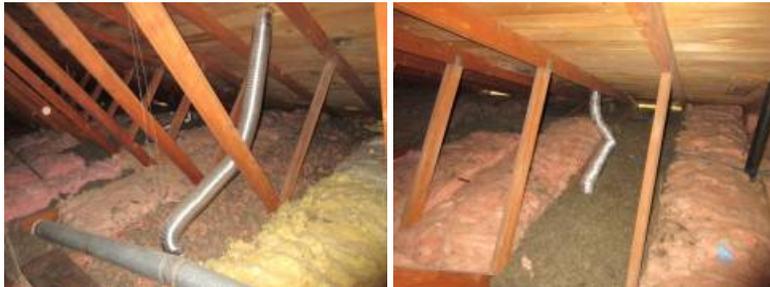
### **5.3 MECHANICAL VENTILATION SYSTEMS**

Flexible plastic duct is used to direct air from the vent fans to the exterior. This type of material is unreliable. Replacing the plastic duct with 4" smooth-wall sheet metal duct is recommended.

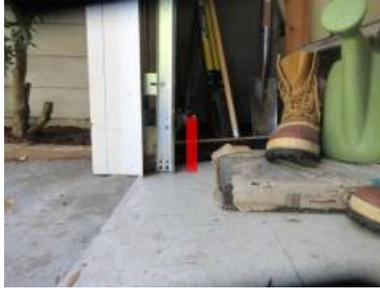
The Photo-eye beam was installed to high above the floor of the garage to adequately offer protection for small children and/or pets. We recommend that the photo-eye be lowered to within 4-6" of the floor.

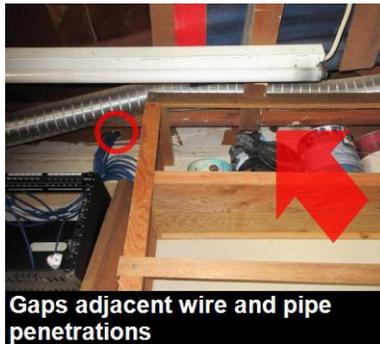
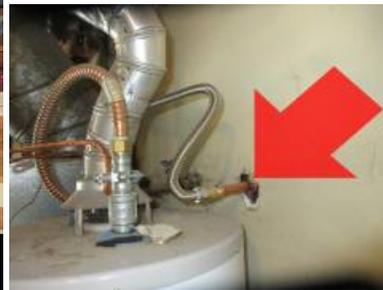
### 6.4 FIRE SEPARATION

There are voids in the fire resistive barrier between the living space and garage (adjacent pipe and wire penetrations) that will allow flames to penetrate. The gypsum barrier slows the spread of a fire from the garage to the structure and/or living space. Patching the voids with a fire retardant caulk is recommended.

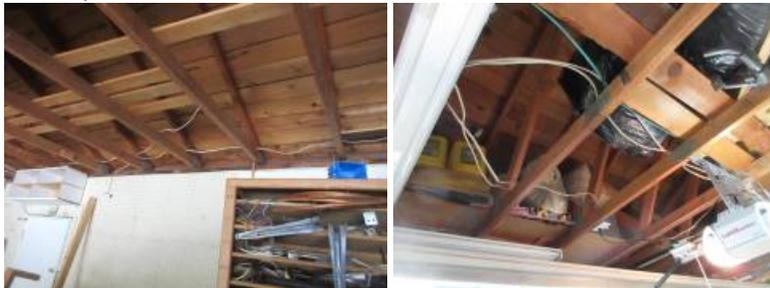
Loose electrical cables were observed in the garage. Loose cables are vulnerable to damage. All loose cables should be secured at 4' intervals using approved cable staples.

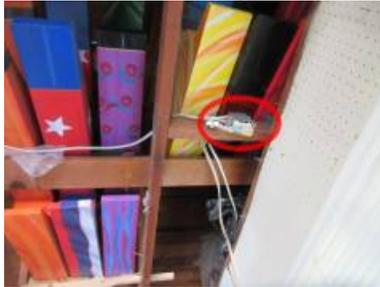
### 7.11 RECEPTACLES

The receptacle on the back wall of the garage is loose. This is a potential shock and a fire hazard. All loose receptacles should be repaired as necessary.

The cover plate is missing from a receptacle in the garage. This is a shock and fire hazard. The installation of a cover plate is recommended.

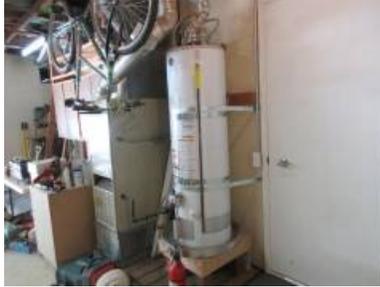
### 9.11 GENERAL COMMENTS

The water heater is at the end of its service life. The services of a qualified plumbing contractor should be retained to replace the water heater.

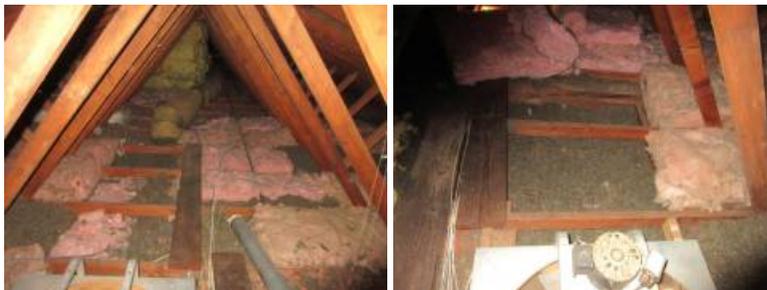
The attic has significantly less than the required amount of insulation, particularly in the areas not covered by the added batt insulation. Adding additional insulation to achieve an R value of 30 is recommended to reduce heat loss through the ceilings.

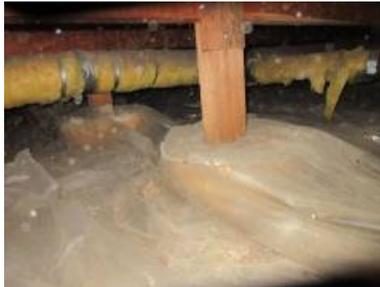
The support post concrete piers are covered with the plastic vapor retarder. This allows the transmission of water vapor from the soil up and into the floor framing. The plastic vapor retarder should be removed from the pier so that it covers at least 85% of the entire surface of the soil only.

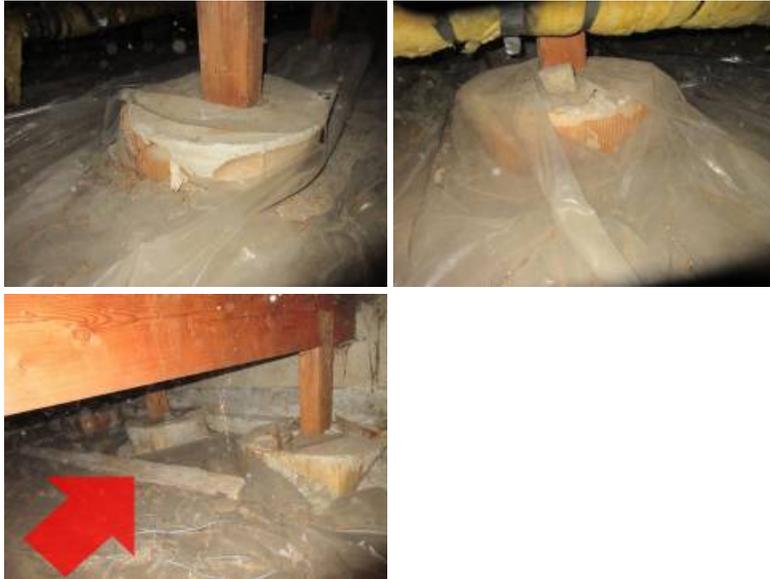
### 19.5 PEST CONTROL

Cellulose forms were left in place on the pier footings. This cellulose is conducive to the infestation of various wood destroying organisms. The removal of the cellulose is recommended.

Good building practice requires that foundation walls or pier footings supporting wood frame construction, should extend at least 8" above the finish grade with at least a 6" clearance between the top of the soil and the bottom of the wood finish materials. Untreated wood should be raised 1-2" above surrounding flatwork and should have a moisture barrier such as 30

lb. asphalt impregnated felt installed between the concrete and wood. For additional information and treatment options, you should retain the services of a qualified pest control operator.
