13724 176th Ave NE

Redmond, WA 98052

At your request, a visual inspection of the above referenced property was conducted on 08/18/2020. We have inspected the major structural components, plumbing, heating and electrical systems for signs of significant non-performance, excessive or unusual wear and general state of repair.

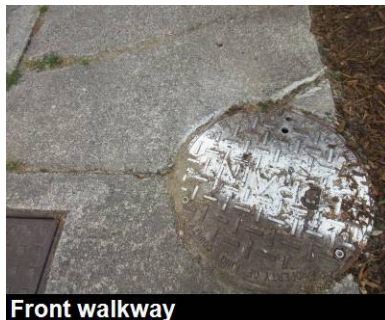
Front walkway

The wooden dividers separating the concrete walkway sections have deteriorated to a point where the gaps are a trip hazard. Replacement with mortar is recommended.

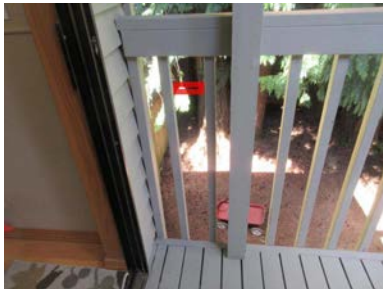
3.7 DECK RAILINGS

The spacing between the balusters is too wide. This is a hazard to small children. The balusters should be spaced close enough together so that a 4" sphere cannot pass through. Upgrading the deck railing is recommended if small children are present.

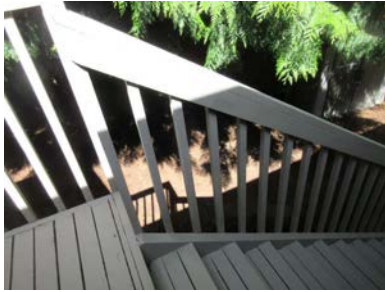
3.8 STAIRS

The stair railing baluster spacing is too wide. This is a hazard for small children. The baluster spacing should

be reduced as a safety upgrade. Current standards require that a 4" sphere not pass through the railing.

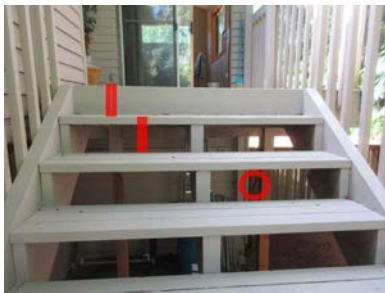
The deck stairs are non-conforming due to the variable and/or excessive rise. Deck stair/step design standards require that step risers do not exceed 8" and that the variation in rise not exceed 3/8" in order to reduce falls from tripping. To increase the margin of safety, consideration should be given to reconfiguring the steps so that rise and run do not vary by more than 3/8". If this proves to be too impractical or expensive, then we recommend exercising caution when using these steps.

The stair rise spacing is too wide. This is a hazard for small children. The spacing should be reduced as a safety upgrade. Current standards require that a 4" sphere not pass through the opening.

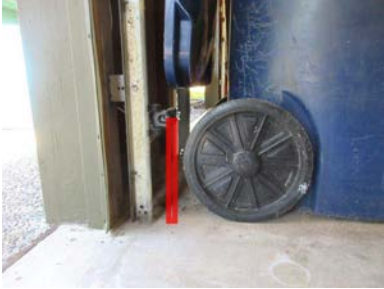
The Photo-eye beam was installed to high above the floor of the garage to adequately offer protection for small children and/or pets. We recommend that the photo-eye be lowered to within 4-6" of the floor.

There was no photo-eye sensor installed for the north garage door to offer protection for small children and/or pets. We recommend that a photo-eye sensor be installed for the garage door at a height of within 4-6" of the floor.

Garage 6.3 Garage Door opener: Garage door photo-eye beam relocated to 4"-6" off floor.

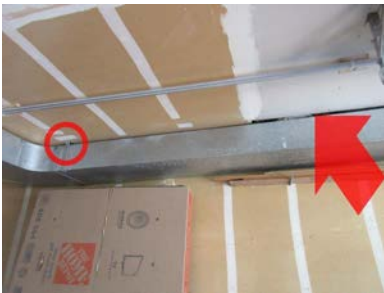
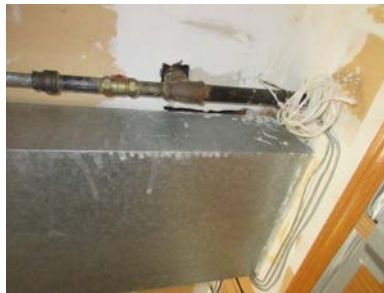
6.4 FIRE SEPARATION

There are voids in the fire resistive barrier between the living space and garage that will allow flames to penetrate. The gypsum barrier slows the spread of a fire from the garage to the structure and/or living space. Patching the voids with a fire retardant caulk is recommended.

Garage 6.4 Fire Separation: All voids in the fire-resistant barrier were filled with fire-resistant foam.

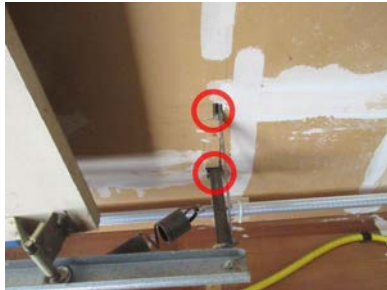
Several of the joints are not taped. Consideration should be given to completely "fire taping" the drywall as a safety upgrade.

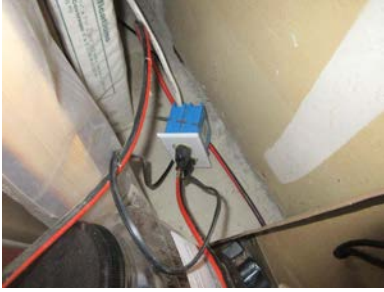
There are unprotected receptacles in the garage. The installation of GFCI protection for all of the garage receptacles is recommended.

The receptacle adjacent the south wall if the garage is loose. This is a potential shock and a fire hazard. All loose receptacles should be repaired as necessary.

Garage 6.6 Receptacles: The unprotected receptacles have been protected through the installation of a GFCI receptacle.

The loose receptacle on the south wall of the garage was removed and is no longer present.

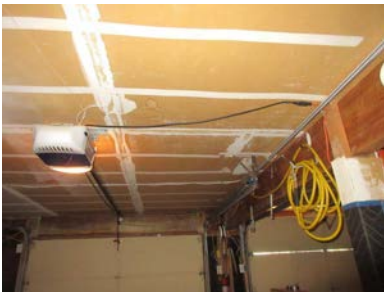
7.10 WIRING

An extension cord is used as a temporary power source for the garage door opener. An extension cord is not suitable as a permanent wiring method. The installation of a receptacle within cords length of the motor is recommended.

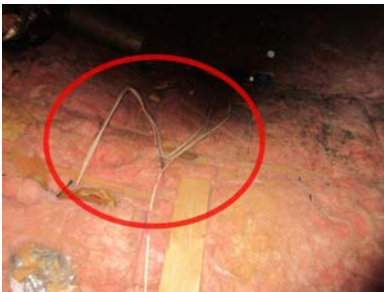
Loose electrical cables were observed in the attic. Loose cables are vulnerable to damage. All loose cables should be secured at 4' intervals using approved cable staples.

Electrical System 7.10 Wiring: The loose electrical cables in the attic were secured as directed with approved cable staples.

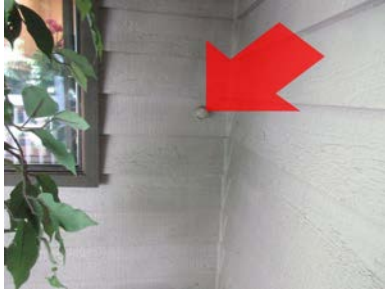
contamination caused by a backflow of waste water. The cap protruding on the exterior wall opposite the dishwasher is not drilled. This renders the air gap non-functional. Drilling a 1/4" hole in the end of the cap will restore its function. The remaining visible portions of the Johnson Tee were properly installed and functioning as intended.

Kitchen 10.8 Air Gap: The external air gap cap was drilled to restore function.

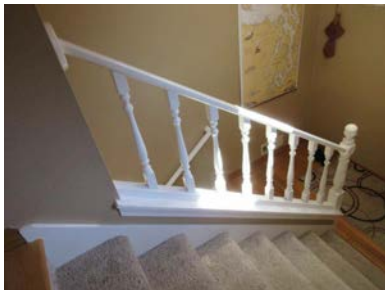
The stair railing baluster spacing is too wide. This is a hazard for small children. The baluster spacing should be reduced as a safety upgrade. Current standards require that a 4" sphere not pass through the railing.

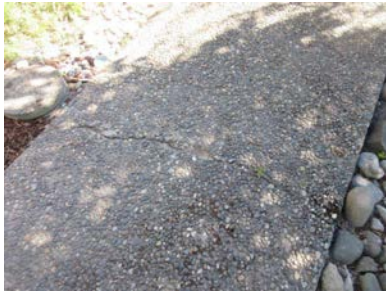
Cracks were observed in the concrete surface of the walkway. Minor cracks can be sealed to minimize moisture entry and further settlement of the concrete.

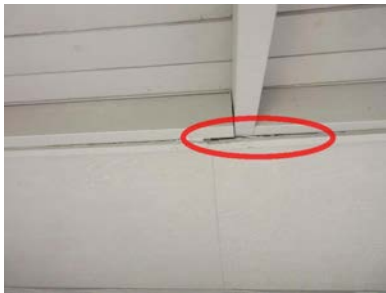
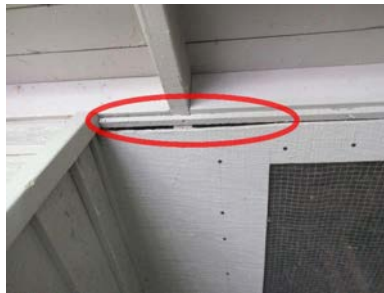
3.3 SOFFITS AND OVERHANGS

There are large gaps over 1/4" in size adjacent the soffits and vent blocks. These gaps allow insects and rodents to enter the attic. Covering the gaps with screening, a strip of wood and/or caulking is recommended.

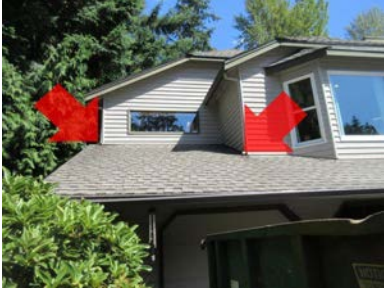
3.4 GUTTERS AND DOWNSPOUTS

Downspouts draining directly onto the asphalt shingle surface causes excessive wear of the roofing material. Downspout extensions to the lower gutters should be installed to prevent excessive wear and tear of the roofing.

The 2" round downspouts are too small and are more vulnerable to clogging than the larger rectangular ones. Consideration should be given to upgrading the downspouts.

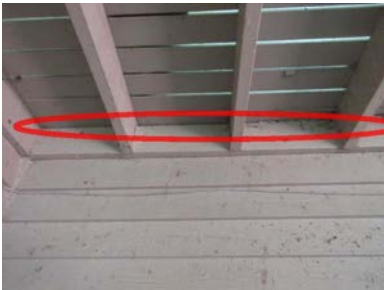
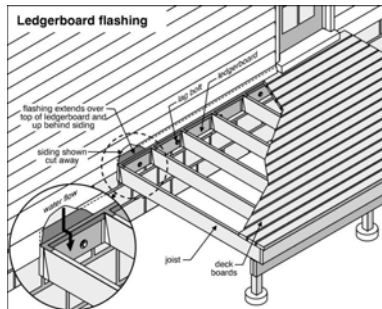
3.6 DECK

There is no flashing at the intersection between the north porch deck and house. This will allow water to enter behind the siding. The installation of flashing in this area is recommended.

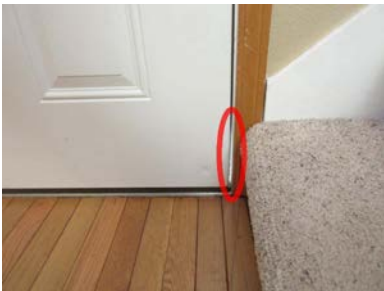
3.11 EXTERIOR DOORS

The front door is not adequately weather stripped. This allows cold air to infiltrate at the bottom of the door. The installation of properly fitted weather stripping on the exterior doors is recommended.

Building Exterior 3.11 Exterior Doors: The front door weather stripping has been replaced with properly fitting weather stripping.

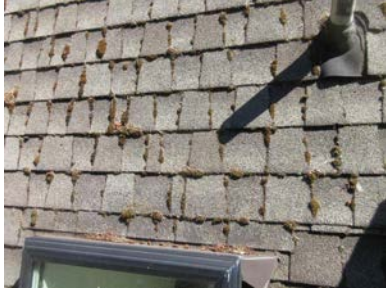
4.7 MAINTENANCE AND REPAIRS

The roof is in need of routine maintenance. The surface should be treated and cleaned to remove moss, lichen and algae. A wood preservative that contains copper naphthenate should be applied liberally to the surface after the shakes have dried. Performing this maintenance will improve the appearance and increase the life expectancy of the roof.

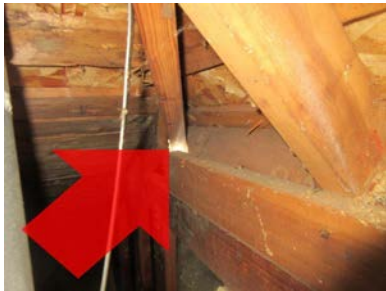
5.4 PEST CONTROL

There is evidence of rodent activity in the attic. The first step in eliminating rodents from the attic is to seal all possible entry points using wire mesh, caulking, wood, stainless steel wool, or aerosol foam. Careful work sealing cracks, holes and gaps over 1/4" in size will discourage further activity. Once this work is completed, snap traps baited with peanut butter should be installed and monitored. The absence of rodents in the traps typically means that the rodents have been excluded from the area.

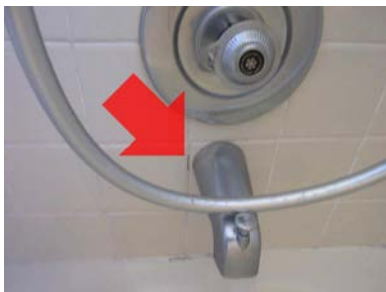
Grout is missing from between some of the wall tiles. This can allow water to enter through the tile and can damage the walls. Regrouting the wall tile is recommended.

Bathrooms - Upper Floor Hallway Bathroom 11.3 Tub Walls: The grout has been repaired in the upper floor bathroom shower area.

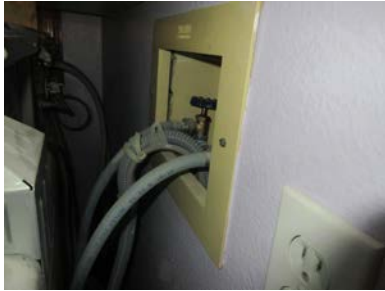
Upgrading the washer connections to high pressure (steel braided) lines is recommended.

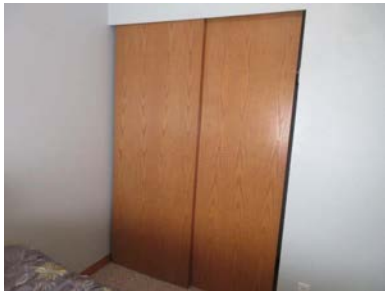
14.6 CLOSET DOORS

Closet door pull hardware is missing in one of the bedrooms.

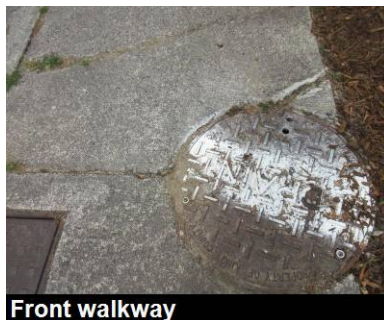
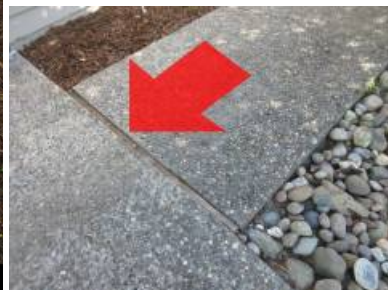
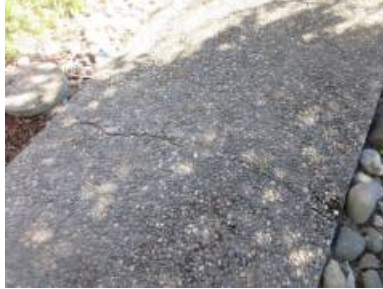
Cracks were observed in the concrete surface of the walkway. Minor cracks can be sealed to minimize moisture entry and further settlement of the concrete.

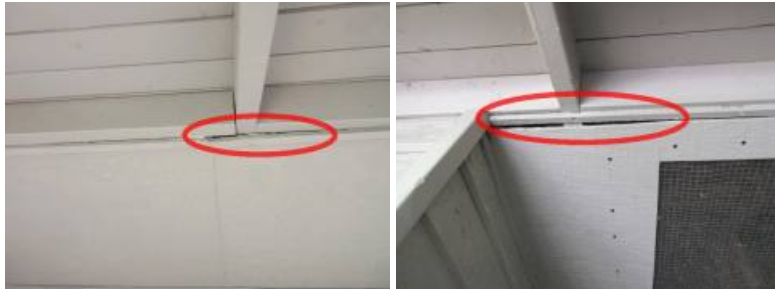
There are large gaps over 1/4" in size adjacent the soffits and vent blocks. These gaps allow insects and rodents to enter the attic. Covering the gaps with screening, a strip of wood and/or caulking is recommended.

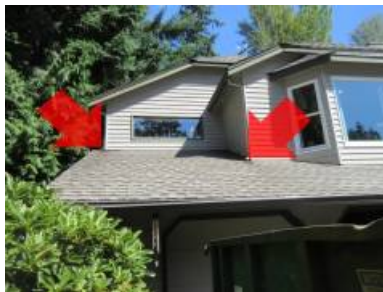
The 2" round downspouts are too small and are more vulnerable to clogging than the larger rectangular ones. Consideration should be given to upgrading the downspouts.

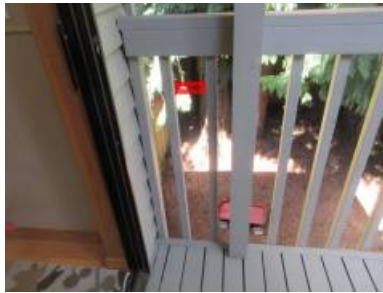
3.7 DECK RAILINGS

The spacing between the balusters is too wide. This is a hazard to small children. The balusters should be spaced close enough together so that a 4" sphere cannot pass through. Upgrading the deck railing is recommended if small children are present.

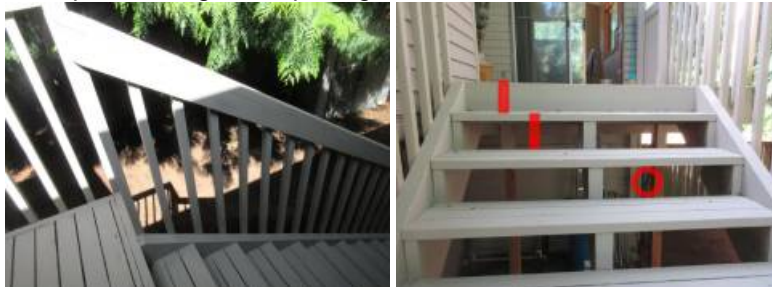
The stair rise spacing is too wide. This is a hazard for small children. The spacing should be reduced as a safety upgrade. Current standards require that a 4" sphere not pass through the opening.

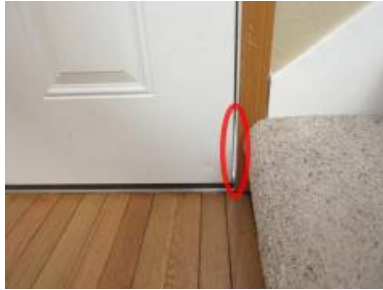
The front door is not adequately weather stripped. This allows cold air to infiltrate at the bottom of the door. The installation of properly fitted weather stripping on the exterior doors is recommended.

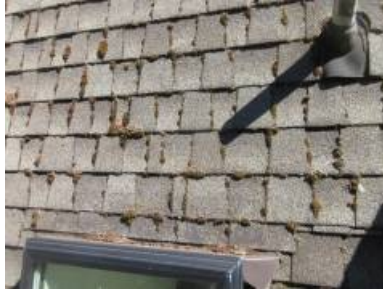
The roof is in need of routine maintenance. The surface should be treated and cleaned to remove moss, lichen and algae. A wood preservative that contains copper naphthenate should be applied liberally to the surface after the shakes have dried. Performing this maintenance will improve the appearance and increase the life expectancy of the roof.

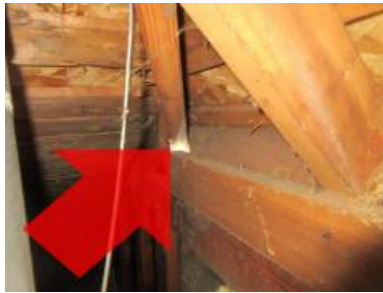
points using wire mesh, caulking, wood, stainless steel wool, or aerosol foam. Careful work sealing cracks, holes and gaps over 1/4" in size will discourage further activity. Once this work is completed, snap traps baited with peanut butter should be installed and monitored. The absence of rodents in the traps typically means that the rodents have been excluded from the area.

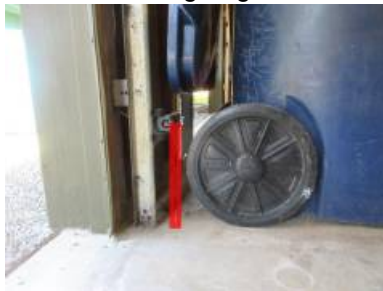
There was no photo-eye sensor installed for the north garage door to offer protection for small children and/or pets. We recommend that a photo-eye sensor be installed for the garage door at a height of within 4-6" of the floor.

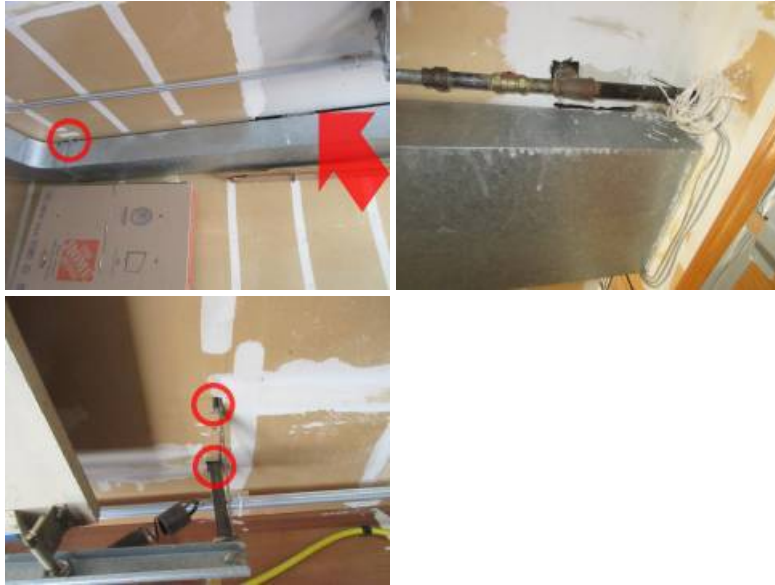
Several of the joints are not taped. Consideration should be given to completely "fire taping" the drywall as a safety upgrade.

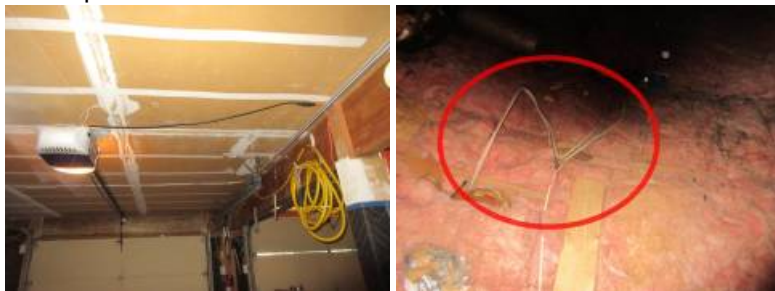
Loose electrical cables were observed in the attic. Loose cables are vulnerable to damage. All loose cables should be secured at 4' intervals using approved cable staples.

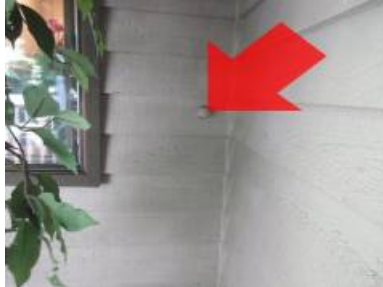
An air gap called a Johnson Tee is installed in the kitchen wall. This air gap protects the dishwasher from contamination caused by a backflow of waste water. The cap protruding on the exterior wall opposite the dishwasher is not drilled. This renders the air gap non-functional. Drilling a 1/4" hole in the end of the cap will restore its function. The remaining visible portions of the Johnson Tee were properly installed and functioning as intended.

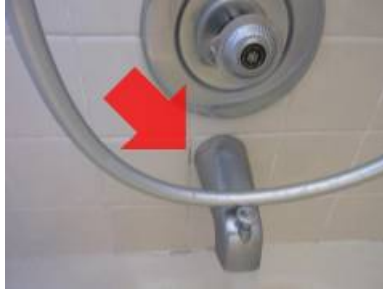
Grout is missing from between some of the wall tiles. This can allow water to enter through the tile and can damage the walls. Regrouting the wall tile is recommended.

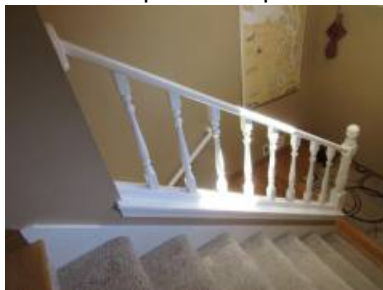
The stair railing baluster spacing is too wide. This is a hazard for small children. The baluster spacing should be reduced as a safety upgrade. Current standards require that a 4" sphere not pass through the railing.

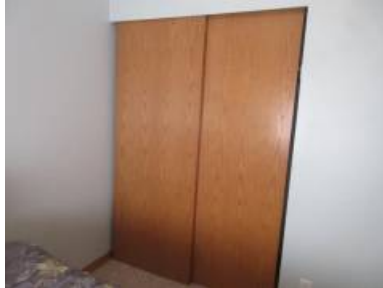
Closet door pull hardware is missing in one of the bedrooms.
