Kyle Whitson and Dana Mauricio

13810 174th Place NE, Redmond, WA 98052

NOTICE TO BUYER: SELLER-PROCURED INSPECTION REPORT

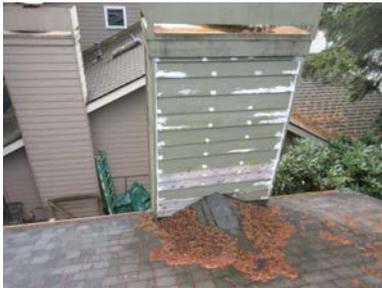
Areas of exposed primer on chimney chase boards was observed from the roof. Paint protects the wood from cupping, checking, warping and rot. Exposed primed areas should be painted.

3.6 Paint. Exposed areas on the chimney chase boards will be repainted.

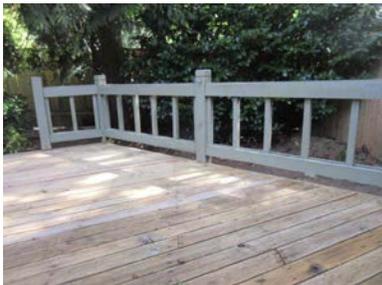
3.8 DECK RAILINGS

The spacing between the balusters is too wide. This is a hazard to small children. The balusters should be spaced close enough together so that a 4" sphere cannot pass through. Upgrading the deck railing is recommended if small children are present.

The deck railing is too low. This is a hazard. Raising the height of the railing to at least 36" is recommended.

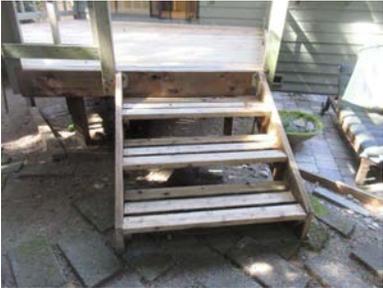
3.9 STAIRS

There is no handrail along the stairs. This is a hazard. The installation of a handrail along the stairs is

recommended.

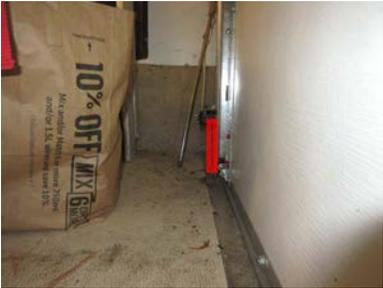
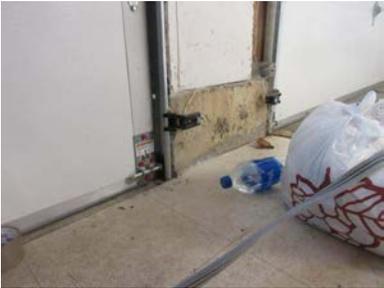
The Photo-eye beams were installed to high above the floor of the garage to adequately offer protection for small children and/or pets. We recommend that the photo-eyes be lowered to within 4-6" of the floor.

The south garage door opener was not tested or inspected. The services of a contractor specializing in automatic openers should be retained to perform the necessary repairs.

6.3 Garage Door Opener. Photo-eye beam has been relocated to within 4"-6" off the floor.

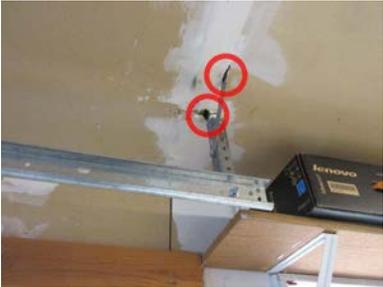
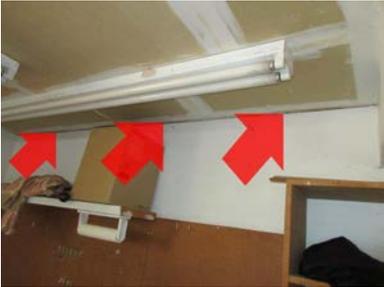
6.4 FIRE SEPARATION

There are voids in the fire resistive barrier between the living space and garage that will allow flames to penetrate. The gypsum barrier slows the spread of a fire from the garage to the structure and/or living space. Patching the voids with a fire retardant caulk is recommended.

6.4 Fire Separation. Voids in garage fire barrier will be sealed.

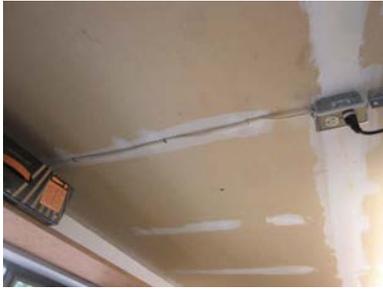
There is Romex cable in the garage that is run over the surface of the ceiling. This cable is vulnerable to damage. The cable should be relocated or protected in conduit.

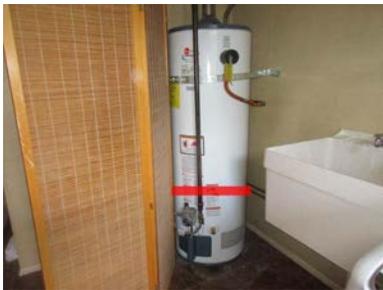
The seismic restraint for the water heater was minimal. Proper strapping is recommended to adequately secure the tank and provide potable water in the event of an earthquake.

11.11 Seismic Restraint. Install additional seismic restraint on hot-water heater.

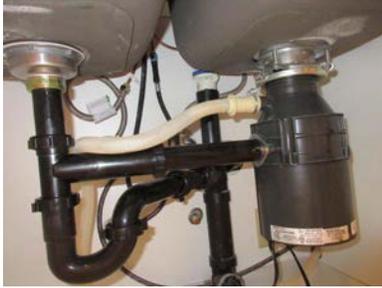
The dishwasher drain lacks an air gap. The dishwasher will function without one, but there is a risk of contamination of the inside of the dishwasher by waste water. The installation of an air gap is recommended or connection to the Johnson Tee that is installed in the kitchen wall. This air gap protects the dishwasher from contamination caused by a backflow of waste water.

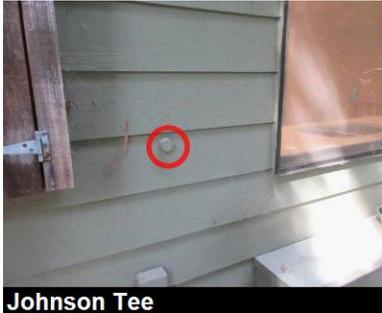
Johnson Tee

This air gap protects the dishwasher from contamination caused by a backflow of waste water. The cap protruding on the exterior wall opposite the dishwasher is not drilled. This renders the air gap non-functional. Drilling a 1/4" hole in the end of the cap will restore its function.

12.8 Air Gap. Air gap cap will be fixed by drilling ventilation hole as recommended in inspection report.

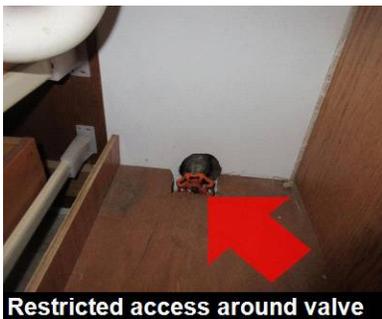
The main water supply shutoff valve is located in the lower bathroom under the sink. The valve did not shut off the water. It should be repaired or replaced as necessary. We recommend that the cutout around the handle be enlarged for quicker access.

Restricted access around valve

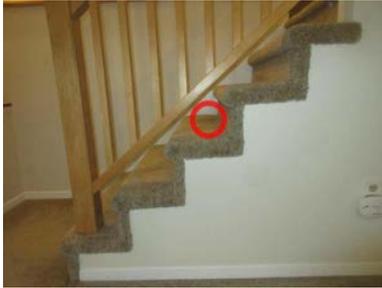
The stair railing spacing at the stair treads is too wide. This is a hazard for small children. The railing spacing should be reduced as a safety upgrade. Current standards require that a 4" sphere not pass through or under the railing.

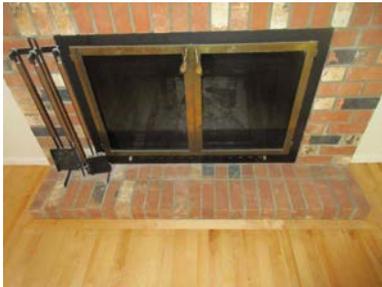
The hearth in front of the firebox does not extend out far enough. This is a safety concern. The hearth should stick out 18" in front of and 12" to either side of the fire box. Portable hearth extensions are available for this type of application. The hearth should be modified as necessary.

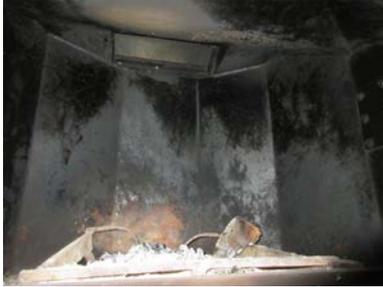
17.5 CHIMNEYS

An examination of the inside of the north chimney revealed a significant accumulation of creosote. Smoldering fires and the burning of green or wet wood are the primary contributors to creosote build-up. Creosote in a chimney flue is dangerous because it is the fuel for a chimney fire. Chimney fires produce intense heat and sparks. The intense heat can damage a metal flue liner. After holes or cracks have developed, chimney fires can cause the wood framing or roof of the house to catch on fire. To avoid chimney fires, flues should be cleaned and inspected at least once a year with moderate use. More frequent cleaning may be required depending on amount of use and burning practice.

17.5 Chimneys. Clean north chimney.

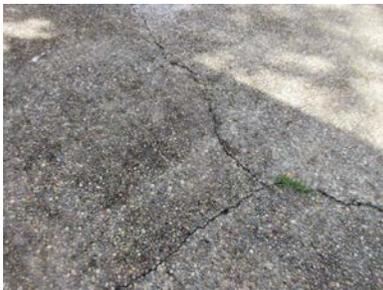
Cracks were observed in the concrete surface of the driveway. Minor cracks can be sealed to minimize moisture entry and further settlement of the concrete. Minor cracks are common and do not affect the serviceability of the concrete.

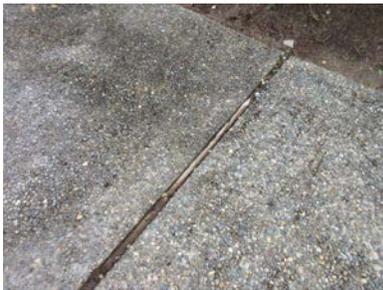
The wooden divider separating the concrete driveway sections has deteriorated to a point where it is a trip hazard. Replacement with mortar is recommended.

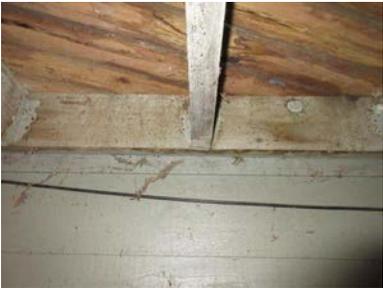
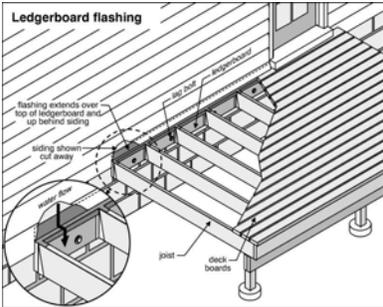
There is no flashing at the intersection between the deck and house. This will allow water to enter behind the siding. The installation of flashing in this area is recommended.

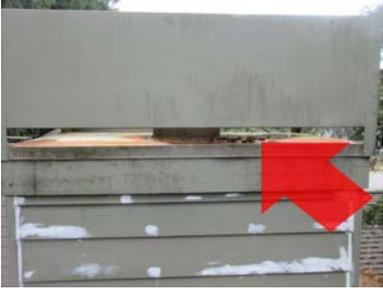
The chase cover for the south fireplace is concave and holds water. This has resulted in corrosion of the sheet metal. When rust holes form the cover will begin to leak. Chase cover replacement is recommended. The new chase cover should be sloped for drainage.

4.3 Chimneys. South chimney chase cover will be replaced.

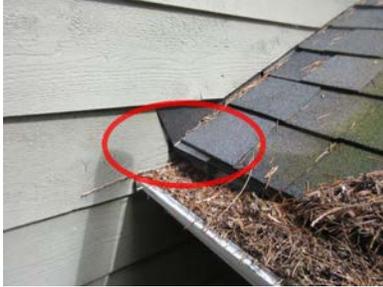
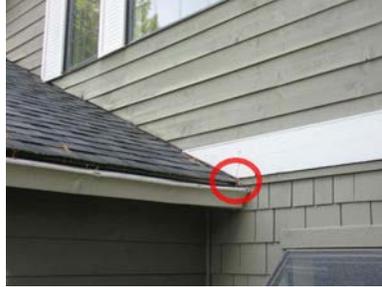
4.5 FLASHINGS

There are no kick out flashings at the roof edge to wall intersections above the gutters. This will allow water to enter the wall behind the siding. The installation of kick-out flashings is recommended.

4.5 Flashings. Install kick-out flashings above gutters.

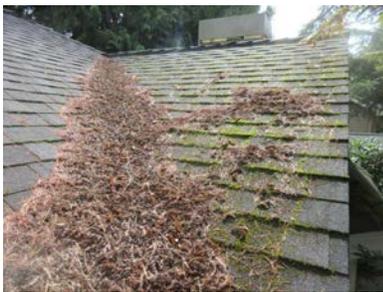
4.6 MAINTENANCE AND REPAIRS

The roof is in need of routine maintenance. The surface should be blown off or washed with a high volume low pressure garden hose to remove moss and organic debris. Performing this maintenance will improve the appearance and increase the life expectancy of the roof.

4.6 Maintenance and Repairs. Roof and gutters have been cleaned.

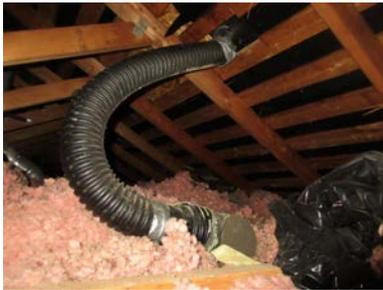
Flexible plastic duct is used to direct air from the vent fans to the exterior. This type of material is unreliable. Replacing the plastic duct with 4" smooth-wall sheet metal duct is recommended.

5.3 Mechanical Ventilation Systems. Replace plastic vent ducting with metal as recommended in inspection report.

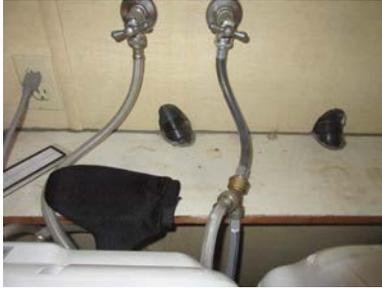
Upgrading the washer connections to high pressure (steel braided) lines is recommended.

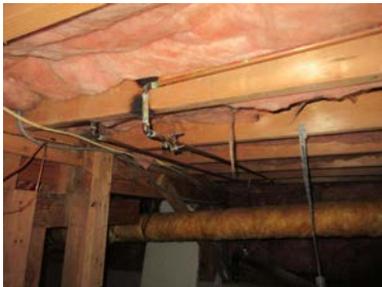
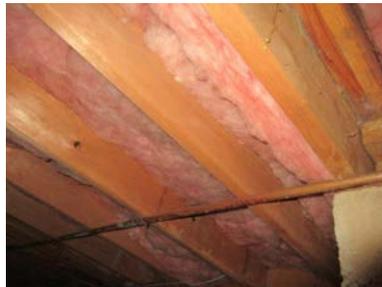
There are water pipes in the crawlspace that are not adequately insulated and could freeze. The installation of foam pipe insulation on all exposed water pipes is recommended.

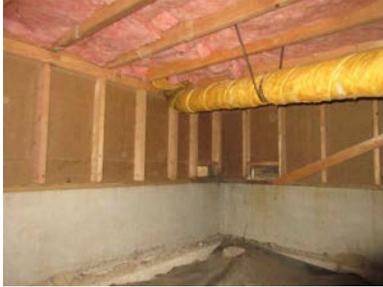
Shear panels are plywood or OSB panels that are mechanically fastened to both vertical and horizontal framing members in critical structural areas of the building. They prevent lateral movement of the structure during an earthquake. Shear panels are often visible in the crawlspace on cripple walls between the first floor and foundation. They may also be installed on interior walls that are covered with drywall. An examination of the crawlspace revealed the absence of shear panels on the cripple walls. The installation of shear panels on the cripple walls is recommended as an upgrade.

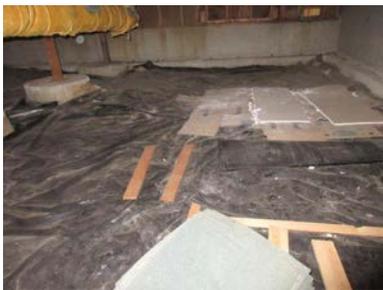
Scrap-wood and other cellulose debris was observed on the crawl floor. This wood debris creates conducive conditions for wood boring insects. The removal of all cellulose debris is recommended.

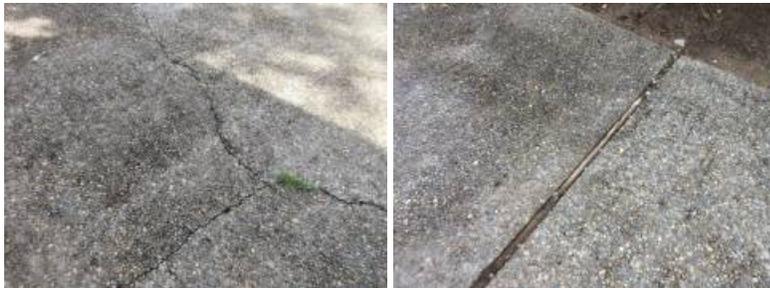
The wooden divider separating the concrete driveway sections has deteriorated to a point where it is a trip hazard. Replacement with mortar is recommended.

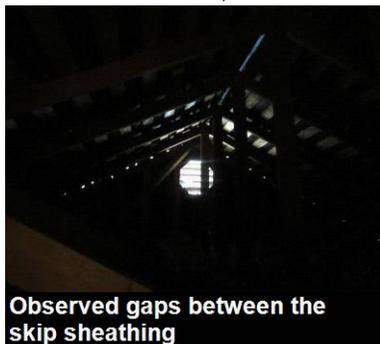
There are openings adjacent the ends of the outlook boards under the overhang through which insects and rodents can enter into the attic. These openings should be covered with wood, wire mesh or filled with aerosol foam.

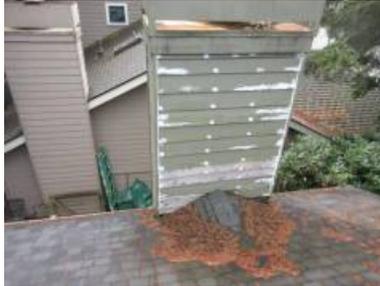
Areas of exposed primer on chimney chase boards was observed from the roof. Paint protects the wood from cupping, checking, warping and rot. Exposed primed areas should be painted.

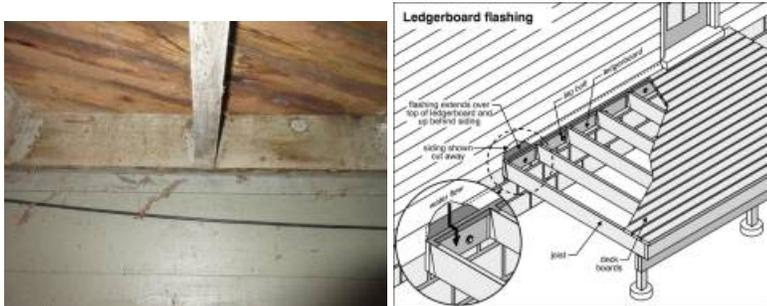
There is no flashing at the intersection between the deck and house. This will allow water to enter behind the siding. The installation of flashing in this area is recommended.

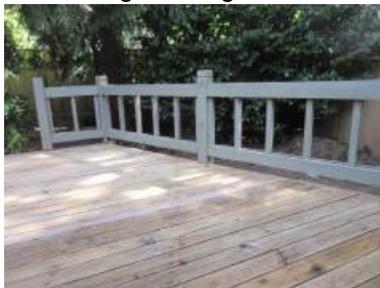
The deck railing is too low. This is a hazard. Raising the height of the railing to at least 36" is recommended.

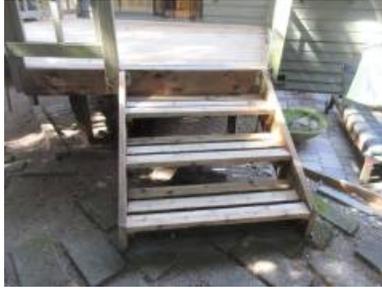
There is no handrail along the stairs. This is a hazard. The installation of a handrail along the stairs is recommended.

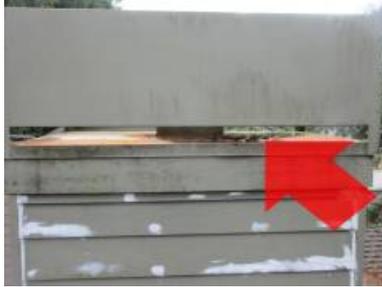
The chase cover for the south fireplace is concave and holds water. This has resulted in corrosion of the sheet metal. When rust holes form the cover will begin to leak. Chase cover replacement is recommended. The new chase cover should be sloped for drainage.

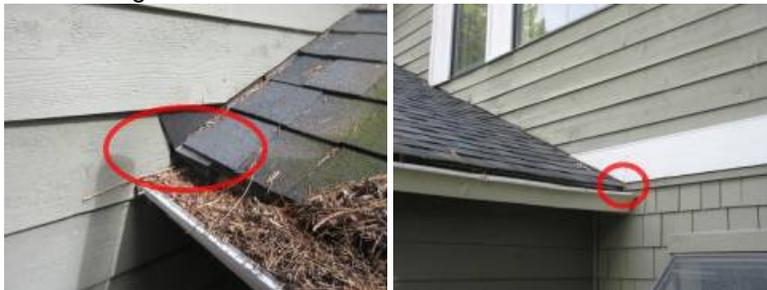
There are no kick out flashings at the roof edge to wall intersections above the gutters. This will allow water to enter the wall behind the siding. The installation of kick-out flashings is recommended.

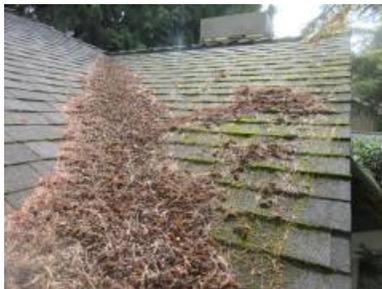
4.6 MAINTENANCE AND REPAIRS

The roof is in need of routine maintenance. The surface should be blown off or washed with a high volume low pressure garden hose to remove moss and organic debris. Performing this maintenance will improve the appearance and increase the life expectancy of the roof.

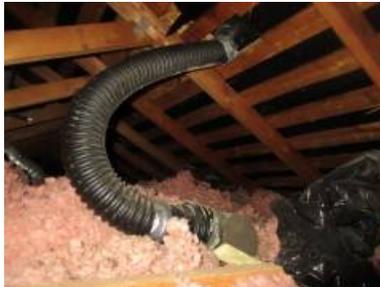
Flexible plastic duct is used to direct air from the vent fans to the exterior. This type of material is unreliable. Replacing the plastic duct with 4" smooth-wall sheet metal duct is recommended.

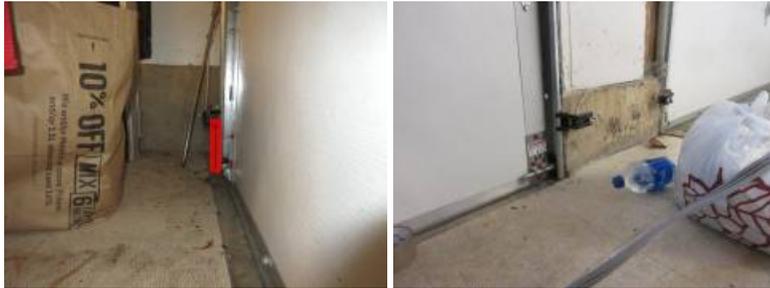
The south garage door opener was not tested or inspected. The services of a contractor specializing in automatic openers should be retained to perform the necessary repairs.

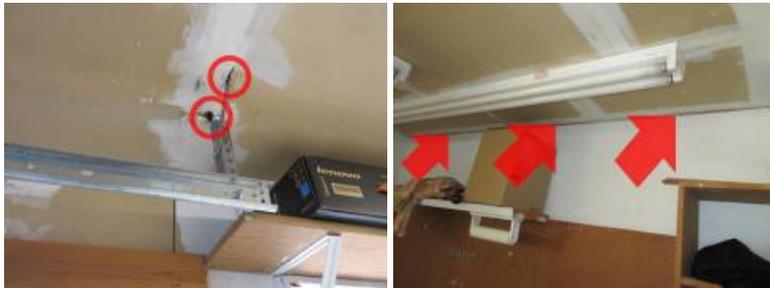
6.4 FIRE SEPARATION

There are voids in the fire resistive barrier between the living space and garage that will allow flames to penetrate. The gypsum barrier slows the spread of a fire from the garage to the structure and/or living space. Patching the voids with a fire retardant caulk is recommended.

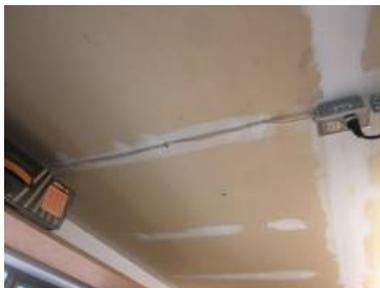
There is Romex cable in the garage that is run over the surface of the ceiling. This cable is vulnerable to damage. The cable should be relocated or protected in conduit.

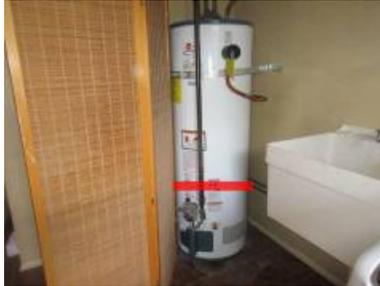
The seismic restraint for the water heater was minimal. Proper strapping is recommended to adequately secure the tank and provide potable water in the event of an earthquake.

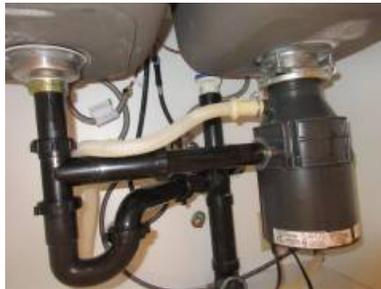
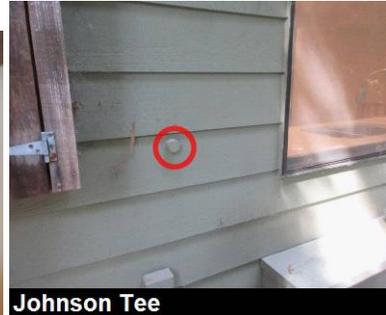
This air gap protects the dishwasher from contamination caused by a backflow of waste water. The cap protruding on the exterior wall opposite the dishwasher is not drilled. This renders the air gap non-functional. Drilling a 1/4" hole in the end of the cap will restore its function.

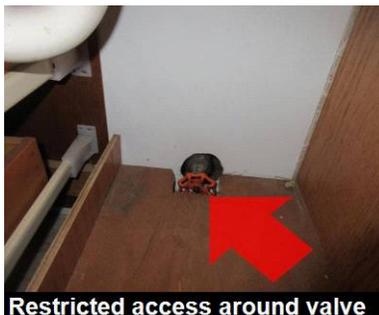
The main water supply shutoff valve is located in the lower bathroom under the sink. The valve did not shut off the water. It should be repaired or replaced as necessary. We recommend that the cutout around the handle be enlarged for quicker access.

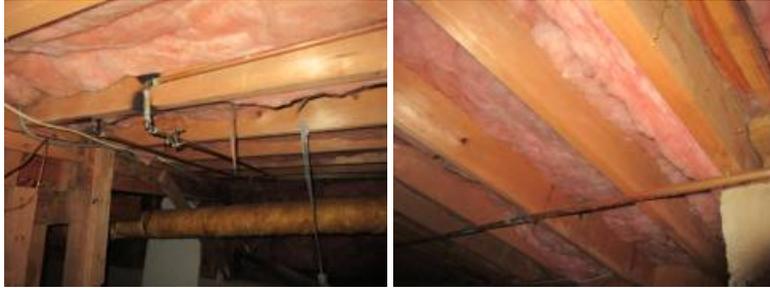
There are water pipes in the crawlspace that are not adequately insulated and could freeze. The installation of foam pipe insulation on all exposed water pipes is recommended.

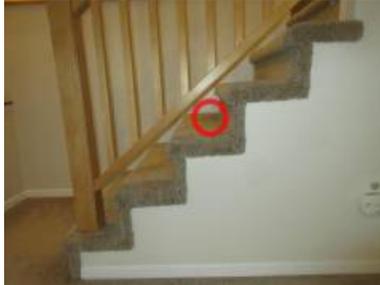
The stair railing spacing at the stair treads is too wide. This is a hazard for small children. The railing spacing should be reduced as a safety upgrade. Current standards require that a 4" sphere not pass through or under the railing.

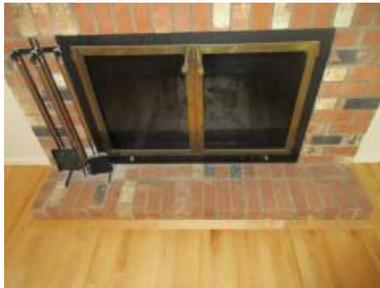
The hearth in front of the firebox does not extend out far enough. This is a safety concern. The hearth should stick out 18" in front of and 12" to either side of the fire box. Portable hearth extensions are available for this type of application. The hearth should be modified as necessary.

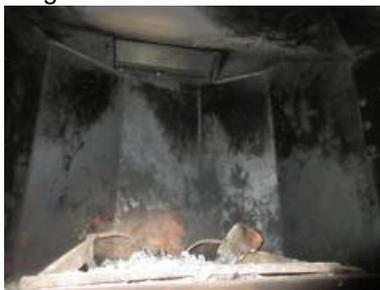
17.5 CHIMNEYS

An examination of the inside of the north chimney revealed a significant accumulation of creosote. Smoldering fires and the burning of green or wet wood are the primary contributors to creosote build-up. Creosote in a chimney flue is dangerous because it is the fuel for a chimney fire. Chimney fires produce intense heat and sparks. The intense heat can damage a metal flue liner. After holes or cracks have developed, chimney fires can cause the wood framing or roof of the house to catch on fire. To avoid chimney fires, flues should be cleaned and inspected at least once a year with moderate use. More frequent cleaning may be required depending on amount of use and burning practice.

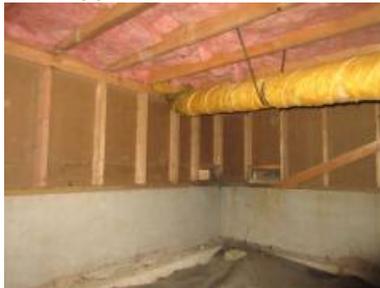
Shear panels are plywood or OSB panels that are mechanically fastened to both vertical and horizontal framing members in critical structural areas of the building. They prevent lateral movement of the structure during an earthquake. Shear panels are often visible in the crawlspace on cripple walls between the first floor and foundation. They may also be installed on interior walls that are covered with drywall. An examination of the crawlspace revealed the absence of shear panels on the cripple walls. The installation of shear panels on the cripple walls is recommended as an upgrade.

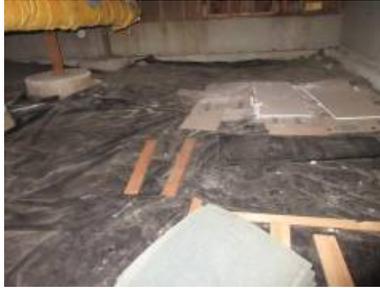
Good building practice requires that foundation walls or pier footings supporting wood frame construction, should extend at least 8" above the finish grade with at least a 6" clearance between the top of the soil and the bottom of the wood finish materials. Untreated wood should be raised 1-2" above surrounding flatwork and should have a moisture barrier such as 30 lb. asphalt impregnated felt installed between the concrete and wood. For additional information and treatment options, you should retain the services of a qualified pest control operator.
