**NOTICE TO BUYER: SELLER-PROCURED INSPECTION REPORT**

The following notice is given with respect to the Purchase and Sale Agreement dated _____ between _____ ("Buyer") and **Marc Holleman** **Kerrie Holleman** ("Seller") concerning **14147 176th Ave NE** **Redmond** **WA 98052** ("the Property").

At your request, a visual inspection of the above referenced property was conducted on 09/24/2020. We have inspected the major structural components, plumbing, heating and electrical systems for signs of significant non-performance, excessive or unusual wear and general state of repair.

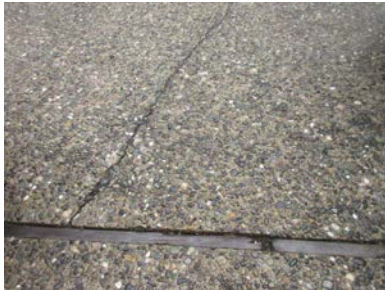
Cracks were observed in the concrete surface of the driveway. Minor cracks can be sealed to minimize moisture entry and further settlement of the concrete. Minor cracks are common and do not affect the serviceability of the concrete.

One or more of the wooden dividers separating the concrete driveway sections were infested by wood destroying organisms and have deteriorated to a point where they are becoming a trip hazard. Replacement with mortar is recommended.

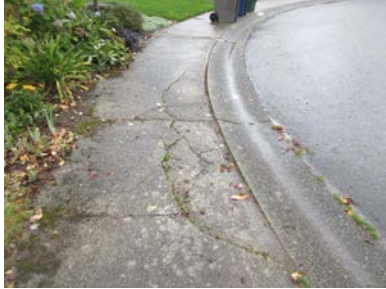
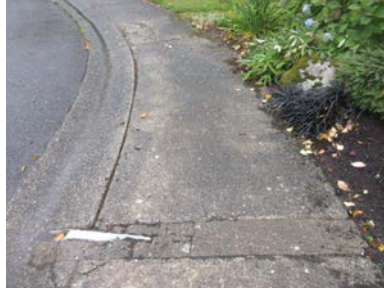
2.6 WALKWAY

The walkway has cracked and settled differentially. This was probably caused by inadequate preparation of the soil prior to the placement of the concrete. This condition can be repaired by pressure grouting the sunken portion of the walkway or by removing and replacing it. Grinding down the raised edges of the concrete will also mitigate the hazard. The walkway remains functional despite this condition. However, the raised edges of the concrete can be a trip hazard for some people. Repairs should be made as necessary.

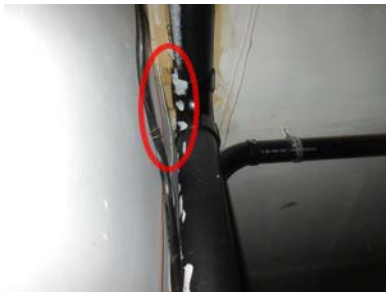
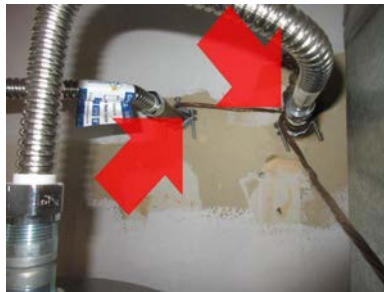
6.4 FIRE SEPARATION

There are voids in the fire resistive barrier between the living space and garage that will allow flames to penetrate. The gypsum barrier slows the spread of a fire from the garage to the structure and/or living space. Patching the voids with a fire retardant caulk is recommended.

6.4 Fire Separation. Voids filled with fire retardant foam seal.

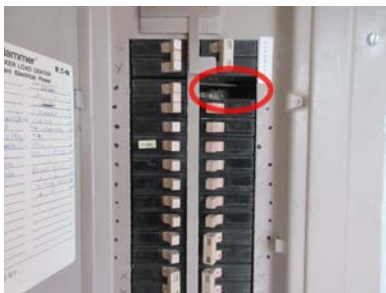
Twist-outs are missing from the service panel cover. This exposes live conductors and is a shock hazard. The installation of snap-in replacement blanks is recommended.

7.8 Service Panel. Snap in replacement blank added.

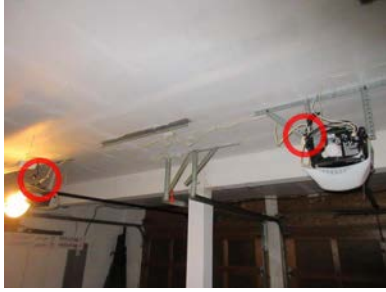
7.10 WIRING

An extension cord is used as a temporary power source for the garage door openers. An extension cord is not suitable as a permanent wiring method. The installation of a receptacle within cords length of the motors is recommended.

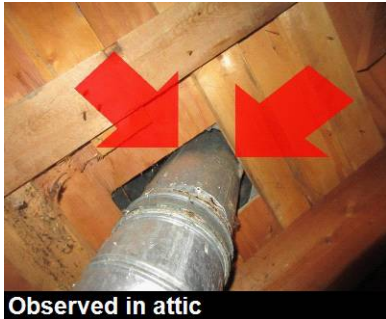
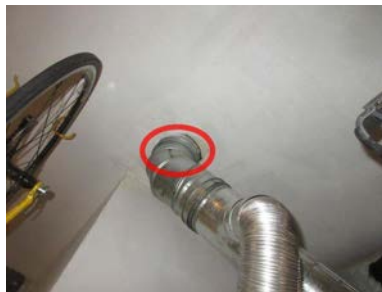
Observed in attic

The furnace type B vent is in contact with combustible materials in the garage and attic. This is a fire hazard. A minimum clearance of 1" is required between the type B vent and the combustible material. Repairs are recommended.

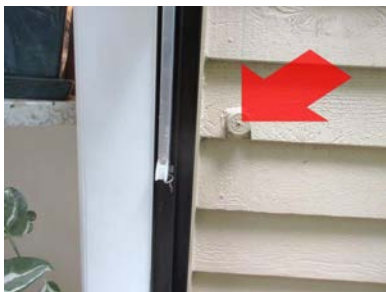
An air gap called a Johnson Tee is installed in the kitchen wall. This air gap protects the dishwasher from contamination caused by a backflow of waste water. The cap protruding on the exterior wall adjacent the kitchen is not drilled with the recommended size hole. This renders the air gap non-functional. Drilling a 1/4" hole in the end of the cap will restore its function. The remaining visible portions of the Johnson Tee were properly installed and functioning as intended.

11.8 Air Gap. A ¼" hole was drilled into the Johnson Tee cap protruding from the exterior wall.

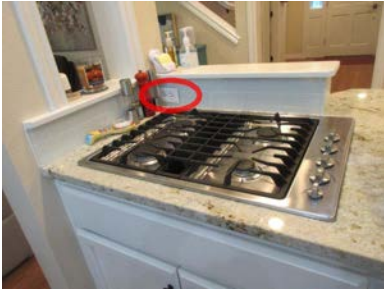
11.14 RECEPTACLES

One of the receptacles in the kitchen is adjacent the cook top. We recommend caution when using this outlet and cooktop simultaneously.

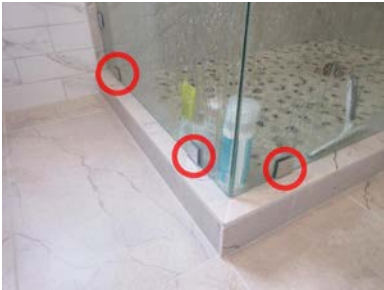
The glass enclosure has been leaking at the lower corners. No damage was visible, but resealing or repairing the enclosure is recommended as preventive maintenance.

12.26 Glass Enclosure. Clear caulk applied at lower corner.

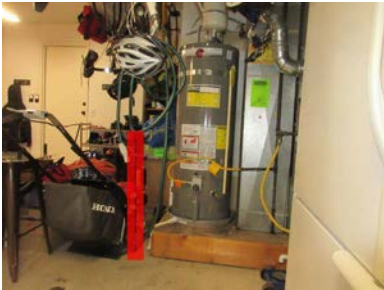
14.10 GAS PIPING

The gas pipes in front of the furnace and water heater are not protected by a bumper stop. A vertical steel pipe, bolted to the floor, is typically installed in front of the water heater to prevent a car bumper from damaging the gas lines.

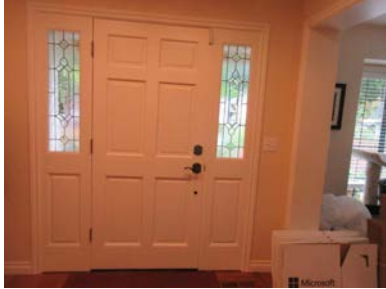
15.6 WINDOWS

The glass adjacent the front entry door is not tempered safety glass. Tempered glass can be identified by the etched emblem in one corner of each pane. A higher margin of safety could be achieved if the glass was approved safety glass. Consideration should be given to replacing the glass as a safety upgrade.

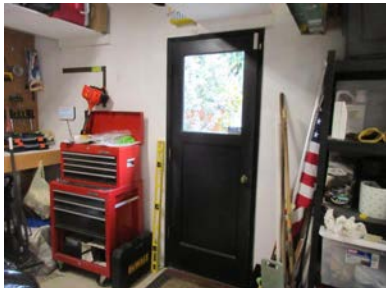
The glass in the garage door is not tempered safety glass. Tempered glass can be identified by the etched emblem in one corner of each pane. A higher margin of safety could be achieved if the glass was approved safety glass. Consideration should be given to replacing the glass as a safety upgrade.

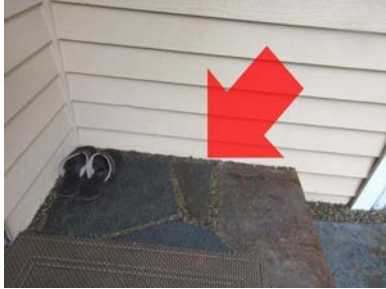
Untreated wood in direct contact with concrete was observed along the patio stoop. Untreated wood should be raised 1-2" above the concrete. Treating the wood with a preservative sometimes will prevent wood destroy organism damage.

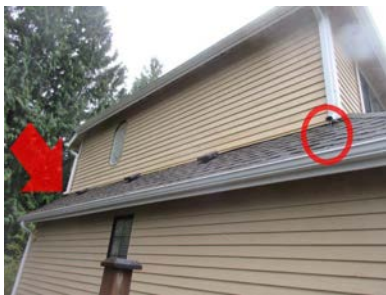
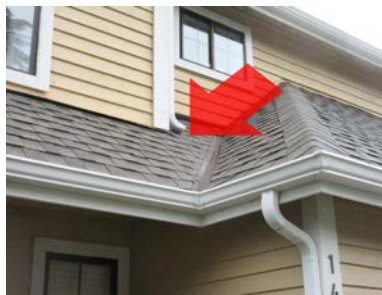
3.4 GUTTERS AND DOWNSPOUTS

Downspouts draining directly onto the asphalt shingle surface causes excessive wear of the roofing material. Downspout extensions to the lower gutters should be installed to prevent excessive wear and tear of the roofing.

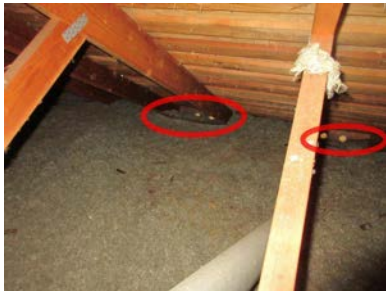
5.2 VENTILATION

Wind baffles locations are compromised in some areas of the attic. The proper placement of wind baffles in front of all soffit vents is recommended.

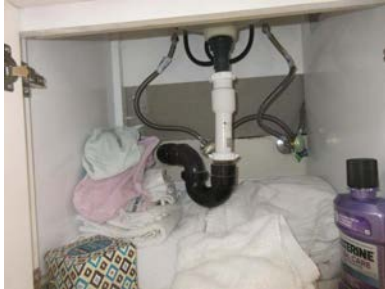
Improper, non-conforming material has been used for the left sink drain pipe fitting. This material will not function reliably. Replacement with industry standard fittings is recommended.

12.17 and 12.30 Drains, Traps and Trap Arms – Will replace with industrial standard fittings

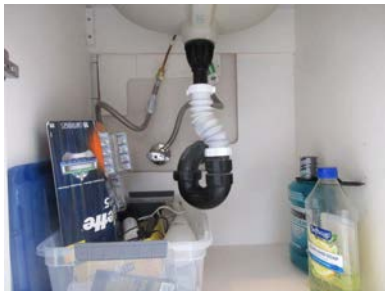
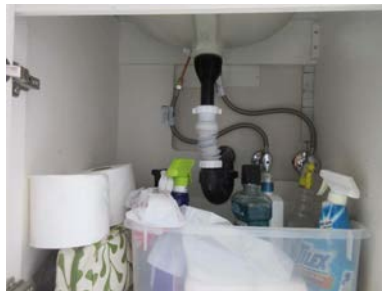
Improper, non-conforming material has been used for the drain pipe fittings. This material will not function reliably. Replacement with industry standard fittings is recommended.

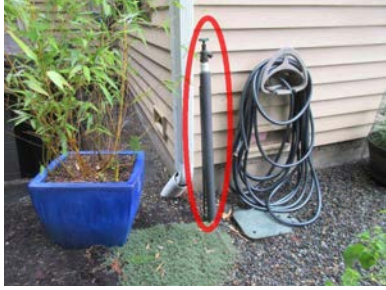
There are water pipes on the south exterior of the house that will freeze in cold weather. These water pipes should be shut off and drained or protected via a thermostatically installed heat tape.

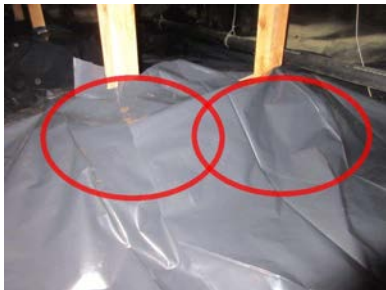
The support post concrete piers are covered with the plastic vapor retarder. This allows the transmission of water vapor from the soil up and into the floor framing. The plastic vapor retarder should be removed from the pier so that it covers at least 85% of the entire surface of the soil only.

12.40 Vapor Retarder. On August 5, 2020 – Crawl space was serviced with all new insulation and vapor barrier. This work comes with a 1 year transferable warranty which will be provided to buyers upon requested.

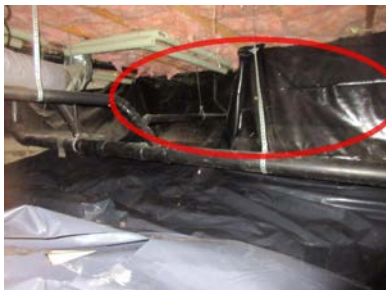
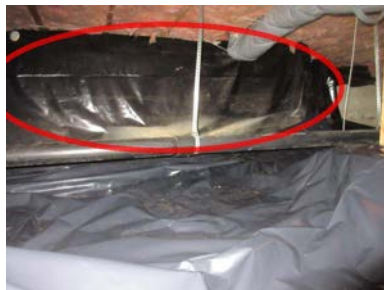
The foundation walls are covered with the plastic vapor retarder. This allows the transmission of water vapor from the soil up and into the exterior wall framing. The plastic vapor retarder should be removed from the foundation so that it covers at least 85% of the entire surface of the soil only.

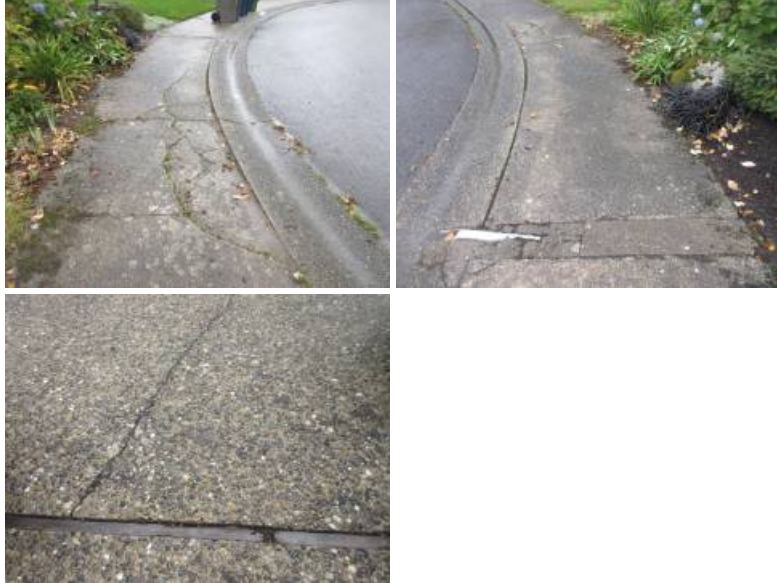
The wooden dividers separating the concrete walkway sections have deteriorated to a point where the gaps are a trip hazard. Replacement with mortar is recommended.

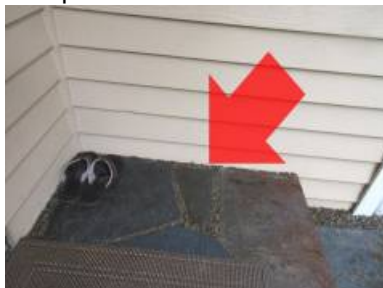
Untreated wood in direct contact with concrete was observed along the patio stoop. Untreated wood should be raised 1-2" above the concrete. Treating the wood with a preservative sometimes will prevent wood destroy organism damage.

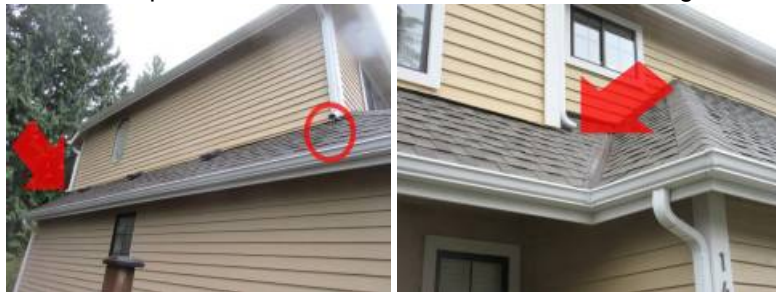
Downspouts draining directly onto the asphalt shingle surface causes excessive wear of the roofing material. Downspout extensions to the lower gutters should be installed to prevent excessive wear and tear of the roofing.

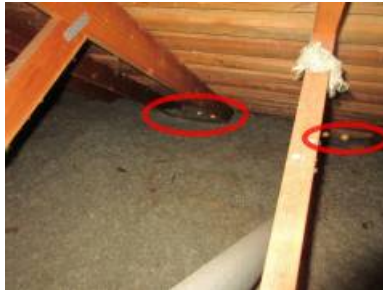
Wind baffles locations are compromised in some areas of the attic. The proper placement of wind baffles in front of all soffit vents is recommended.

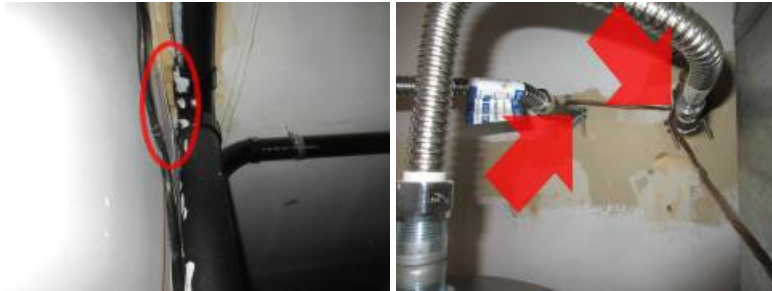
There are voids in the fire resistive barrier between the living space and garage that will allow flames to penetrate. The gypsum barrier slows the spread of a fire from the garage to the structure and/or living space. Patching the voids with a fire retardant caulk is recommended.

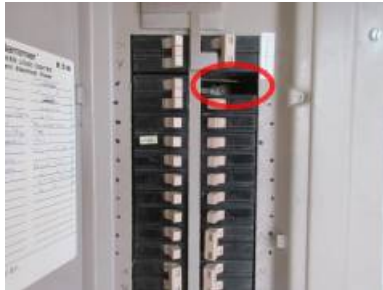
The circuits are labeled. The accuracy of the labeling was not verified. Do not assume the labeled circuit is off unless it has been checked with a voltage tester.

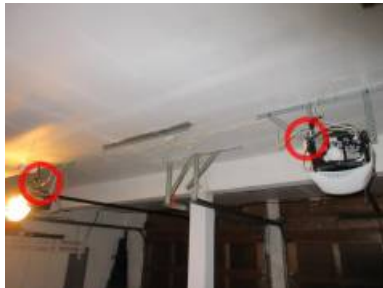
An extension cord is used as a temporary power source for the garage door openers. An extension cord is not suitable as a permanent wiring method. The installation of a receptacle within cords length of the motors is recommended.

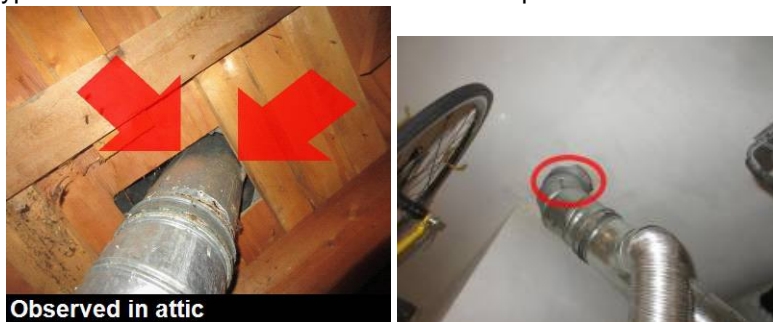
The furnace type B vent is in contact with combustible materials in the garage and attic. This is a fire hazard. A minimum clearance of 1" is required between the type B vent and the combustible material. Repairs are recommended.

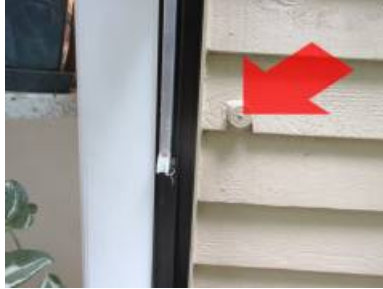
An air gap called a Johnson Tee is installed in the kitchen wall. This air gap protects the dishwasher from contamination caused by a backflow of waste water. The cap protruding on the exterior wall adjacent the kitchen is not drilled with the recommended size hole. This renders the air gap non-functional. Drilling a 1/4" hole in the end of the cap will restore its function. The remaining visible portions of the Johnson Tee were properly installed and functioning as intended.

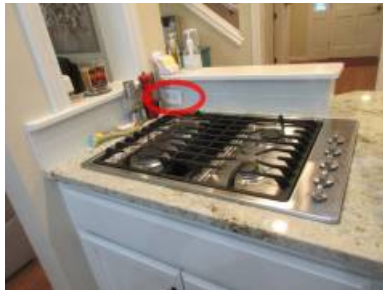
One of the receptacles in the kitchen is adjacent the cook top. We recommend caution when using this outlet and cooktop simultaneously.

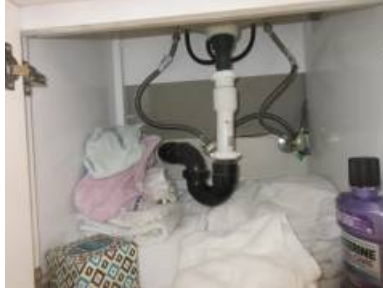
Improper, non-conforming material has been used for the left sink drain pipe fitting. This material will not function reliably. Replacement with industry standard fittings is recommended.

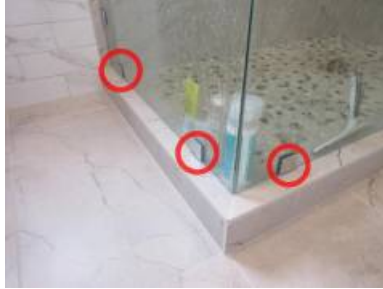
The glass enclosure has been leaking at the lower corners. No damage was visible, but resealing or repairing the enclosure is recommended as preventive maintenance.

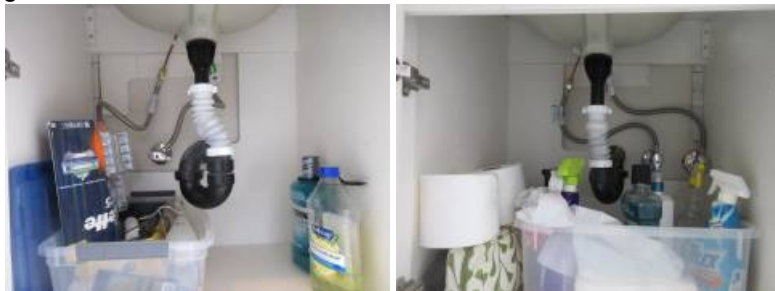
Improper, non-conforming material has been used for the drain pipe fittings. This material will not function reliably. Replacement with industry standard fittings is recommended.

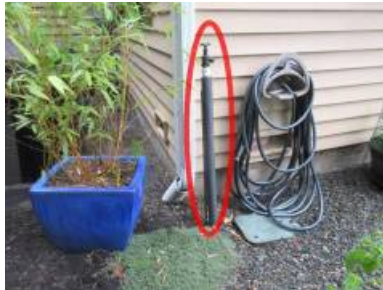
There are water pipes on the south exterior of the house that will freeze in cold weather. These water pipes should be shut off and drained or protected via a thermostatically installed heat tape.

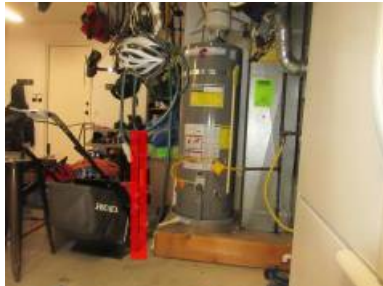
The gas pipes in front of the furnace and water heater are not protected by a bumper stop. A vertical steel pipe, bolted to the floor, is typically installed in front of the water heater to prevent a car bumper from damaging the gas lines.

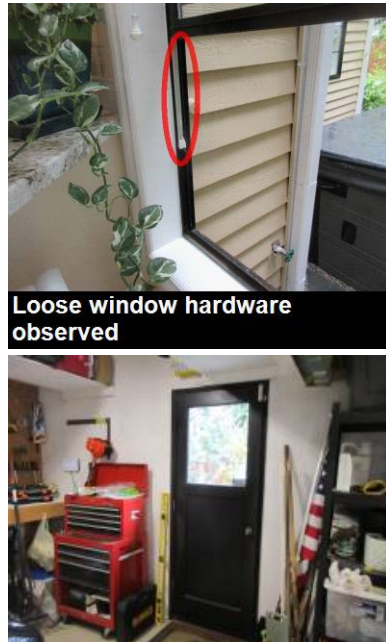
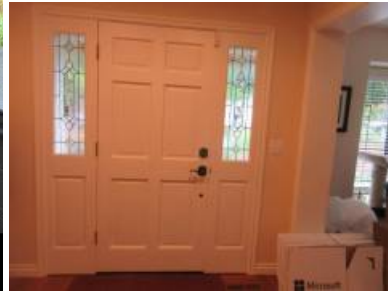
The glass in the garage door is not tempered safety glass. Tempered glass can be identified by the etched emblem in one corner of each pane. A higher margin of safety could be achieved if the glass was approved safety glass. Consideration should be given to replacing the glass as a safety upgrade.

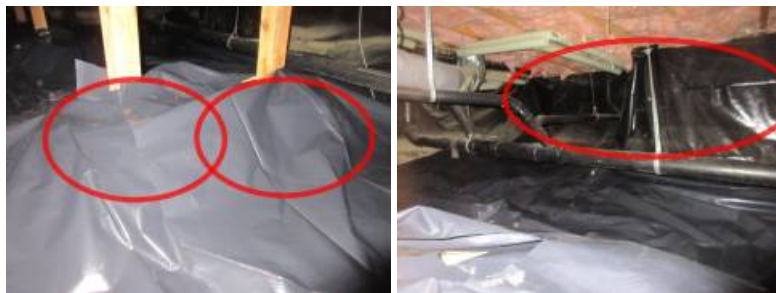
The support post concrete piers are covered with the plastic vapor retarder. This allows the transmission of water vapor from the soil up and into the floor framing. The plastic vapor retarder should be removed from the pier so that it covers at least 85% of the entire surface of the soil only.
