NOTICE TO BUYER: SELLER-PROCURED INSPECTION REPORT

Karri and Taru Kuoppamaki
13008 176th Place NE. Redmond, WA 98052

13008 176th Pl. NE
Redmond WA.

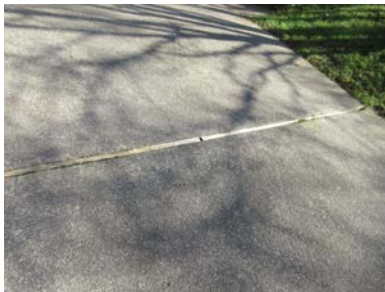
2.5 DRIVEWAY

One or more of the wooden dividers separating the concrete driveway sections were infested by wood destroying organisms and have deteriorated to a point where they are becoming a trip hazard. Replacement with mortar is recommended.

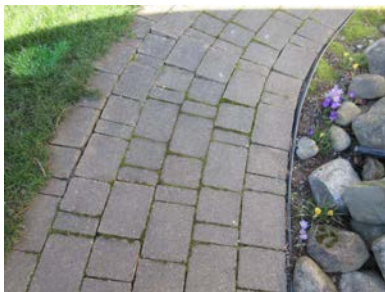
2.7 WALKWAY

The walking surface adjacent the house was not even and trip hazards were present. We recommend all walking surfaces be maintained free of trip hazards.

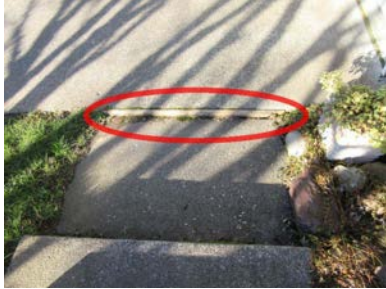
A section of the walkway has cracked and settled differentially. This was probably caused by inadequate preparation of the soil prior to the placement of the concrete. This condition can be repaired by pressure grouting the sunken portion of the walkway or by removing and replacing it. The walkway remains functional despite this condition. However, the raised edges of the concrete can be a trip hazard for some people. Grinding down the raised edges of the concrete will mitigate the hazard. Repairs should be made as necessary.

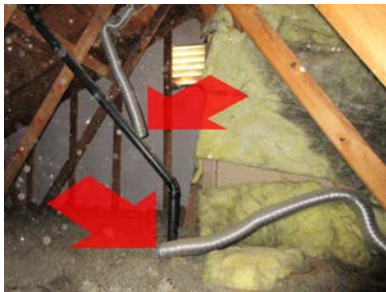
5.3 MECHANICAL VENTILATION SYSTEMS

The duct for the hallway bathroom vent fan has become detached in the attic. This allows moisture laden air to be discharged in the attic rather than outside. This is an undesirable condition that causes excessive moisture in the attic and can result in mold or fungus growth. The duct should be reconnected and secured.

5.3 Mechanical ventilation system – Duct re-attached

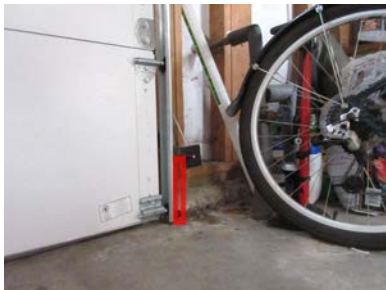
The Photo-eye beam was installed too high above the floor of the garage to adequately offer protection for small children and/or pets. We recommend that the photo-eye be lowered to within 4-6" of the floor.

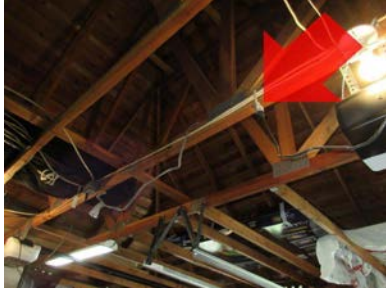
An extension cord is used as a temporary power source for the garage door opener. An extension cord is not suitable as a permanent wiring method. The installation of a receptacle within cords length of the motor is recommended.

7.10 Wiring – Receptacle installed within cords length of the garage door opener

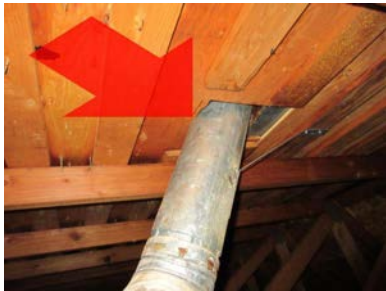
8.9 VENT

The furnace vent connector is too close to a combustible material in the attic. This is a hazard. A minimum clearance of 6" is required between the single wall vent connector and the combustible material. The double wall type B vent requires only 1" of clearance. Repairs are recommended.

8.9 Vent – Furnace vent connector replaced with new vent, now meets the minimum clearance requirements

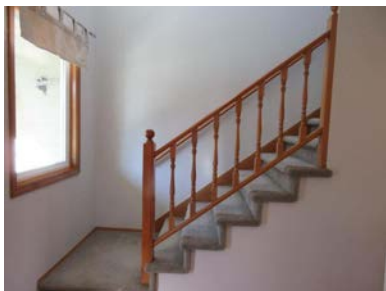
The stair railing baluster spacing is too wide. This is a hazard for small children. The baluster spacing should be reduced as a safety upgrade. Current standards require that a 4" sphere not pass through the railing.

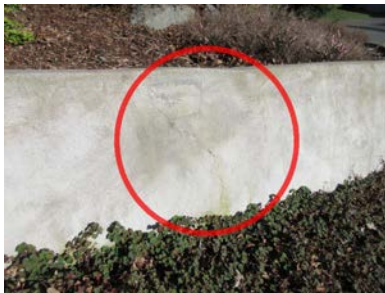
A concrete retaining wall is used along the yard to stabilize and contain the soil. The wall is performing its intended function however, noticeable cracking was observed. We recommend boring weep holes at 3'-4' intervals through the concrete several inches above the surface of the walkway. This will help relieve hydrostatic pressure from the soils side of the concrete and may help minimize further movement of the retaining wall.

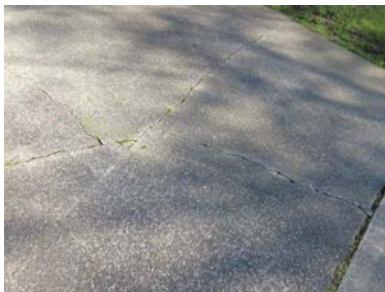
2.5 DRIVEWAY

Cracks were observed in the concrete surface of the driveway. Minor cracks can be sealed to minimize moisture entry and further settlement of the concrete. Minor cracks are common and do not affect the serviceability of the concrete.

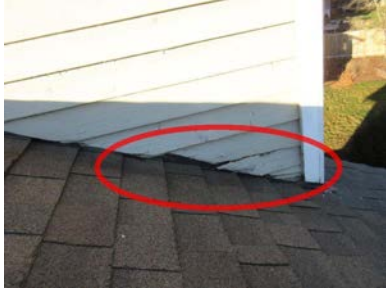
3.1 PRIMARY EXTERIOR WALL CLADDING

Sections of siding located at the chimney chase above the roof are loose and cracked. Consideration should be given to replacing the damaged siding.

3.1 Primary exterior wall cladding – Sections of siding at the chimney chase replaced with new ones

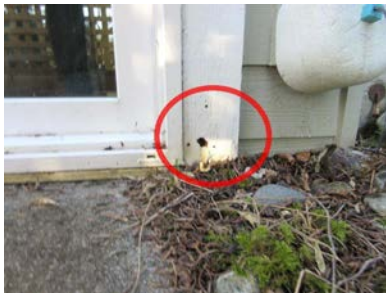
Rot damage was observed in some of the door trim board. Wood rot commonly referred to as "Dry Rot" occurs when untreated wood is allowed to retain moisture for extended periods of time. Wood rot is caused by fungi which grow in the cell structure and spread like a root system through the wood. Fungi can also develop from spores which are present in the soil and are transferred through the air. Rotted wood creates an environment that is conducive to various types of wood boring insects (e.g. carpenter ants, moisture ants, dampwood termites, etc.) Wood rot can be prevented by keeping the wood dry, or if this is not possible, such as in the case of outdoor wood, by using pressure treated wood, by treating exposed wood with semi-transparent stain and/or wood preservative, and by keeping untreated wood out of and 6" above the soil.

3.2 Pest control – Door trim board around basement sliding door replaced with new board

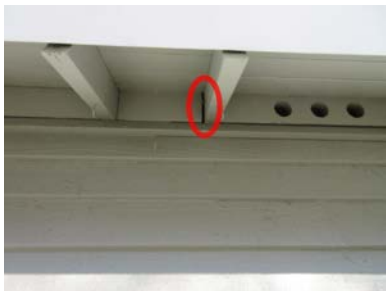
There are large gaps over 1/4" in size adjacent the soffit vent blocks. These gaps allow insects and rodents to enter the attic. Covering the gaps with screening, a strip of wood and/or caulking is recommended.

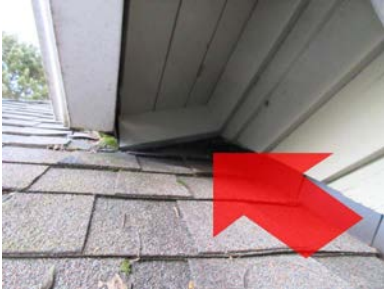
There are openings at the intersection between the overhang and the roof through which birds and rodents can enter into the attic. These openings should be covered with wood, wire mesh or filled with aerosol foam.

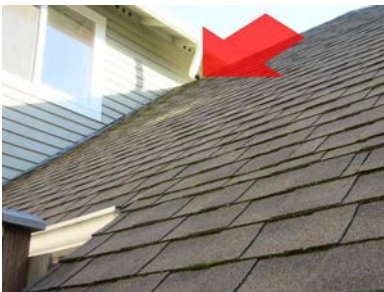
3.4 GUTTERS AND DOWNSPOUTS

Downspouts draining directly onto the asphalt shingle surface causes excessive wear of the roofing material. Downspout extensions to the lower gutters should be installed to prevent excessive wear and tear of the roofing.

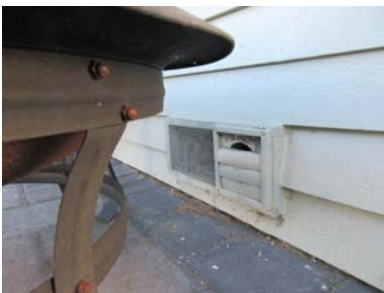
The dryer duct back-draft damper is damaged at the termination. The installation of a hooded back-draft damper is recommended to prevent entry by rodents, birds insects, etc.

3.8 Vent Damper – Back-draft damper fixed

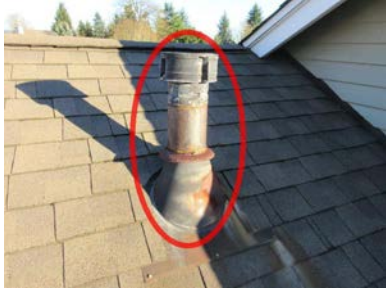
4.5 GAS APPLIANCE VENTS

The gas appliance vent is corroded above the roof line. Cleaning and painting the vent will prolong its service life.

4.5 Gas Appliance vent – Gas appliance vent replaced

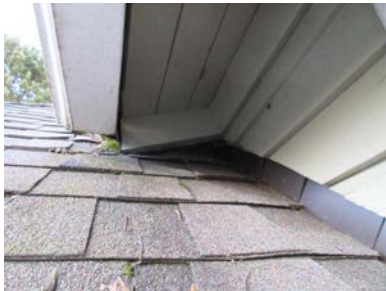
Flashings are improperly installed on the top of the siding. These flashings will not perform as intended. Step flashings should be installed under the siding. Repairs are recommended.

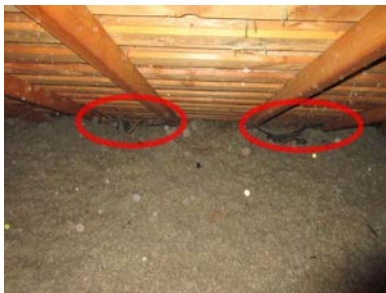
5.2 VENTILATION

Wind baffles locations are compromised in some areas of the attic. The proper placement of wind baffles in front of all soffit vents is recommended.

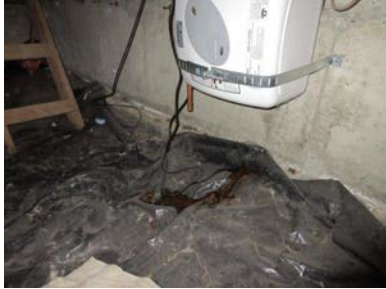
9.11 GENERAL COMMENTS

The water storage tank in the crawlspace is leaking. The services of a qualified plumbing contractor should be retained to repair or replace the water heater.

9.11 General comments – Water storage tank in the crawlspace replaced with new one

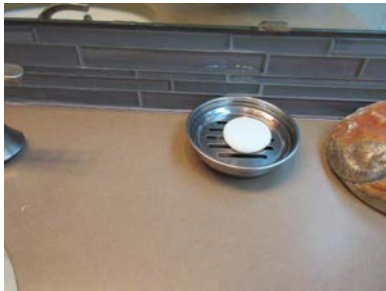
The backsplash caulking is cracked. Cracking of the caulk allows water to enter the gap and is difficult to clean. Caulking the cracks and/or gaps is recommended.

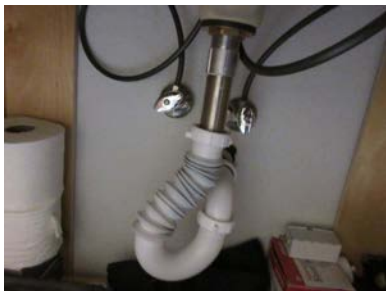
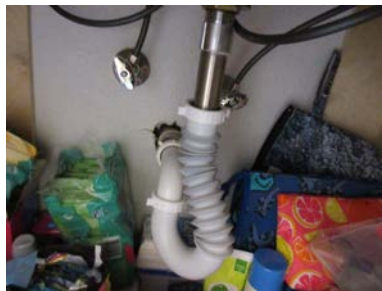
Improper, non-conforming material has been used for the drain pipe fittings. This material will not function reliably. Replacement with industry standard fittings is recommended.

11.20 Drains, traps and trap arms – Current materials replaced with industry standard fittings

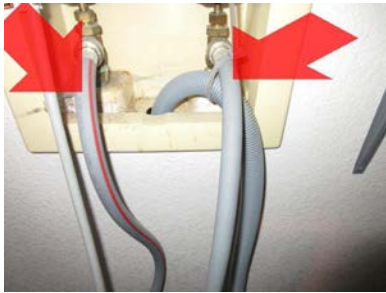
12.2 APPLIANCES

Upgrading the washer connections to high pressure (steel braided) lines is recommended.

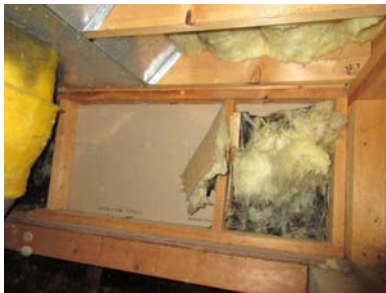
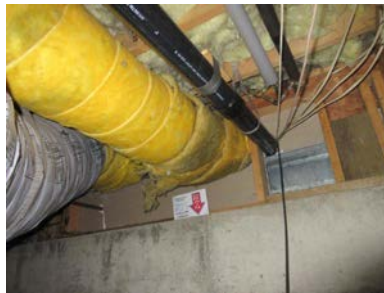
One of the insulation batts is missing. The missing batt should be replaced .

Some of the insulation batts are missing at the stairwell landing. The missing batts should be replaced.

17.3 Floor insulation – new insulation bats installed to replace the missing bats in the crawlspace

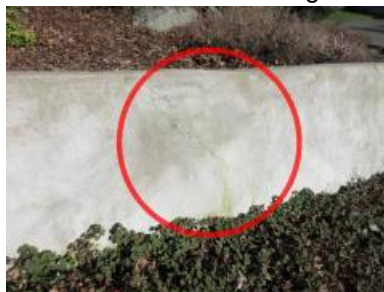
A concrete retaining wall is used along the yard to stabilize and contain the soil. The wall is performing its intended function however, noticeable cracking was observed. We recommend boring weep holes at 3'-4' intervals through the concrete several inches above the surface of the walkway. This will help relieve hydrostatic pressure from the soils side of the concrete and may help minimize further movement of the retaining wall.

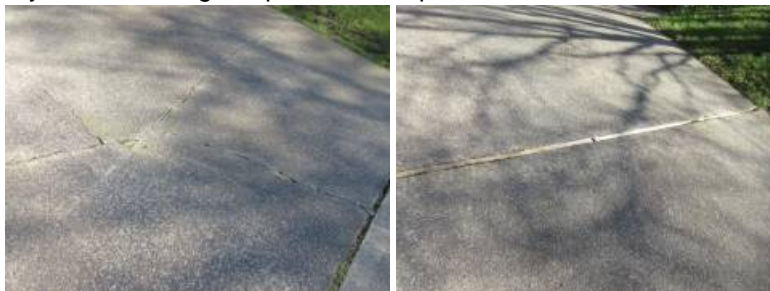
One or more of the wooden dividers separating the concrete driveway sections were infested by wood destroying organisms and have deteriorated to a point where they are becoming a trip hazard. Replacement with mortar is recommended.

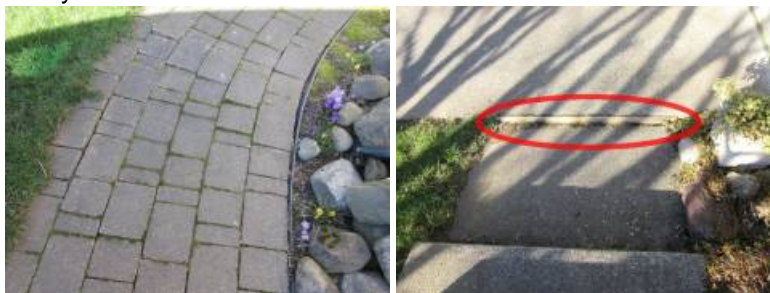
A section of the walkway has cracked and settled differentially. This was probably caused by inadequate preparation of the soil prior to the placement of the concrete. This condition can be repaired by pressure grouting the sunken portion of the walkway or by removing and replacing it. The walkway remains functional despite this condition. However, the raised edges of the concrete can be a trip hazard for some people. Grinding down the raised edges of the concrete will mitigate the hazard. Repairs should be made as necessary.

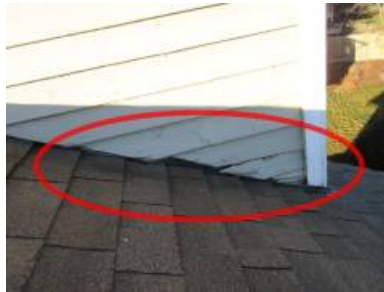
Sections of siding located at the chimney chase above the roof are loose and cracked. Consideration should be given to replacing the damaged siding.

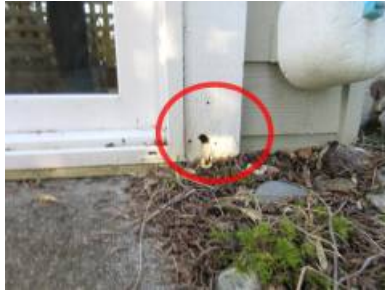
Rot damage was observed in some of the door trim board. Wood rot commonly referred to as "Dry Rot" occurs when untreated wood is allowed to retain moisture for extended periods of time. Wood rot is caused by fungi which grow in the cell structure and spread like a root system through the wood. Fungi can also develop from spores which are present in the soil and are transferred through the air. Rotted wood creates an environment that is conducive to various types of wood boring insects (e.g. carpenter ants, moisture ants, dampwood termites, etc.) Wood rot can be prevented by keeping the wood dry, or if this is not possible, such as in the case of outdoor wood, by using pressure treated wood, by treating exposed wood with semi-transparent stain and/or wood preservative, and by keeping untreated wood out of and 6" above the soil.

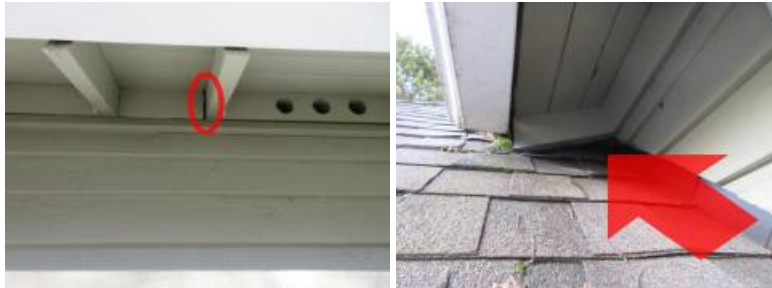
There are openings at the intersection between the overhang and the roof through which birds and rodents can enter into the attic. These openings should be covered with wood, wire mesh or filled with aerosol foam.

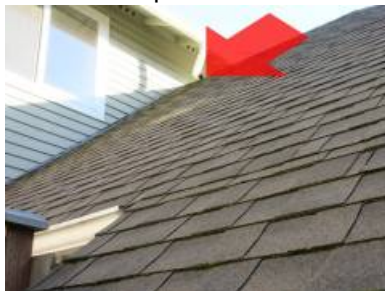
Downspouts draining directly onto the asphalt shingle surface causes excessive wear of the roofing material. Downspout extensions to the lower gutters should be installed to prevent excessive wear and tear of the roofing.

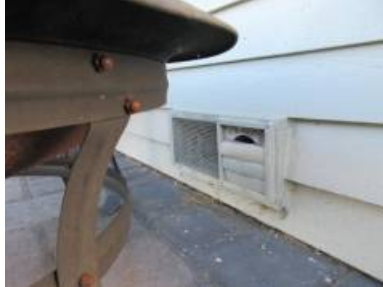
The dryer duct back-draft damper is damaged at the termination. The installation of a hooded back-draft damper is recommended to prevent entry by rodents, birds insects, etc.

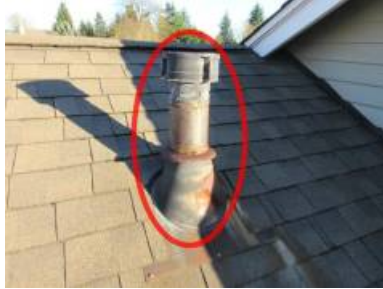
The gas appliance vent is corroded above the roof line. Cleaning and painting the vent will prolong its service life.

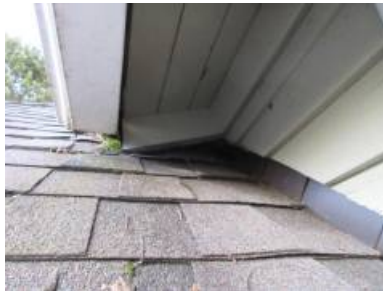
Flashings are improperly installed on the top of the siding. These flashings will not perform as intended. Step flashings should be installed under the siding. Repairs are recommended.

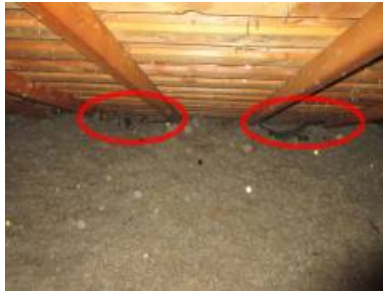
Wind baffles locations are compromised in some areas of the attic. The proper placement of wind baffles in front of all soffit vents is recommended.

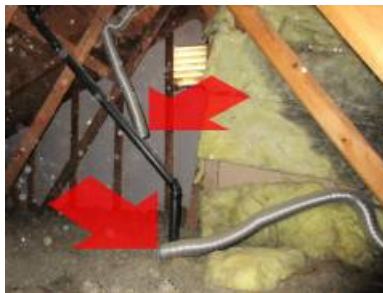
5.3 MECHANICAL VENTILATION SYSTEMS

The duct for the hallway bathroom vent fan has become detached in the attic. This allows moisture laden air to be discharged in the attic rather than outside. This is an undesirable condition that causes excessive moisture in the attic and can result in mold or fungus growth. The duct should be reconnected and secured.

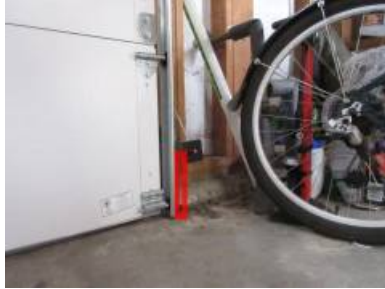
The Photo-eye beam was installed too high above the floor of the garage to adequately offer protection for small children and/or pets. We recommend that the photo-eye be lowered to within 4-6" of the floor.

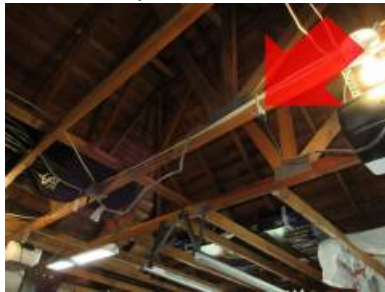
An extension cord is used as a temporary power source for the garage door opener. An extension cord is not suitable as a permanent wiring method. The installation of a receptacle within cords length of the motor is recommended.

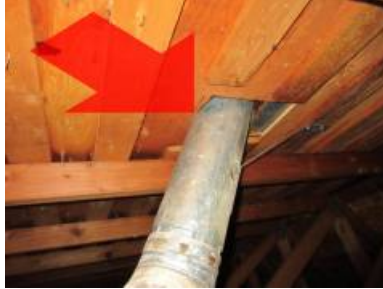
The furnace vent connector is too close to a combustible material in the attic. This is a hazard. A minimum clearance of 6" is required between the single wall vent connector and the combustible material. The double wall type B vent requires only 1" of clearance. Repairs are recommended.

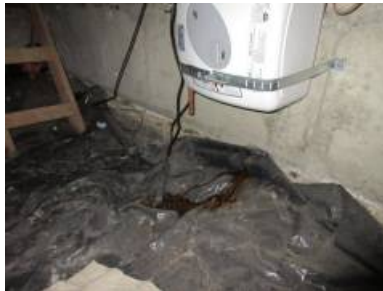
The water storage tank in the crawlspace is leaking. The services of a qualified plumbing contractor should be retained to repair or replace the water heater.

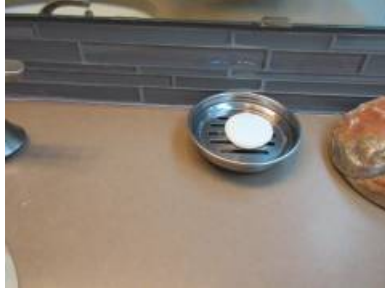
The backsplash caulking is cracked. Cracking of the caulk allows water to enter the gap and is difficult to clean. Caulking the cracks and/or gaps is recommended.

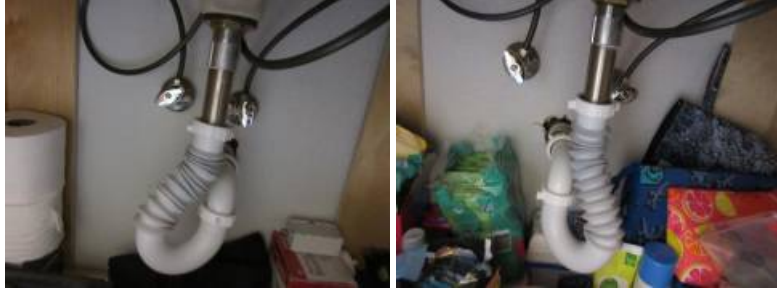
Improper, non-conforming material has been used for the drain pipe fittings. This material will not function reliably. Replacement with industry standard fittings is recommended.

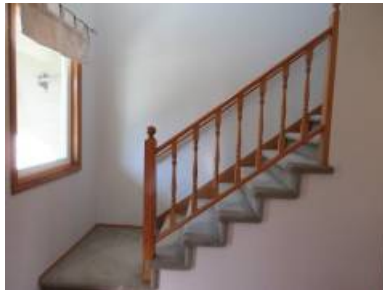
The stair railing baluster spacing is too wide. This is a hazard for small children. The baluster spacing should be reduced as a safety upgrade. Current standards require that a 4" sphere not pass through the railing.

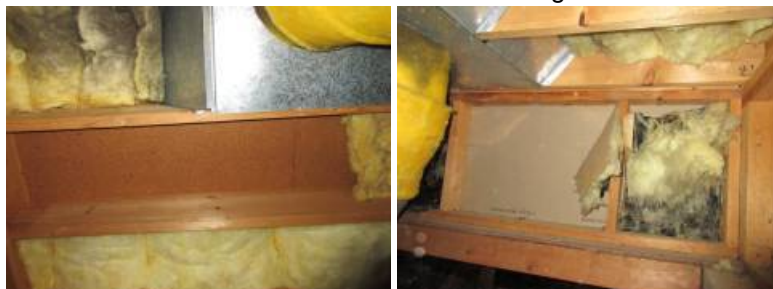
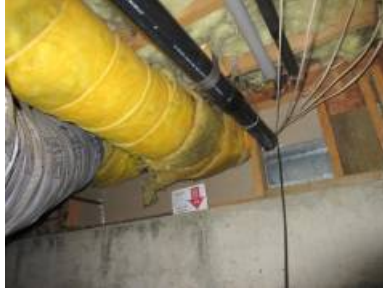
Some of the insulation batts are missing from the furnace room closet wall. The missing batts should be replaced.
