**NOTICE TO BUYER: SELLER-PROCURED INSPECTION REPORT**

Karri and Taru Kuoppamaki  
13008 176<sup>th</sup> Place NE. Redmond, WA 98052

13008 176th Pl. NE  
Redmond WA.

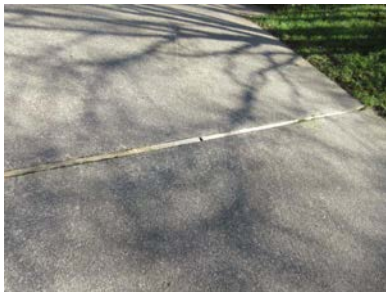
#### **2.5 DRIVEWAY**

One or more of the wooden dividers separating the concrete driveway sections were infested by wood destroying organisms and have deteriorated to a point where they are becoming a trip hazard. Replacement with mortar is recommended.

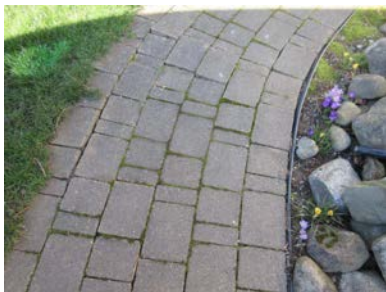
#### **2.7 WALKWAY**

The walking surface adjacent the house was not even and trip hazards were present. We recommend all walking surfaces be maintained free of trip hazards.

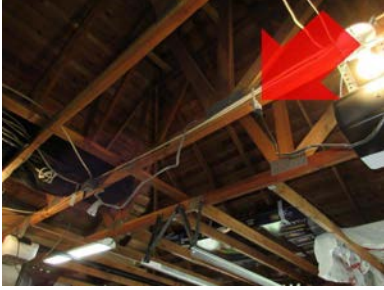
**7.10 WIRING**

An extension cord is used as a temporary power source for the garage door opener. An extension cord is not suitable as a permanent wiring method. The installation of a receptacle within cords length of the motor is recommended.

**7.10 Wiring** – Receptacle installed within cords length of the garage door opener

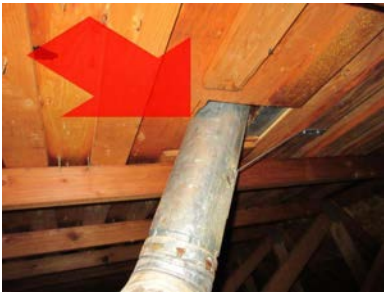
The furnace vent connector is too close to a combustible material in the attic. This is a hazard. A minimum clearance of 6" is required between the single wall vent connector and the combustible material. The double wall type B vent requires only 1" of clearance. Repairs are recommended.

**8.9 Vent** – Furnace vent connector replaced with new vent, now meets the minimum clearance requirements

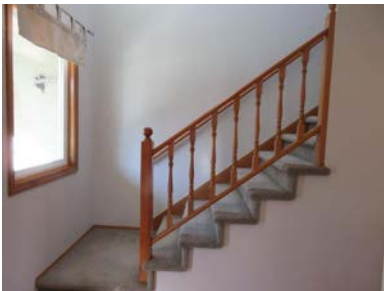
The stair railing baluster spacing is too wide. This is a hazard for small children. The baluster spacing should be reduced as a safety upgrade. Current standards require that a 4" sphere not pass through the railing.

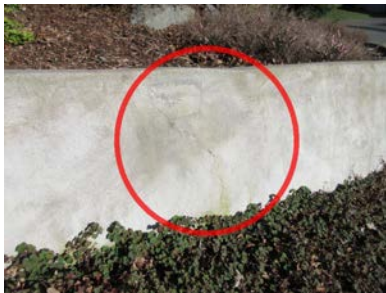
A concrete retaining wall is used along the yard to stabilize and contain the soil. The wall is performing its intended function however, noticeable cracking was observed. We recommend boring weep holes at 3'-4' intervals through the concrete several inches above the surface of the walkway. This will help relieve hydrostatic pressure from the soils side of the concrete and may help minimize further movement of the retaining wall.

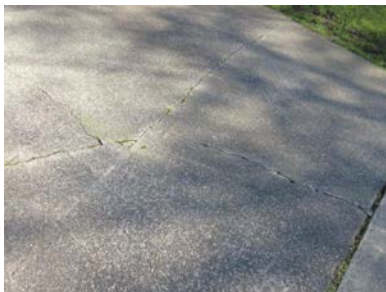
##### 2.5 DRIVEWAY

Cracks were observed in the concrete surface of the driveway. Minor cracks can be sealed to minimize moisture entry and further settlement of the concrete. Minor cracks are common and do not affect the serviceability of the concrete.

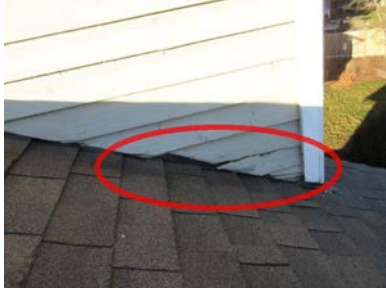
##### 3.1 PRIMARY EXTERIOR WALL CLADDING

Sections of siding located at the chimney chase above the roof are loose and cracked. Consideration should be given to replacing the damaged siding.

**3.1 Primary exterior wall cladding** – Sections of siding at the chimney chase replaced with new ones

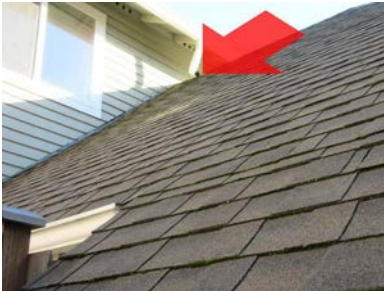
### 3.4 GUTTERS AND DOWNSPOUTS

Downspouts draining directly onto the asphalt shingle surface causes excessive wear of the roofing material. Downspout extensions to the lower gutters should be installed to prevent excessive wear and tear of the roofing.

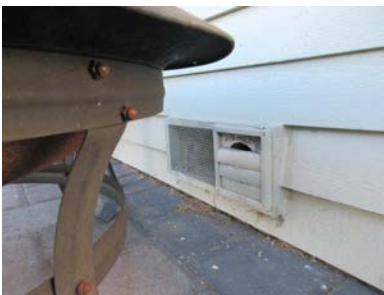
The dryer duct back-draft damper is damaged at the termination. The installation of a hooded back-draft damper is recommended to prevent entry by rodents, birds insects, etc.

**3.8 Vent Damper** – Back-draft damper fixed

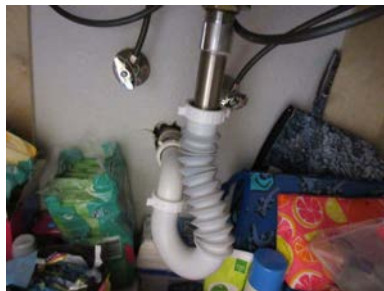
Improper, non-conforming material has been used for the drain pipe fittings. This material will not function reliably. Replacement with industry standard fittings is recommended.

**11.20 Drains, traps and trap arms** – Current materials replaced with industry standard fittings

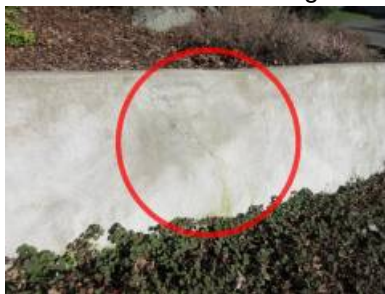
A concrete retaining wall is used along the yard to stabilize and contain the soil. The wall is performing its intended function however, noticeable cracking was observed. We recommend boring weep holes at 3'-4' intervals through the concrete several inches above the surface of the walkway. This will help relieve hydrostatic pressure from the soils side of the concrete and may help minimize further movement of the retaining wall.

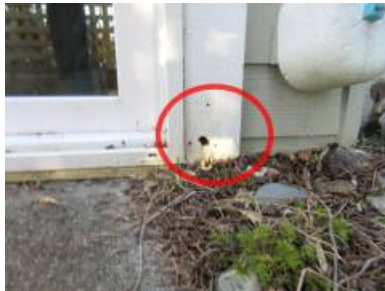
Rot damage was observed in some of the door trim board. Wood rot commonly referred to as "Dry Rot" occurs when untreated wood is allowed to retain moisture for extended periods of time. Wood rot is caused by fungi which grow in the cell structure and spread like a root system through the wood. Fungi can also develop from spores which are present in the soil and are transferred through the air. Rotted wood creates an environment that is conducive to various types of wood boring insects (e.g. carpenter ants, moisture ants, dampwood termites, etc.) Wood rot can be prevented by keeping the wood dry, or if this is not possible, such as in the case of outdoor wood, by using pressure treated wood, by treating exposed wood with semi-transparent stain and/or wood preservative, and by keeping untreated wood out of and 6" above the soil.

**3.2 Pest control** – Door trim board around basement sliding door replaced with new board

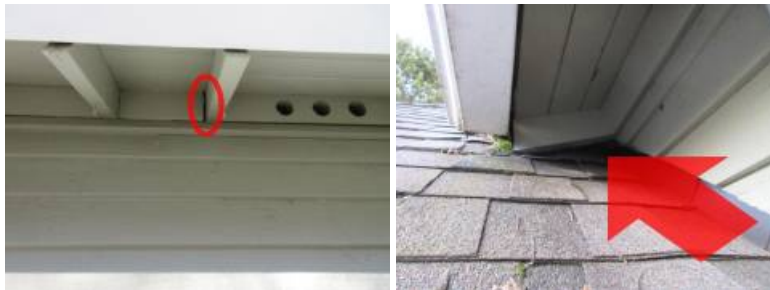
There are openings at the intersection between the overhang and the roof through which birds and rodents can enter into the attic. These openings should be covered with wood, wire mesh or filled with aerosol foam.

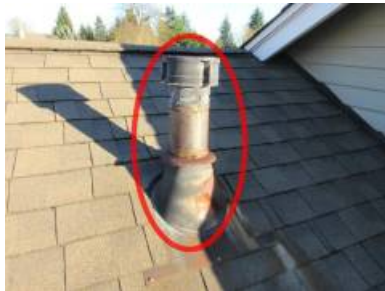
The gas appliance vent is corroded above the roof line. Cleaning and painting the vent will prolong its service life.

**4.5 Gas Appliance vent** – Gas appliance vent replaced

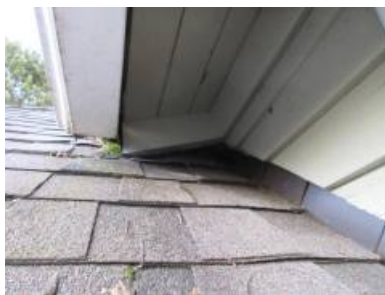
Flashings are improperly installed on the top of the siding. These flashings will not perform as intended. Step flashings should be installed under the siding. Repairs are recommended.

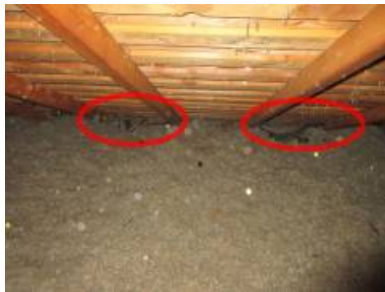
Wind baffles locations are compromised in some areas of the attic. The proper placement of wind baffles in front of all soffit vents is recommended.

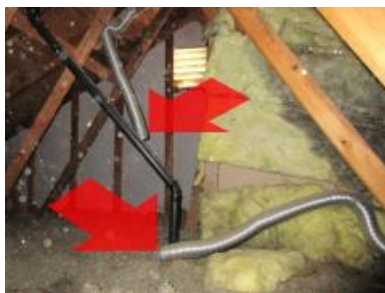
### 5.3 MECHANICAL VENTILATION SYSTEMS

The duct for the hallway bathroom vent fan has become detached in the attic. This allows moisture laden air to be discharged in the attic rather than outside. This is an undesirable condition that causes excessive moisture in the attic and can result in mold or fungus growth. The duct should be reconnected and secured.

**5.3 Mechanical ventilation system** – Duct re-attached

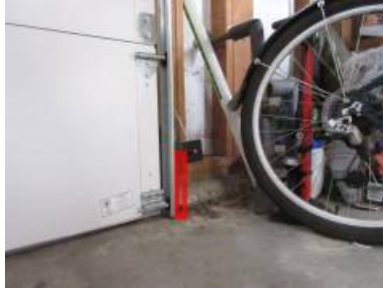
The Photo-eye beam was installed too high above the floor of the garage to adequately offer protection for small children and/or pets. We recommend that the photo-eye be lowered to within 4-6" of the floor.

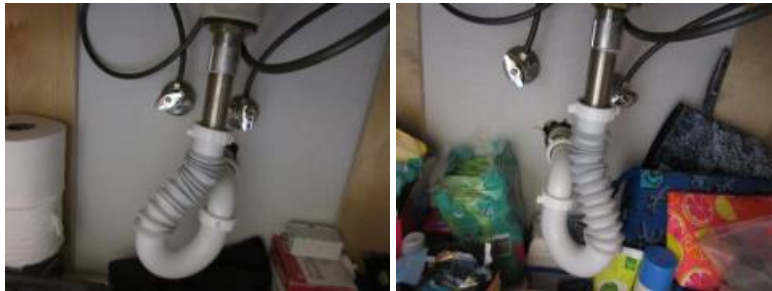
Improper, non-conforming material has been used for the drain pipe fittings. This material will not function reliably. Replacement with industry standard fittings is recommended.

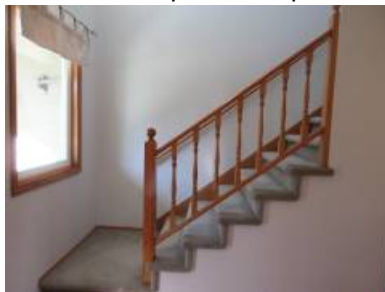
The stair railing baluster spacing is too wide. This is a hazard for small children. The baluster spacing should be reduced as a safety upgrade. Current standards require that a 4" sphere not pass through the railing.

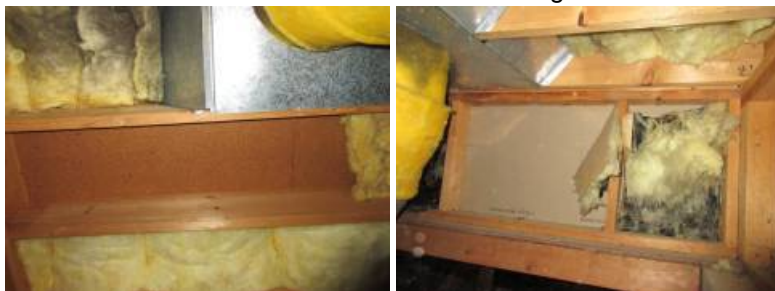
Some of the insulation batts are missing from the furnace room closet wall. The missing batts should be replaced.
