NOTICE TO BUYER: SELLER-PROCURED INSPECTION REPORT

The following notice is given with respect to the Purchase and Sale Agreement dated _____
between _____ (“Buyer”)
and Jeff and Valerie Hunter (“Seller”)
concerning 14135 175th Ave NE Redmond, Wa 98052 (“the Property”).

At your request, a visual inspection of the above referenced property was conducted on 02/02/2018. We have inspected the major structural components, plumbing, heating and electrical systems for signs of significant non-performance, excessive or unusual wear and general state of repair.

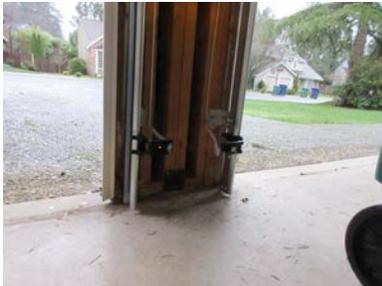
6.3 GARAGE DOOR OPENER

The Photo-eye beam was installed to high above the floor of the garage to adequately offer protection for small children and/or pets. We recommend that the photo-eye be lowered to within 4-6" of the floor.

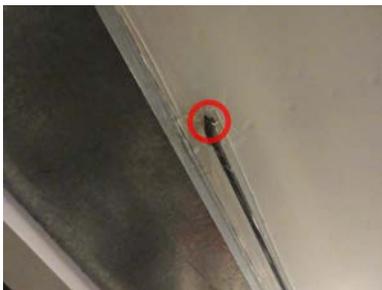
6.4 FIRE SEPARATION

There are voids in the fire resistive barrier between the living space and garage that will allow flames to penetrate. The gypsum barrier slows the spread of a fire from the garage to the structure and/or living space. Patching the voids with a fire retardant caulk is recommended.

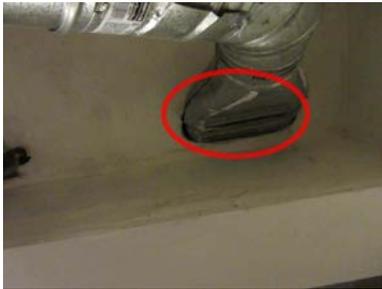
8.10 VENT

The furnace vent connector is too close to a combustible material. This is a hazard. A minimum clearance of 6" is required between the single wall vent connector and the combustible material. The double wall type B vent requires only 1" of clearance. Repairs are recommended.

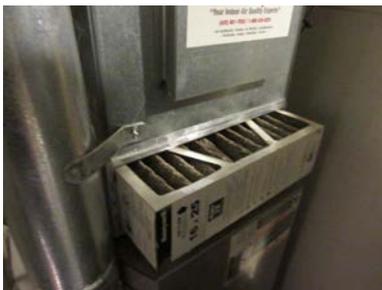
8.12 AIR FILTER

The air filter is clogged with dust. This reduces air flow and furnace efficiency. Removal and replacement of the air filter is recommended. Pleated style air filters are recommended as they offer better filtration of dust than the coarser hogs hair or fiberglass filters.

8.12 Air filter - The air filter will be removed and replaced. – to be done by seller before by closing.

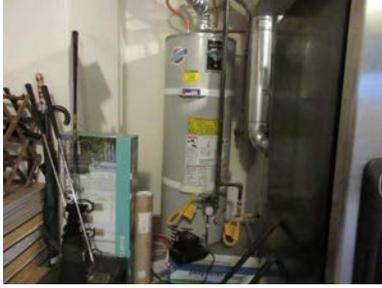
9.12 ELEVATION ABOVE GARAGE FLOOR

The water heater is not elevated above the garage floor in accordance with industry standards. This is a hazard. Elevating the water heater so that the burner is at least 18" above the garage floor prevents ignition of gasoline fumes.

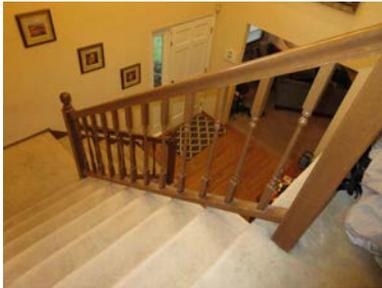
14.3 STAIRS

The stair railing baluster spacing is too wide. This is a hazard for small children. The baluster spacing should be reduced as a safety upgrade. Current standards require that a 4" sphere not pass through the railing.

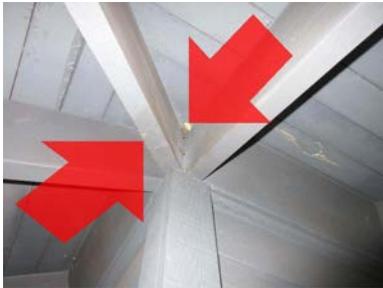
3.3 SOFFITS AND OVERHANGS

There are large gaps over 1/4" in size adjacent the soffit vent blocks. These gaps allow insects and rodents to enter the attic. Covering the gaps with screening, a strip of wood and/or caulking is recommended.

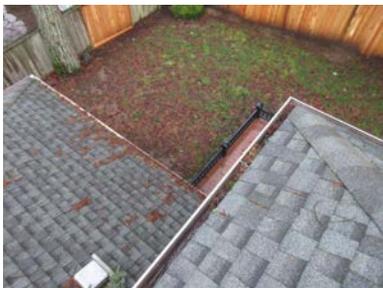
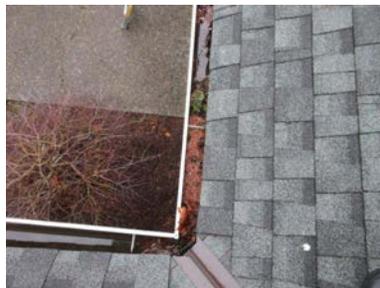
3.4 GUTTERS AND DOWNSPOUTS

There is a build-up of organic debris inside the gutters. Proper maintenance of gutters and downspouts is essential and should be performed routinely in order to prevent clogging. Maintenance consists primarily of keeping leaves and other organic debris out of the system. Failure to clean the gutters will result in water splash on the building when they overflow. Gutters can be damaged under the weight of the water and organic matter inside the gutter. Gutters should be cleaned as necessary to maintain a free flow of water into the downspouts.

3.4 Debris in gutters - Gutters have been cleaned and debris has been removed. - repaired

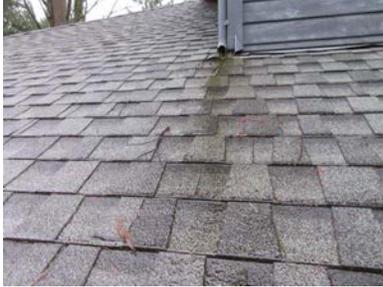
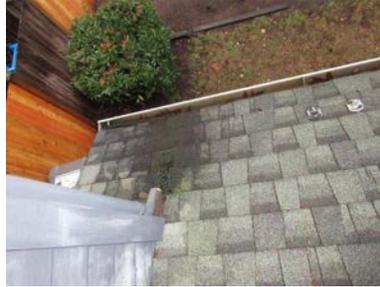
Downspouts draining directly onto the asphalt shingle surface causes excessive wear of the roofing material. Downspout extensions to the lower gutters should be installed to prevent excessive wear and tear of the roofing.

The 2" round downspouts are too small and are more vulnerable to clogging than the larger rectangular ones. Consideration should be given to upgrading the downspouts.

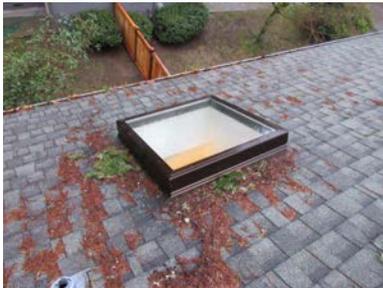
4.3 SKYLIGHTS

The skylight is not secured to the roof. Skylights can get blown off roofs during high winds if they are not secured. Fastening the skylight to the curb with four plated or stainless screws is recommended.

4.3 Skylights – skylight will be secured to the roof – repaired.

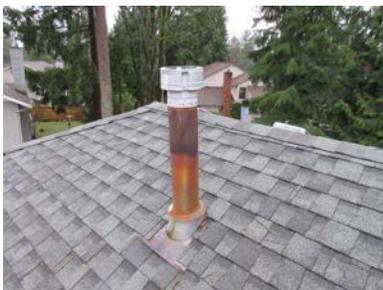
4.5 GAS APPLIANCE VENTS

The gas appliance vent is corroded above the roof line. Cleaning and painting the vent will prolong its service life.

4.5 Gas appliance vents – the vent was cleaned and paint – repaired.

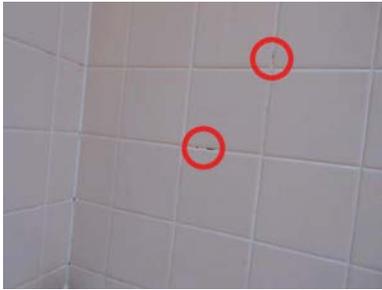
11.26 TUB WALLS

Grout is missing from between some of the wall tiles. This can allow water to enter through the tile and can damage the walls. Regrouting the wall tile is recommended.

11.26 tub walls – the gaps in the wall tiles will be caulked or grouted – repaired.

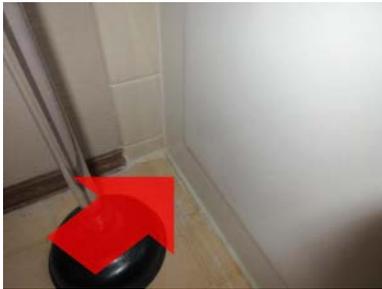
11.27 FLOORING MATERIAL

The caulking is cracked at the intersection between the tub/shower and floor. This can lead to water damage to the flooring and substrate. Caulking this area with a flexible caulk is recommended.

11.27 flooring material – this was fixed with the new floor - repaired

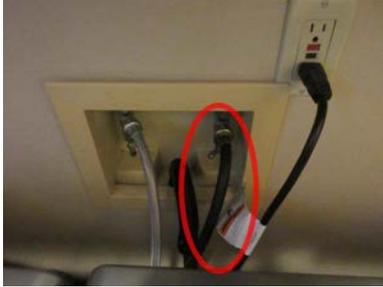
12.6 APPLIANCES

Upgrading both of the washer connections to high pressure (steel braided) lines is recommended.

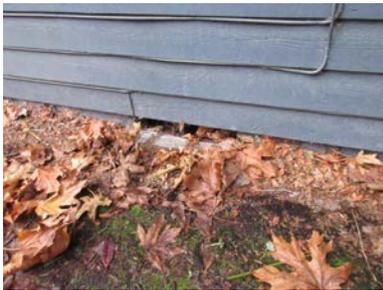
19.3 VENTILATION

The crawlspace is adequately ventilated. Vents should be kept unobstructed and clear of leaves and other organic debris. Screens should be maintained to prevent rodent entry.

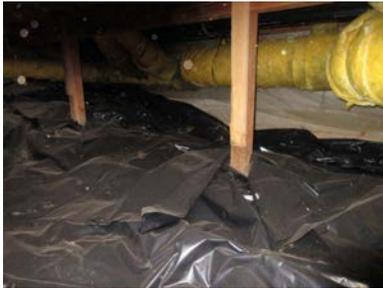
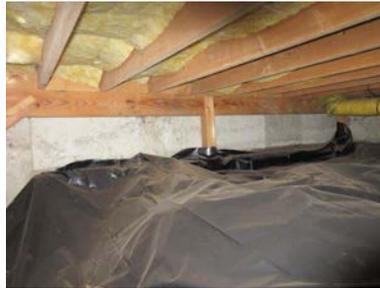
19.4 VAPOR RETARDER

The support post concrete piers are covered with the plastic vapor retarder. This allows the transmission of water vapor from the soil up and into the floor framing. The plastic vapor retarder should be removed from the pier so that it covers the entire surface of the soil only.

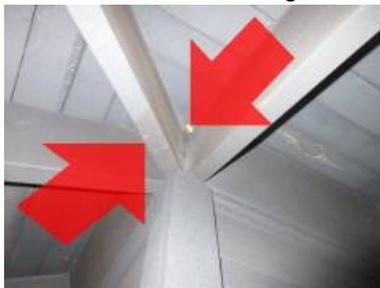
There are large gaps over 1/4" in size adjacent the soffit vent blocks. These gaps allow insects and rodents to enter the attic. Covering the gaps with screening, a strip of wood and/or caulking is recommended.

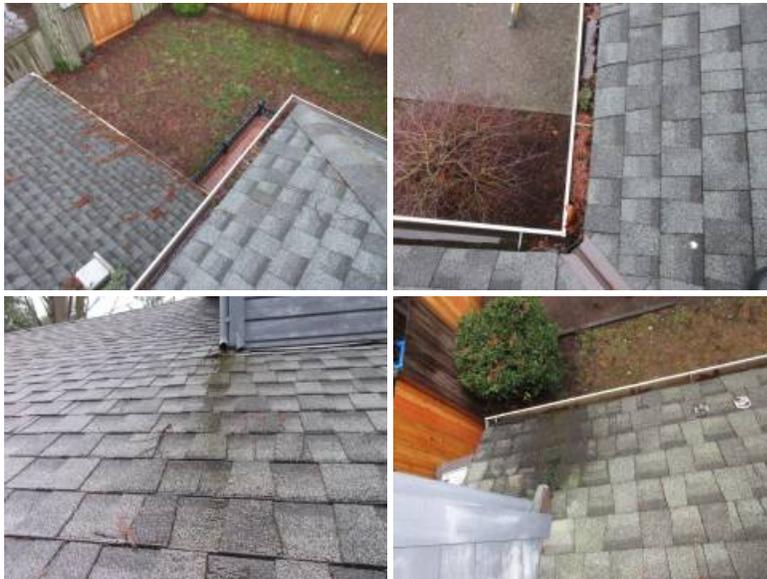
The 2" round downspouts are too small and are more vulnerable to clogging than the larger rectangular ones. Consideration should be given to upgrading the downspouts.

Downspouts draining directly onto the asphalt shingle surface causes excessive wear of the roofing material. Downspout extensions to the lower gutters should be installed to prevent excessive wear and tear of the roofing.

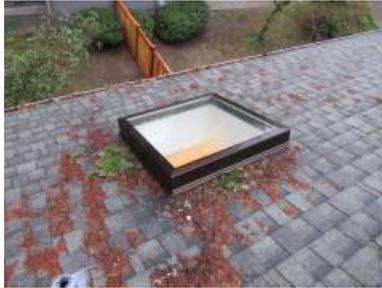
4.3 SKYLIGHTS

The skylight is not secured to the roof. Skylights can get blown off roofs during high winds if they are not secured. Fastening the skylight to the curb with four plated or stainless screws is recommended.

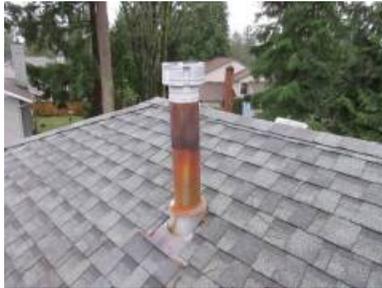
The gas appliance vent is corroded above the roof line. Cleaning and painting the vent will prolong its service life.

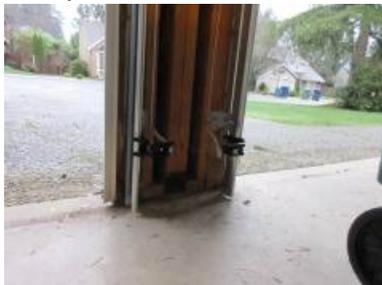
The Photo-eye beam was installed too high above the floor of the garage to adequately offer protection for small children and/or pets. We recommend that the photo-eye be lowered to within 4-6" of the floor.

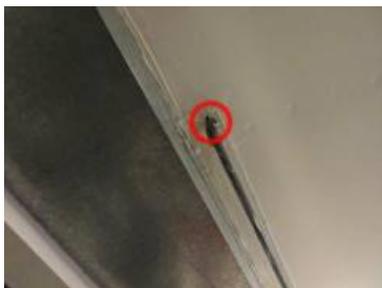
6.4 FIRE SEPARATION

There are voids in the fire resistive barrier between the living space and garage that will allow flames to penetrate. The gypsum barrier slows the spread of a fire from the garage to the structure and/or living space. Patching the voids with a fire retardant caulk is recommended.

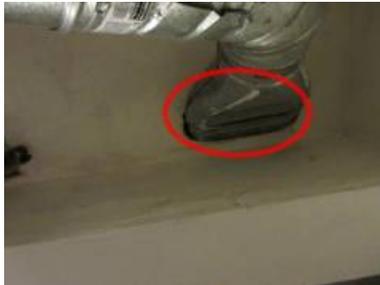
8.10 VENT

The furnace vent connector is too close to a combustible material. This is a hazard. A minimum clearance of 6" is required between the single wall vent connector and the combustible material. The double wall type B vent requires only 1" of clearance. Repairs are recommended.

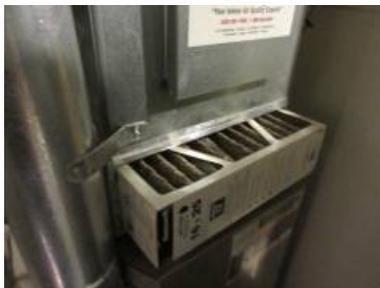
The air filter is clogged with dust. This reduces air flow and furnace efficiency. Removal and replacement of the air filter is recommended. Pleated style air filters are recommended as they offer better filtration of dust than the coarser hogs hair or fiberglass filters.

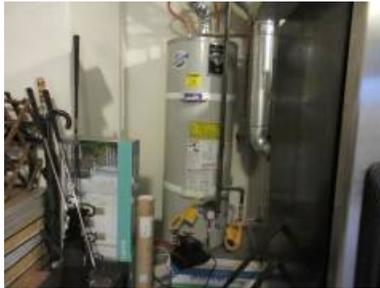
The water heater is not elevated above the garage floor in accordance with industry standards. This is a hazard. Elevating the water heater so that the burner is at least 18" above the garage floor prevents ignition of gasoline fumes.

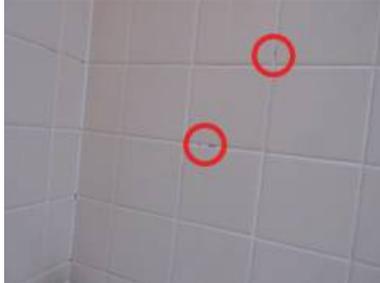
Grout is missing from between some of the wall tiles. This can allow water to enter through the tile and can damage the walls. Regrouting the wall tile is recommended.

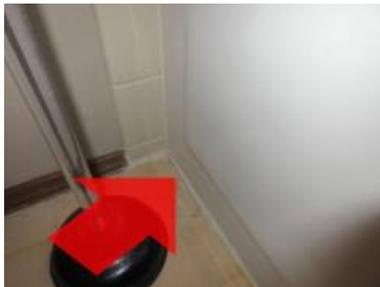
The caulking is cracked at the intersection between the tub/shower and floor. This can lead to water damage to the flooring and substrate. Caulking this area with a flexible caulk is recommended.

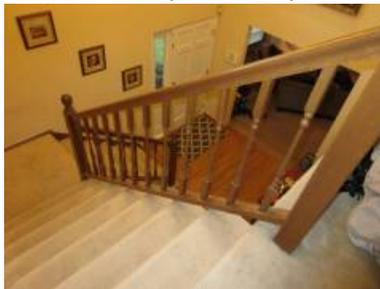
The stair railing baluster spacing is too wide. This is a hazard for small children. The baluster spacing should be reduced as a safety upgrade. Current standards require that a 4" sphere not pass through the railing.

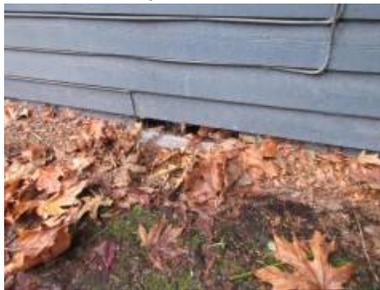
19.3 VENTILATION

The crawlspace is adequately ventilated. Vents should be kept unobstructed and clear of leaves and other organic debris. Screens should be maintained to prevent rodent entry.

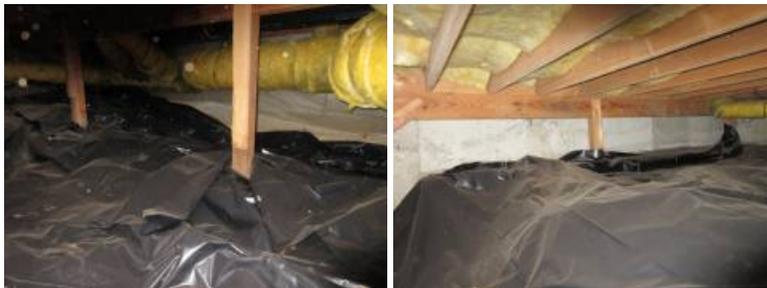
19.4 VAPOR RETARDER

The support post concrete piers are covered with the plastic vapor retarder. This allows the transmission of water vapor from the soil up and into the floor framing. The plastic vapor retarder should be removed from the pier so that it covers the entire surface of the soil only.
