NOTICE TO BUYER: SELLER-PROCURED INSPECTION REPORT

Lloyd and Jan Worthen
14120 177th AVE NE
Redmond, WA 98052

At your request, a visual inspection of the above referenced property was conducted on 04/12/2018. We have inspected the major structural components, plumbing, heating and electrical systems for signs of significant non-performance, excessive or unusual wear and general state of repair.

14120 177th Ave. NE
Redmond WA.

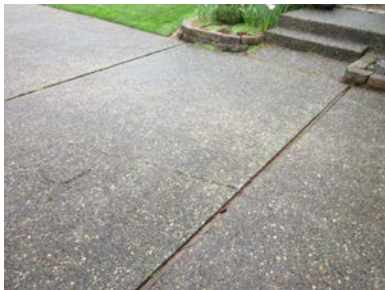
2.4 DRIVEWAY

One or more of the wooden dividers separating the concrete driveway sections were infested by wood destroying organisms and have deteriorated to a point where they are becoming a trip hazard. Replacement with mortar is recommended.

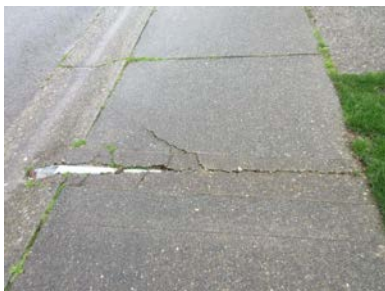
2.6 WALKWAY

The gaps separating the concrete walkway sections are a trip hazard. Replacement with mortar is recommended.

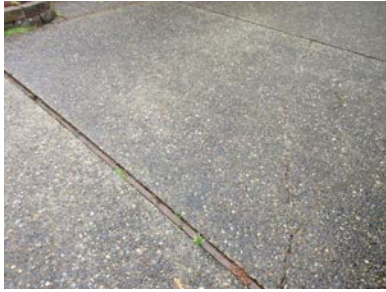
The wooden dividers separating the concrete walkway sections have deteriorated to a point where the gaps

are a trip hazard. Replacement with mortar is recommended.

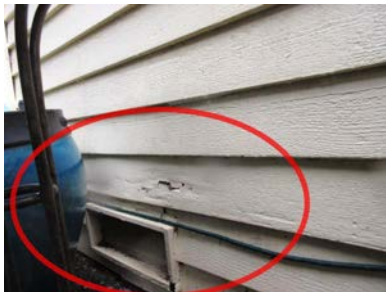
3.1 PRIMARY EXTERIOR WALL CLADDING

Portions of the walls under the dining room window are rotted where they have had chronic contact with moisture. Rot damaged material should be repaired and protected from chronic contact with moisture.

3.1 Primary Exterior Wall Cladding – Will be fixed by Seller prior to closing.

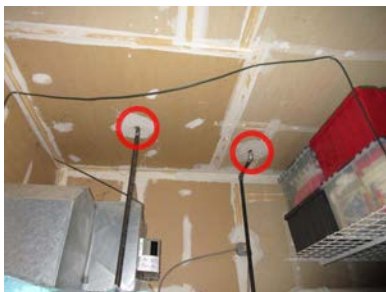
6.4 FIRE SEPARATION

There are voids in the fire resistive barrier between the living space and garage that will allow flames to penetrate. The gypsum barrier slows the spread of a fire from the garage to the structure and/or living space. Patching the voids with a fire retardant caulk is recommended.

6.4 Fire Separation – Will be fixed by Seller prior to closing.

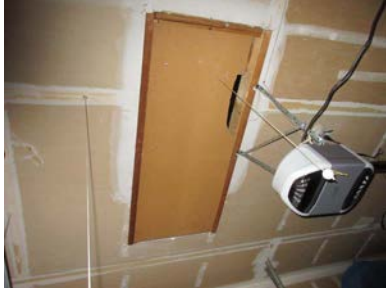
The pull down ladder is a breach in the fire resistive barrier in the garage. This is a safety concern. The gypsum barrier on the ceiling slows the spread of a fire from the garage to the attic. The installation of a layer of 5/8" gypsum type X board over the 1/4" plywood is recommended.

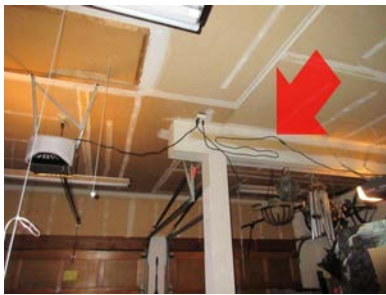
7.10 WIRING

An extension cord is used as a temporary power source for the garage door openers. An extension cord is not suitable as a permanent wiring method. The installation of a receptacle within cords length of the motors is recommended.

7.10 Wiring – Will be fixed by Seller prior to closing.

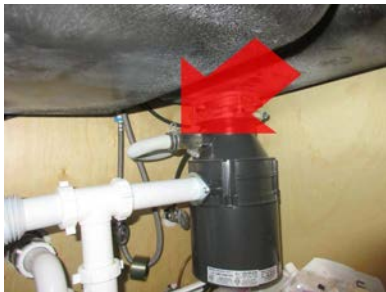
10.8 AIR GAP

The dishwasher drain lacks an air gap. The dishwasher will function without one, but there is a risk of contamination of the inside of the dishwasher by waste water. The installation of an air gap is recommended.

10.8 Air Gap – Will be fixed by Seller prior to closing.

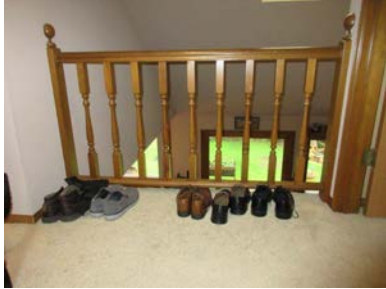
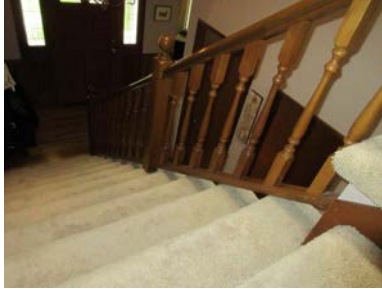
14.2 STAIRS

The stair railing baluster spacing is too wide. This is a hazard for small children. The baluster spacing should be reduced as a safety upgrade. Current standards require that a 4" sphere not pass through the railing.

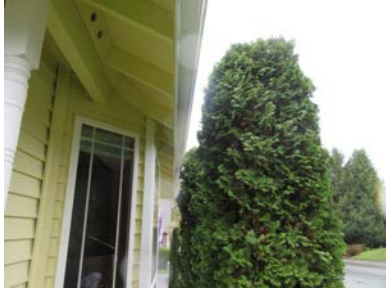
2.3 VEGETATION

Trees are nearly touching the building on the north side. Low hanging tree branches can damage the roof, siding, doors and windows. Tree branches should be trimmed back where necessary.

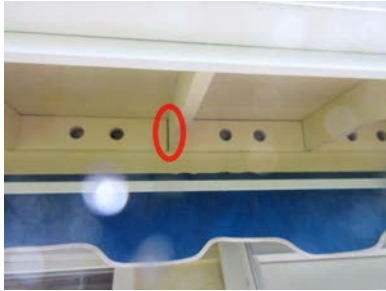
3.3 SOFFITS AND OVERHANGS

There are large gaps over 1/4" in size adjacent the soffit vent blocks. These gaps allow insects and rodents to enter the attic. Covering the gaps with screening, a strip of wood and/or caulking is recommended.

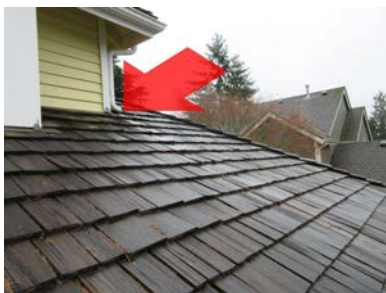
3.4 GUTTERS AND DOWNSPOUTS

Downspouts draining directly onto the asphalt shingle surface causes excessive wear of the roofing material. Downspout extensions to the lower gutters should be installed to prevent excessive wear and tear of the roofing.

3.4 Gutters & Downspouts – To be done if requested.

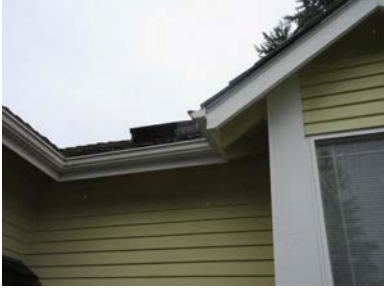
The gutters are leaking. The end joints should be cleaned and sealed with "Gutter Seal" or a similar type gutter joint sealant.

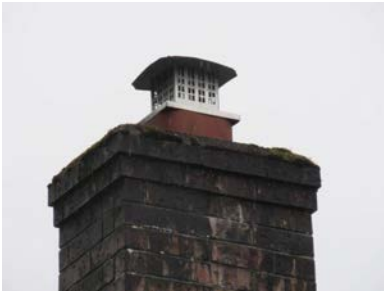
4.4 CHIMNEYS

Moss/vegetation was observed in several areas around the upper portion of the chimney. This will lead to accelerated deterioration of the brick masonry mortar. We recommend removal of all organic growth. Damaged areas can be repaired by filling in cutout or defective mortar joints with fresh mortar. (Tuck pointing)

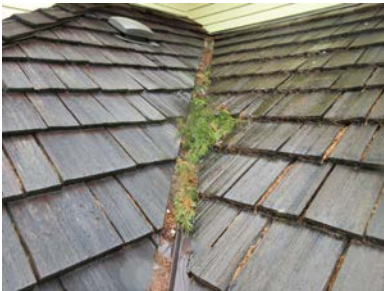
4.7 MAINTENANCE AND REPAIRS

The roof is in need of routine maintenance. The surface should be blown off or washed with a high volume low pressure garden hose to remove moss and organic debris. Performing this maintenance will improve the appearance and increase the life expectancy of the roof.

4.7 Maintenance & Repairs – To be done if requested.

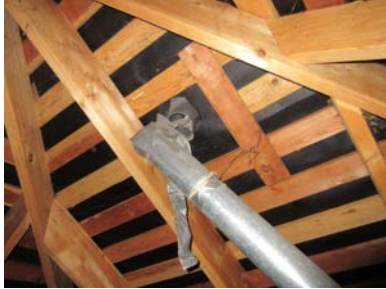
5.3 MECHANICAL VENTILATION SYSTEMS

The duct for the master bedroom bathroom vent fan has become detached in the attic. This allows moisture laden air to be discharged in the attic rather than outside. This is an undesirable condition that causes excessive moisture in the attic and can result in mold or fungus growth. The duct should be reconnected and secured.

5.3 Mechanical Ventilation Systems – Will be fixed by Seller prior to closing.

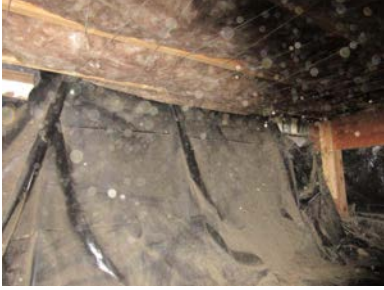
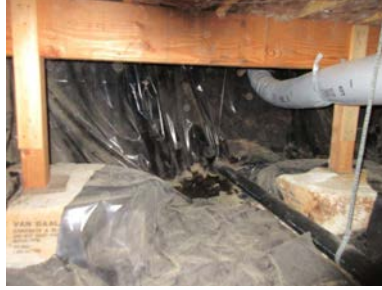
The foundation walls are covered with the plastic vapor retarder. This allows the transmission of water vapor from the soil up and into the exterior wall framing. The plastic vapor retarder should be removed from the foundation so that it covers the entire surface of the soil only.

The support post concrete piers are covered with the plastic vapor retarder. This allows the transmission of water vapor from the soil up and into the floor framing. The plastic vapor retarder should be removed from the pier so that it covers the entire surface of the soil only.

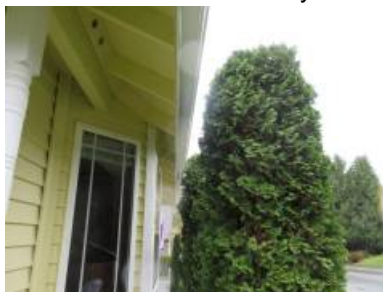
Trees are nearly touching the building on the north side. Low hanging tree branches can damage the roof, siding, doors and windows. Tree branches should be trimmed back where necessary.

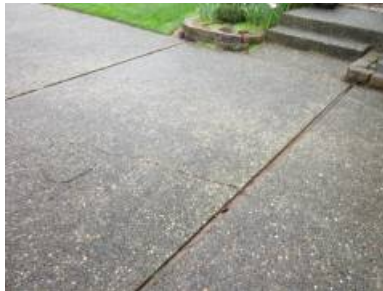
2.4 DRIVEWAY

One or more of the wooden dividers separating the concrete driveway sections were infested by wood destroying organisms and have deteriorated to a point where they are becoming a trip hazard. Replacement with mortar is recommended.

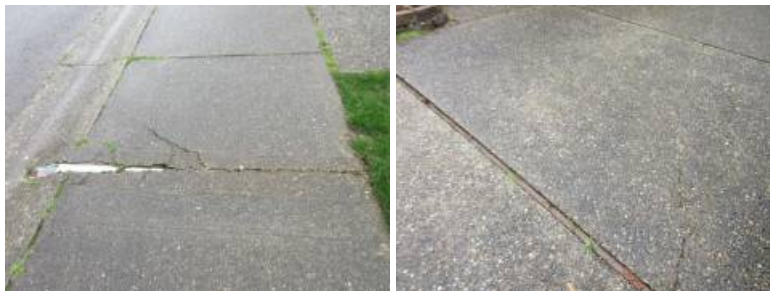
The wooden dividers separating the concrete walkway sections have deteriorated to a point where the gaps are a trip hazard. Replacement with mortar is recommended.

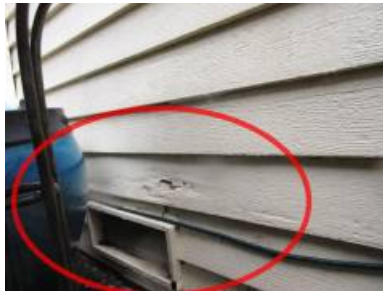
Portions of the walls under the dining room window are rotted where they have had chronic contact with moisture. Rot damaged material should be repaired and protected from chronic contact with moisture.

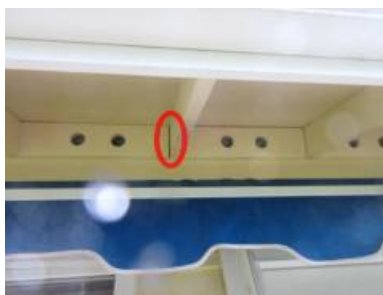
There are soffit vent screens that are damaged. This is allowing birds to enter the attic. Quarter inch wire mesh should be installed over the vent holes.

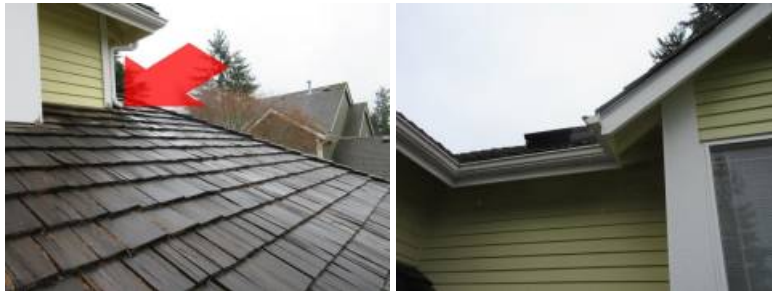
The gutters are leaking. The end joints should be cleaned and sealed with "Gutter Seal" or a similar type gutter joint sealant.

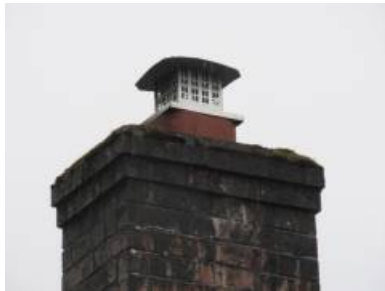
Moss/vegetation was observed in several areas around the upper portion of the chimney. This will lead to accelerated deterioration of the brick masonry mortar. We recommend removal of all organic growth. Damaged areas can be repaired by filling in cutout or defective mortar joints with fresh mortar. (Tuck pointing)

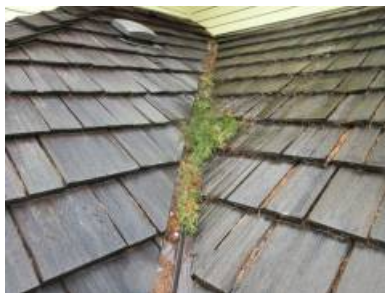
4.7 MAINTENANCE AND REPAIRS

The roof is in need of routine maintenance. The surface should be blown off or washed with a high volume low pressure garden hose to remove moss and organic debris. Performing this maintenance will improve the appearance and increase the life expectancy of the roof.

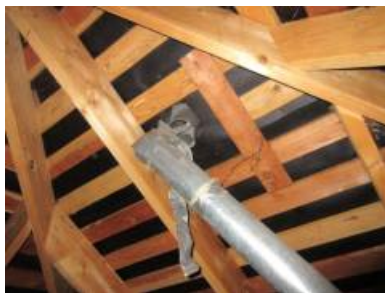
5.3 MECHANICAL VENTILATION SYSTEMS

The duct for the master bedroom bathroom vent fan has become detached in the attic. This allows moisture laden air to be discharged in the attic rather than outside. This is an undesirable condition that causes excessive moisture in the attic and can result in mold or fungus growth. The duct should be reconnected and secured.

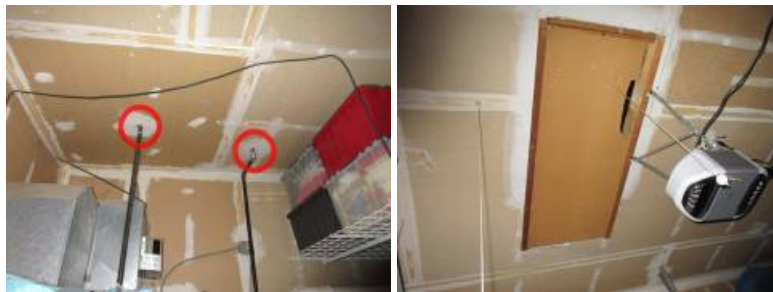
The pull down ladder is a breach in the fire resistive barrier in the garage. This is a safety concern. The gypsum barrier on the ceiling slows the spread of a fire from the garage to the attic. The installation of a layer of 5/8" gypsum type X board over the 1/4" plywood is recommended.

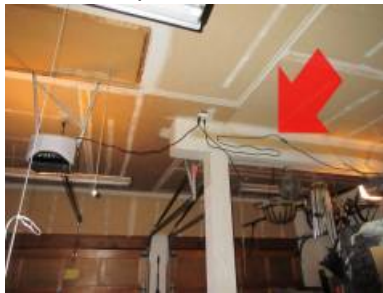
An extension cord is used as a temporary power source for the garage door openers. An extension cord is not suitable as a permanent wiring method. The installation of a receptacle within cords length of the motors is recommended.

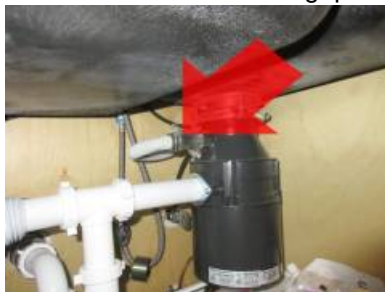
The dishwasher drain lacks an air gap. The dishwasher will function without one, but there is a risk of contamination of the inside of the dishwasher by waste water. The installation of an air gap is recommended.

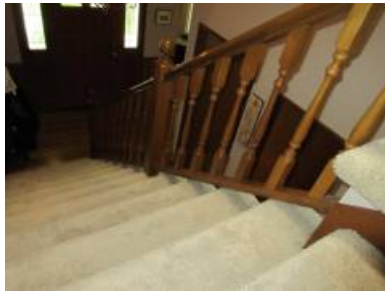
The stair railing baluster spacing is too wide. This is a hazard for small children. The baluster spacing should be reduced as a safety upgrade. Current standards require that a 4" sphere not pass through the railing.

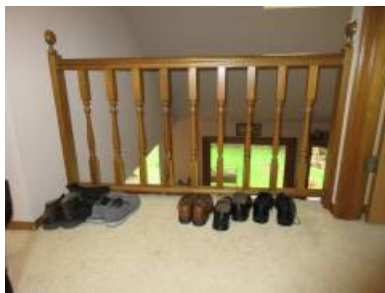
14.3 GUARD RAILINGS

The spacing between the balusters is too wide. This is a hazard to small children. The balusters should be spaced close enough together so that a 4" sphere cannot pass through. Upgrading the guard railing is recommended if small children are present.

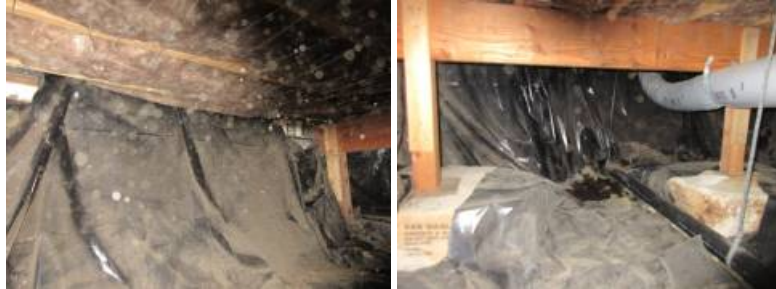
The support post concrete piers are covered with the plastic vapor retarder. This allows the transmission of water vapor from the soil up and into the floor framing. The plastic vapor retarder should be removed from the pier so that it covers the entire surface of the soil only.

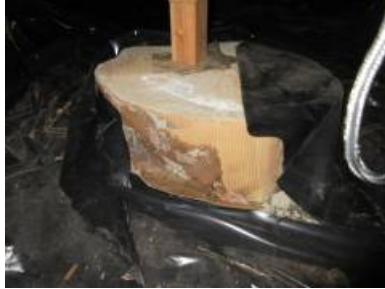
Good building practice requires that foundation walls or pier footings supporting wood frame construction, should extend at least 8" above the finish grade with at least a 6" clearance between the top of the soil and the bottom of the wood finish materials. Untreated wood should be raised 1-2" above surrounding flatwork and should have a moisture barrier such as 30 lb. asphalt impregnated felt installed between the concrete and wood. For additional information and treatment options, you should retain the services of a qualified pest control operator.
