NOTICE TO BUYER: SELLER-PROCURED INSPECTION REPORT

Lloyd and Jan Worthen
14120 177th AVE NE
Redmond, WA 98052

At your request, a visual inspection of the above referenced property was conducted on 04/12/2018. We have inspected the major structural components, plumbing, heating and electrical systems for signs of significant non-performance, excessive or unusual wear and general state of repair.

14120 177th Ave. NE
Redmond WA.

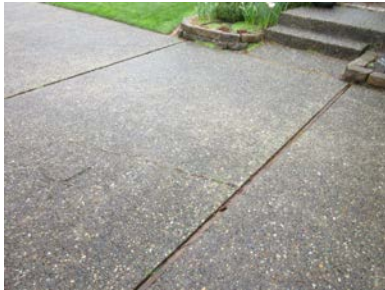
2.4 DRIVEWAY

One or more of the wooden dividers separating the concrete driveway sections were infested by wood destroying organisms and have deteriorated to a point where they are becoming a trip hazard. Replacement with mortar is recommended.

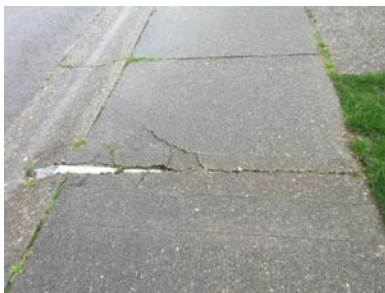
2.6 WALKWAY

The gaps separating the concrete walkway sections are a trip hazard. Replacement with mortar is recommended.

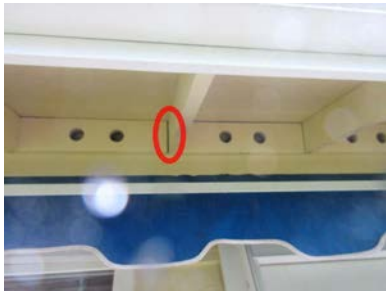
3.3 SOFFITS AND OVERHANGS

There are large gaps over 1/4" in size adjacent the soffit vent blocks. These gaps allow insects and rodents to enter the attic. Covering the gaps with screening, a strip of wood and/or caulking is recommended.

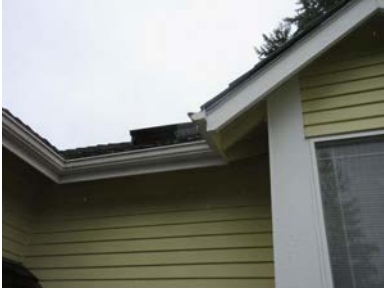
The gutters are leaking. The end joints should be cleaned and sealed with "Gutter Seal" or a similar type gutter joint sealant.

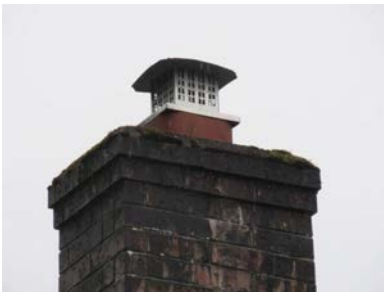
4.4 CHIMNEYS

Moss/vegetation was observed in several areas around the upper portion of the chimney. This will lead to accelerated deterioration of the brick masonry mortar. We recommend removal of all organic growth. Damaged areas can be repaired by filling in cutout or defective mortar joints with fresh mortar. (Tuck pointing)

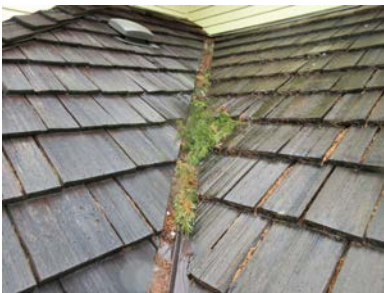
4.7 MAINTENANCE AND REPAIRS

The roof is in need of routine maintenance. The surface should be blown off or washed with a high volume low pressure garden hose to remove moss and organic debris. Performing this maintenance will improve the appearance and increase the life expectancy of the roof.

4.7 Maintenance & Repairs – To be done if requested.

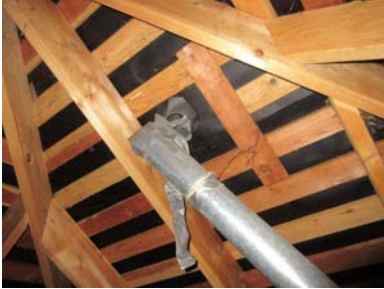
5.3 MECHANICAL VENTILATION SYSTEMS

The duct for the master bedroom bathroom vent fan has become detached in the attic. This allows moisture laden air to be discharged in the attic rather than outside. This is an undesirable condition that causes excessive moisture in the attic and can result in mold or fungus growth. The duct should be reconnected and secured.

5.3 Mechanical Ventilation Systems – Will be fixed by Seller prior to closing.

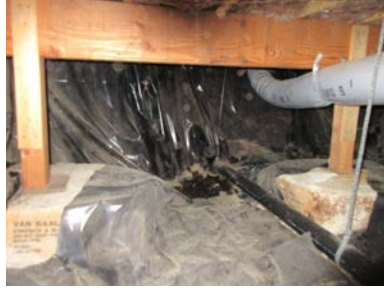
The foundation walls are covered with the plastic vapor retarder. This allows the transmission of water vapor from the soil up and into the exterior wall framing. The plastic vapor retarder should be removed from the foundation so that it covers the entire surface of the soil only.

The support post concrete piers are covered with the plastic vapor retarder. This allows the transmission of water vapor from the soil up and into the floor framing. The plastic vapor retarder should be removed from the pier so that it covers the entire surface of the soil only.

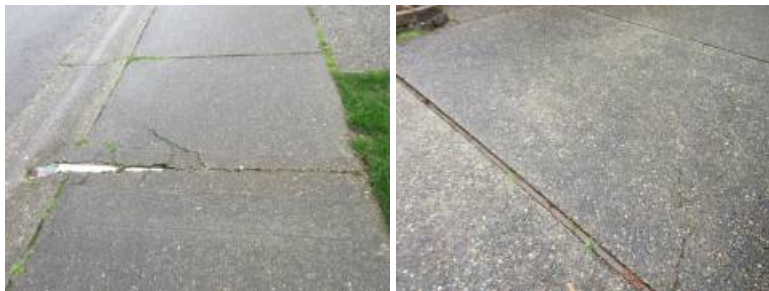
The wooden dividers separating the concrete walkway sections have deteriorated to a point where the gaps are a trip hazard. Replacement with mortar is recommended.

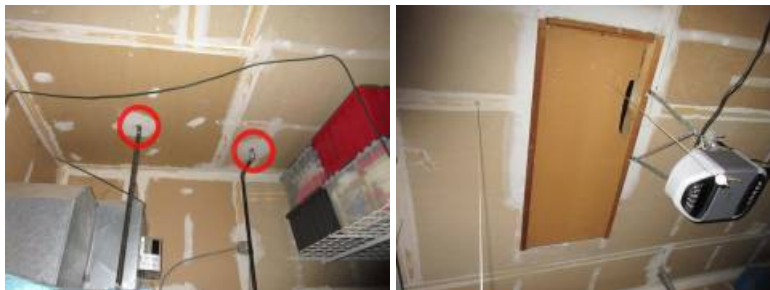
The pull down ladder is a breach in the fire resistive barrier in the garage. This is a safety concern. The gypsum barrier on the ceiling slows the spread of a fire from the garage to the attic. The installation of a layer of 5/8" gypsum type X board over the 1/4" plywood is recommended.
