## **William and Brenda Millhollin**

15107 103<sup>rd</sup> Av NE, Bothell Wa. 98011

At your request, a visual inspection of the above referenced property was conducted on 05/16/2018. We have inspected the major structural components, plumbing, heating and electrical systems for signs of significant non-performance, excessive or unusual wear and general state of repair.

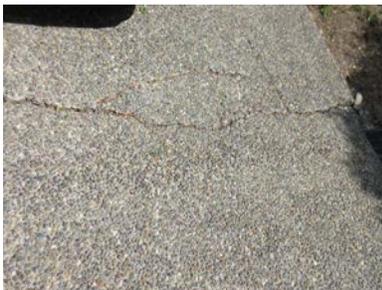
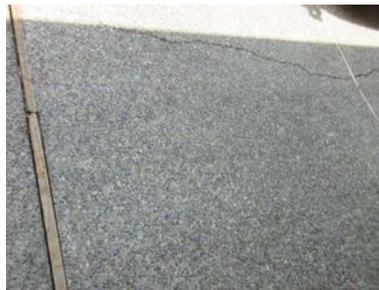
### 2.4 DRIVEWAY

The driveway has cracked and settled differentially. This was probably caused by inadequate preparation of the soil prior to the placement of the concrete. This condition can be repaired by pressure grouting the sunken portion of the driveway or by removing and replacing it. The driveway remains functional despite this condition.

One or more of the wooden dividers separating the concrete driveway sections were infested by wood destroying organisms and have deteriorated to a point where they are becoming a trip hazard. Replacement with mortar is recommended.

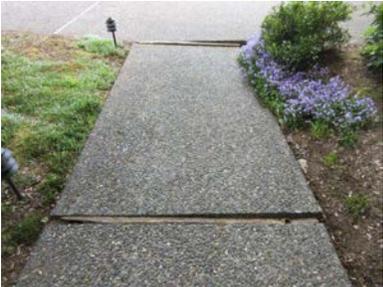
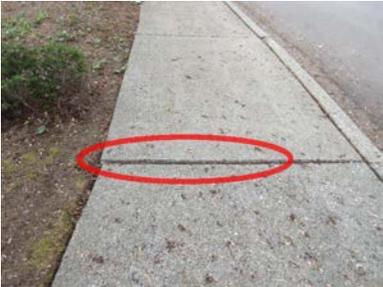
### 2.6 WALKWAY

The walkway has cracked and settled differentially. This was probably caused by inadequate preparation of the soil prior to the placement of the concrete. This condition can be repaired by pressure grouting the sunken portion of the walkway or by removing and replacing it. The walkway remains functional despite this condition. However, the raised edges of the concrete can be a trip hazard for some people. Grinding down the raised edges of the concrete will mitigate the hazard. Repairs should be made as necessary.

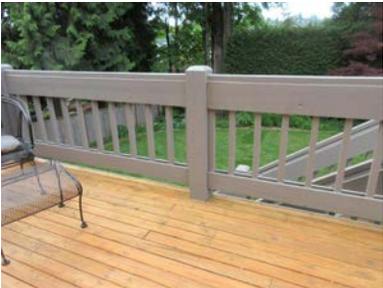
**3.8 DECK RAILINGS**

The spacing between the balusters is too wide. This is a hazard to small children. The balusters should be spaced close enough together so that a 4" sphere cannot pass through. Upgrading the deck railing is recommended if small children are present.

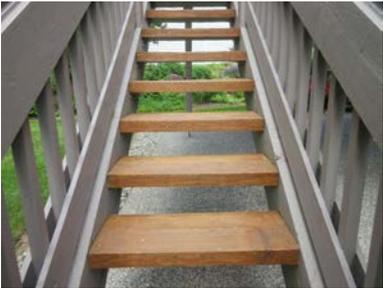
**3.9 STAIRS**

The stair rise spacing is too wide. This is a hazard for small children. The spacing should be reduced as a safety upgrade. Current standards require that a 4" sphere not pass through the opening.

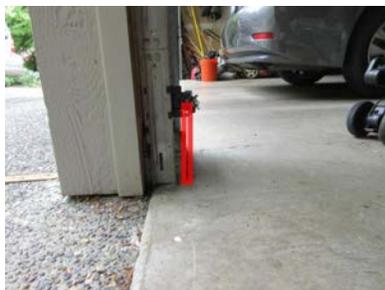
**6.3 GARAGE DOOR OPENER**

The Photo-eye beam for the single garage door was installed too high above the floor of the garage to adequately offer protection for small children and/or pets. We recommend that the photo-eye be lowered to within 4-6" of the floor.

6.3 Garage Door Opener – corrected

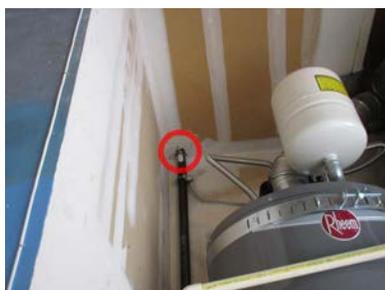
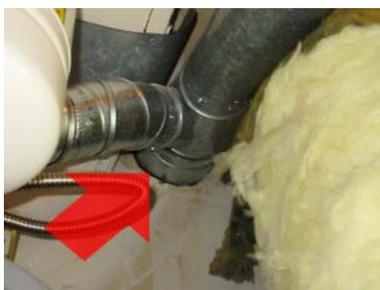
#### 6.4 FIRE SEPARATION

There are voids in the fire resistive barrier between the living space and garage that will allow flames to penetrate. The gypsum barrier slows the spread of a fire from the garage to the structure and/or living space. Patching the voids with a fire retardant caulk is recommended.

6.4 Fire Separation – corrected

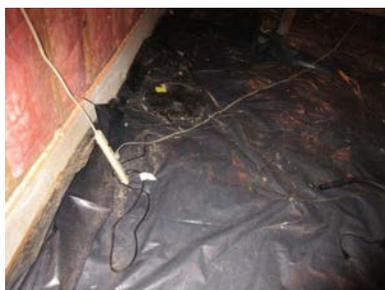
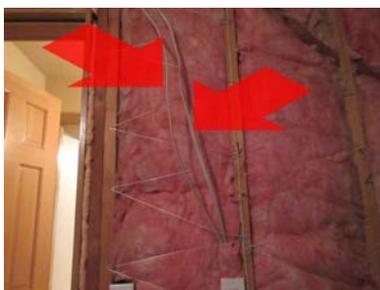
#### 7.10 WIRING

Lamp cord wire or "zip cord" is used as a permanent wiring method in the crawlspace. This is a potential fire hazard. The lamp cord wire should be removed and replaced with an approved wiring method.

A loose electrical cable was observed in the crawlspace. Loose cables are vulnerable to damage. All loose cables should be secured at 4' intervals using approved cable staples.

7.10 Wiring – corrected

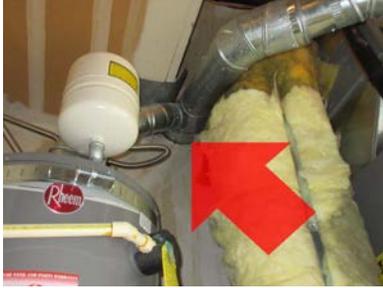
### 8.10 VENT

The furnace vent connector is too close to a combustible material. This is a hazard. A minimum clearance of 6" is required between the single wall vent connector and the combustible material. The double wall type B vent requires only 1" of clearance. Repairs are recommended.

8.10 Vent – corrected

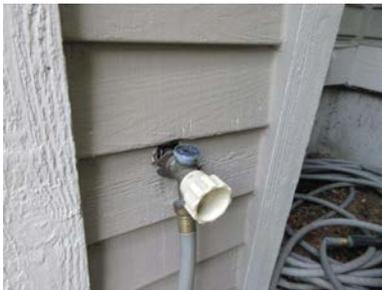
#### *3.3 PEST CONTROL*

There are openings adjacent the hose bibb through which rodents can enter into the structure. These openings should be covered with wood, wire mesh or filled with aerosol foam.

3.3 Pest Control – corrected

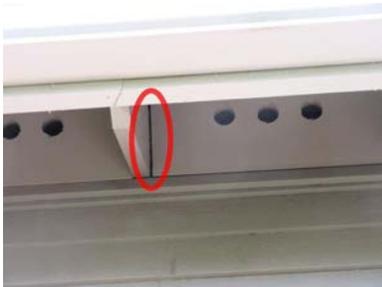
#### *3.4 SOFFITS AND OVERHANGS*

There are large gaps over 1/4" in size adjacent the soffit vent blocks. These gaps allow insects and rodents to enter the attic. Covering the gaps with screening, a strip of wood and/or caulking is recommended.

3.4 Soffits and Overhangs – corrected

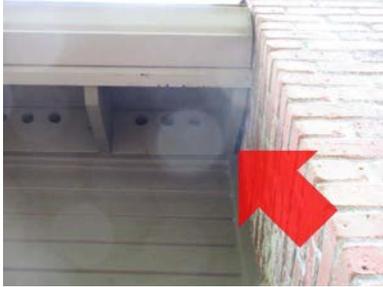
There are openings at the intersection between the overhang and the chimney through which birds and rodents can enter into the attic. These openings should be covered with wood, wire mesh or filled with aerosol foam.

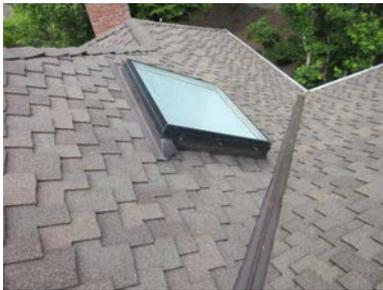
### 4.3 SKYLIGHTS

One of the skylights is not secured to the roof. Skylights can get blown off roofs during high winds if they are not secured. Fastening the skylight to the curb with four plated or stainless screws is recommended.

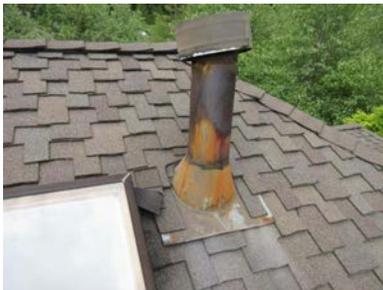
### 4.5 GAS APPLIANCE VENTS

The gas appliance vent is corroded above the roof line. Cleaning and painting the vent will prolong its service life.

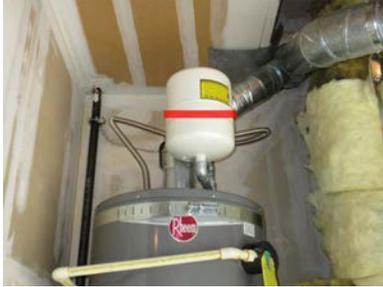
### 10.6 EXPANSION TANK

The expansion tank is not adequately secured to the wall. This could result in damage to the water pipe and leakage during an earth quake. A seismic restraint should be installed to secure the expansion tank.

10.6 Expansion Tank – corrected

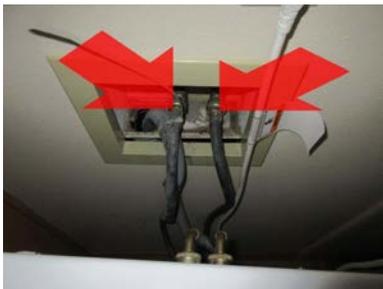
### 13.8 APPLIANCES

Upgrading the washer connections to high pressure (steel braided) lines is recommended.

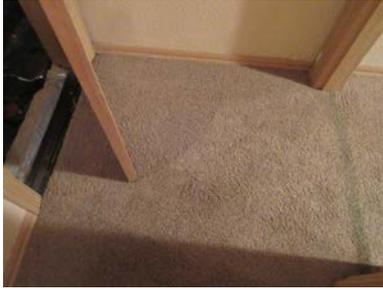
Some of the doors are missing their door stops. This condition will lead to damage of the wall surfaces. Door stops should be installed where necessary.

One of the doors rubs on the carpeting. This can damage the carpet. The doors threshold should be adjusted.

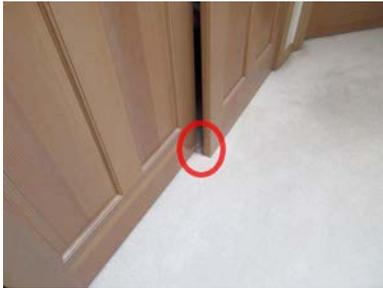
### 15.5 CLOSET DOORS

The floor guides are damaged at the bypass closet doors in the bedroom. Missing floor guides could result in damage to the doors. The installation of floor guides is recommended.

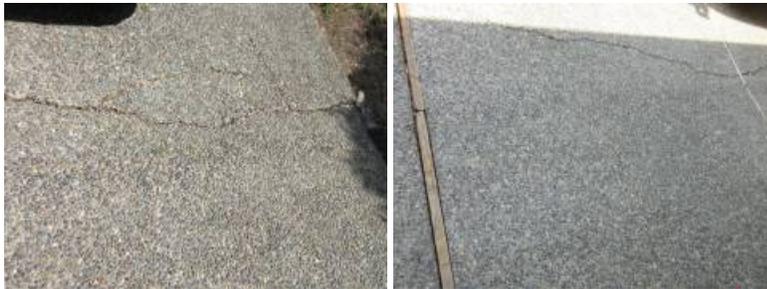
The driveway has cracked and settled differentially. This was probably caused by inadequate preparation of the soil prior to the placement of the concrete. This condition can be repaired by pressure grouting the sunken portion of the driveway or by removing and replacing it. The driveway remains functional despite this condition.

One or more of the wooden dividers separating the concrete driveway sections were infested by wood destroying organisms and have deteriorated to a point where they are becoming a trip hazard. Replacement with mortar is recommended.

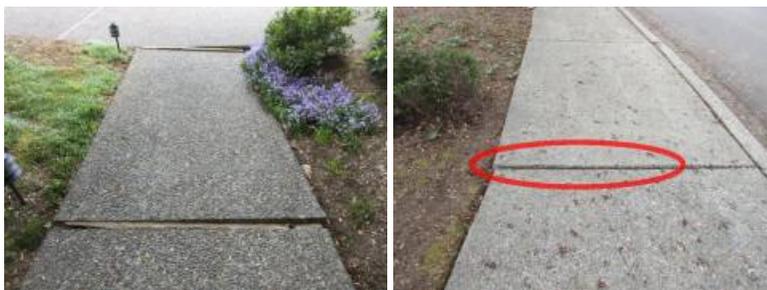
The walkway has cracked and settled differentially. This was probably caused by inadequate preparation of the soil prior to the placement of the concrete. This condition can be repaired by pressure grouting the sunken portion of the walkway or by removing and replacing it. The walkway remains functional despite this condition. However, the raised edges of the concrete can be a trip hazard for some people. Grinding down the raised edges of the concrete will mitigate the hazard. Repairs should be made as necessary.

Many legal and public works departments have defined a trip hazard as an irregularity in a walking surface exceeding one inch (1") in height. All walking surfaces should maintain, free of a vertical surface change of 3/4" or more, in the interest of public and personal safety.

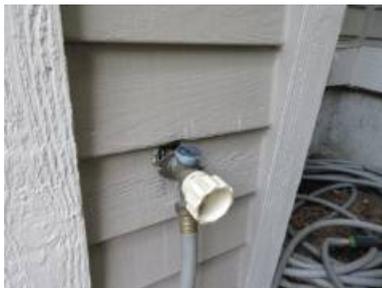
There are openings adjacent the hose bibb through which rodents can enter into the structure. These openings should be covered with wood, wire mesh or filled with aerosol foam.

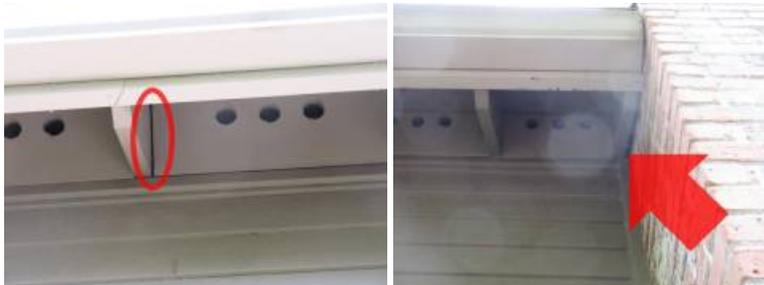
There are openings at the intersection between the overhang and the chimney through which birds and rodents can enter into the attic. These openings should be covered with wood, wire mesh or filled with aerosol foam.

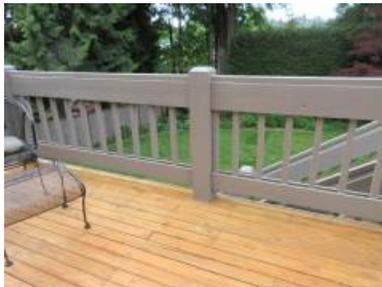
### 3.8 DECK RAILINGS

The spacing between the balusters is too wide. This is a hazard to small children. The balusters should be spaced close enough together so that a 4" sphere cannot pass through. Upgrading the deck railing is recommended if small children are present.

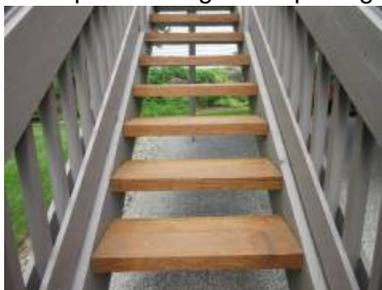
### 3.9 STAIRS

The stair rise spacing is too wide. This is a hazard for small children. The spacing should be reduced as a safety upgrade. Current standards require that a 4" sphere not pass through the opening.

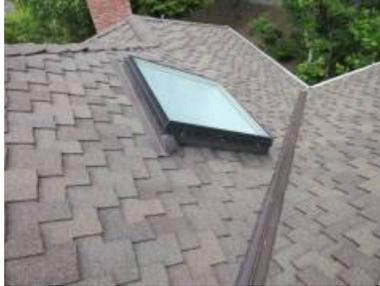
One of the skylights is not secured to the roof. Skylights can get blown off roofs during high winds if they are not secured. Fastening the skylight to the curb with four plated or stainless screws is recommended.

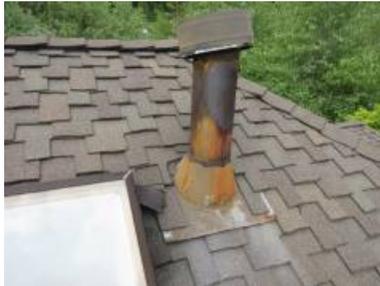
#### 4.5 GAS APPLIANCE VENTS

The gas appliance vent is corroded above the roof line. Cleaning and painting the vent will prolong its service life.

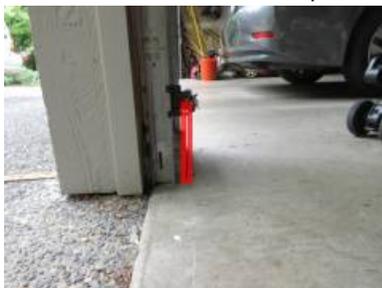
The Photo-eye beam for the single garage door was installed to high above the floor of the garage to adequately offer protection for small children and/or pets. We recommend that the photo-eye be lowered to within 4-6" of the floor.

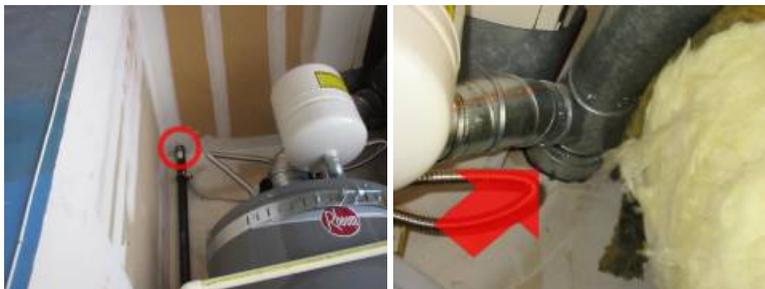
#### 6.4 FIRE SEPARATION

There are voids in the fire resistive barrier between the living space and garage that will allow flames to penetrate. The gypsum barrier slows the spread of a fire from the garage to the structure and/or living space. Patching the voids with a fire retardant caulk is recommended.

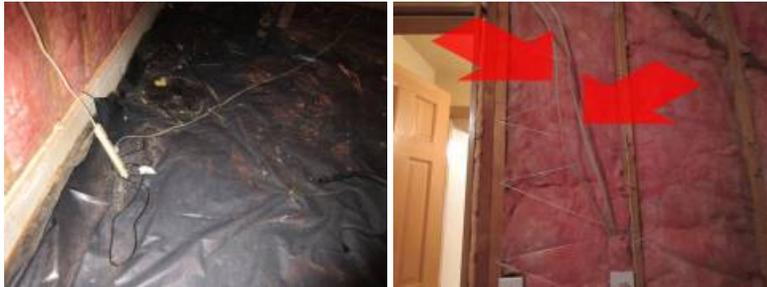
A loose electrical cable was observed in the crawlspace. Loose cables are vulnerable to damage. All loose cables should be secured at 4' intervals using approved cable staples.

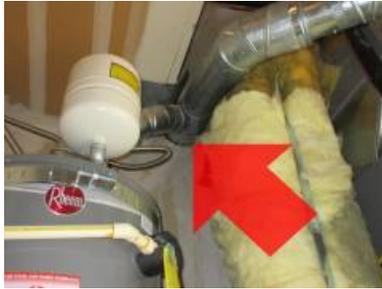
The furnace vent connector is too close to a combustible material. This is a hazard. A minimum clearance of 6" is required between the single wall vent connector and the combustible material. The double wall type B vent requires only 1" of clearance. Repairs are recommended.

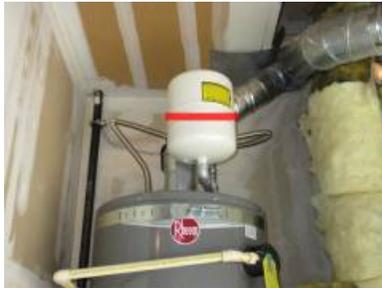
The expansion tank is not adequately secured to the wall. This could result in damage to the water pipe and leakage during an earth quake. A seismic restraint should be installed to secure the expansion tank.

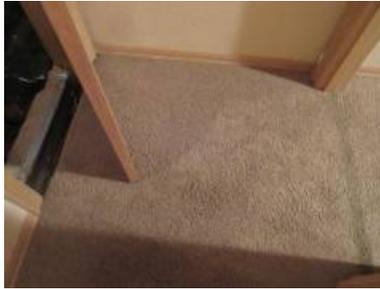
Some of the doors are missing their door stops. This condition will lead to damage of the wall surfaces. Door stops should be installed where necessary.

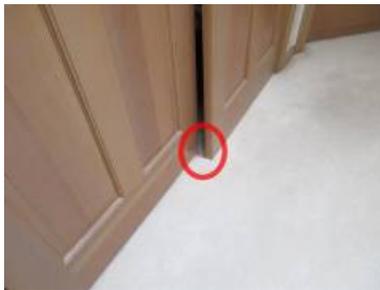
### 15.5 CLOSET DOORS

The floor guides are damaged at the bypass closet doors in the bedroom. Missing floor guides could result in damage to the doors. The installation of floor guides is recommended.
