NOTICE TO BUYER: SELLER-PROCURED INSPECTION REPORT

The following notice is given with respect to the Purchase and Sale Agreement dated _____
between _____ (“Buyer”)
and William and Lydia Brinton (“Seller”)
concerning 460 Rosario Place NE Renton, WA 98059 (“the Property”).

Aaron and Lydia Brinton
460 Rosario Place NE
Renton, WA 98059

460 Rosario Pl. NE
Renton WA.

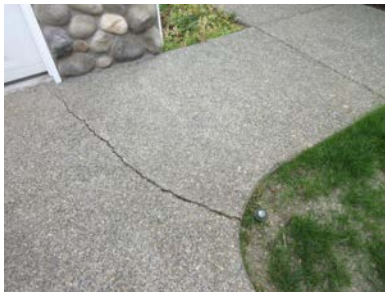
2.6 WALKWAY

The walkway has cracked and settled differentially. The walkway remains functional despite this condition. However, the raised edges of the concrete can be a trip hazard for some people. Grinding down the raised edges of the concrete will mitigate the hazard. Repairs should be made as necessary.

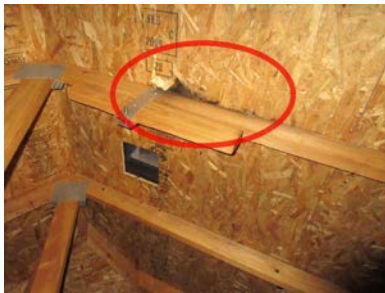
5.5 LEAKAGE

There is evidence of an active roof leak in the area above the hallway. Repairs are recommended.

When the original roof was installed, the safety anchors (what the roofers clip their ropes onto) weren't properly sealed. This is a very minor repair of \$475 for the two anchors to be properly sealed (the one that is leaking and the other one that is not leaking as a preventative measure). North Creek Roofing will do the repair on June 27th (weather permitting).

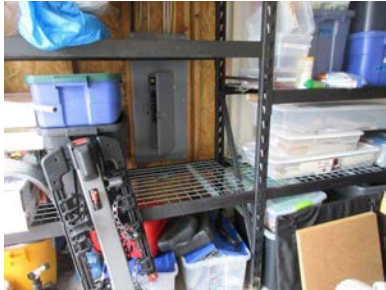
7.8 SERVICE PANEL

Access to the service panel was limited by shelves in front of the panel cover. A 36" clearance should be maintained in front of the panel cover.

The shelves in front of the panel were bought by a neighbor so they won't be here after we move.

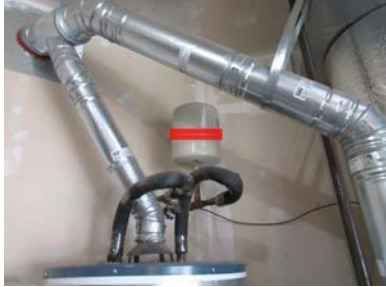
9.6 EXPANSION TANK

The expansion tank is not adequately secured to the wall. This could result in damage to the water pipe and leakage during an earth quake. A seismic restraint should be installed to secure the expansion tank.

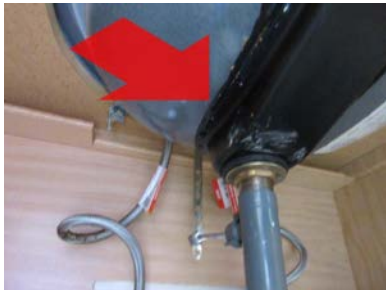
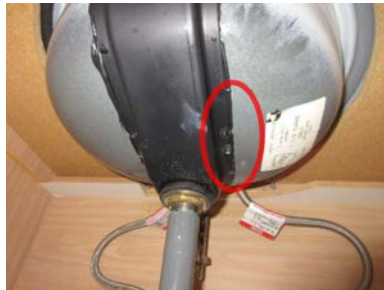
11.19 SINK

The sinks are leaking at the overflow drain welds. Replacement of the sinks is recommended.

Both Sinks in the master bathroom have been replaced

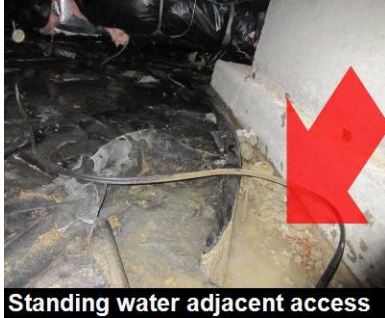
19.2 MOISTURE

Standing water in the crawlspace creates moisture problems inside the house, causes mold and fungus growth and creates conditions that are conducive to wood destroying organisms. Action should be taken to remediate this condition. The most common repair consists of installing a perimeter drainage system on the inside of the crawlspace that collects incoming water and diverts it into a drain or sump pump. Consult with a contractor specializing in ground water mitigation systems for additional information and cost estimates.

Wu Construction installed a full interior perimeter french drain and sump pump drain system on June 19th, 2018. This system eliminates any standing water in the crawl space. The french drain portion of the system comes with a 25 year written warranty that transfers to new owners as house is sold. The sump pump comes with a three year manufacturers warranty and a one year service warranty. The crawl space is completely cleaned up including:

- Loose insulation has been reinstalled
- All debris and old vapor barriers have been removed
- New black 6mm plastic vapor barrier has been installed

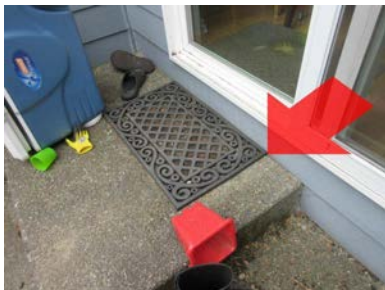
3.2 PEST CONTROL

Untreated wood in direct contact with concrete was observed along the patio stoop. Untreated wood should be raised 1-2" above the concrete. Treating the wood with a preservative sometimes will prevent wood destroy organism damage.

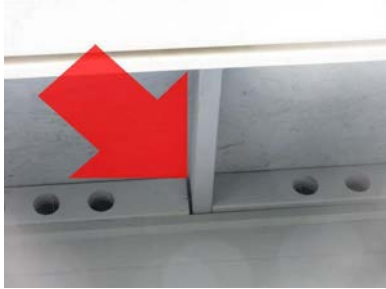
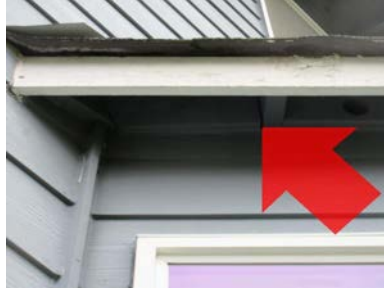
3.3 SOFFITS AND OVERHANGS

There are large gaps over 1/4" in size adjacent the soffit vent blocks. These gaps allow insects and rodents to enter the attic. Covering the gaps with screening, a strip of wood and/or caulking is recommended.

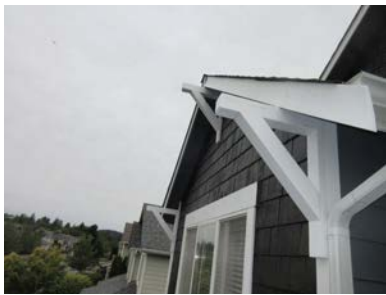
The beams that stick out beyond the drip edge of the roof are vulnerable to rot damage. They should be covered with a metal cap flashing or cut off flush with the edge of the overhang.

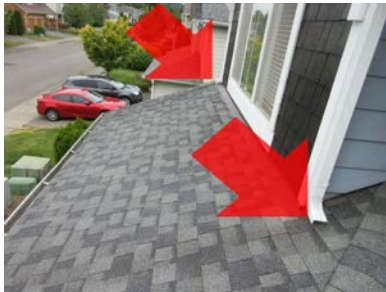
3.4 GUTTERS AND DOWNSPOUTS

Downspouts draining directly onto the asphalt shingle surface causes excessive wear of the roofing material. Downspout extensions to the lower gutters should be installed to prevent excessive wear and tear of the roofing.

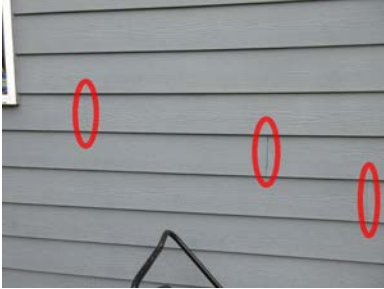
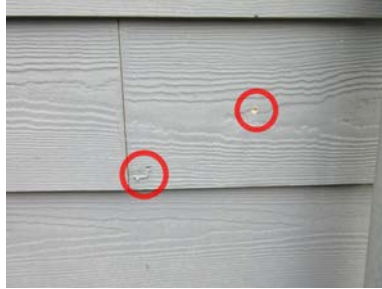
3.5 PAINT

The bottom edge of the lower sections of siding on the exterior are unprotected. Paint protects the siding from moisture absorption. Painting of the exposed edges is recommended.

Siding nails that have damaged the surface overlay need to be caulked and end joint caulking that has cracked and failed needs repair/replacement. Caulking prevents water intrusion into the wall, damage usually occurs to the substrate when the exterior gaps and joints are not sealed. Consideration should be given to caulking the siding as necessary. Exterior caulking is recommended.

Localized areas of peeling paint were noted on numerous trim boards. Paint protects the wood from cupping, checking, warping and rot. These areas should be scraped, primed and repainted.

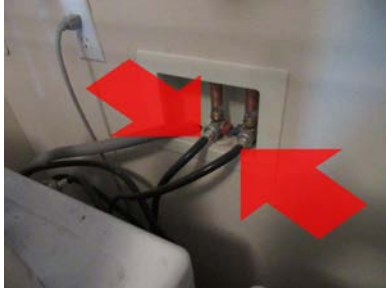
12.1 APPLIANCES

Upgrading the washer connections to high pressure (steel braided) lines is recommended.

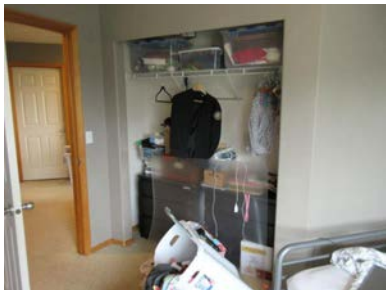
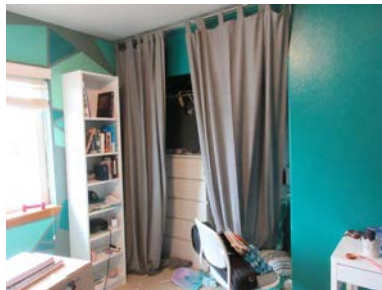
14.6 CLOSET DOORS

Closet doors are missing in two of the bedrooms.

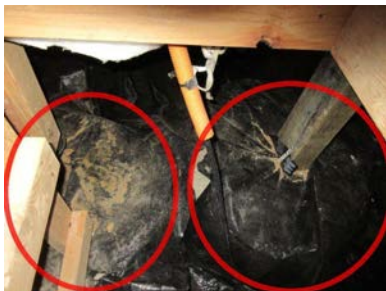
19.4 VAPOR RETARDER

The support post concrete piers are covered with the plastic vapor retarder. This allows the transmission of water vapor from the soil up and into the floor framing. The plastic vapor retarder should be removed from the pier so that it covers the entire surface of the soil only.

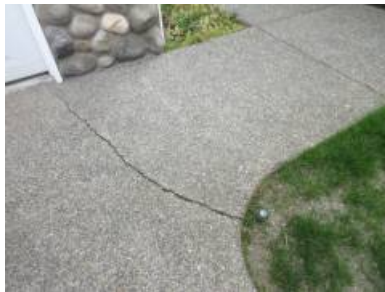
Many legal and public works departments have defined a trip hazard as an irregularity in a walking surface exceeding one

inch (1") in height. All walking surfaces should maintain, free of a vertical surface change of 3/4" or more, in the interest of public and personal safety.

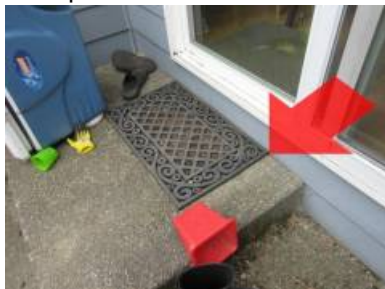
Untreated wood in direct contact with concrete was observed along the patio stoop. Untreated wood should be raised 1-2" above the concrete. Treating the wood with a preservative sometimes will prevent wood destroy organism damage.

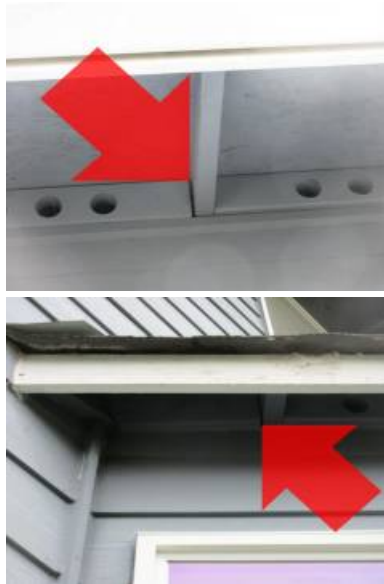
3.3 SOFFITS AND OVERHANGS

There are large gaps over 1/4" in size adjacent the soffit vent blocks. These gaps allow insects and rodents to enter the attic. Covering the gaps with screening, a strip of wood and/or caulking is recommended.

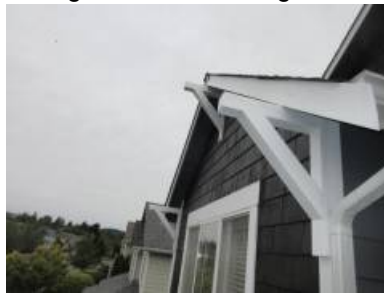
The beams that stick out beyond the drip edge of the roof are vulnerable to rot damage. They should be covered with a metal cap flashing or cut off flush with the edge of the overhang.

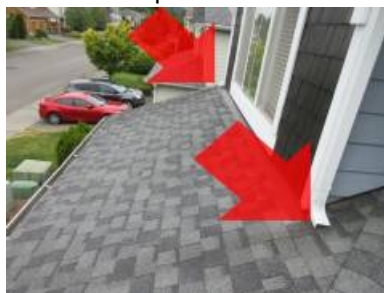
3.4 GUTTERS AND DOWNSPOUTS

Downspouts draining directly onto the asphalt shingle surface causes excessive wear of the roofing material. Downspout extensions to the lower gutters should be installed to prevent excessive wear and tear of the roofing.

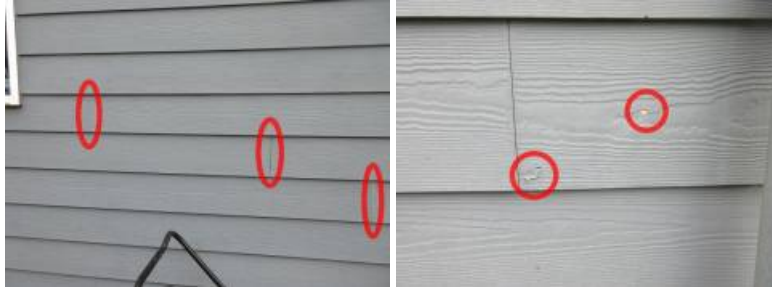
3.5 PAINT

The bottom edge of the lower sections of siding on the exterior are unprotected. Paint protects the siding from moisture

Siding nails that have damaged the surface overlay need to be caulked and end joint caulking that has cracked and failed needs repair/replacement. Caulking prevents water intrusion into the wall, damage usually occurs to the substrate when the exterior gaps and joints are not sealed. Consideration should be given to caulking the siding as necessary. Exterior caulking is recommended.

Localized areas of peeling paint were noted on numerous trim boards. Paint protects the wood from cupping, checking, warping and rot. These areas should be scraped, primed and repainted.

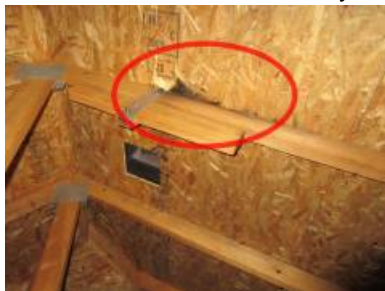
5.5 LEAKAGE

There is evidence of an active roof leak in the area above the hallway. Repairs are recommended.

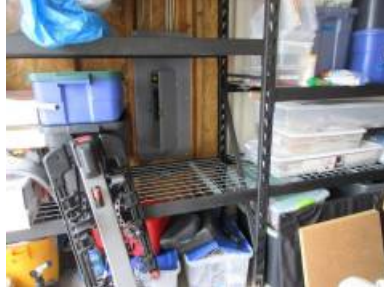
Access to the service panel was limited by shelves in front of the panel cover. A 36" clearance should be maintained in front of the panel cover.

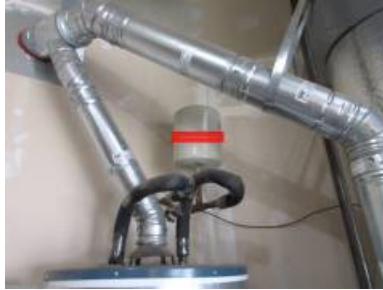
The expansion tank is not adequately secured to the wall. This could result in damage to the water pipe and leakage during an earth quake. A seismic restraint should be installed to secure the expansion tank.

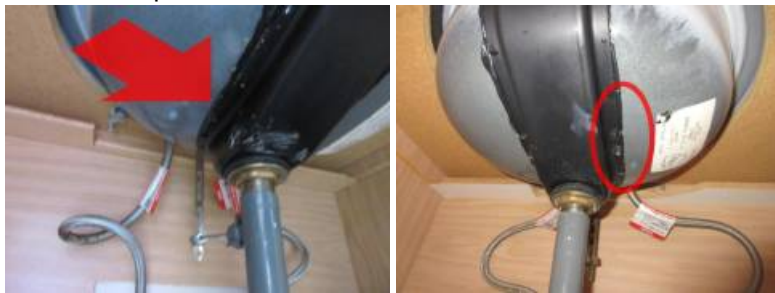
11.19 SINK

The sinks are leaking at the overflow drain welds. Replacement of the sinks is recommended.

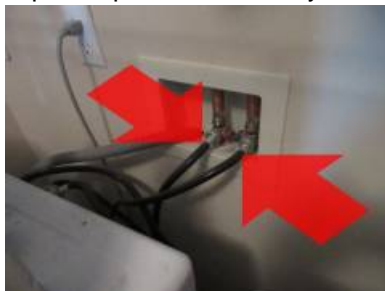
Upgrading the washer connections to high pressure (steel braided) lines is recommended.

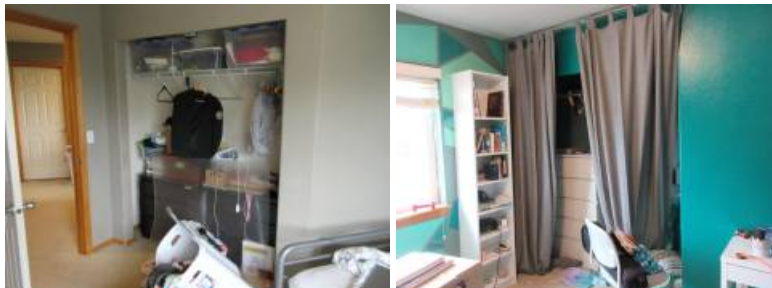
14.6 CLOSET DOORS

Closet doors are missing in two of the bedrooms.

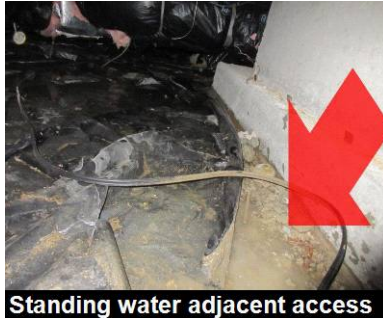
19.2 MOISTURE

Standing water in the crawlspace creates moisture problems inside the house, causes mold and fungus growth and creates conditions that are conducive to wood destroying organisms. Action should be taken to remediate this condition. The most common repair consists of installing a perimeter drainage system on the inside of the crawlspace that collects incoming water and diverts it into a drain or sump pump. Consult with a contractor specializing in ground water mitigation systems for additional information and cost estimates.

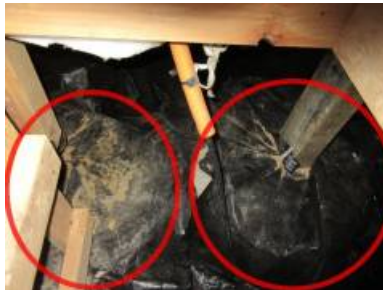
19.4 VAPOR RETARDER

The support post concrete piers are covered with the plastic vapor retarder. This allows the transmission of water vapor from the soil up and into the floor framing. The plastic vapor retarder should be removed from the pier so that it covers the entire surface of the soil only.
