NOTICE TO BUYER: SELLER-PROCURED INSPECTION REPORT

February 20, 2019

Re: 18200 NE 143rd Pl.
Woodinville, WA.

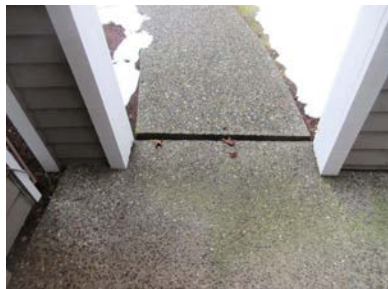
2.6 WALKWAY

The walkway has cracked and settled differentially. This was probably caused by inadequate preparation of the soil prior to the placement of the concrete. This condition can be repaired by pressure grouting the sunken portion of the walkway or by removing and replacing it. Grinding down the raised edges of the concrete will also mitigate the hazard. The walkway remains functional despite this condition. However, the raised edges of the concrete can be a trip hazard for some people. Repairs should be made as necessary.

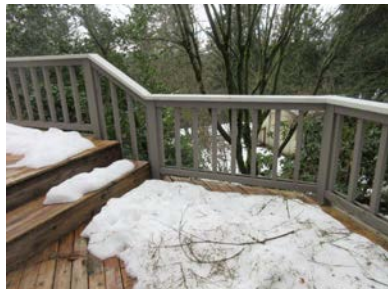
3.7 DECK RAILINGS

The spacing between the balusters is too wide. This is a hazard to small children. The balusters should be spaced close enough together so that a 4" sphere cannot pass through. Upgrading the deck railing is recommended if small children are present.

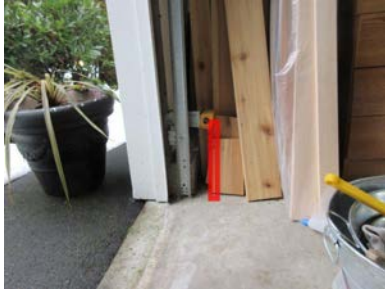
The Photo-eye beam was installed too high above the floor of the garage to adequately offer protection for small children and/or pets. We recommend that the photo-eye be lowered to within 4-6" of the floor.

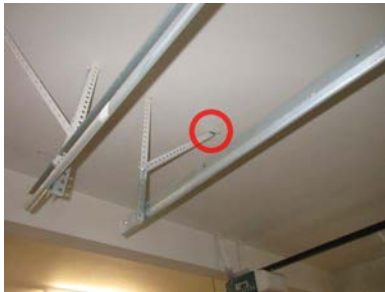
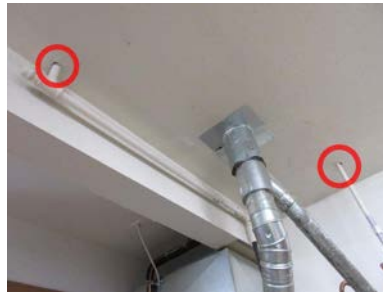
6.4 FIRE SEPARATION

There are voids in the fire resistive barrier between the living space and garage that will allow flames to penetrate. The gypsum barrier slows the spread of a fire from the garage to the structure and/or living space. Patching the voids with a fire retardant caulk is recommended.

- 6.4 Voids in garage ceiling have been filled
- 7.12 Loose receptacles have been corrected
- 7.13 GFCI outlets have been installed in the garage
- 10.11 Seismic restraint installed at water heater
- 11.8 Dishwasher drain is to code
- 12.27 Glass enclosure has been caulked
- 9.5 Filters will be cleaned when weather allows
- 11.1, 12.20, 12.28 & 13.2 Caulking applied
- 12.26 Grout has been repaired

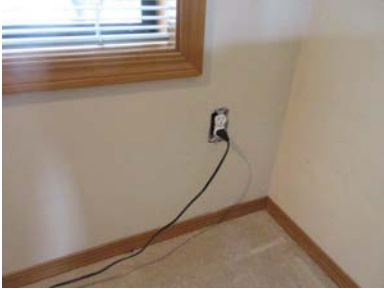
7.12 RECEPTACLES

There are numerous loose receptacles throughout the home. This is a potential shock and a fire hazard. All loose receptacles should be repaired as necessary.

Testing revealed several open grounds (ungrounded receptacles) Open grounds are a potential hazard and could damage some electronic equipment. All receptacles with open grounds should be repaired in accordance with applicable electrical codes.

The cover plate is missing from a receptacle in the office. This is a shock and fire hazard. The installation of a cover plate is recommended.

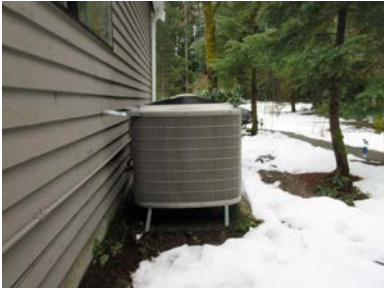
The pad supporting the outdoor condensing unit has settled, leaving it out of level. The connections can be stressed and accelerated wear of the bearings and other components may occur. The unit should be leveled.

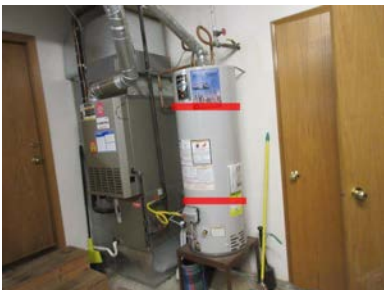
The seismic restraint for the water heater was minimal. Proper strapping is recommended to adequately secure the tank and provide potable water in the event of an earthquake.

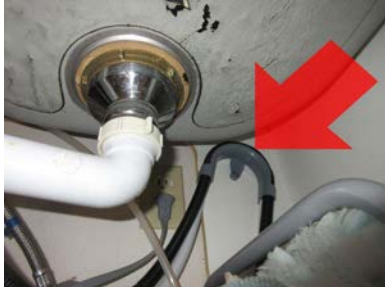
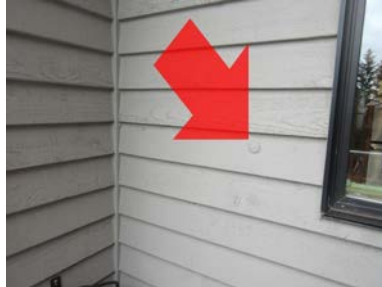
The dishwasher drain lacks an air gap. The dishwasher will function without one, but there is a risk of contamination of the inside of the dishwasher by waste water. The installation of an air gap is recommended or connection to the Johnson Tee that is installed in the kitchen wall. (see below) An air gap protects the dishwasher from contamination caused by a backflow of waste water.

The cap protruding on the exterior wall opposite the dishwasher is not drilled. This renders the air gap non-functional. Drilling a 1/4" hole in the end of the cap will restore its function when used.

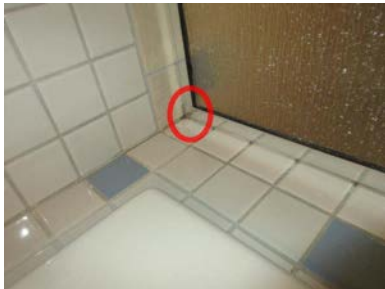
The glass enclosure has been leaking at the lower corners. No damage was visible, but resealing or repairing the enclosure is recommended as preventive maintenance.

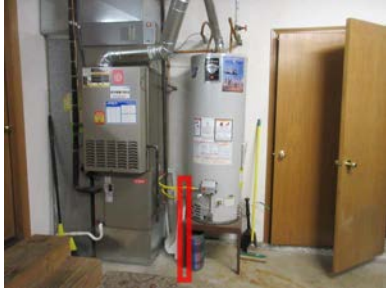
14.10 GAS PIPING

The gas pipes in front of the furnace and water heater are not protected by a bumper stop. A vertical steel pipe, bolted to the floor, is typically installed in front of the water heater to prevent a car bumper from damaging the gas lines.

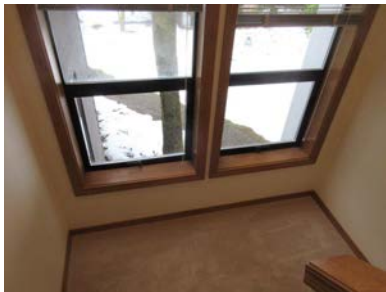
15.7 WINDOWS

The stairway landing window glass is not labeled as tempered safety glass. The existing glass is nonconforming by current building standards and would be hazardous if broken. The installation of safety glass is recommended as a safety upgrade.

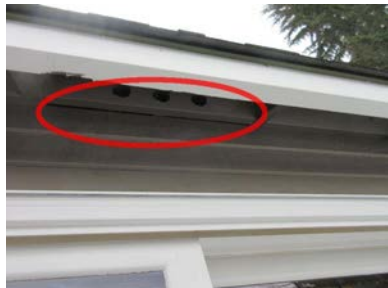
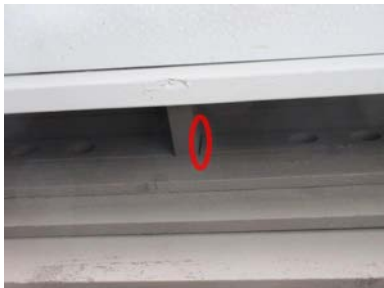
There are large gaps over 1/4" in size adjacent the soffit vent blocks. These gaps allow insects and rodents to enter the attic. Covering the gaps with screening, a strip of wood and/or caulking is recommended.

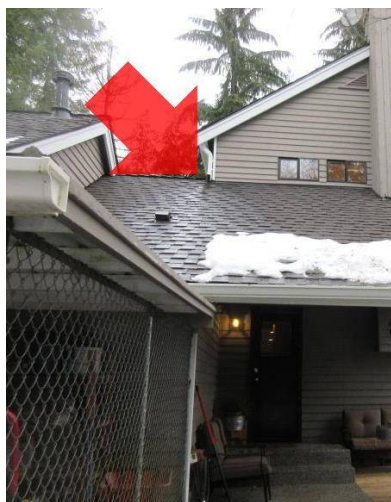
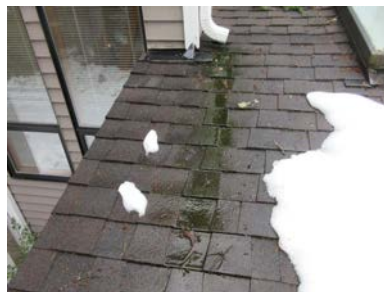
3.4 GUTTERS AND DOWNSPOUTS

There is a build-up of organic debris inside the gutters. Gutters should be cleaned as necessary to maintain a free flow of water into the downspouts.

Downspouts draining directly onto the asphalt shingle surface causes excessive wear of the roofing material. Downspout extensions to the lower gutters should be installed to prevent excessive wear and tear of the roofing.

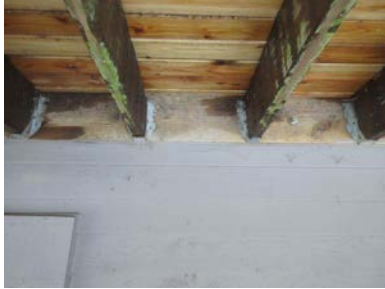
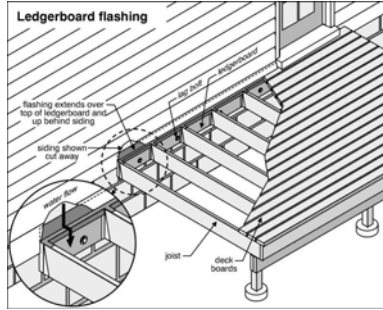
3.6 DECK

Localized areas of rot damaged wood and rot fungi was observed in the decking. Rot weakens the wood and can result in catastrophic failure of the structure. Replacement of all rotted wood is recommended.

There is no flashing at the intersection between the deck and house. This will allow water to enter behind the siding. The installation of flashing in this area is recommended.

The deck structure lacks lateral bracing. The installation of a diagonal brace underneath the deck is recommended.

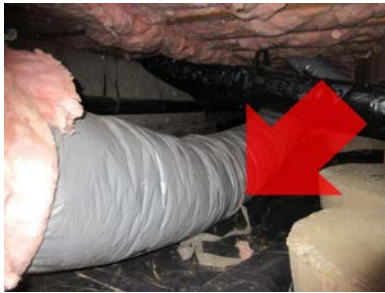
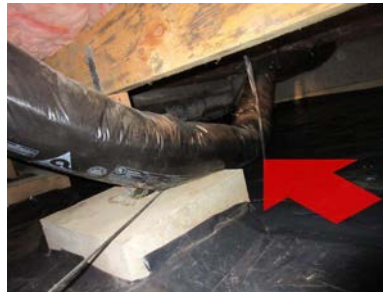
There are missing/broken duct support straps under two of the ducts. This condition restricts air flow, may compromise the conditioned air and can damage the air ducts. New straps should be installed in accordance with industry standards.

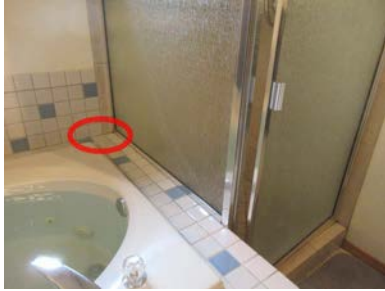
Grout is missing from between some of the deck tiles. This can allow water to enter through the tile and can damage the walls. Regrouting the deck tile is recommended.

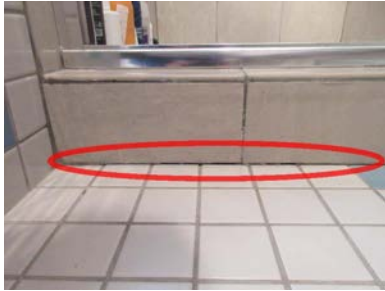
12.28 FLOORING MATERIAL

The caulking is deteriorated at the intersection between the shower and floor. This can lead to water damage to the flooring and substrate. Recaulking this area is recommended.

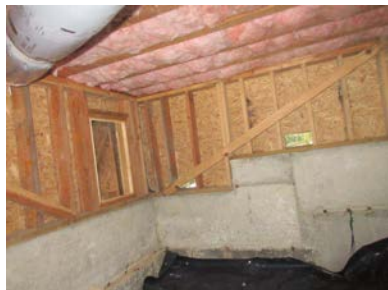
Shear panels are plywood or OSB panels that are mechanically fastened to both vertical and horizontal framing members in critical structural areas of the building. They prevent lateral movement of the structure during an earthquake. Shear panels are often visible in the crawlspace on cripple walls between the first floor and foundation. They may also be installed on interior walls that are covered with drywall. An examination of the crawlspace revealed the absence of shear panels on the cripple walls. The installation of shear panels on the cripple walls is recommended as an upgrade.

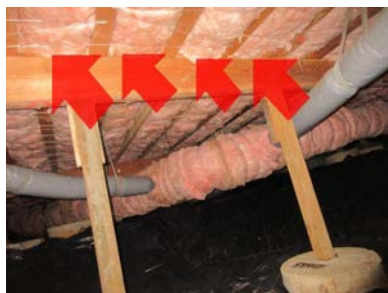
19.7 FLOOR JOISTS

Blocks are missing from between the joists above the support beams under the load bearing walls. This can result in differential settlement of the wall structure particularly under highly stressed point loads like those found adjacent to door openings and under beam supports. Blocking also prevents lateral movement of the joists. The installation of blocking between the joists is recommended.

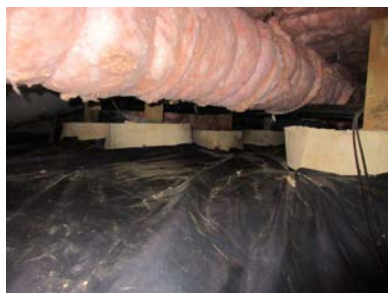
20.5 PEST CONTROL

Cellulose forms were left in place on the pier footings. This cellulose is conducive to the infestation of various wood destroying organisms. The removal of the cellulose is recommended.

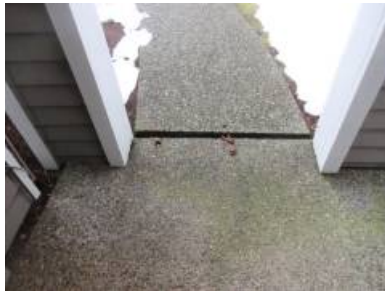
Many legal and public works departments have defined a trip hazard as an irregularity in a walking surface exceeding one inch (1") in height. All walking surfaces should maintain, free of a vertical surface change of 3/4" or more, in the interest of public and personal safety.

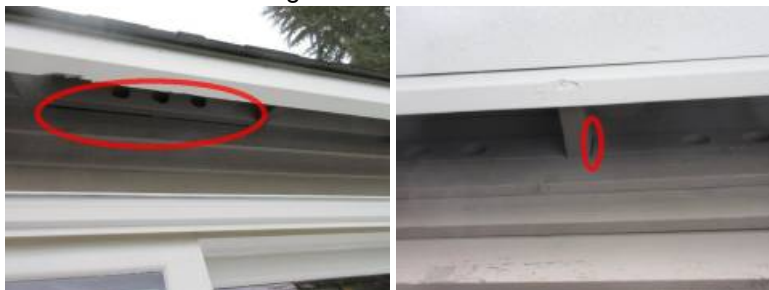
There are large gaps over 1/4" in size adjacent the soffit vent blocks. These gaps allow insects and rodents to enter the attic. Covering the gaps with screening, a strip of wood and/or caulking is recommended.

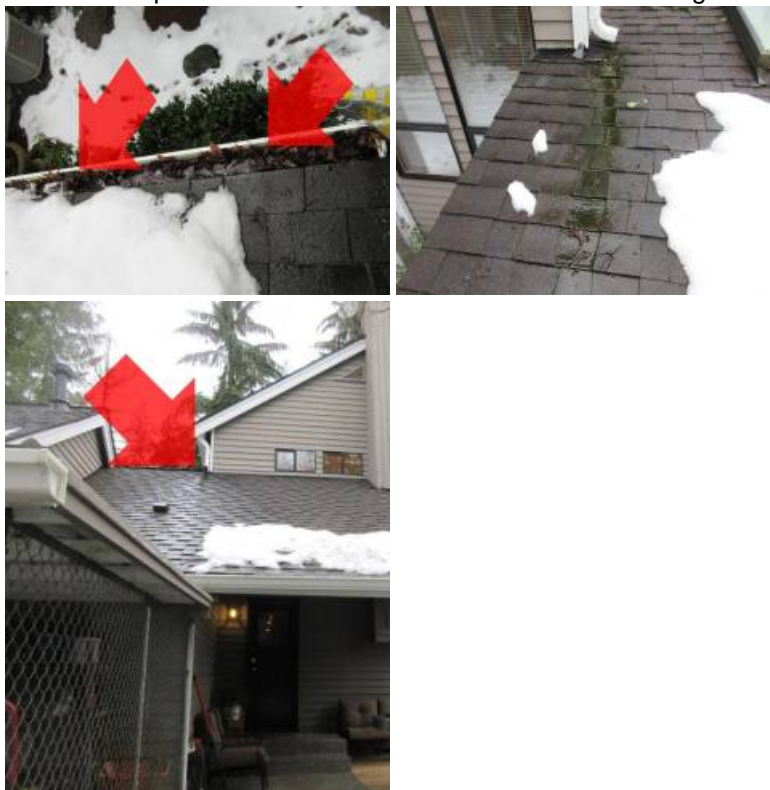
3.4 GUTTERS AND DOWNSPOUTS

Downspouts draining directly onto the asphalt shingle surface causes excessive wear of the roofing material. Downspout extensions to the lower gutters should be installed to prevent excessive wear and tear of the roofing.

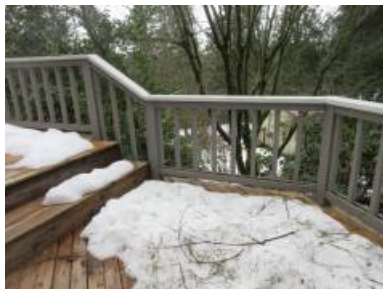
3.7 DECK RAILINGS

The spacing between the balusters is too wide. This is a hazard to small children. The balusters should be spaced close enough together so that a 4" sphere cannot pass through. Upgrading the deck railing is recommended if small children are present.

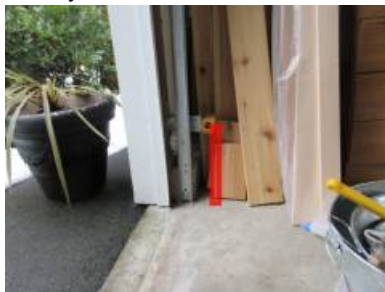
The Photo-eye beam was installed too high above the floor of the garage to adequately offer protection for small children and/or pets. We recommend that the photo-eye be lowered to within 4-6" of the floor.

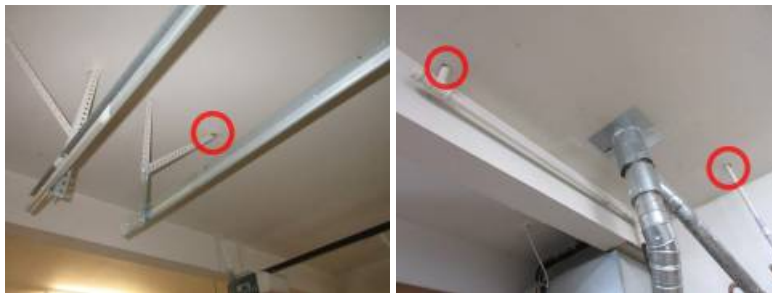
6.4 FIRE SEPARATION

There are voids in the fire resistive barrier between the living space and garage that will allow flames to penetrate. The gypsum barrier slows the spread of a fire from the garage to the structure and/or living space. Patching the voids with a fire retardant caulk is recommended.

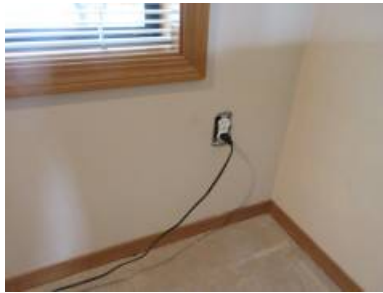
The cover plate is missing from a receptacle in the office. This is a shock and fire hazard. The installation of a cover plate is recommended.

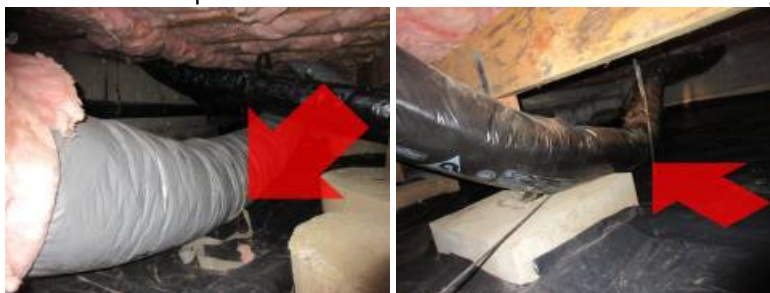
There are missing/broken duct support straps under two of the ducts. This condition restricts air flow, may compromise the conditioned air and can damage the air ducts. New straps should be installed in accordance with industry standards.

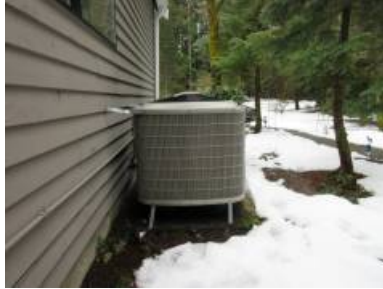
The pad supporting the outdoor condensing unit has settled, leaving it out of level. The connections can be stressed and accelerated wear of the bearings and other components may occur. The unit should be leveled.

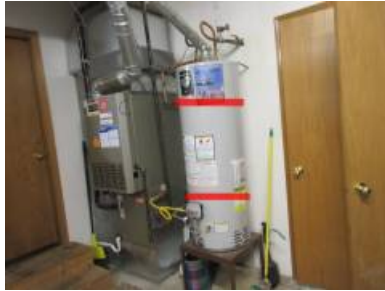
The seismic restraint for the water heater was minimal. Proper strapping is recommended to adequately secure the tank and provide potable water in the event of an earthquake.

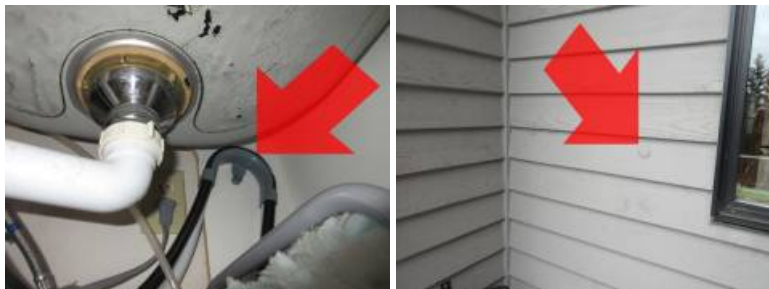
The cap protruding on the exterior wall opposite the dishwasher is not drilled. This renders the air gap non-functional. Drilling a 1/4" hole in the end of the cap will restore its function when used.

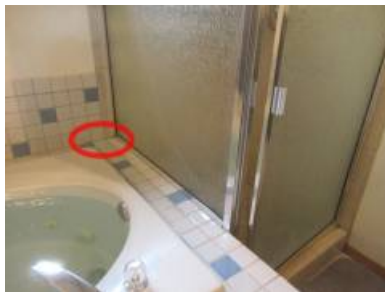
Grout is missing from between some of the deck tiles. This can allow water to enter through the tile and can damage the walls. Regrouting the deck tile is recommended.

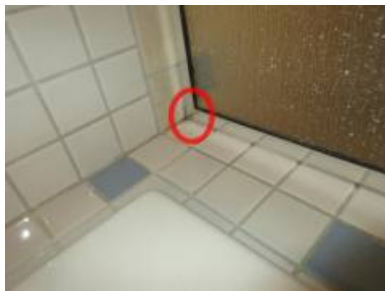
The glass enclosure has been leaking at the lower corners. No damage was visible, but resealing or repairing the enclosure is recommended as preventive maintenance.

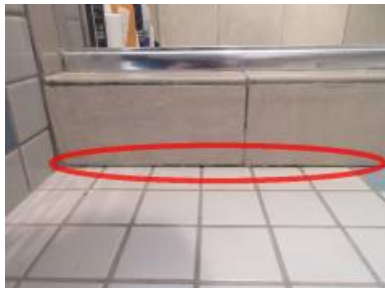
The caulking is deteriorated at the intersection between the shower and floor. This can lead to water damage to the flooring and substrate. Recaulking this area is recommended.

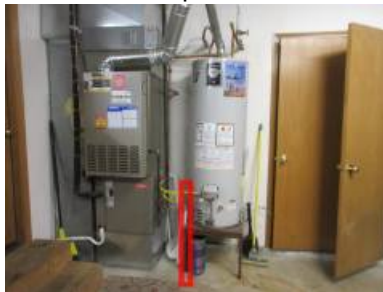
The gas pipes in front of the furnace and water heater are not protected by a bumper stop. A vertical steel pipe, bolted to the floor, is typically installed in front of the water heater to prevent a car bumper from damaging the gas lines.

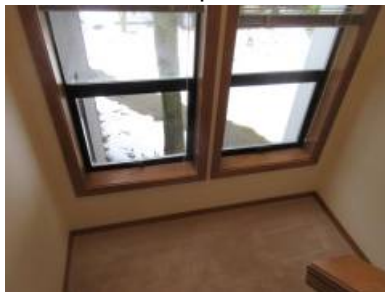
There is condensation or mineral deposits between the panes of glass in several of the insulated glass windows. This indicates failed seals. The glass assemblies should be replaced, which is the only method for correcting this deficiency.

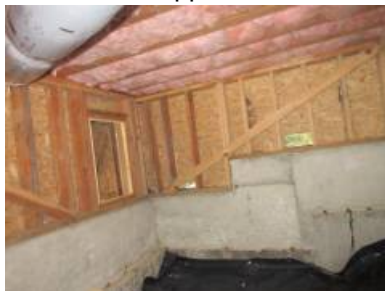
Shear panels are plywood or OSB panels that are mechanically fastened to both vertical and horizontal framing members in critical structural areas of the building. They prevent lateral movement of the structure during an earthquake. Shear panels are often visible in the crawlspace on cripple walls between the first floor and foundation. They may also be installed on interior walls that are covered with drywall. An examination of the crawlspace revealed the absence of shear panels on the cripple walls. The installation of shear panels on the cripple walls is recommended as an upgrade.

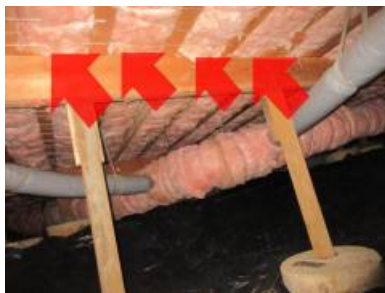
Blocks are missing from between the joists above the support beams under the load bearing walls. This can result in differential settlement of the wall structure particularly under highly stressed point loads like those found adjacent to door openings and under beam supports. Blocking also prevents lateral movement of the joists. The installation of blocking between the joists is recommended.

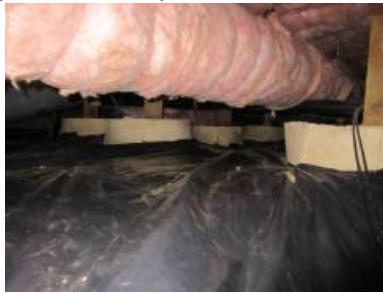
Good building practice requires that foundation walls or pier footings supporting wood frame construction, should extend at least 8" above the finish grade with at least a 6" clearance between the top of the soil and the bottom of the wood finish materials. Untreated wood should be raised 1-2" above surrounding flatwork and should have a moisture barrier such as 30 lb. asphalt impregnated felt installed between the concrete and wood. For additional information and treatment options, you should retain the services of a qualified pest control operator.
