On-Site Septic System Property Transfer Report

18200 NE 143RD PL
WOODINVILLE, WA

Inspection Type: PROPERTY SALE - Correction Status: All corrections made
Tax ID: 1926069138
Inspection Date: 07/13/2018
GENERAL SYSTEM TYPE: Gravity
Site Address: 18200 NE 143RD PL **City:** WOODINVILLE

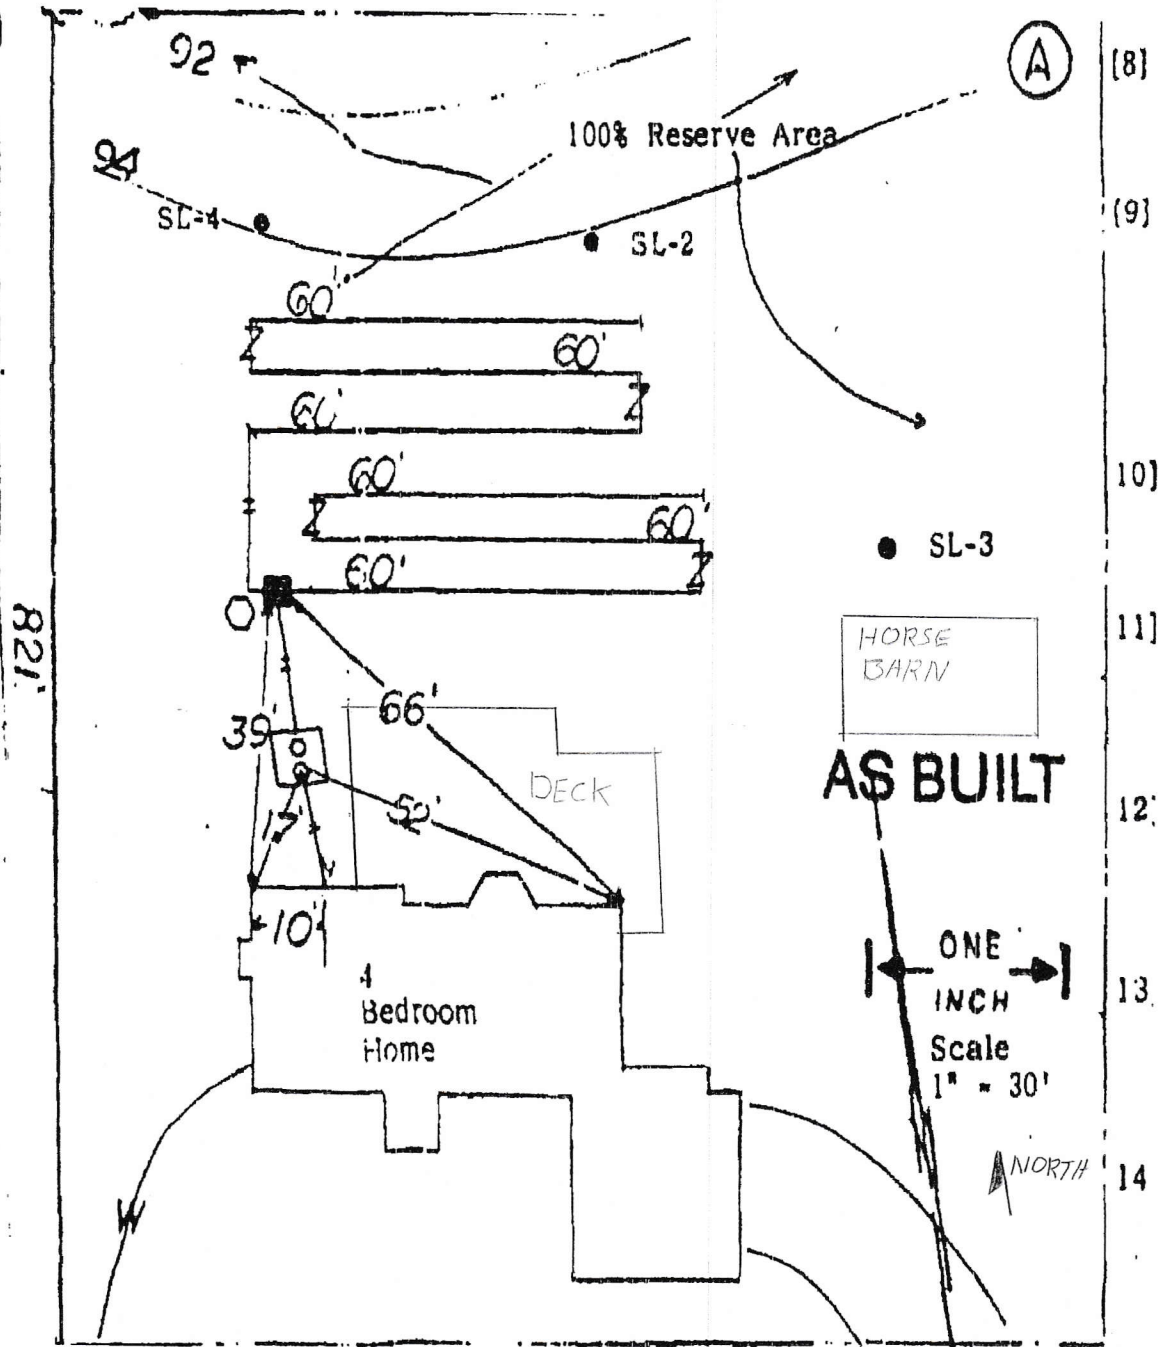
MODIFIED TO SHOW DECK AND BARN
