**NOTICE TO BUYER: SELLER-PROCURED INSPECTION REPORT**

**John and Margaret Nordmark  
12948 177<sup>th</sup> PI NE  
Redmond WA 98052**

April 14, 2019

**Re: 12948 177th Pl. NE  
Redmond, WA.**

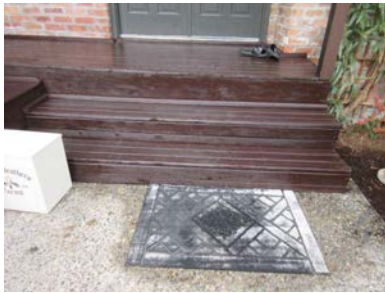
The steps are non-conforming due to the variable and/or excessive rise. Stair design standards require that step risers do not exceed 8" and that the variation in rise not exceed 3/8" in order to reduce falls from tripping. To increase the margin of safety, consideration should be given to reconfiguring the steps so that rise and run do not vary by more than 3/8". If this proves to be too impractical or expensive, then we recommend exercising caution when using.

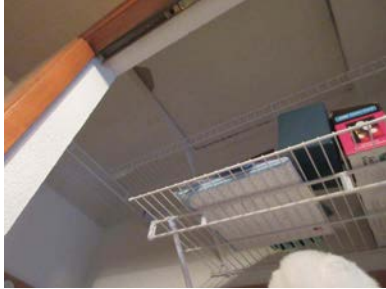
#### 5.1 ACCESS

The access area to the attic opening is too small by today's standards. The area opening should not be less than 22 inches by 30 inches. Modification of the access area is recommended for inspection and servicing of components in the attic.

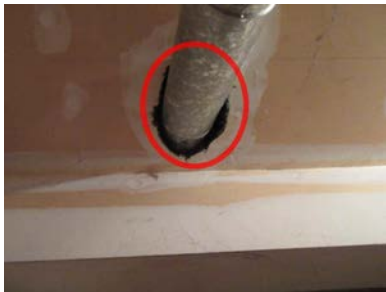
There are voids in the fire resistive barrier between the living space and garage that will allow flames to penetrate. The gypsum barrier slows the spread of a fire from the garage to the structure and/or living space. Patching the voids with a fire retardant caulk is recommended.

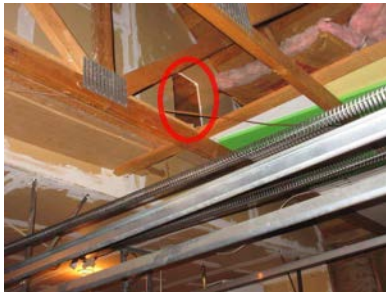
The cover for the attic access is missing. This is a safety concern. The gypsum barrier on the ceiling slows the spread of a fire from the garage to the attic. The installation of an access cover is recommended.

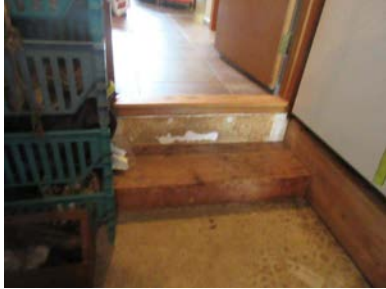
6.6 STAIRS

The garage steps are non-conforming due to the variable and/or excessive rise. Stair design standards require that stair risers do not exceed 8" and that the variation in rise not exceed 3/8" in order to reduce falls from tripping. To increase the margin of safety, consideration should be given to reconfiguring the steps so that rise and run do not vary by more than 3/8". If this proves to be too impractical or expensive, then we recommend exercising caution when using these steps.

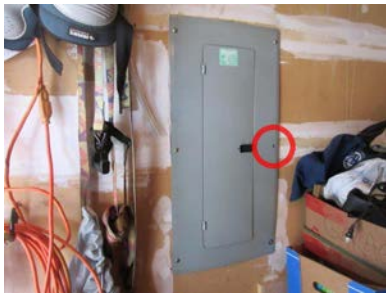
Screws that secure the panel cover to the panel box are missing. This is a potential hazard. Missing screws should be replaced with the original style blunt end screws.

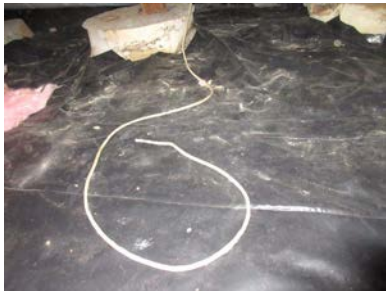
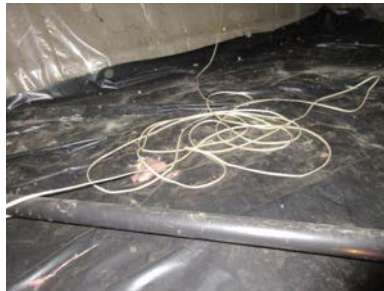
### 7.10 WIRING

There are abandoned electrical cables with exposed conductors in the crawlspace. This is a shock hazard. The cables should be terminated in a covered junction box or removed.

7.10 Wiring – Lines in crawlspace put in junction boxes

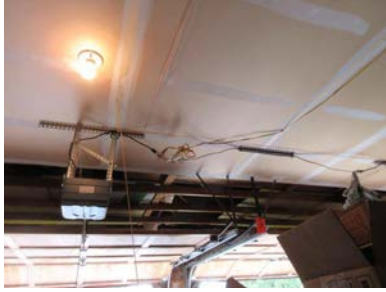
An extension cord is used as a temporary power source for the garage door openers. An extension cord is not suitable as a permanent wiring method. The installation of a receptacle within cords length of the motors is recommended.

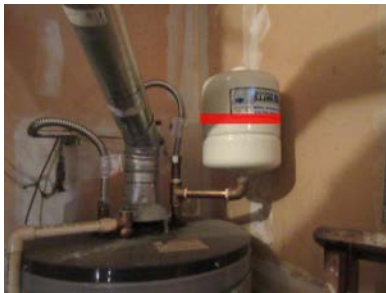
The expansion tank is not adequately secured to the wall. This could result in damage to the water pipe and leakage during an earth quake. A seismic restraint should be installed to secure the expansion tank.

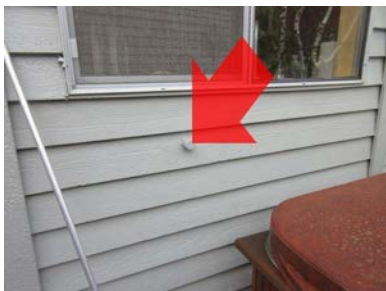
An air gap called a Johnson Tee is installed in the kitchen wall. This air gap protects the dishwasher from contamination caused by a backflow of waste water. The cap protruding on the exterior wall opposite the dishwasher is not drilled. This renders the air gap non-functional. Drilling a 1/4" hole in the end of the cap will restore its function. The remaining visible portions of the Johnson Tee were properly installed and functioning as intended.

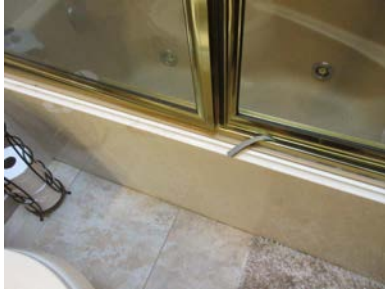
The glass door is in serviceable condition. However, the door does not seal properly. The door seals should be replaced.

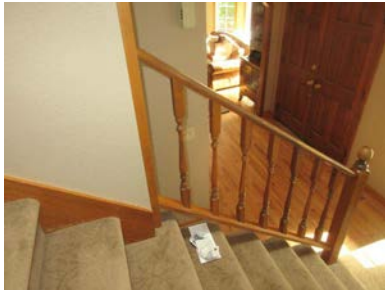
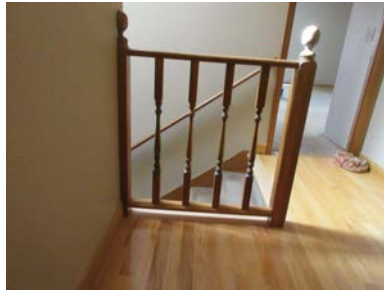
The stair railing baluster spacing is too wide. This is a hazard for small children. The baluster spacing should be reduced as a safety upgrade. Current standards require that a 4" sphere not pass through the railing.

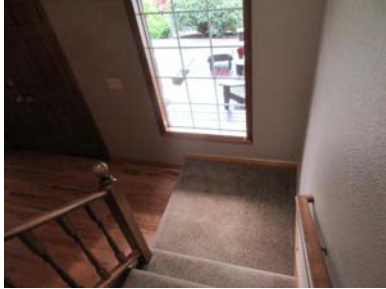
The stairway landing window glass is not labeled as tempered safety glass. The existing glass is nonconforming by current building standards and would be hazardous if broken. The installation of safety glass is recommended as a safety upgrade.

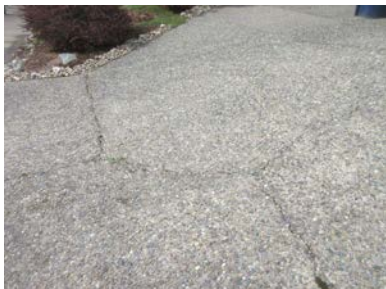
Cracks were observed in the concrete surface of the driveway. Minor cracks can be sealed to minimize moisture entry and further settlement of the concrete. Minor cracks are common and do not affect the serviceability of the concrete.

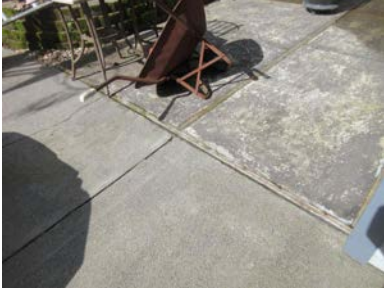
#### 2.5 PATIO

The wooden dividers separating the concrete patio sections will eventually deteriorate to a condition where the gaps would be a trip hazard. Replacement with mortar is recommended.

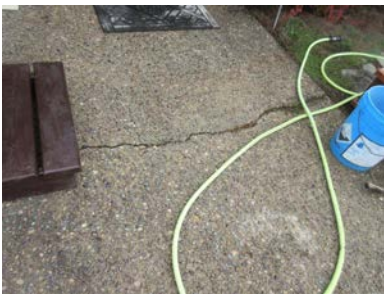
### 2.6 WALKWAY

There are minor cracks in the walkway, however, they do not affect its functionality and it remains in serviceable condition. Minor cracks can be sealed to minimize moisture entry and further settlement of the concrete.

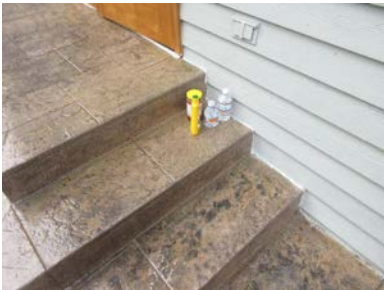
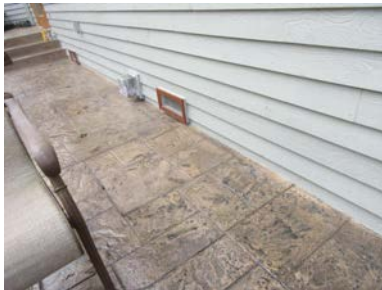
Untreated wood in direct contact with concrete was observed along the stoop and walkway. Untreated wood should be raised 1-2" above the concrete. Treating the wood with a preservative sometimes will prevent wood destroy organism damage.

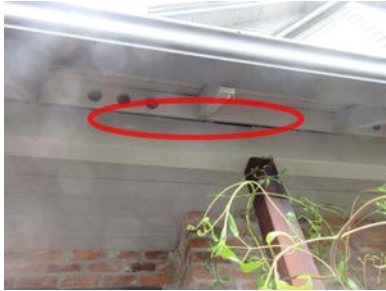
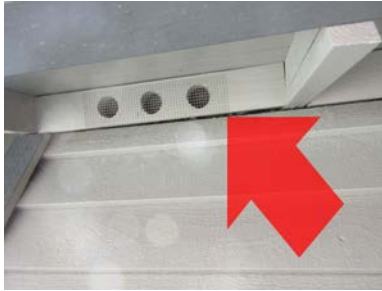
### 3.3 SOFFITS AND OVERHANGS

There are large gaps over 1/4" in size adjacent the soffit vent blocks. These gaps allow insects and rodents to enter the attic. Covering the gaps with screening, a strip of wood and/or caulking is recommended.

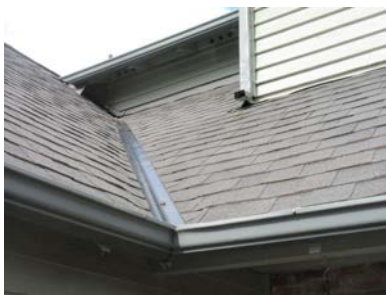
### 3.4 GUTTERS AND DOWNSPOUTS

Downspouts draining directly onto the asphalt shingle surface causes excessive wear of the roofing material. Downspout extensions to the lower gutters should be installed to prevent excessive wear and tear of the roofing.

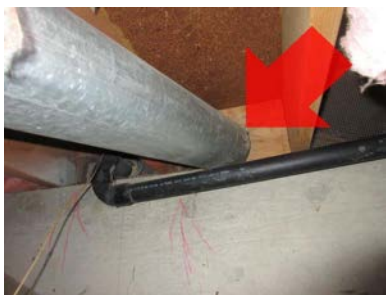
The kitchen is provided by a down draft vent system that is an integral part of the cooktop unit. The vent is discharging into the crawlspace. The installation of a ducted vent to carry the exhaust from the vent to the exterior is recommended. The vent fan is otherwise properly installed and is performing its intended function.

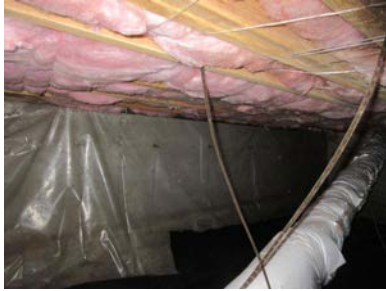
The foundation walls are partially covered with the plastic vapor retarder. This allows the transmission of

water vapor from the soil up and into the exterior wall framing. The plastic vapor retarder should be removed from the foundation so that it covers at least 85% of the entire surface of the soil only.

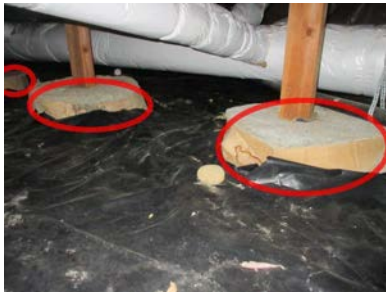
#### 20.5 PEST CONTROL

Cellulose forms were left in place on the pier footings. This cellulose is conducive to the infestation of various wood destroying organisms. The removal of the cellulose is recommended.

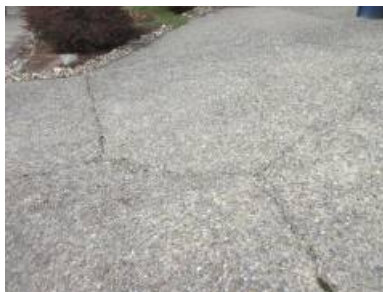
Cracks were observed in the concrete surface of the driveway. Minor cracks can be sealed to minimize moisture entry and further settlement of the concrete. Minor cracks are common and do not affect the serviceability of the concrete.

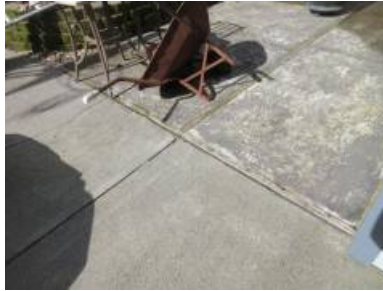
### **2.5 PATIO**

The wooden dividers separating the concrete patio sections will eventually deteriorate to a condition where the gaps would be a trip hazard. Replacement with mortar is recommended.

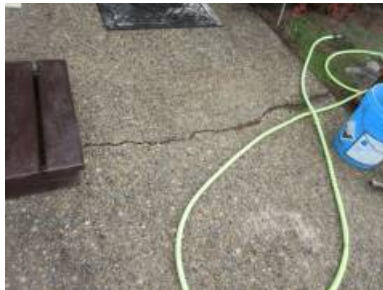
## 2.6 WALKWAY

Many legal and public works departments have defined a trip hazard as an irregularity in a walking surface exceeding one inch (1") in height. All walking surfaces should maintain, free of a vertical surface change of 3/4" or more, in the interest of public and personal safety.

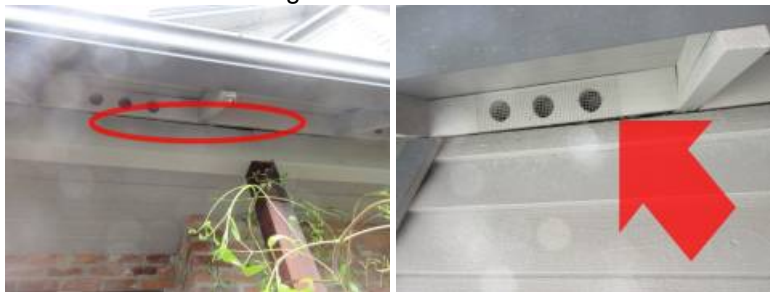
### 3.3 SOFFITS AND OVERHANGS

There are large gaps over 1/4" in size adjacent the soffit vent blocks. These gaps allow insects and rodents to enter the attic. Covering the gaps with screening, a strip of wood and/or caulking is recommended.

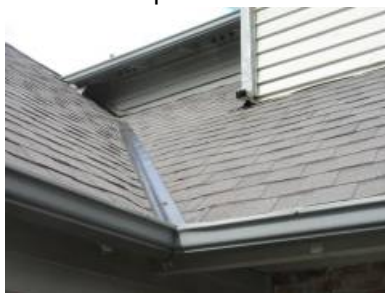
### 3.4 GUTTERS AND DOWNSPOUTS

Downspouts draining directly onto the asphalt shingle surface causes excessive wear of the roofing material. Downspout extensions to the lower gutters should be installed to prevent excessive wear and tear of the roofing.

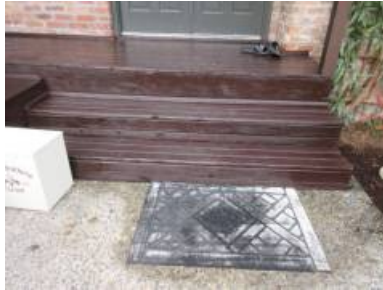
The steps are non-conforming due to the variable and/or excessive rise. Stair design standards require that step risers do not exceed 8" and that the variation in rise not exceed 3/8" in order to reduce falls from tripping. To increase the margin of safety, consideration should be given to reconfiguring the steps so that rise and run do not vary by more than 3/8". If this proves to be too impractical or expensive, then we recommend exercising caution when using.

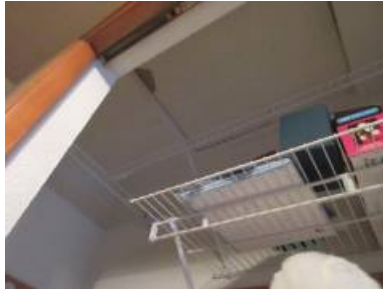
The access area to the attic opening is too small by today's standards. The area opening should not be less than 22 inches by 30 inches. Modification of the access area is recommended for inspection and servicing of components in the attic.

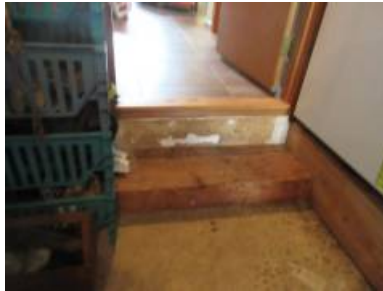
The garage steps are non-conforming due to the variable and/or excessive rise. Stair design standards require that stair risers do not exceed 8" and that the variation in rise not exceed 3/8" in order to reduce falls from tripping. To increase the margin of safety, consideration should be given to reconfiguring the steps so that rise and run do not vary by more than 3/8". If this proves to be too impractical or expensive, then we recommend exercising caution when using these steps.

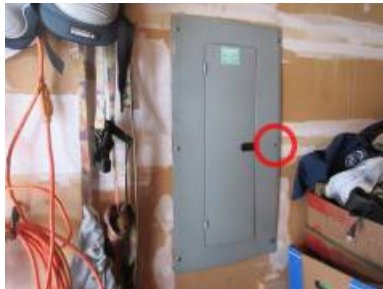
Screws that secure the panel cover to the panel box are missing. This is a potential hazard. Missing screws should be replaced with the original style blunt end screws.

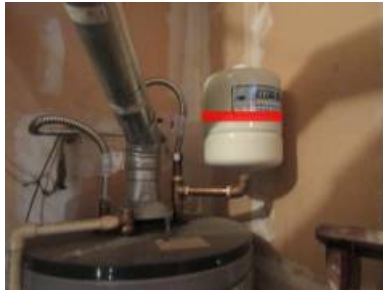
The expansion tank is not adequately secured to the wall. This could result in damage to the water pipe and leakage during an earth quake. A seismic restraint should be installed to secure the expansion tank.

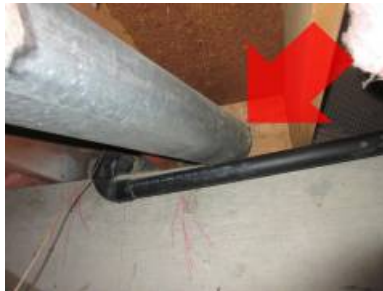
The kitchen is provided by a down draft vent system that is an integral part of the cooktop unit. The vent is discharging into the crawlspace. The installation of a ducted vent to carry the exhaust from the vent to the exterior is recommended. The vent fan is otherwise properly installed and is performing its intended function.

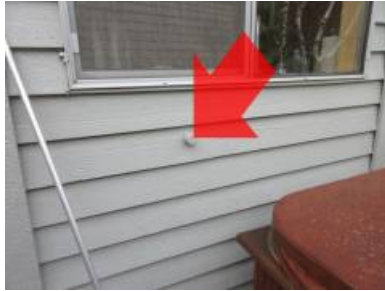
An air gap called a Johnson Tee is installed in the kitchen wall. This air gap protects the dishwasher from contamination caused by a backflow of waste water. The cap protruding on the exterior wall opposite the dishwasher is not drilled. This renders the air gap non-functional. Drilling a 1/4" hole in the end of the cap will restore its function. The remaining visible portions of the Johnson Tee were properly installed and functioning as intended.

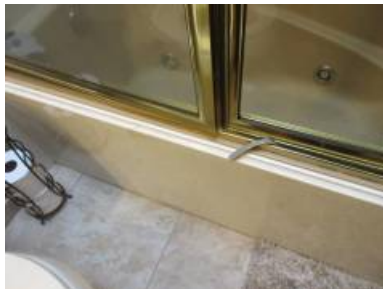
The glass door is in serviceable condition. However, the door does not seal properly. The door seals should be replaced.

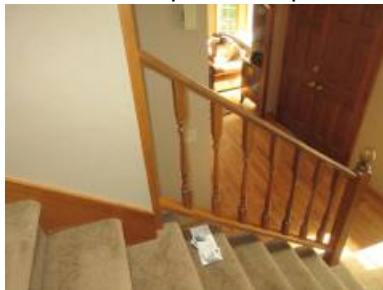
The stair railing baluster spacing is too wide. This is a hazard for small children. The baluster spacing should be reduced as a safety upgrade. Current standards require that a 4" sphere not pass through the railing.

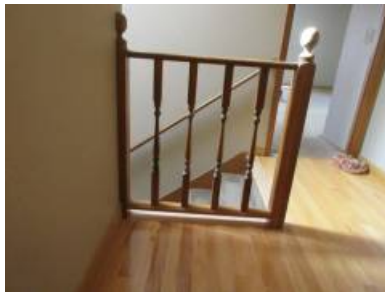
#### **15.3 GUARD RAILINGS**

enough together so that a 4" sphere cannot pass through. Upgrading the guard railing is recommended if small children are present.

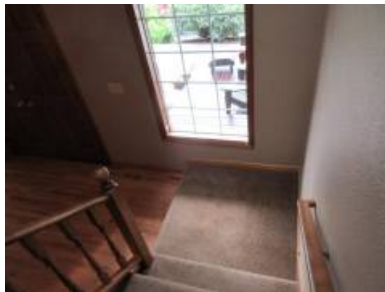
The stairway landing window glass is not labeled as tempered safety glass. The existing glass is nonconforming by current building standards and would be hazardous if broken. The installation of safety glass is recommended as a safety upgrade.

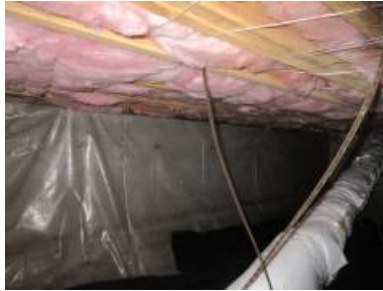
The foundation walls are partially covered with the plastic vapor retarder. This allows the transmission of water vapor from the soil up and into the exterior wall framing. The plastic vapor retarder should be removed from the foundation so that it covers at least 85% of the entire surface of the soil only.

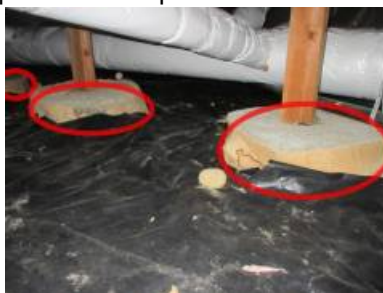
## 20.5 PEST CONTROL

Good building practice requires that foundation walls or pier footings supporting wood frame construction, should extend at least 8" above the finish grade with at least a 6" clearance between the top of the soil and the bottom of the wood finish materials. Untreated wood should be raised 1-2" above surrounding flatwork and should have a moisture barrier such as 30 lb. asphalt impregnated felt installed between the concrete and wood. For additional information and treatment options, you should retain the services of a qualified pest control operator.
