NOTICE TO BUYER: SELLER-PROCURED INSPECTION REPORT

May 15, 2019

**Re: 13730 176th Ave NE
Redmond, WA.**

At your request, a visual inspection of the above referenced property was conducted on 05/15/2019. We have inspected the major structural components, plumbing, heating and electrical systems for signs of significant non-performance, excessive or unusual wear and general state of repair.

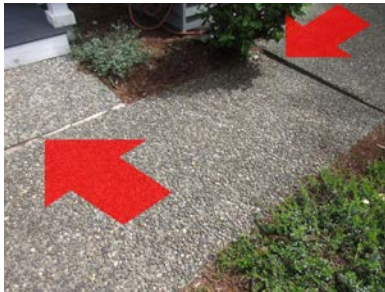
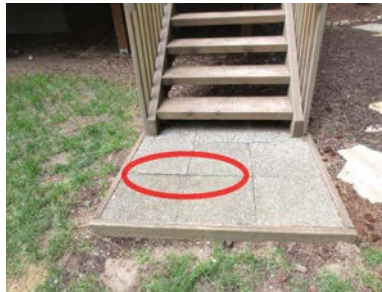
The walkway has settled differentially. This was probably caused by inadequate preparation of the soil prior to the placement of the concrete. This condition can be repaired by pressure grouting the sunken portion of the walkway or by removing and replacing it. Grinding down the raised edges of the concrete will also mitigate the hazard. The walkway remains functional despite this condition. However, the raised edges of the concrete can be a trip hazard for some people. Repairs should be made as necessary.

The wooden dividers separating the concrete walkway sections have deteriorated to a point where the gaps are a trip hazard. Replacement with mortar is recommended.

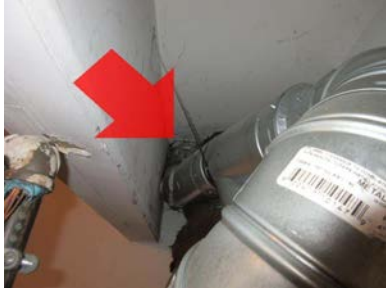
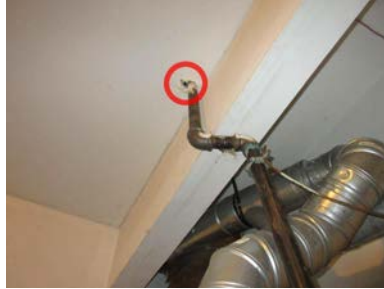
6.4 FIRE SEPARATION

There are voids in the fire resistive barrier between the living space and garage that will allow flames to penetrate. The gypsum barrier slows the spread of a fire from the garage to the structure and/or living space. Patching the voids with a fire retardant caulk is recommended.

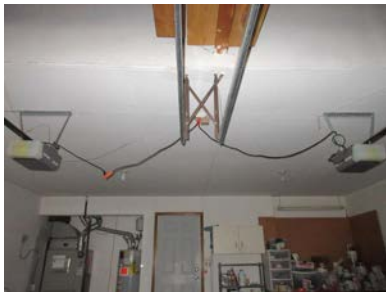
7.10 WIRING

An extension cord is used as a temporary power source for the garage door openers. An extension cord is not suitable as a permanent wiring method. The installation of a receptacle within cords length of the motors is recommended.

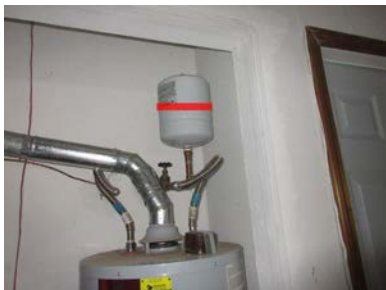
10.6 EXPANSION TANK

The expansion tank is not adequately secured to the wall. This could result in damage to the water pipe and leakage during an earth quake. A seismic restraint should be installed to secure the expansion tank.

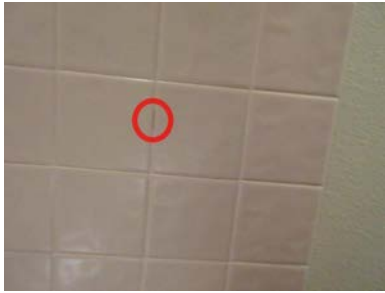
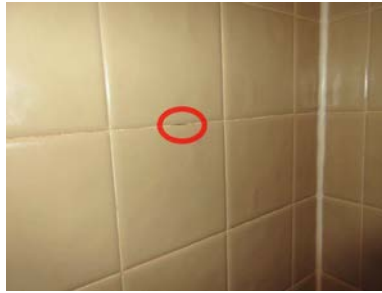
12.25 TUB WALLS

Grout is missing from between some of the wall tiles. This can allow water to enter through the tile and can damage the walls. Regrouting the wall tile is recommended.

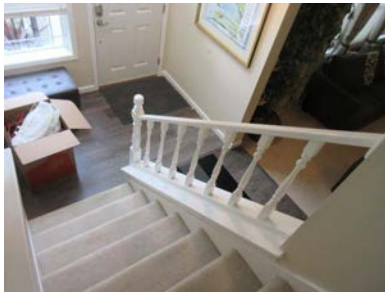
15.2 STAIRS

The stair railing baluster spacing is too wide. This is a hazard for small children. The baluster spacing should be reduced as a safety upgrade. Current standards require that a 4" sphere not pass through the railing.

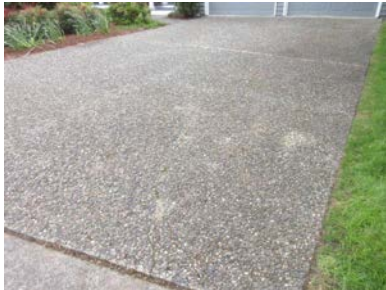
2.4 DRIVEWAY

Cracks were observed in the concrete surface of the driveway. Minor cracks can be sealed to minimize moisture entry and further settlement of the concrete. Minor cracks are common and do not affect the serviceability of the concrete.

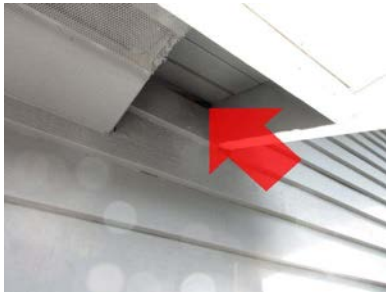
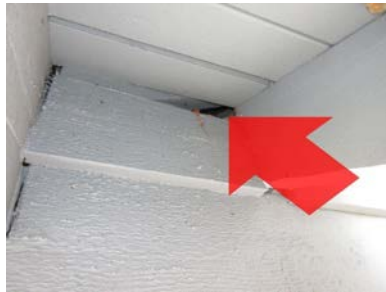
3.3 SOFFITS AND OVERHANGS

There are openings at the intersection between the overhang and the roof through which birds and rodents can enter into the attic. These openings should be covered with wood, wire mesh or filled with aerosol foam.

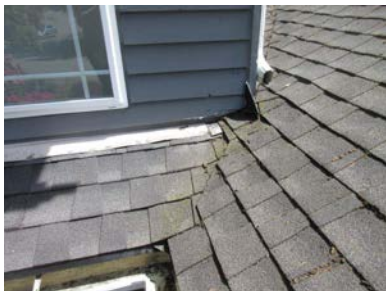
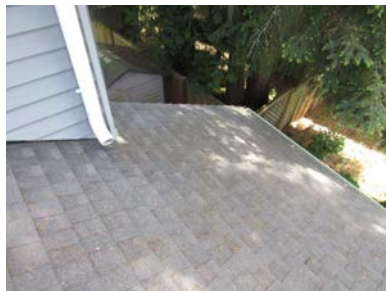
3.4 GUTTERS AND DOWNSPOUTS

Downspouts draining directly onto the asphalt shingle surface causes excessive wear of the roofing material. Downspout extensions to the lower gutters should be installed to prevent excessive wear and tear of the roofing.

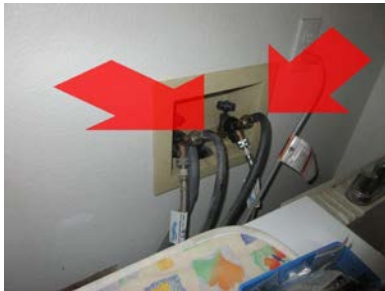
13.6 APPLIANCES

High pressure (steel braided) washer line connections is recommended.

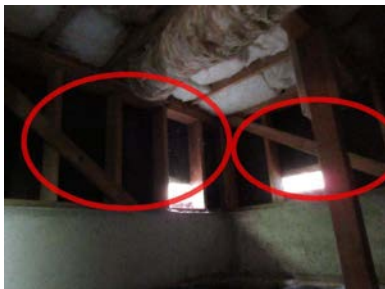
19.6 SHEAR PANELS

Shear panels are plywood or OSB panels that are mechanically fastened to both vertical and horizontal framing members in critical structural areas of the building. They prevent lateral movement of the structure during an earthquake. Shear panels are often visible in the crawlspace on cripple walls between the first floor and foundation. They may also be installed on interior walls that are covered with drywall. An examination of the crawlspace revealed the absence of shear panels on the cripple walls. The installation of shear panels on the cripple walls is recommended as an upgrade.

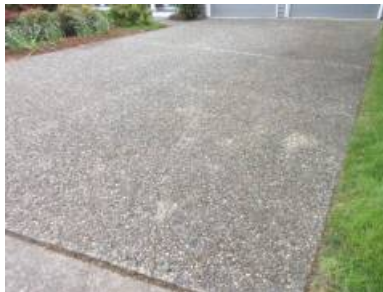
2.4 DRIVEWAY

Cracks were observed in the concrete surface of the driveway. Minor cracks can be sealed to minimize moisture entry and further settlement of the concrete. Minor cracks are common and do not affect the serviceability of the concrete.

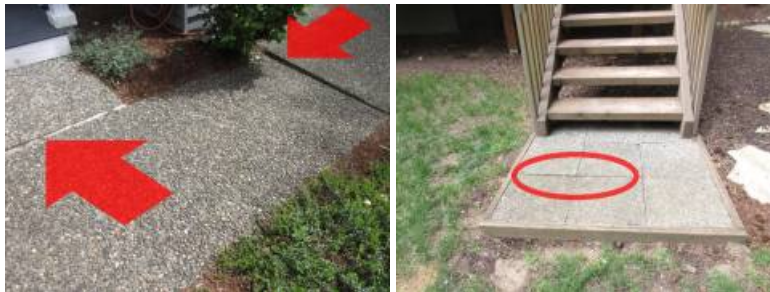
2.5 WALKWAY

The walkway has settled differentially. This was probably caused by inadequate preparation of the soil prior to the placement of the concrete. This condition can be repaired by pressure grouting the sunken portion of the walkway or by removing and replacing it. Grinding down the raised edges of the concrete will also mitigate the hazard. The walkway remains functional despite this condition. However, the raised edges of the concrete can be a trip hazard for some people. Repairs should be made as necessary.

The wooden dividers separating the concrete walkway sections have deteriorated to a point where the gaps are a trip hazard. Replacement with mortar is recommended.

Many legal and public works departments have defined a trip hazard as an irregularity in a walking surface exceeding one

inch (1") in height. All walking surfaces should maintain, free of a vertical surface change of 3/4" or more, in the interest of public and personal safety.

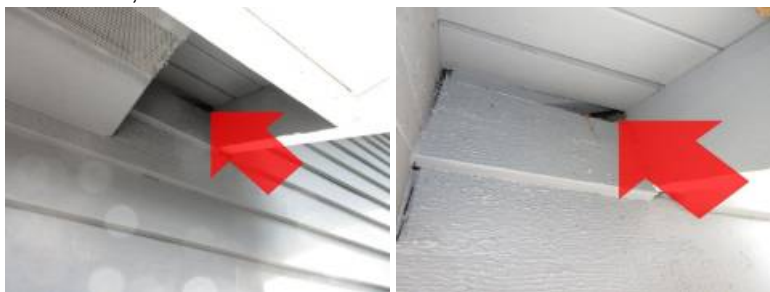
There are openings at the intersection between the overhang and the roof through which birds and rodents can enter into the attic. These openings should be covered with wood, wire mesh or filled with aerosol foam.

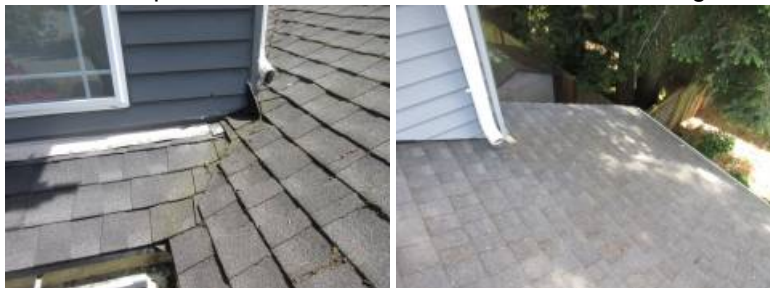
3.4 GUTTERS AND DOWNSPOUTS

Downspouts draining directly onto the asphalt shingle surface causes excessive wear of the roofing material. Downspout extensions to the lower gutters should be installed to prevent excessive wear and tear of the roofing.

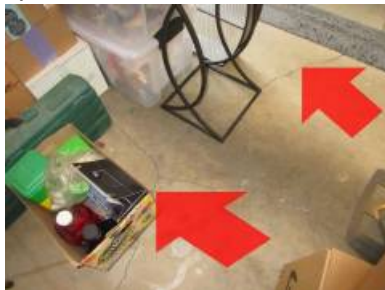
6.1 GARAGE FLOOR

There are large cracks and some vertical displacement of the garage floor slab. This type of defect is usually caused by a lack of proper soil preparation (compacting) prior to the placement of the concrete. This is primarily an aesthetic defect, since the floor slab is not a structural component.

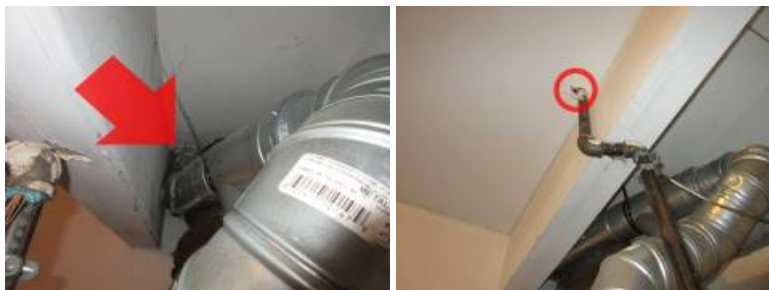
6.4 FIRE SEPARATION

There are voids in the fire resistive barrier between the living space and garage that will allow flames to penetrate. The gypsum barrier slows the spread of a fire from the garage to the structure and/or living space. Patching the voids with a fire retardant caulk is recommended.

- 1) fill noted voids in garage with fire resistive barrier caulking as noted in the inspection report
- 2) will remove all hardware (hanging materials) and repair all holes and repaint where pictures, etc. have been hung
- 3) will grout the bathrooms and kitchen as per the inspection report for the areas identified as needed

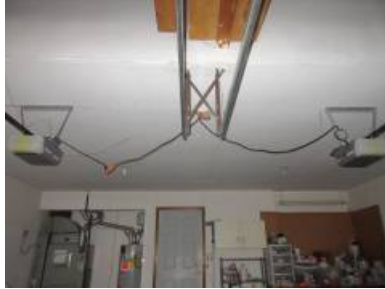
An extension cord is used as a temporary power source for the garage door openers. An extension cord is not suitable as a permanent wiring method. The installation of a receptacle within cords length of the motors is recommended.

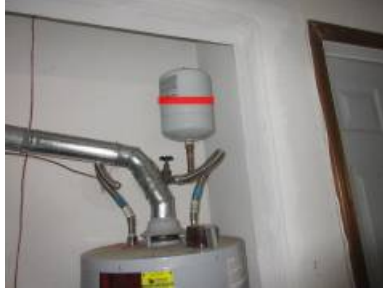
The expansion tank is not adequately secured to the wall. This could result in damage to the water pipe and leakage during an earth quake. A seismic restraint should be installed to secure the expansion tank.

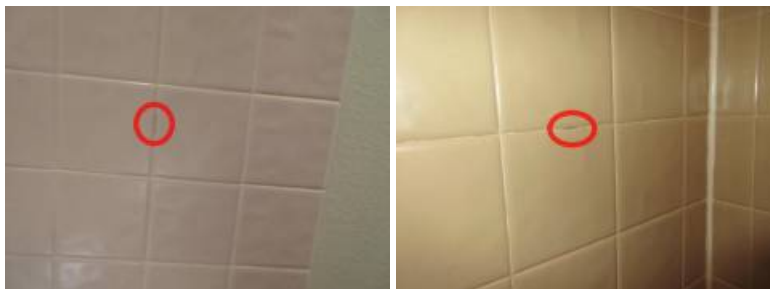
Grout is missing from between some of the wall tiles. This can allow water to enter through the tile and can damage the walls. Regrouting the wall tile is recommended.

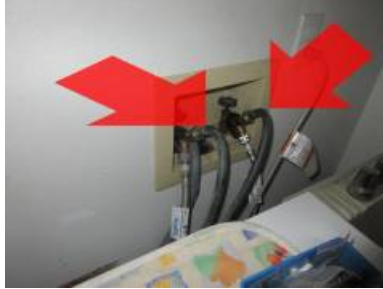
High pressure (steel braided) washer line connections is recommended.

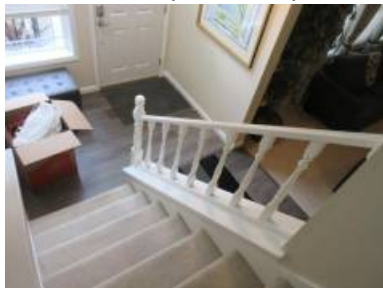
The stair railing baluster spacing is too wide. This is a hazard for small children. The baluster spacing should be reduced as a safety upgrade. Current standards require that a 4" sphere not pass through the railing.

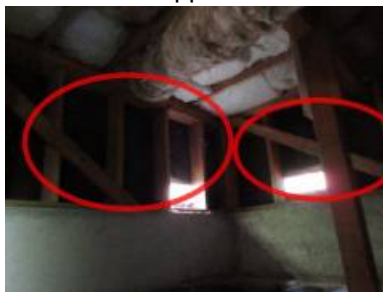
19.6 SHEAR PANELS

Shear panels are plywood or OSB panels that are mechanically fastened to both vertical and horizontal framing members in critical structural areas of the building. They prevent lateral movement of the structure during an earthquake. Shear panels are often visible in the crawlspace on cripple walls between the first floor and foundation. They may also be installed on interior walls that are covered with drywall. An examination of the crawlspace revealed the absence of shear panels on the cripple walls. The installation of shear panels on the cripple walls is recommended as an upgrade.
