NOTICE TO BUYER: SELLER-PROCURED INSPECTION REPORT

The following notice is given with respect to the Purchase and Sale Agreement dated _____
between _____ (“Buyer”)
and Jonathan Dahlke and Melanie Muradian (“Seller”)
concerning 13828 174th Place NE, Redmond WA 98052 (“the Property”).

SELLERS' RESPONSES TO ACTION ITEMS, SIGNIFICANT DEFECTS AND/OR HEALTH AND SAFETY ISSUES IDENTIFIED IN 10/08/19 INSPECTION REPORT

Melanie Muradian and Jonathan Dahlke
13828 174th Place NE
Redmond, WA 98052

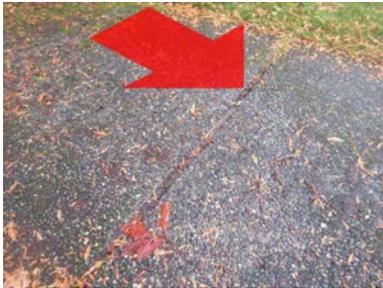
One or more of the wooden dividers separating the concrete driveway sections were infested by wood destroying organisms and have deteriorated to a point where they are becoming a trip hazard. Replacement with mortar is recommended.

Potential trip hazards – The offending wood expansion gap filler was removed to minimize the tripping hazard. Refilling the expansion gap will be completed if requested in the Purchase and Sales Agreement.

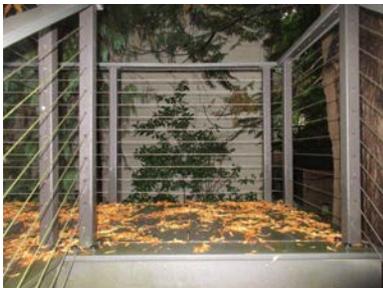
3.7 DECK RAILINGS

The spacing between the balusters is too wide. This is a hazard to small children. The balusters should be spaced close enough together so that a 4" sphere cannot pass through. Upgrading the deck railing is recommended if small children are present.

The spacing between the balusters is too wide - minor variance, exercise caution if small children are present.

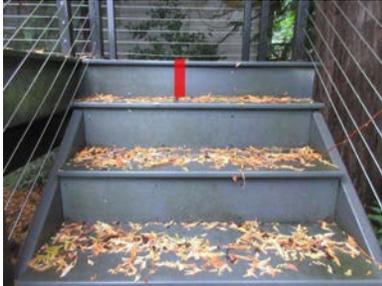
3.8 STAIRS

The stairs are non-conforming due to the variable and/or excessive rise. Stair design standards require that stair risers do not exceed 8" and that the variation in rise not exceed 3/8" in order to reduce falls from tripping. To increase the margin of safety, consideration should be given to reconfiguring the stairs so that rise and run do not vary by more than 3/8". If this proves to be too impractical or expensive, then we recommend exercising caution when using these stairs.

Non-conforming stair step rise – minor variance, exercise caution.

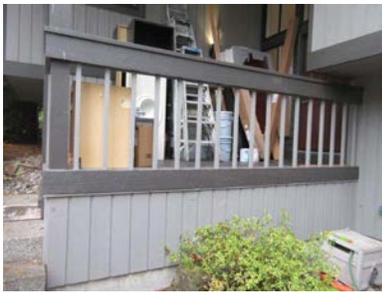
3.10 PORCH RAILING

The spacing between the balusters is too wide. This is a hazard to small children. The balusters should be spaced close enough together so that a 4" sphere cannot pass through. Upgrading the porch railing is recommended if small children are present.

The spacing between the balusters is too wide - minor variance, exercise caution if small children are present.

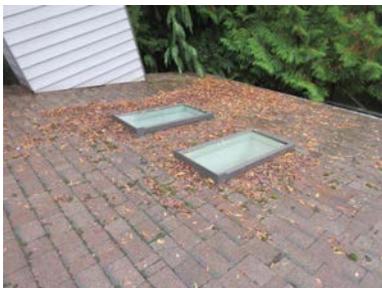
4.7 MAINTENANCE AND REPAIRS

The roof is in need of routine maintenance. The surface should be blown off or washed with a high volume low pressure garden hose to remove moss and organic debris. Performing this maintenance will improve the appearance and increase the life expectancy of the roof.

This work was completed on 10/11/19. Rick A. Roach, Roofing Maintenance Contractor blew off the surface with a high volume low pressure hose to remove all moss and organic debris as well as applied a treatment to the surface to improve appearance and increase life expectancy of the roof.

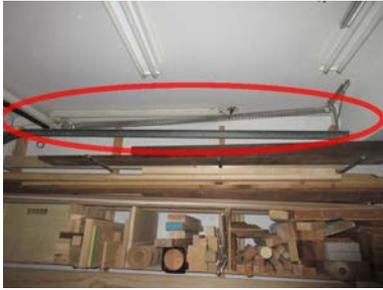
Safeties are cables run through the center of the garage door springs that prevent broken springs from becoming projectiles that can cause injury. There are no safeties installed. The installation of safeties is recommended.

No safety cables in garage door springs – the garage door springs are in good working condition and under normal use should not pose a safety risk.

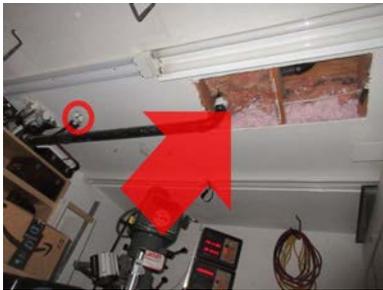
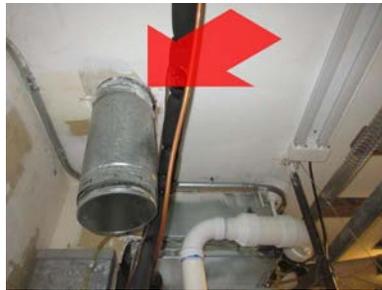
6.3 FIRE SEPARATION

There are voids in the fire resistive barrier between the living space and garage that will allow flames to penetrate. The gypsum barrier slows the spread of a fire from the garage to the structure and/or living space. Patching the voids with a fire retardant caulk is recommended.

Voids in the fire resistive barrier. Patching the voids with a fire retardant caulk is recommended- the missing drywall and voids have all been properly patched with drywall and fire retardant caulk.

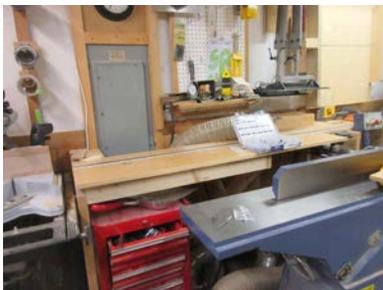
Access to the electrical panel is blocked by a work bench. Benches should be removed or modified so that there is a 30" wide by 36" deep by 7' tall clearance in front of the panel.

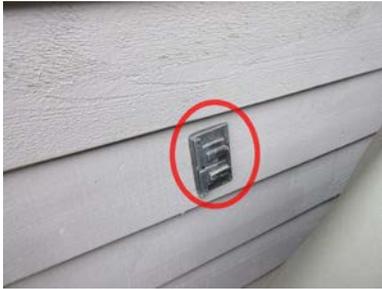
7.10 RECEPTACLES

The cover plate is damaged at the exterior receptacle. This is a shock and fire hazard. The installation of a weather tight cover plate is recommended.

There are several loose receptacles throughout the home. This is a potential shock and a fire hazard. All loose receptacles should be repaired as necessary.

Cover plates are missing from numerous receptacles. This is a shock and fire hazard. The installation of cover plates on all receptacles is recommended.

The cover plate is damaged at the exterior receptacle. The installation of a weather tight cover plate is recommended - The exterior receptacle cover plate has been replaced.

Loose receptacles throughout the home - all loose receptacles identified by the inspector have been tightened.

Cover plates are missing from numerous receptacles. These were removed for interior painting. They have now been installed on all receptacles.

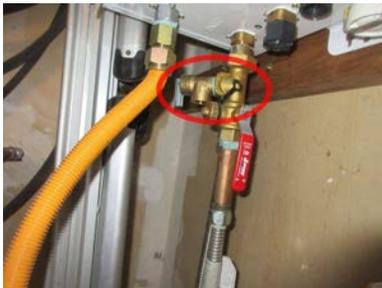
The pressure relief valve lacks a drain pipe. This is a scald hazard. The installation of a 3/4" copper, CPVC plastic or galvanized steel drain pipe is recommended. Ideally, the drain should be routed to the exterior. However, running the pipe straight down to the floor eliminates the scald hazard.

The pressure relief valve is damaged. This can result in failure of the pressure relief valve. The pressure relief valve should be reconfigured so that it allows for the relief valves proper operation.

The pressure relief valve lacks a drain pipe. The installation of a 3/4" copper, CPVC plastic or galvanized steel drain pipe is recommended. Running the pipe straight down to the floor is recommended.

The pressure relief valve is damaged. The pressure relief valve should be reconfigured so that it allows for the relief valves proper operation

This water heater was installed only a few months ago by Wallner Plumbing Inc. They will be contacted and the recommendations addressed, if requested in the Purchase and Sales Agreement.

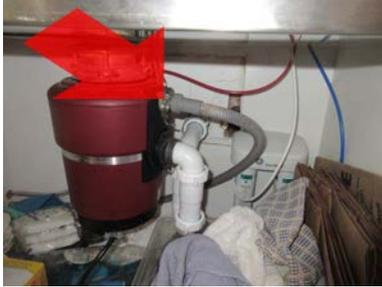
12.8 AIR GAP

The dishwasher drain lacks an air gap. The dishwasher will function without one, but there is a risk of contamination of the inside of the dishwasher by waste water. The installation of an air gap is recommended.

The dishwasher drain lacks an air gap. The dishwasher will function without one, but there is a risk of contamination of the inside of the dishwasher by waste water. The installation of an air gap is recommended, however the dishwasher functions perfectly - no action to be taken.

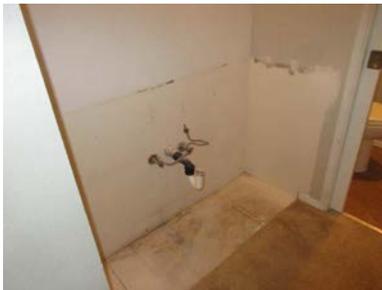
A bathroom cabinet was not installed at the time of the inspection.

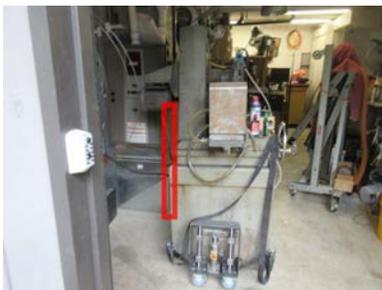
The gas pipes in front of the furnace and water heater are not protected by a bumper stop. A vertical steel pipe, bolted to the floor, is typically installed in front of the water heater to prevent a car bumper from damaging the gas lines.

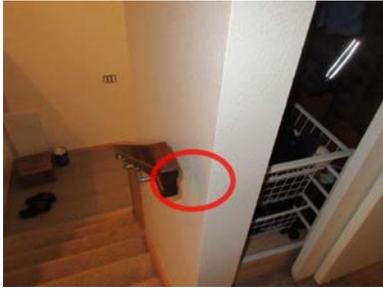
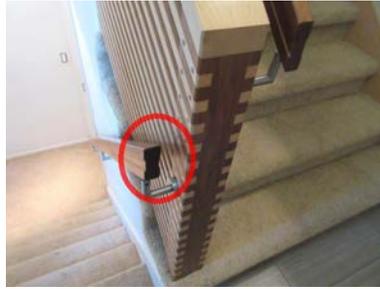
16.2 STAIRS

The railing ends in the stairwell does not return to the wall. This is a safety hazard. The installation of a

continuous handrail should be considered as a safety upgrade.

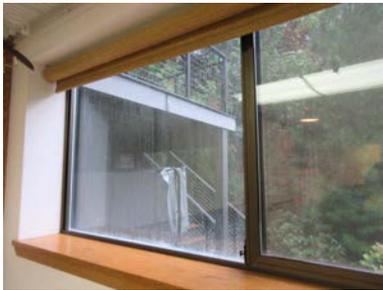
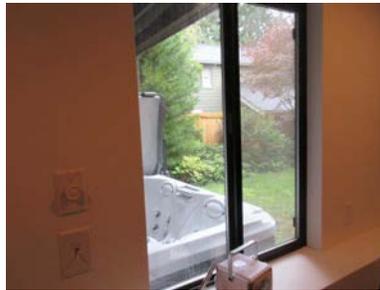
16.7 WINDOWS

There is condensation or mineral deposits between the panes of glass in several of the insulated glass windows. This indicates failed seals. The glass assemblies should be replaced, which is the only method for correcting this deficiency.

There is condensation or mineral deposits between the panes of glass in some of the insulated glass windows. Most of the windows in the home have been replaced. Some windows, like the laundry room, were in the back of the house on the lower level and were not replaced. No action to be taken.

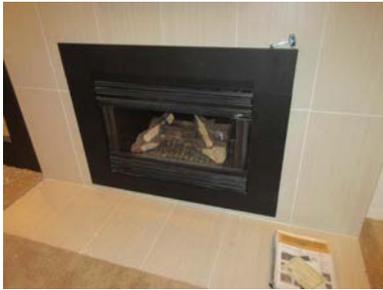
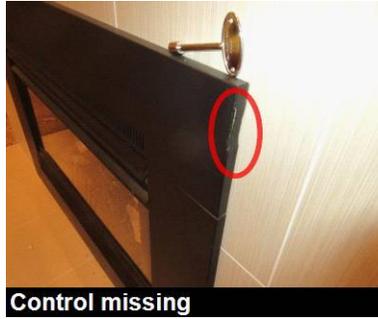
The controls for the lower floor fireplace were not found and the fireplace was not tested. The operation of the gas appliance was not verified.

The gas supply for the fireplace's is located on the wall or floor adjacent to the hearth. The key that turns on this valve should be kept out of the reach of children.

The fireplace in the living room is controlled by the thermostat on the opposite wall. This fireplace was cleaned and serviced by Alexander's Heating on 10/09/19 and is in good working condition.

The lower floor fireplace is controlled by the thermostat on the adjacent wall. This fireplace was cleaned and serviced by Alexander's Heating on 10/09/19 and is in good working condition.

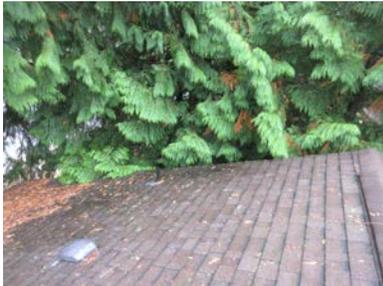
Trees are touching the building on the east side. Low hanging tree branches can damage the roof, gutters, siding, doors and/or windows. Tree branches should be trimmed back where necessary.

All trees that were contacting the roof have been trimmed back.

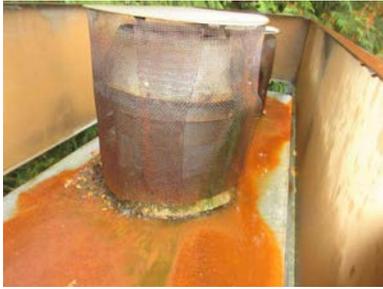
The chase cover for the fireplace is concave and holds water. This has resulted in corrosion of the sheet metal. When rust holes form the cover will begin to leak. Chase cover replacement is recommended. The

new chase cover should be sloped for drainage.

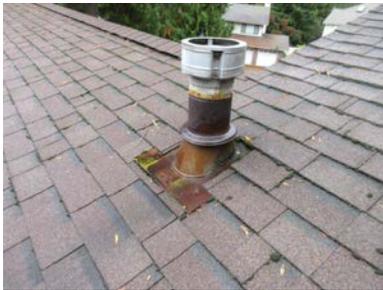
4.5 GAS APPLIANCE VENTS

The gas appliance vent is corroded above the roof line. Cleaning and painting the vent will prolong its service life.

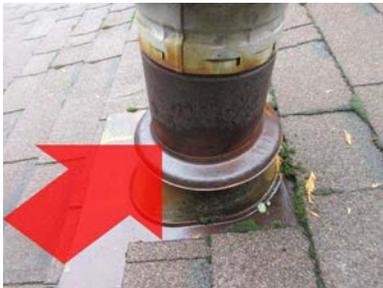
The storm collar is not sealed. This is allowing leakage to occur. Sealing the storm collar is recommended.

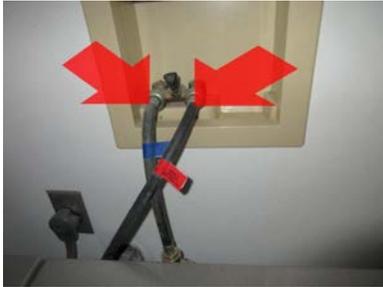
Upgrading the washer connections to high pressure (steel braided) lines is recommended.

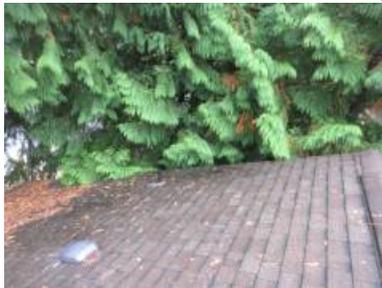
Trees are touching the building on the east side. Low hanging tree branches can damage the roof, gutters, siding, doors and/or windows. Tree branches should be trimmed back where necessary.

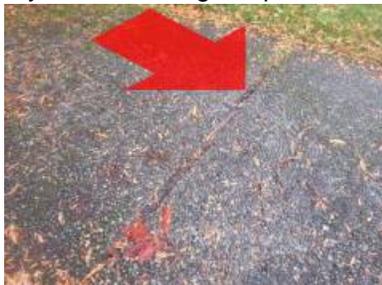
2.4 DRIVEWAY

The driveway is paved with concrete. There are minor shrinkage cracks visible in the concrete. Shrinkage cracks are common and do not affect the serviceability of the concrete.

One or more of the wooden dividers separating the concrete driveway sections were infested by wood destroying organisms and have deteriorated to a point where they are becoming a trip hazard. Replacement with mortar is recommended.

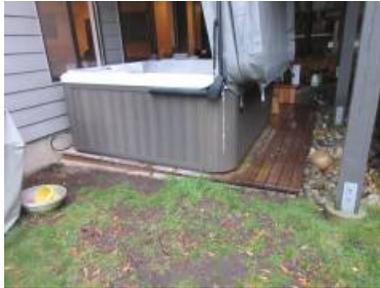
2.5 PATIO

The proximity of the decking over the patio prevented an inspection of the patio. The patio has cracked and settled differentially. This was probably caused by inadequate preparation of the soil prior to the placement of the concrete. This condition can be repaired by pressure grouting the sunken portion of the walkway or by removing and replacing it.

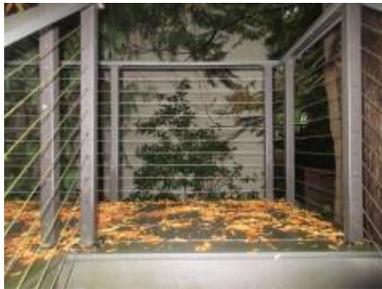
The spacing between the balusters is too wide. This is a hazard to small children. The balusters should be spaced close enough together so that a 4" sphere cannot pass through. Upgrading the deck railing is recommended if small children are present.

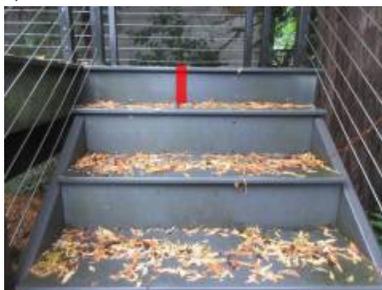
3.8 STAIRS

The stairs are non-conforming due to the variable and/or excessive rise. Stair design standards require that stair risers do not exceed 8" and that the variation in rise not exceed 3/8" in order to reduce falls from tripping. To increase the margin of safety, consideration should be given to reconfiguring the stairs so that rise and run do not vary by more than 3/8". If this proves to be too impractical or expensive, then we recommend exercising caution when using these stairs.

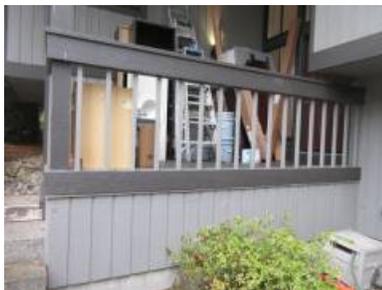
The spacing between the balusters is too wide. This is a hazard to small children. The balusters should be spaced close enough together so that a 4" sphere cannot pass through. Upgrading the porch railing is recommended if small children are present.

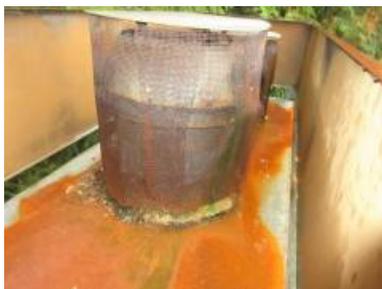
The chase cover for the fireplace is concave and holds water. This has resulted in corrosion of the sheet metal. When rust holes form the cover will begin to leak. Chase cover replacement is recommended. The new chase cover should be sloped for drainage.

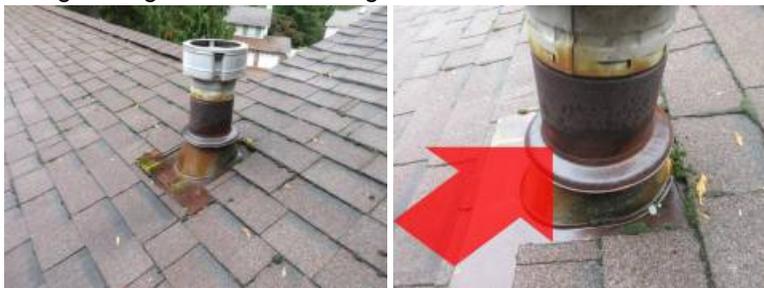
The storm collar is not sealed. This is allowing leakage to occur. Sealing the storm collar is recommended.

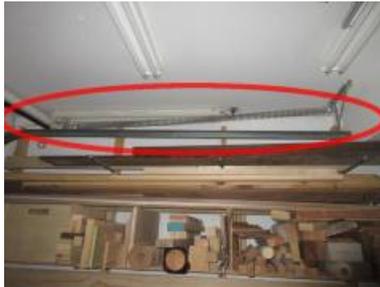
Safeties are cables run through the center of the garage door springs that prevent broken springs from becoming projectiles that can cause injury. There are no safeties installed. The installation of safeties is recommended.

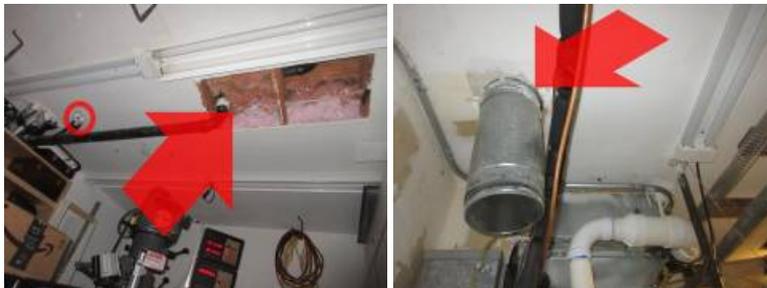
6.3 FIRE SEPARATION

There are voids in the fire resistive barrier between the living space and garage that will allow flames to penetrate. The gypsum barrier slows the spread of a fire from the garage to the structure and/or living space. Patching the voids with a fire retardant caulk is recommended.

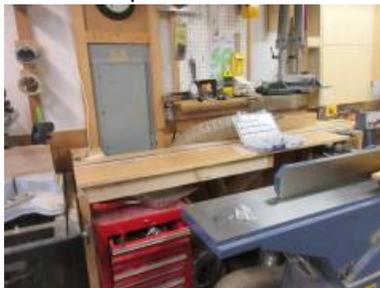
Access to the electrical panel is blocked by a work bench. Benches should be removed or modified so that there is a 30" wide by 36" deep by 7' tall clearance in front of the panel.

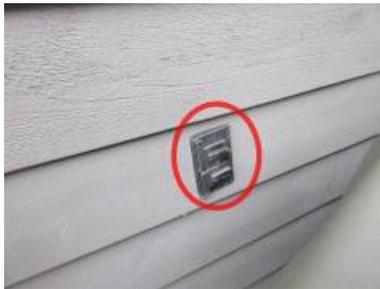
Cover plates are missing from numerous receptacles. This is a shock and fire hazard. The installation of cover plates on all receptacles is recommended.

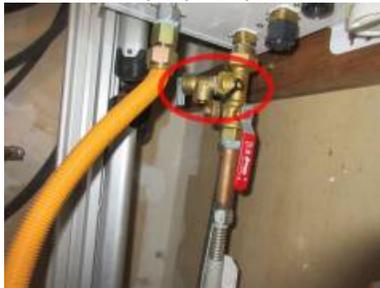
The pressure relief valve is damaged. This can result in failure of the pressure relief valve. The pressure relief valve should be reconfigured so that it allows for the relief valves proper operation.

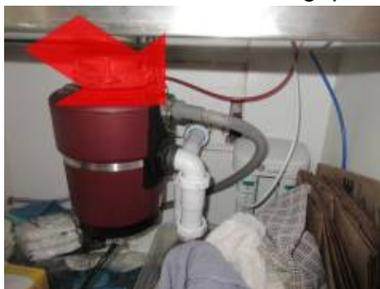
The dishwasher drain lacks an air gap. The dishwasher will function without one, but there is a risk of contamination of the inside of the dishwasher by waste water. The installation of an air gap is recommended.

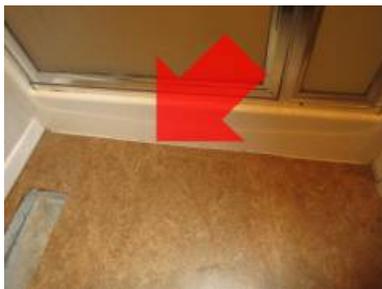
The caulking is deteriorated at the intersection between the shower and floor. This can lead to water damage to the flooring and substrate. Recaulking this area is recommended.

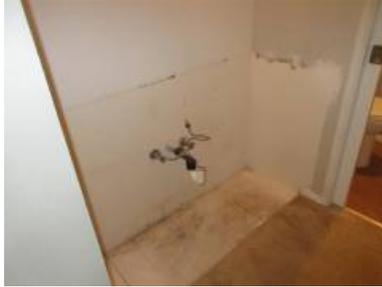
A bathroom cabinet was not installed at the time of the inspection.

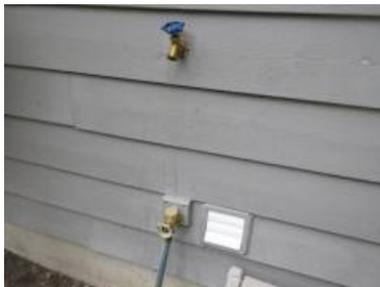
The higher hose bibb is the old style that must be protected during freezing weather. This can be accomplished either by installing a foam cap over the bibb or by shutting off the water supply at the indoor gate valve opposite the bibb and then opening the bibb to allow the water to drain out.

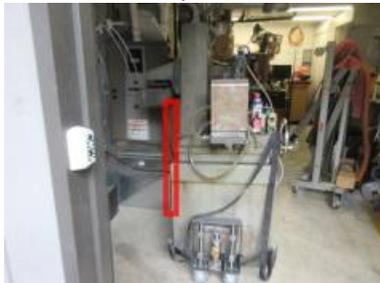
15.11 GAS PIPING

The gas pipes in front of the furnace and water heater are not protected by a bumper stop. A vertical steel pipe, bolted to the floor, is typically installed in front of the water heater to prevent a car bumper from damaging the gas lines.

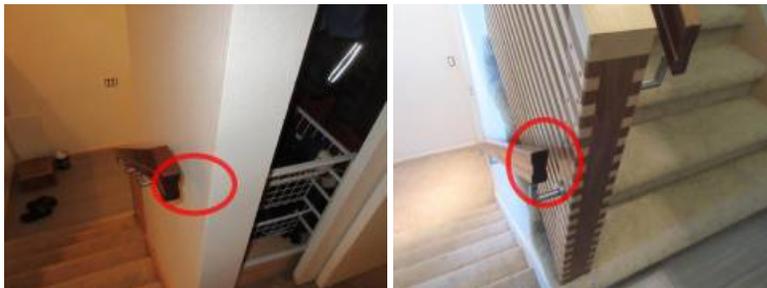
The railing ends in the stairwell does not return to the wall. This is a safety hazard. The installation of a continuous handrail should be considered as a safety upgrade.

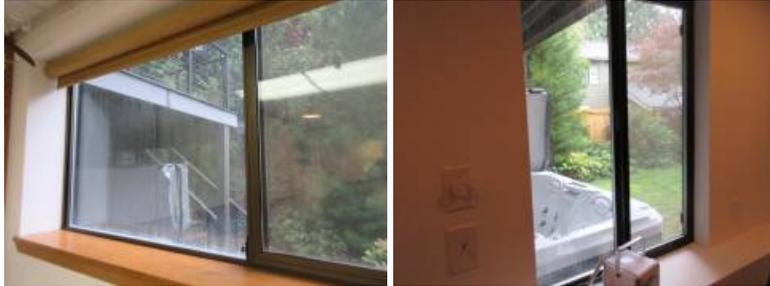
There is condensation or mineral deposits between the panes of glass in several of the insulated glass windows. This indicates failed seals. The glass assemblies should be replaced, which is the only method for correcting this deficiency.

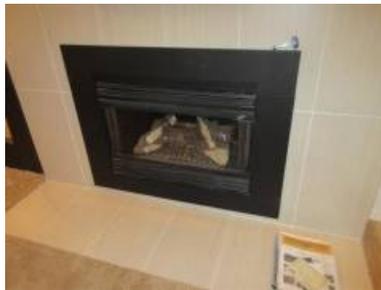
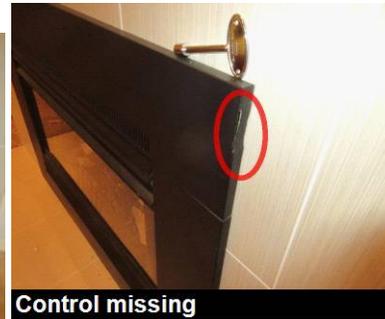
The gas supply for the fireplace's is located on the wall or floor adjacent to the hearth. The key that turns on this valve should be kept out of the reach of children.

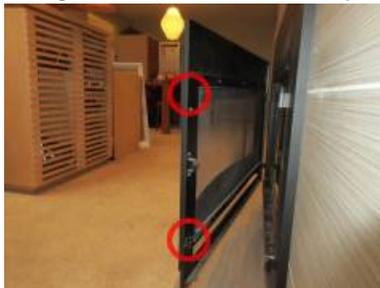
17.2 GLASS DOORS

The glass cover is not secured in place. The glass cover should be repaired or replaced as necessary.

The glass cover was repaired by Alexander's Heating on 10/09/19.
