NOTICE TO BUYER: SELLER-PROCURED INSPECTION REPORT

Olaf and Sherri Hubel
14136 174th Place NE
Redmond, WA 98052

At your request, a visual inspection of the above referenced property was conducted on 09/30/2019. We have inspected the major structural components, plumbing, heating and electrical systems for signs of significant non-performance, excessive or unusual wear and general state of repair.

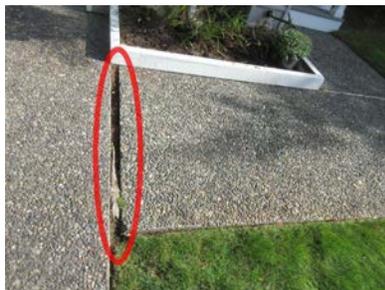
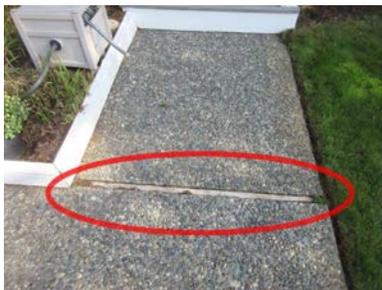
2.5 WALKWAY

One or more of the wooden dividers separating the concrete walkway sections were infested by wood destroying organisms and have deteriorated to a point where they are becoming a trip hazard. Replacement with mortar is recommended.

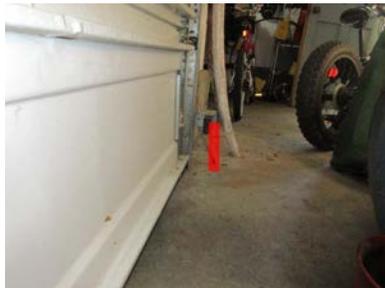
6.3 GARAGE DOOR OPENER

The Photo-eye beam was installed to high above the floor of the garage to adequately offer protection for small children and/or pets. We recommend that the photo-eye be lowered to within 4-6" of the floor.

6.3 Garage door opener

-The photo eye will be lowered to within 4"-6" of the floor.

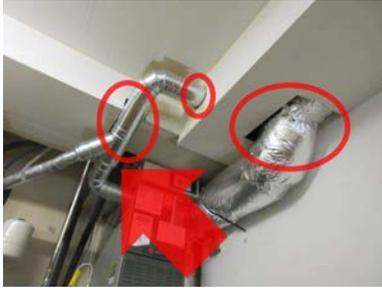
6.4 FIRE SEPARATION

There are voids in the fire resistive barrier between the living space and garage that will allow flames to

penetrate. The gypsum barrier slows the spread of a fire from the garage to the structure and/or living space. Patching the voids with a fire retardant caulk is recommended.

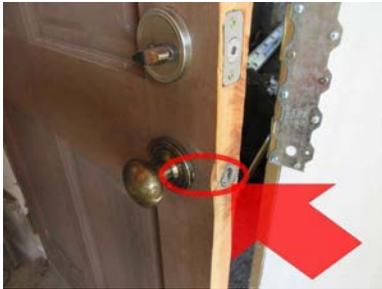
6.6 EXTERIOR DOOR(S)

Hardware is damaged at the exterior garage door. Replacement of the damaged hardware is recommended.

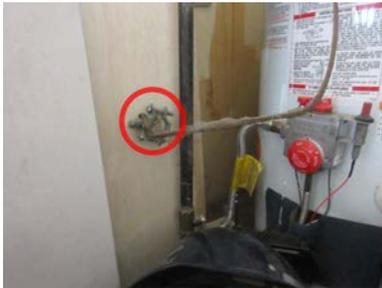
7.7 SERVICE GROUNDING AND BONDING

The service grounding electrode conductor is detached from the gas pipe. The service grounding electrode conductor should be reattached using a clamp suitable for a gas pipe.

-The service grounding electrode conductor should be reattached using a clamp suitable for a gas pipe.

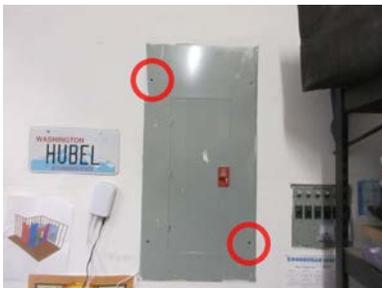
7.8 SERVICE PANEL

Screws that secure the panel cover to the panel box are missing. This is a potential hazard. Missing screws should be replaced with the original style blunt end screws.

-The missing screws will be replaced as recommended.

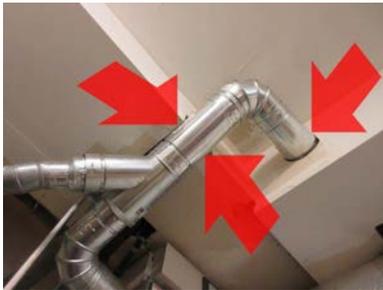
The furnace vent connector is too close to a combustible material. This is a hazard. A minimum clearance of 6" is required between the single wall vent connector and the combustible material. The double wall type B vent requires only 1" of clearance. Repairs are recommended.

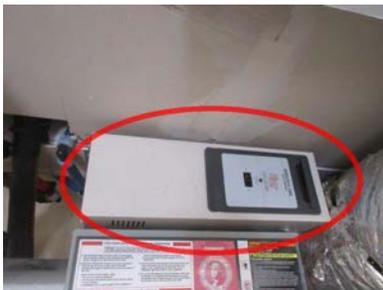
8.12 AIR FILTER

We were unable to remove the air filter cover. Ready access should be provided for air filter inspection and maintenance. Repairs are recommended.

Clogged air filters reduces air flow and furnace efficiency. Removal and replacement of the air filter is recommended.

-Air filter was unable to be removed. We will fix it so that it is easier accessible. Our air filters were just cleaned at the beginning of September.

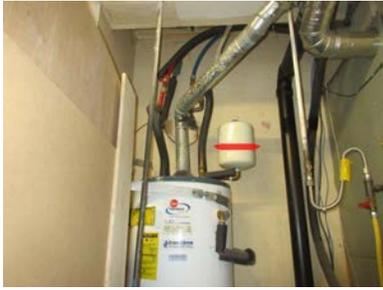
The expansion tank is not adequately secured to the wall. This could result in damage to the water pipe and leakage during an earth quake. A seismic restraint should be installed to secure the expansion tank.

-We will adequately secure the expansion tank to the wall.

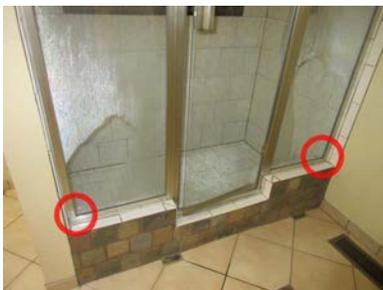
The glass enclosure has been leaking at the lower corners. No damage was visible, but resealing or repairing the enclosure is recommended as preventive maintenance.

-glass enclosure will be resealed in the recommended location.

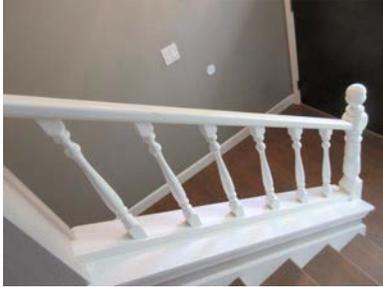
15.2 STAIRS

The stair railing baluster spacing is too wide. This is a hazard for small children. The baluster spacing should be reduced as a safety upgrade. Current standards require that a 4" sphere not pass through the railing.

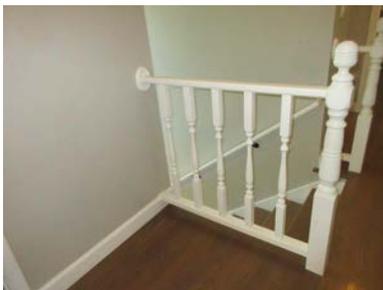
15.3 GUARD RAILINGS

The spacing between the balusters is too wide. This is a hazard to small children. The balusters should be spaced close enough together so that a 4" sphere cannot pass through. Upgrading the guard railing is recommended if small children are present.

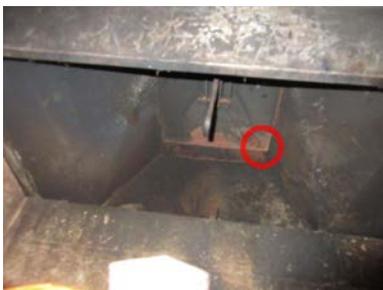
A C-clamp should be installed on the fireplace damper to prevent full closure. This is a safety measure designed to insure that carbon monoxide does not spill out into the room in the event that you forget to open the damper after lighting the gas log.

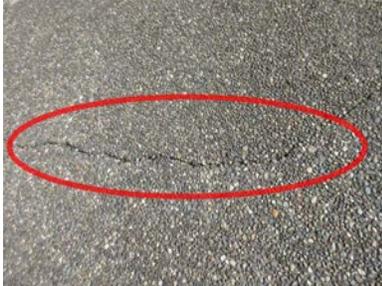
Cracks were observed in the concrete surface of the driveway. Minor cracks can be sealed to minimize moisture entry and further settlement of the concrete. Minor cracks are common and do not affect the serviceability of the concrete.

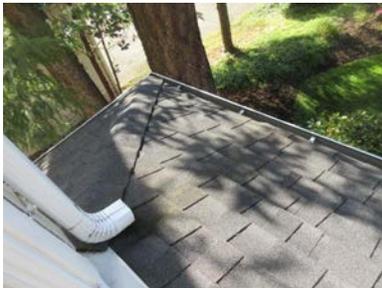
3.4 GUTTERS AND DOWNSPOUTS

Downspouts draining directly onto the asphalt shingle surface causes excessive wear of the roofing material. Downspout extensions to the lower gutters should be installed to prevent excessive wear and tear of the roofing.

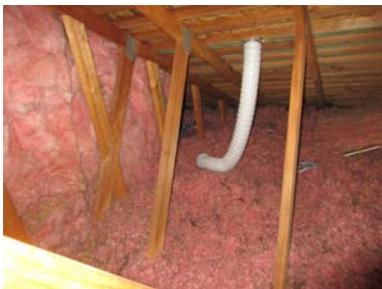
5.3 MECHANICAL VENTILATION SYSTEMS

Flexible plastic duct is used to direct air from the vent fan to the exterior. This type of material is unreliable. Replacing the plastic duct with 4" smooth-wall sheet metal duct is recommended.

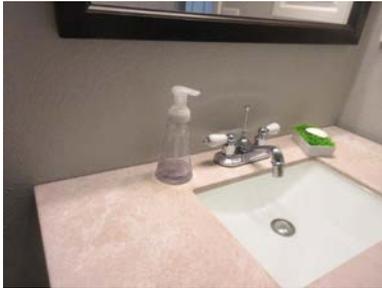
The backsplash is missing. The installation of a backsplash is recommended.

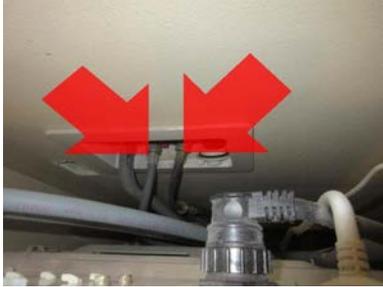
Upgrading the washer connections to high pressure (steel braided) lines is recommended.

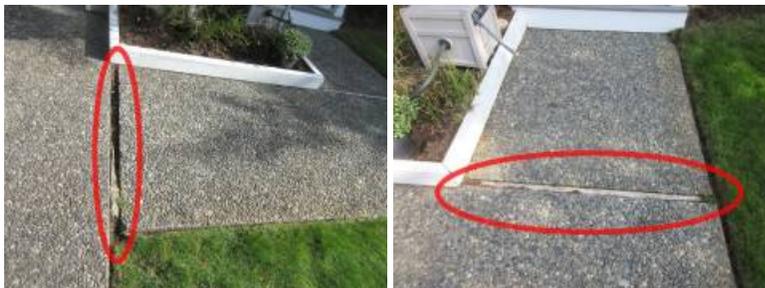
2.5 WALKWAY

One or more of the wooden dividers separating the concrete walkway sections were infested by wood destroying organisms and have deteriorated to a point where they are becoming a trip hazard. Replacement with mortar is recommended.

Many legal and public works departments have defined a trip hazard as an irregularity in a walking surface exceeding one inch (1") in height. All walking surfaces should maintain, free of a vertical surface change of 3/4" or more, in the interest of public and personal safety.

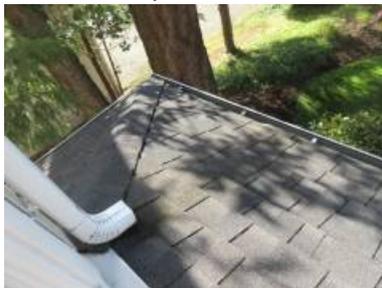
Downspouts draining directly onto the asphalt shingle surface causes excessive wear of the roofing material. Downspout extensions to the lower gutters should be installed to prevent excessive wear and tear of the roofing.

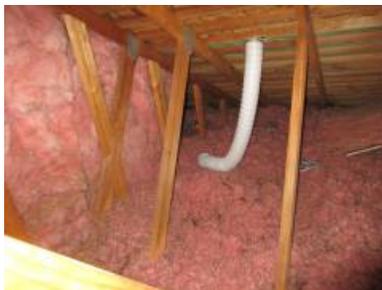
Flexible plastic duct is used to direct air from the vent fan to the exterior. This type of material is unreliable. Replacing the plastic duct with 4" smooth-wall sheet metal duct is recommended.

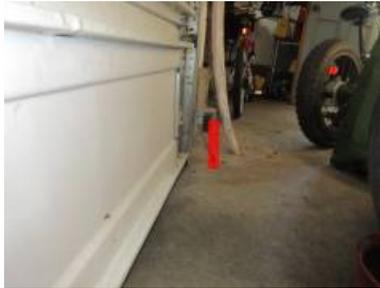
The Photo-eye beam was installed too high above the floor of the garage to adequately offer protection for small children and/or pets. We recommend that the photo-eye be lowered to within 4-6" of the floor.

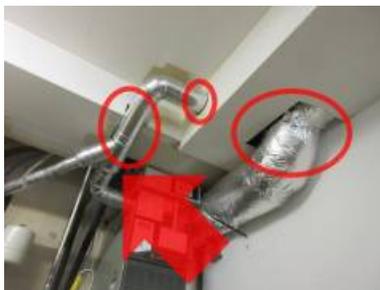
6.4 FIRE SEPARATION

There are voids in the fire resistive barrier between the living space and garage that will allow flames to penetrate. The gypsum barrier slows the spread of a fire from the garage to the structure and/or living space. Patching the voids with a fire retardant caulk is recommended.

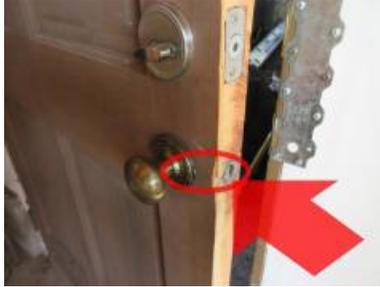
Hardware is damaged at the exterior garage door. Replacement of the damaged hardware is recommended.

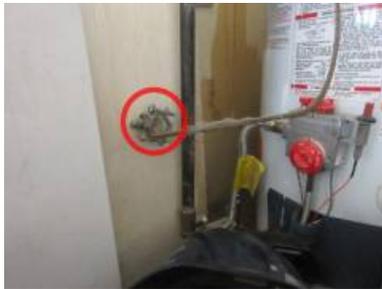
The service grounding electrode conductor is detached from the gas pipe. The service grounding electrode conductor should be reattached using a clamp suitable for a gas pipe.

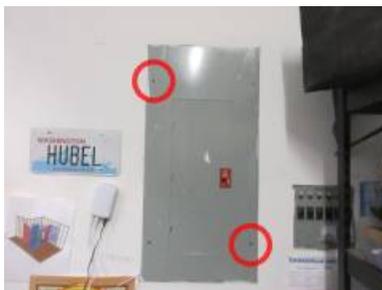
7.8 SERVICE PANEL

Screws that secure the panel cover to the panel box are missing. This is a potential hazard. Missing screws should be replaced with the original style blunt end screws.

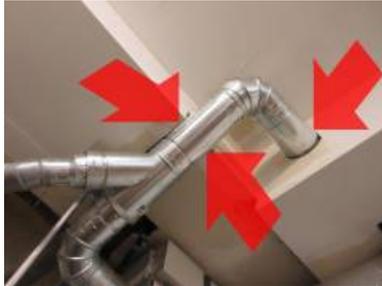
The furnace vent connector is too close to a combustible material. This is a hazard. A minimum clearance of 6" is required between the single wall vent connector and the combustible material. The double wall type B vent requires only 1" of clearance. Repairs are recommended.

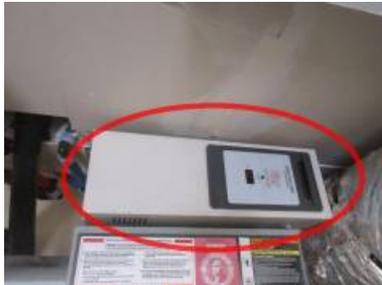
Clogged air filters reduces air flow and furnace efficiency. Removal and replacement of the air filter is recommended.

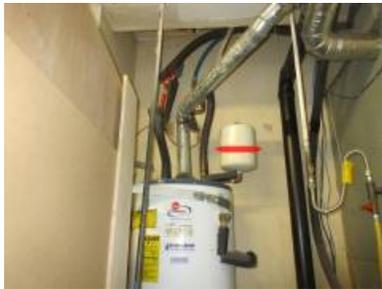
The expansion tank is not adequately secured to the wall. This could result in damage to the water pipe and leakage during an earth quake. A seismic restraint should be installed to secure the expansion tank.

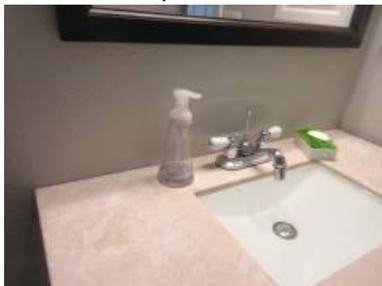
The backsplash is missing. The installation of a backsplash is recommended.

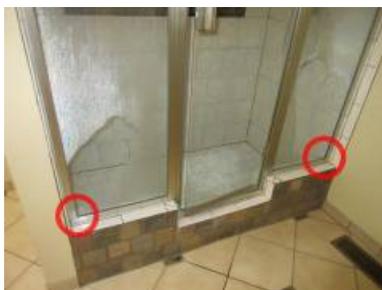
The glass enclosure has been leaking at the lower corners. No damage was visible, but resealing or repairing the enclosure is recommended as preventive maintenance.

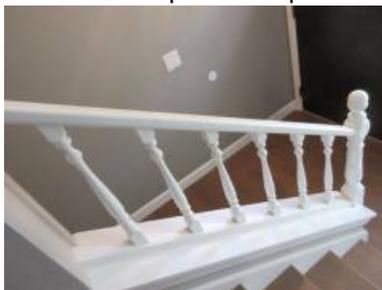
The stair railing baluster spacing is too wide. This is a hazard for small children. The baluster spacing should be reduced as a safety upgrade. Current standards require that a 4" sphere not pass through the railing.

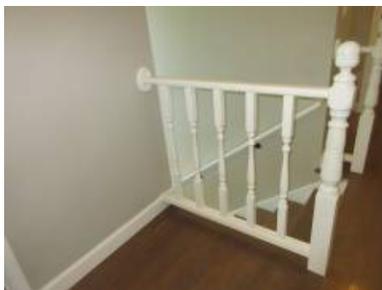
15.3 GUARD RAILINGS

The spacing between the balusters is too wide. This is a hazard to small children. The balusters should be spaced close enough together so that a 4" sphere cannot pass through. Upgrading the guard railing is recommended if small children are present.

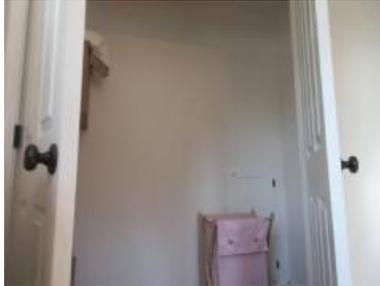
The closet package is missing from one of the bedrooms. Replacement of the missing closet rod(s) and/or shelves is recommended.

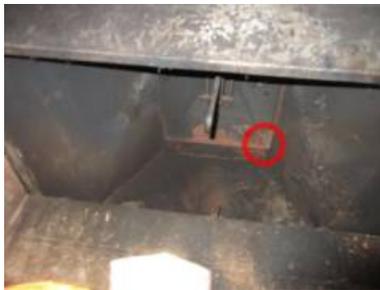
A C-clamp should be installed on the fireplace damper to prevent full closure. This is a safety measure designed to insure that carbon monoxide does not spill out into the room in the event that you forget to open the damper after lighting the gas log.
