NOTICE TO BUYER: SELLER-PROCURED INSPECTION REPORT

**Steve & Patti Nelson
17409 NE 141st Street
Redmond, WA 98052**

At your request, a visual inspection of the above referenced property was conducted on 07/28/2020. We have inspected the major structural components, plumbing, heating and electrical systems for signs of significant non-performance, excessive or unusual wear and general state of repair.

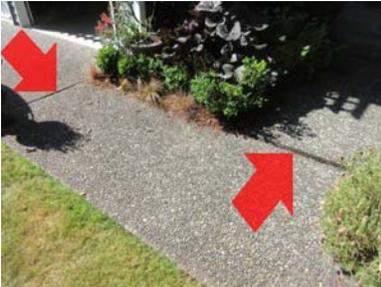
2.6 WALKWAY

The wooden dividers separating the concrete walkway sections have deteriorated to a point where the gaps are a trip hazard. Replacement with mortar is recommended.

2.6 Walkway: Added new wooden dividers in sidewalk.

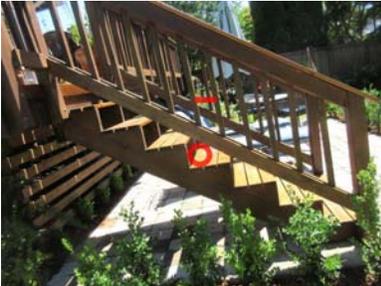
3.8 STAIRS

The stair railing baluster spacing is too wide. This is a hazard for small children. The baluster spacing should be reduced as a safety upgrade. Current standards require that a 4" sphere not pass through the railing.

The spacing under stair railing is too wide. This is a hazard for small children. The spacing should be reduced as a safety upgrade. Current standards require that a 4" sphere not pass under the railing.

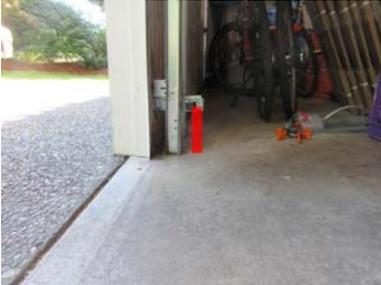
One of the Photo-eye beams was installed to high above the floor of the garage to adequately offer protection for small children and/or pets. We recommend that the photo-eye be lowered to within 4-6" of the floor.

6.3 Garage Door Opener Sensor: Garage door photo-eye beam relocated to 4"-6" off floor.

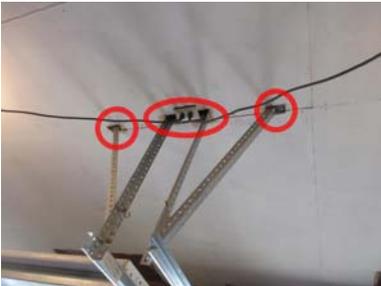
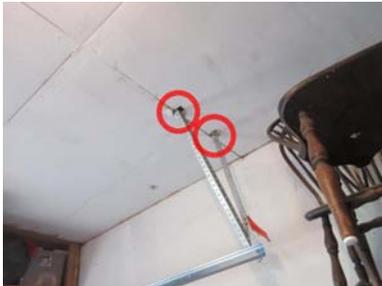
6.4 FIRE SEPARATION

There are voids in the fire resistive barrier between the living space and garage that will allow flames to penetrate. The gypsum barrier slows the spread of a fire from the garage to the structure and/or living space. Patching the voids with a fire retardant caulk is recommended.

6.4 Fire Separation: The drywall seams in these areas are not required to be fire-taped or sealed by code since they are not adjacent to a living space, but all other areas required by code in the garage are fire-taped. The original duct penetration was allowed by the County at the time of construction and is likely in a protected rated shaft and no "thimble is needed.

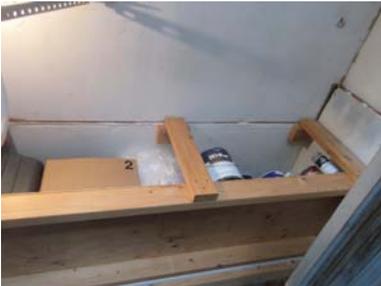
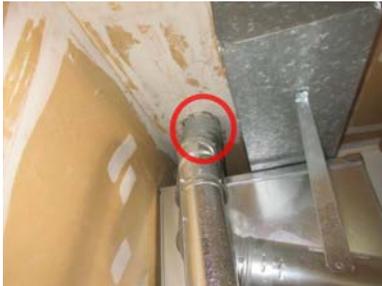
The fire resistive barrier joints are not taped. Consideration should be given to "fire taping" the drywall as a safety upgrade.

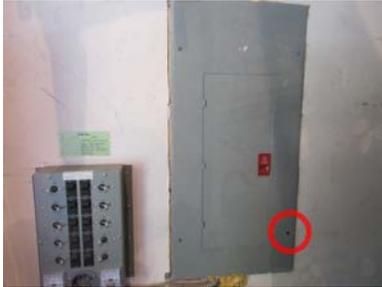
Screws that secure the panel cover to the panel box are missing. This is a potential hazard. Missing screws should be replaced with the original style blunt end screws.

7.8 Service Panel: One screw was added.

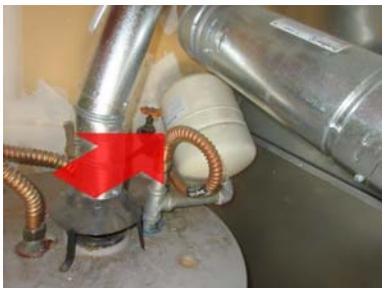
The expansion tank is not adequately secured to the wall. This could result in damage to the water pipe and leakage during an earth quake. A seismic restraint should be installed to secure the expansion tank.

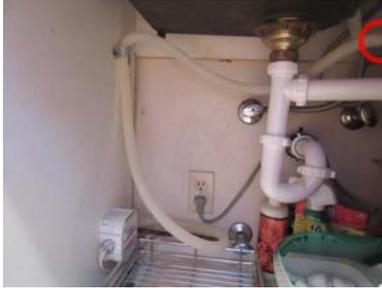
The dishwasher drain lacks an air gap. The dishwasher will function without one, but there is a risk of contamination of the inside of the dishwasher by waste water. The installation of an air gap is recommended or connection to the Johnson Tee that is installed in the kitchen wall. This air gap protects the dishwasher from contamination caused by a backflow of waste water.

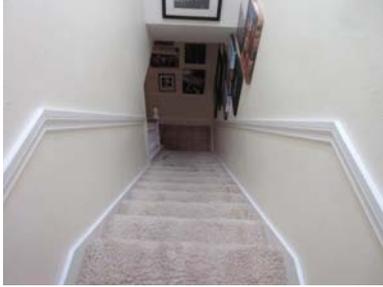
There is no handrail in the stairwell. This is a safety hazard. The installation of a graspable handrail that conforms to present industry standards is recommended.

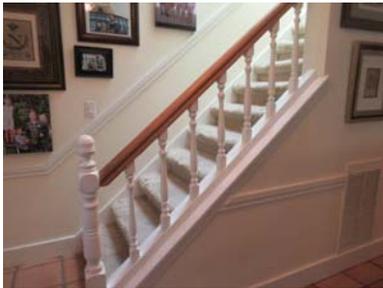
The stair railing baluster spacing is too wide. This is a hazard for small children. The baluster spacing should be reduced as a safety upgrade. Current standards require that a 4" sphere not pass through the railing.

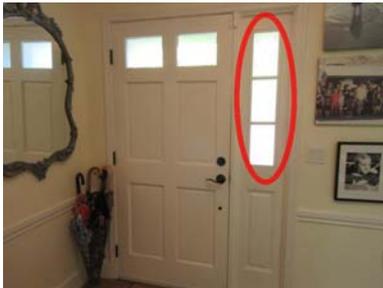
15.6 WINDOWS

The glass adjacent to the front entry door is not tempered safety glass. Tempered glass can be identified by the etched emblem in one corner of each pane. A higher margin of safety could be achieved if the glass was approved safety glass. Consideration should be given to replacing the glass as a safety upgrade.

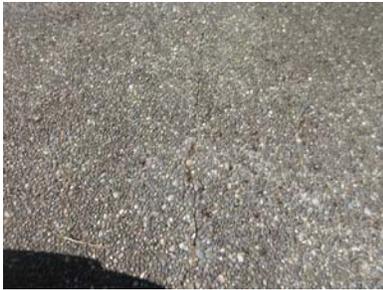
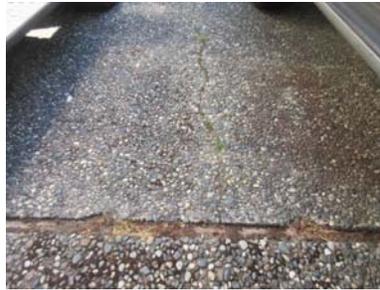
One or more of the wooden dividers separating the concrete driveway sections were infested by wood destroying organisms and have deteriorated to a point where they are becoming a trip hazard. Replacement with mortar is recommended.

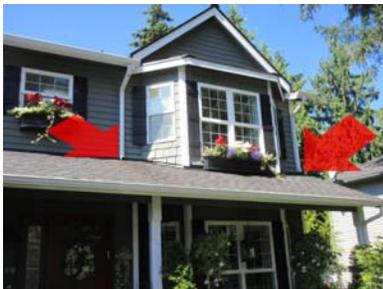
3.4 GUTTERS AND DOWNSPOUTS

Downspouts draining directly onto the asphalt shingle surface causes excessive wear of the roofing material. Downspout extensions to the lower gutters should be installed to prevent excessive wear and tear of the roofing.

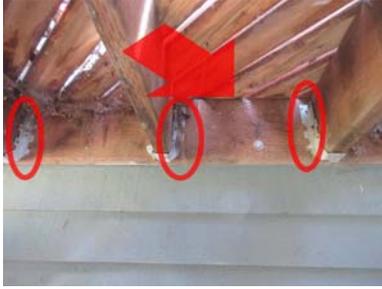
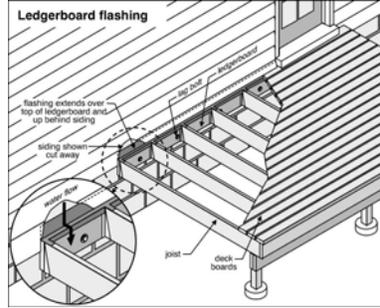
3.6 DECK

The deck support brackets are not secured with the specified fasteners recommended. The installation of 16d common nails or designed screws for the framing brackets is recommended.

There is no flashing at the intersection between the deck and house. This will allow water to enter behind the siding. The installation of flashing in this area is recommended.

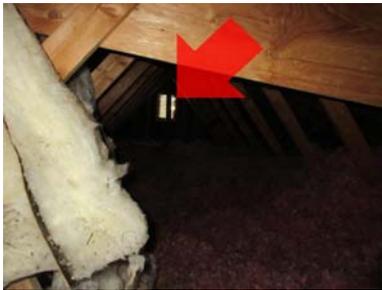
5.2 VENTILATION

The south gable vent is damaged. This allows birds, insects and rodents to enter the attic. The inside of the vent should be covered with 1/4" wire mesh.

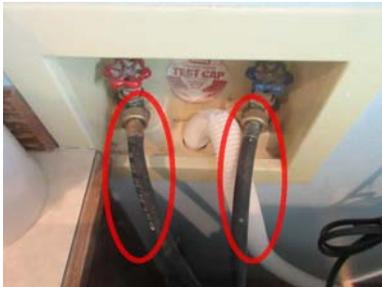
High pressure (steel braided) washer line connections is recommended.

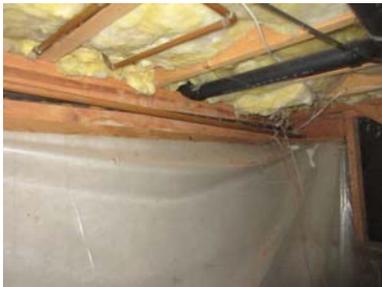
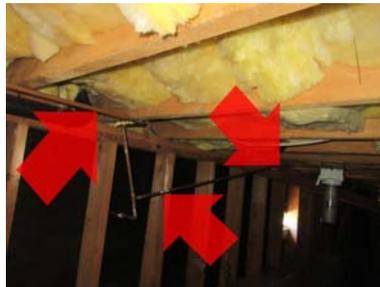
14.4 INTERIOR WATER SUPPLY PIPES

There are water pipes in the crawlspace that are not adequately insulated and could freeze. The installation of foam pipe insulation on all exposed water pipes is recommended.

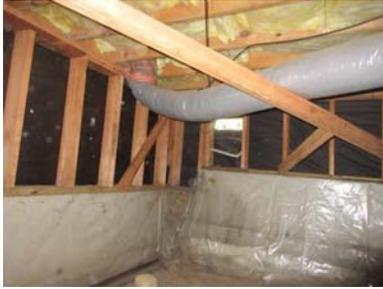
Shear panels are plywood or OSB panels that are mechanically fastened to both vertical and horizontal framing members in critical structural areas of the building. They prevent lateral movement of the structure during an earthquake. Shear panels are often visible in the crawlspace on cripple walls between the first floor and foundation. They may also be installed on interior walls that are covered with drywall. An examination of the crawlspace revealed the absence of shear panels on the cripple walls. The installation of shear panels on

the cripple walls is recommended as an upgrade.

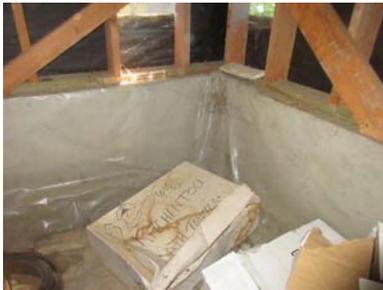
20.4 VAPOR RETARDER

The foundation walls are covered with the plastic vapor retarder. This allows the transmission of water vapor from the soil up and into the exterior wall framing. The plastic vapor retarder should be removed from the foundation leaving coverage of at least 85% of the entire surface of the soil only.

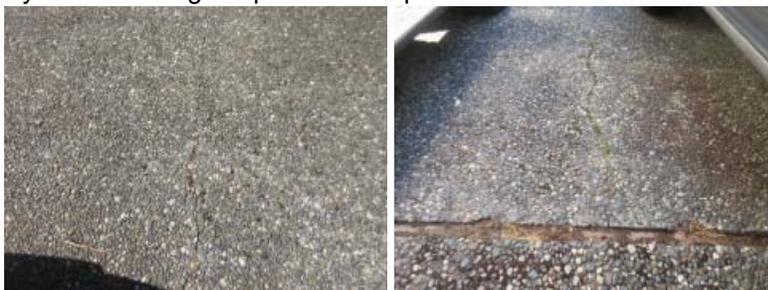
One or more of the wooden dividers separating the concrete driveway sections were infested by wood destroying organisms and have deteriorated to a point where they are becoming a trip hazard. Replacement with mortar is recommended.

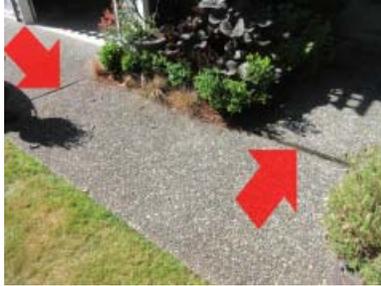
The wooden dividers separating the concrete walkway sections have deteriorated to a point where the gaps are a trip hazard. Replacement with mortar is recommended.

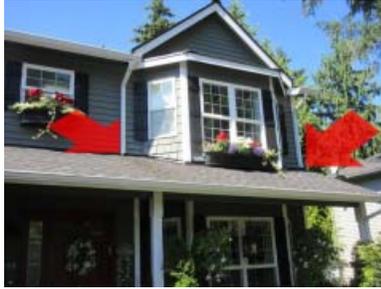
Downspouts draining directly onto the asphalt shingle surface causes excessive wear of the roofing material. Downspout extensions to the lower gutters should be installed to prevent excessive wear and tear of the roofing.

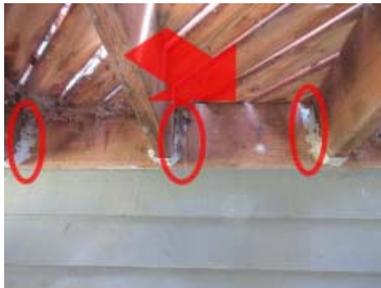
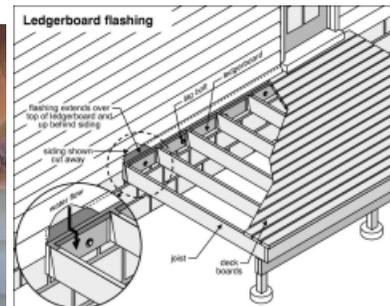
There is no flashing at the intersection between the deck and house. This will allow water to enter behind the siding. The installation of flashing in this area is recommended.

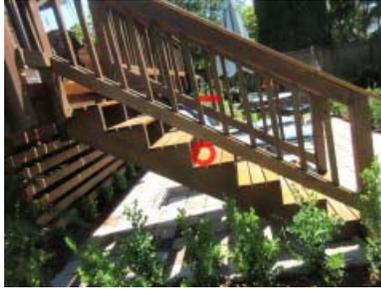
The spacing under stair railing is too wide. This is a hazard for small children. The spacing should be reduced as a safety upgrade. Current standards require that a 4" sphere not pass under the railing.

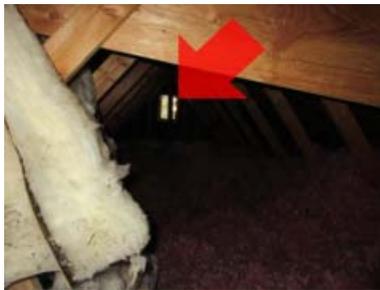
The south gable vent is damaged. This allows birds, insects and rodents to enter the attic. The inside of the vent should be covered with 1/4" wire mesh.

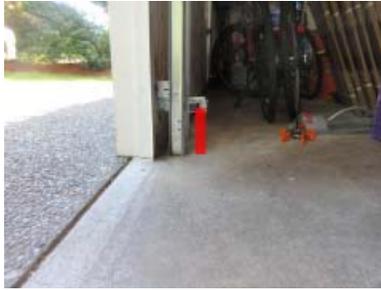
One of the Photo-eye beams was installed to high above the floor of the garage to adequately offer protection for small children and/or pets. We recommend that the photo-eye be lowered to within 4-6" of the floor.

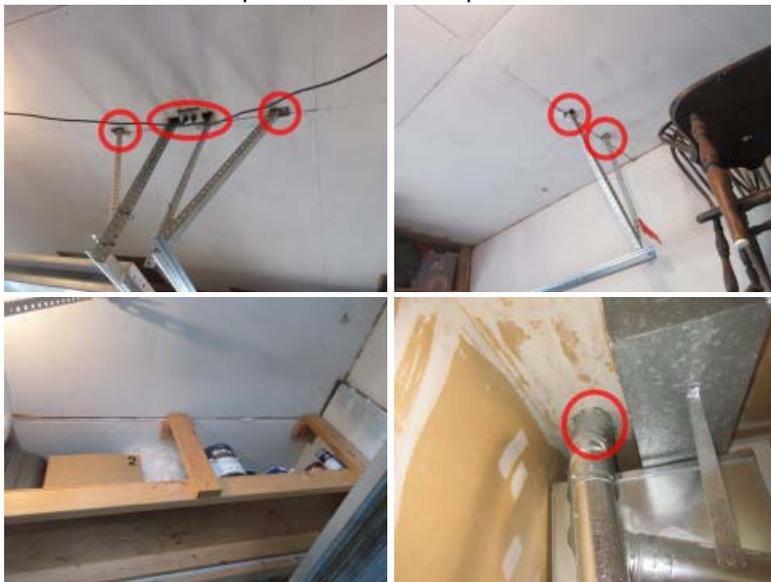
6.4 FIRE SEPARATION

There are voids in the fire resistive barrier between the living space and garage that will allow flames to penetrate. The gypsum barrier slows the spread of a fire from the garage to the structure and/or living space. Patching the voids with a fire retardant caulk is recommended.

The installation of a furnace vent thimble is recommended to prevent flames to spread to the structure.

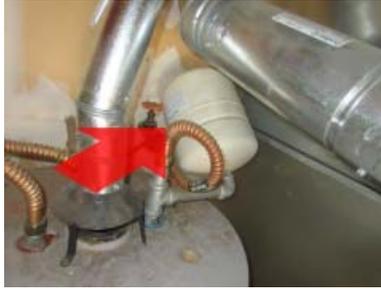
The expansion tank is not adequately secured to the wall. This could result in damage to the water pipe and leakage during an earth quake. A seismic restraint should be installed to secure the expansion tank.

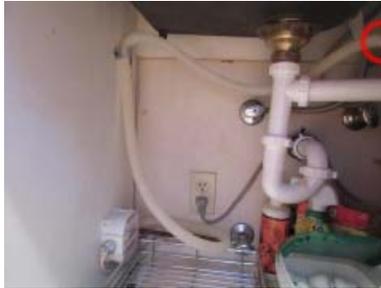
The dishwasher drain lacks an air gap. The dishwasher will function without one, but there is a risk of contamination of the inside of the dishwasher by waste water. The installation of an air gap is recommended or connection to the Johnson Tee that is installed in the kitchen wall. This air gap protects the dishwasher from contamination caused by a backflow of waste water.

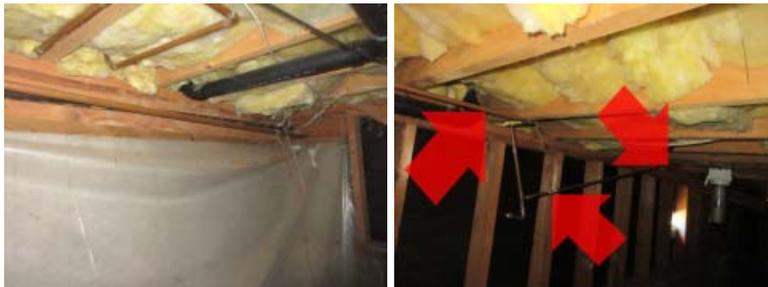
There are water pipes in the crawlspace that are not adequately insulated and could freeze. The installation of foam pipe insulation on all exposed water pipes is recommended.

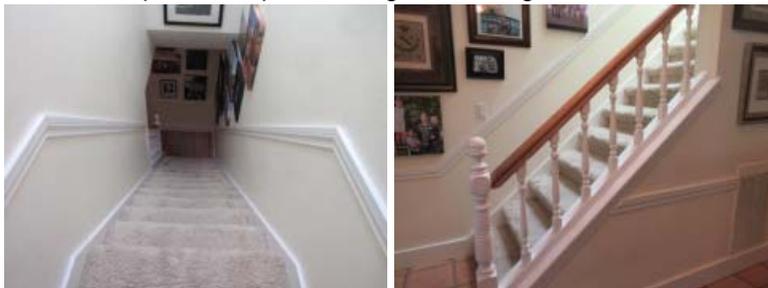
The stair railing baluster spacing is too wide. This is a hazard for small children. The baluster spacing should be reduced as a safety upgrade. Current standards require that a 4" sphere not pass through the railing.

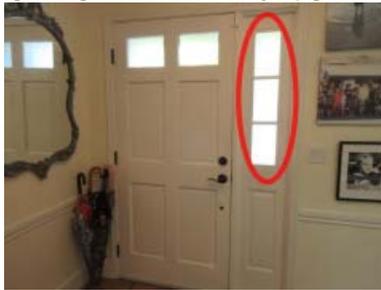
The glass adjacent to the front entry door is not tempered safety glass. Tempered glass can be identified by the etched emblem in one corner of each pane. A higher margin of safety could be achieved if the glass was approved safety glass. Consideration should be given to replacing the glass as a safety upgrade.

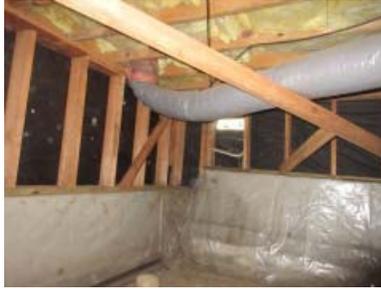
Shear panels are plywood or OSB panels that are mechanically fastened to both vertical and horizontal framing members in critical structural areas of the building. They prevent lateral movement of the structure during an earthquake. Shear panels are often visible in the crawlspace on cripple walls between the first floor and foundation. They may also be installed on interior walls that are covered with drywall. An examination of the crawlspace revealed the absence of shear panels on the cripple walls. The installation of shear panels on the cripple walls is recommended as an upgrade.

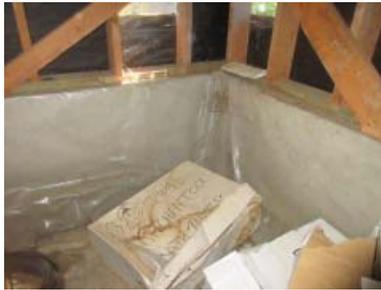
The foundation walls are covered with the plastic vapor retarder. This allows the transmission of water vapor from the soil up and into the exterior wall framing. The plastic vapor retarder should be removed from the foundation so that it covers at least 85% of the entire surface of the soil only.
