**Phyllis Kroeger by POA Kristina Schmidt**

**23869 NE 112th Circle, Unit 2**

**Per the seller as of July 31, 2020, the following items listed on the inspection summary, dated July 30, 2020, have been corrected by the seller:**

July 30, 2020

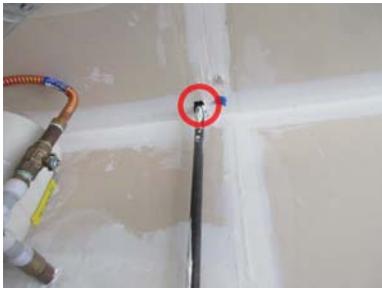
##### 6.4 FIRE SEPARATION

There are voids in the fire resistive barrier between the roof/wall framing and garage that will allow flames to penetrate. The gypsum barrier slows the spread of a fire from the garage to the structure and/or living space. Patching the voids with a fire retardant caulk is recommended.

Item 6.4 Fire Separation. Voids have been filled with fire retardant foam seal.

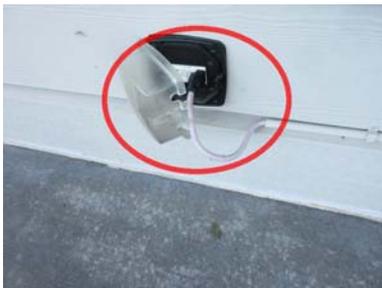
#### 7.10 WIRING

Lamp cord wire or "zip cord" is used as a permanent wiring method at the north exterior. This is a potential fire hazard. The lamp cord wire should be removed and replaced with an approved wiring method.

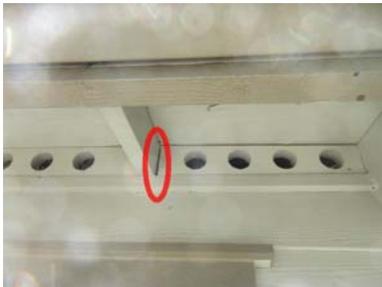
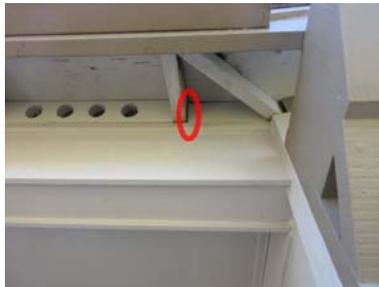
### 3.4 SOFFITS AND OVERHANGS

There are large gaps over 1/4" in size adjacent the soffit vent blocks. These gaps allow insects and rodents to enter the attic. Covering the gaps with screening, a strip of wood and/or caulking is recommended.

Item 3.4 & 3.6 – Inspection report has been forwarded to HOA management company to address any exterior issues

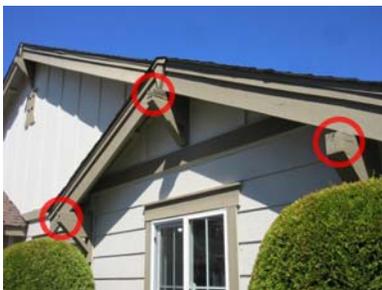
The beams that stick out beyond the drip edge of the roof are vulnerable to rot damage. They should be covered with a metal cap flashing or cut off flush with the edge of the overhang.

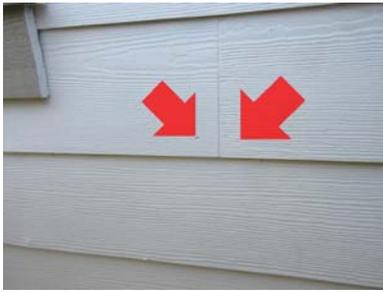
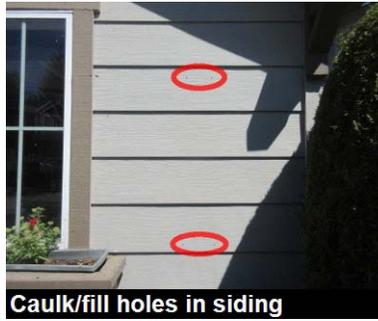
### 3.6 PAINT

Siding nails that have damaged the surface overlay need to be caulked. Caulking prevents water intrusion of the siding. Consideration should be given to caulking the siding as necessary. Exterior caulking is recommended.

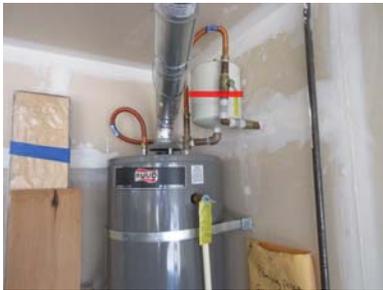
### *9.6 EXPANSION TANK*

The expansion tank is not adequately secured to the wall. This could result in damage to the water pipe and leakage during an earth quake. A seismic restraint should be installed to secure the expansion tank.

Item 9.6 Expansion Tank. A seismic restraint has been installed to secure the expansion tank.

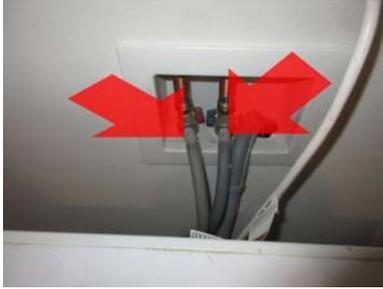
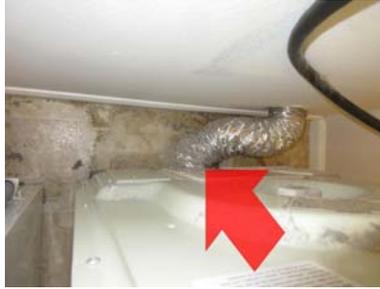
### *12.2 APPLIANCES*

High pressure (steel braided) washer line connections is recommended.

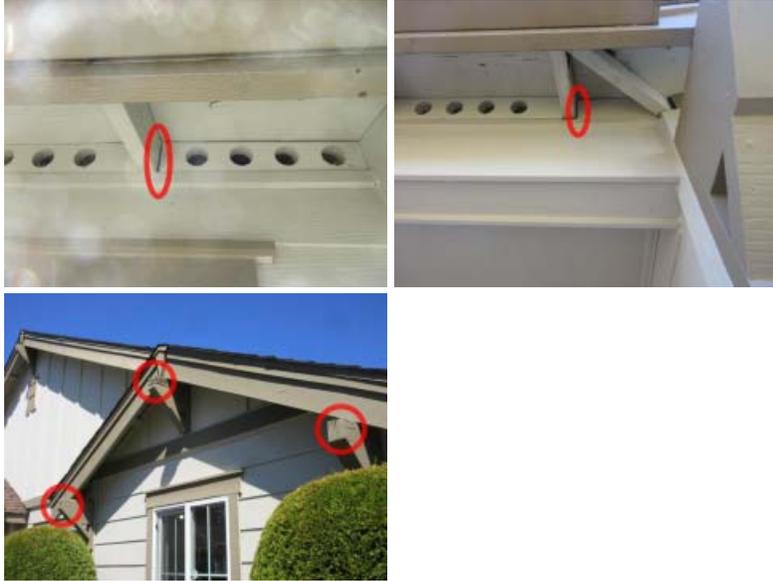
There are large gaps over 1/4" in size adjacent the soffit vent blocks. These gaps allow insects and rodents to enter the attic. Covering the gaps with screening, a strip of wood and/or caulking is recommended.

The beams that stick out beyond the drip edge of the roof are vulnerable to rot damage. They should be covered with a metal cap flashing or cut off flush with the edge of the overhang.

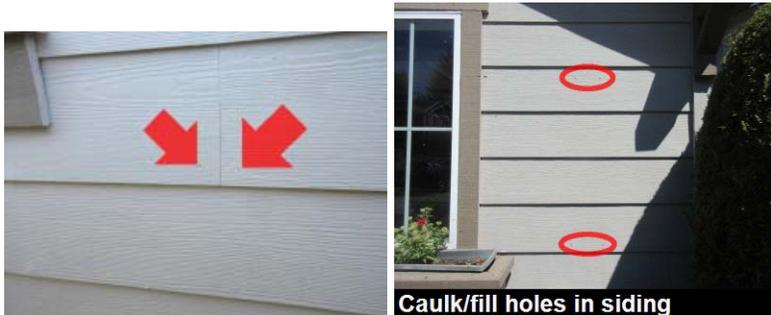
Siding nails that have damaged the surface overlay need to be caulked. Caulking prevents water intrusion of the siding. Consideration should be given to caulking the siding as necessary. Exterior caulking is recommended.

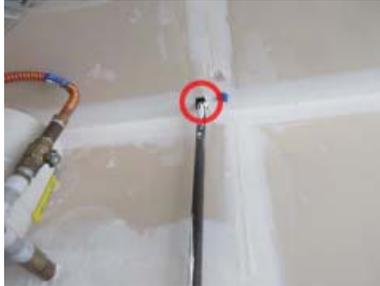
### 6.4 FIRE SEPARATION

There are voids in the fire resistive barrier between the roof/wall framing and garage that will allow flames to penetrate. The gypsum barrier slows the spread of a fire from the garage to the structure and/or living space. Patching the voids with a fire retardant caulk is recommended.

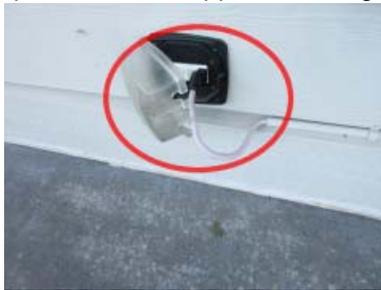
Lamp cord wire or "zip cord" is used as a permanent wiring method at the north exterior. This is a potential fire hazard. The lamp cord wire should be removed and replaced with an approved wiring method.

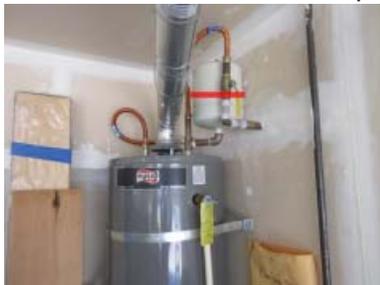
The expansion tank is not adequately secured to the wall. This could result in damage to the water pipe and leakage during an earth quake. A seismic restraint should be installed to secure the expansion tank.

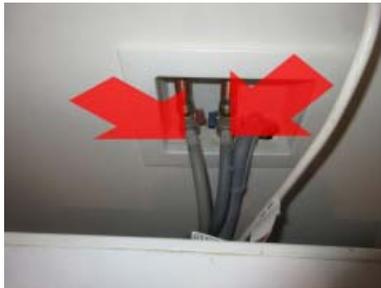
High pressure (steel braided) washer line connections is recommended.

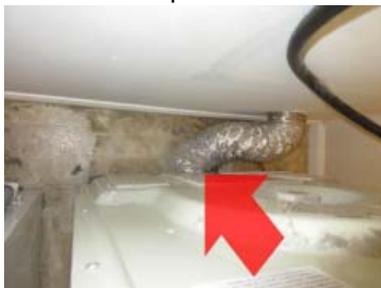
### 12.3 DRYER VENT

The dryer vent duct has become disconnected and is now discharging moisture and lint in the laundry closet. The duct should be reconnected and secured to avoid lint and moisture problems in this area.
