September 23, 2020

Re: 19614 222nd Ave. NE
Woodinville, WA.

19614 222nd Ave. NE
Woodinville WA.

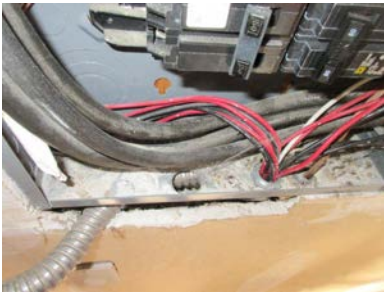
7.9 SERVICE PANEL

There are openings in the panel box where knock-outs have been removed. Missing knock-outs should be replaced with snap in metal plugs.

- 7.9 - Snap in plug installed in main circuit breaker box in garage where knock outs had been removed
- 7.10 - Snap in plug installed in sub panel box where knock outs had been removed
- 7.12 – An approved electrical connection box was installed in east attic area, and splices moved inside box per code.
- 8.2 – gas pipe in garage was secured with metal brackets on ceiling
- 9.10 – Approved water heater seismic restraint straps were installed to secure water heater to the wall
- 13.10 – gas pipe supply line in garage was secured with additional metal strap brackets on ceiling
- 14.7 – installed the additional smoke detector per code. There are smoke detectors in every bedroom, as well as in hallway outside bedrooms and hallway downstairs

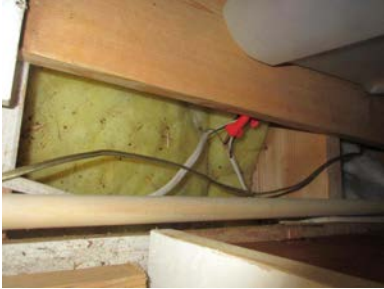
7.12 WIRING

Splices in cable made outside of a junction box were observed in the east attic. This is a fire hazard. The splices should be made inside an approved box with a cover.

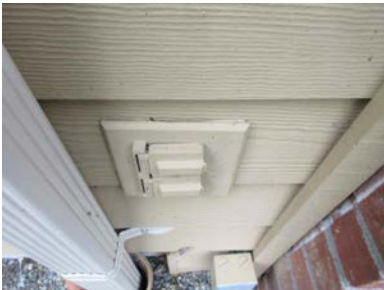
7.14 RECEPTACLES

The exterior receptacle adjacent the chimney is loose. This is a potential shock and a fire hazard. All loose receptacles should be repaired as necessary.

The receptacle adjacent the crawl space access is loose. This is a potential shock and a fire hazard. All loose receptacles should be repaired as necessary.

- 6.3: Garage door opener. Garage door photo-eye beam relocated to 4"-6" off floor.
 - 7.10 – sub panel breakers will be labelled clearly
 - 7.14 – Loose receptacles will be tightened and repaired, and cover plate will be added to receptacle in crawl space

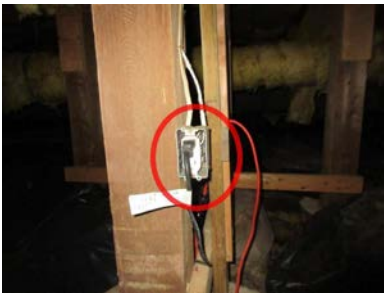
The cover plate is missing from a receptacle in the crawlspace. This is a shock and fire hazard. The installation of a cover plate is recommended.

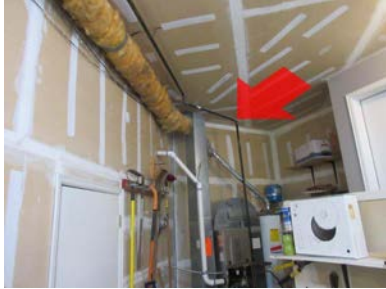
The vertical portion of the gas pipe is not adequately secured. Movement of the gas pipe could crack the flexible gas connector. The gas pipe should be secured in such a manner as to prevent lateral movement.

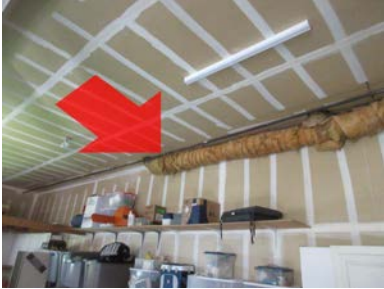
The gas pipe in the garage was not adequately secured. This can damage the pipe. The gas pipe should be secured in accordance with industry standards.

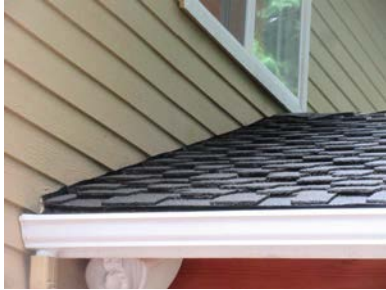
The siding is vulnerable to damage where it has been close to or in contact with the roofing material. The siding should be modified and a minimum of a 2" clearance should be maintained between the top of the roofing and bottom of the siding.

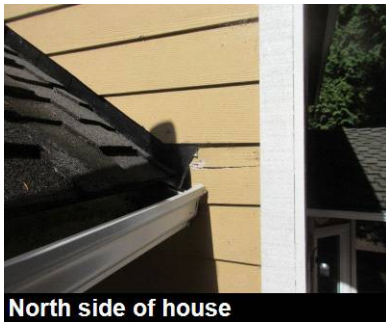
Sections of siding that have cracked should be replaced or flashing installed to prevent moisture or pest entry into these areas.

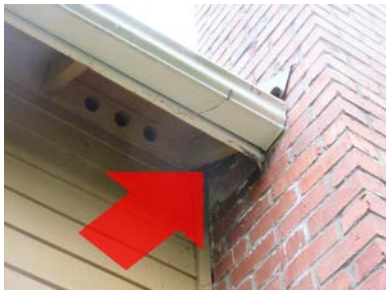
3.3 SOFFITS AND OVERHANGS

There are openings at the intersection between the overhang and the roof and adjacent the chimney through which birds and rodents can enter into the attic. These openings should be covered with wood, wire mesh or filled with aerosol foam.

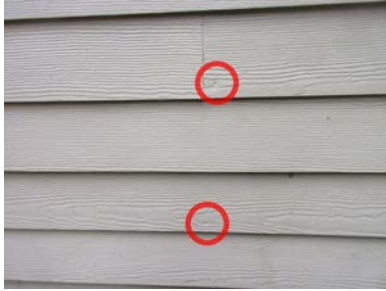
3.5 PAINT

The bottom edge of the lower sections of siding on the exterior are unprotected. Paint protects the siding from moisture absorption and its propensity to hold paint. Painting of the exposed edges is recommended.

Siding nails that have damaged the surface overlay need to be caulked. Caulking prevents water intrusion of

the siding. Consideration should be given to caulking the siding as necessary. Exterior caulking is recommended.

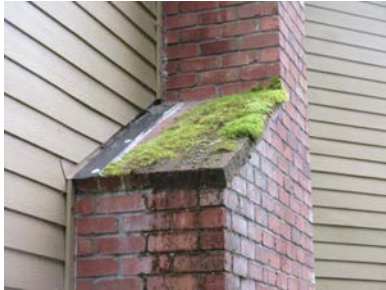
4.3 CHIMNEYS

Moss/vegetation was observed in several areas around the upper portions and at the corbeling of the chimney. This will lead to accelerated deterioration of the brick masonry mortar. We recommend removal of all organic growth. Damaged areas can be repaired by filling in cutout or defective mortar joints with fresh mortar. (Tuck pointing)

- 4.3 Moss will be removed from Chimney on south side of house
 - 5.4 – Issaquah Pest Control is scheduled to perform rodent inspection and all recommended service on October 7th.

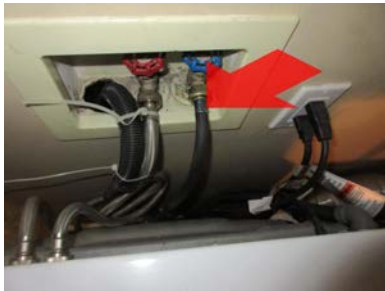
Upgrading all of the washer connections to high pressure (steel braided) lines is recommended.

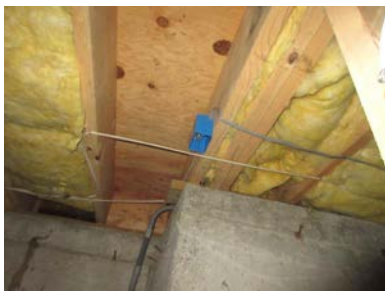
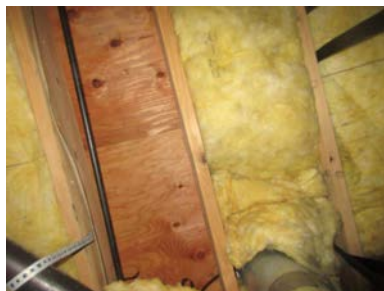
Some of the insulation batts were not properly secured and have falling down. The fallen batts should be reinstalled and secured.

- 10.1 – re-caulking as recommended
 - 11.18 and .33 – repair drain stops
 - 11.22, 31, 37, and 12.2 – re-caulking as recommended
 - 17.3 – repair fallen insulation in crawl space

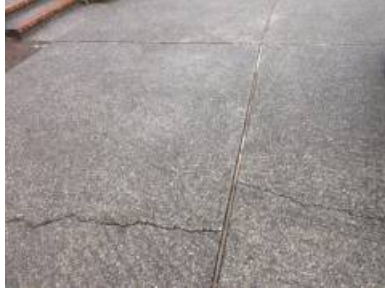
One or more of the wooden dividers separating the concrete driveway sections were infested by wood destroying organisms and have deteriorated to a point where they are becoming a trip hazard. Replacement with mortar is recommended.

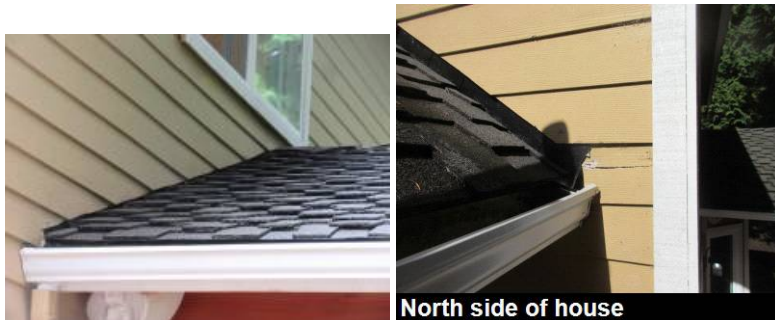
Sections of siding that have cracked should be replaced or flashing installed to prevent moisture or pest entry into these areas.

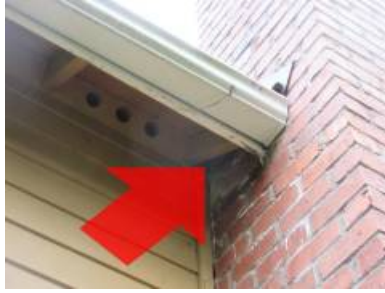
There are openings at the intersection between the overhang and the roof and adjacent the chimney through which birds and rodents can enter into the attic. These openings should be covered with wood, wire mesh or filled with aerosol foam.

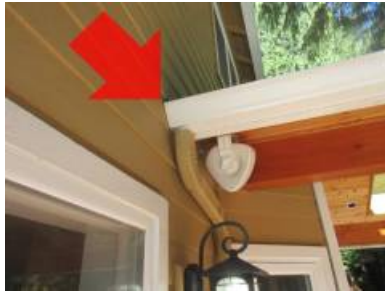
Gutter ends are too close to the siding. Gutter ends should be installed with a 1" clearance from cement fiber board siding.

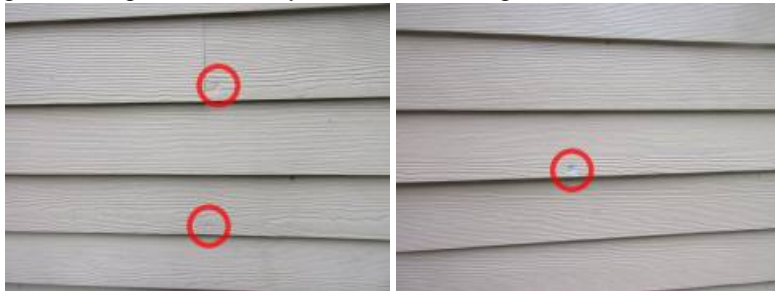
Siding nails that have damaged the surface overlay need to be caulked. Caulking prevents water intrusion of the siding. Consideration should be given to caulking the siding as necessary. Exterior caulking is recommended.

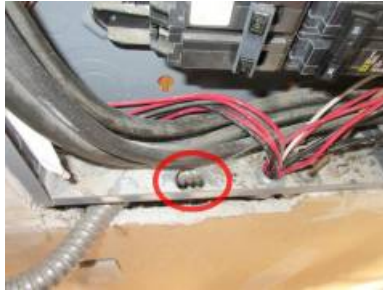
There are openings in the panel box where knock-outs have been removed. Missing knock-outs should be replaced with snap in metal plugs.

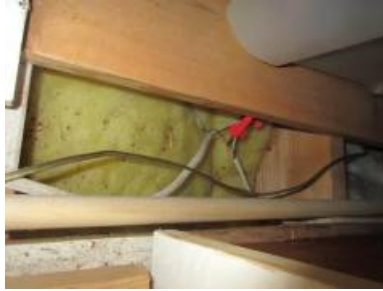
Splices in cable made outside of a junction box were observed in the east attic. This is a fire hazard. The splices should be made inside an approved box with a cover.

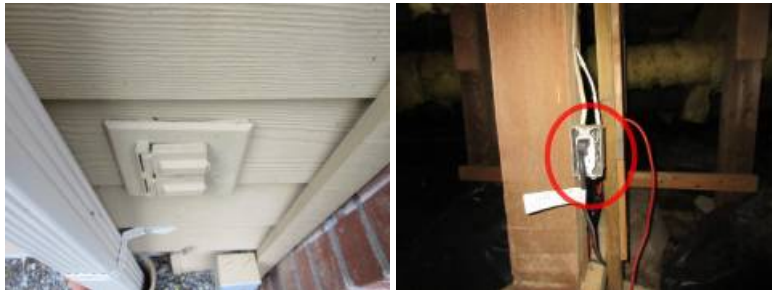
The cover plate is missing from a receptacle in the crawlspace. This is a shock and fire hazard. The installation of a cover plate is recommended.

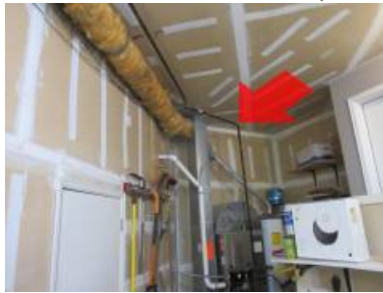
The vertical portion of the gas pipe is not adequately secured. Movement of the gas pipe could crack the flexible gas connector. The gas pipe should be secured in such a manner as to prevent lateral movement.

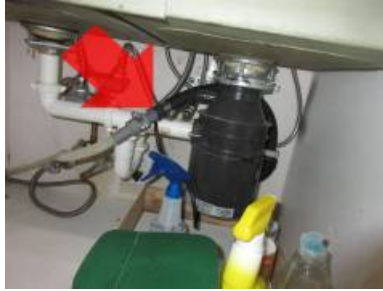
The dishwasher drain lacks an air gap. The dishwasher will function without one, but there is a risk of contamination of the inside of the dishwasher by waste water. The installation of an air gap is recommended.

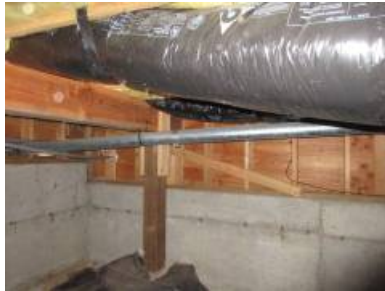
Shear panels are plywood or OSB panels that are mechanically fastened to both vertical and horizontal framing members in critical structural areas of the building. They prevent lateral movement of the structure during an earthquake. Shear panels are often visible in the crawlspace on cripple walls between the first floor and foundation. They may also be installed on interior walls that are covered with drywall. An examination of the crawlspace revealed the absence of shear panels on the cripple walls. The installation of shear panels on the cripple walls is recommended as an upgrade.

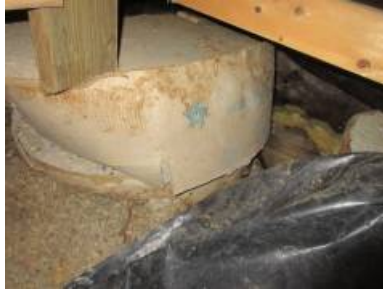
Good building practice requires that foundation walls or pier footings supporting wood frame construction, should extend at least 8" above the finish grade with at least a 6" clearance between the top of the soil and the bottom of the wood finish materials. Untreated wood should be raised 1-2" above surrounding flatwork and should have a moisture barrier such as 30 lb. asphalt impregnated felt installed between the concrete and wood. For additional information and treatment options, you should retain the services of a qualified pest control operator.
