NOTICE TO BUYER: SELLER-PROCURED INSPECTION REPORT

At your request, a visual inspection of the above referenced property was conducted on 10/15/2020. We have inspected the major structural components, plumbing, heating and electrical systems for signs of significant non-performance, excessive or unusual wear and general state of repair.

14151 177th Ave. NE
Redmond WA.

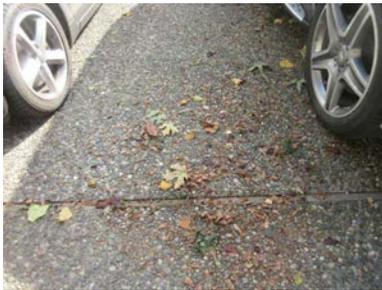
One or more of the wooden dividers separating the concrete driveway sections were infested by wood destroying organisms and have deteriorated to a point where they are becoming a trip hazard. Replacement with mortar is recommended.

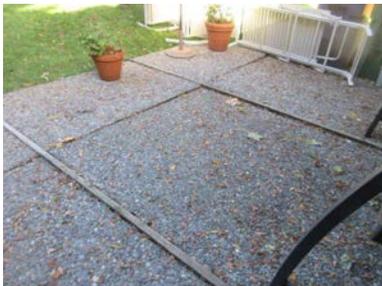
2.5 PATIO

The patio has settled differentially. This was probably caused by inadequate preparation of the soil prior to the placement of the concrete. This condition can be repaired by pressure grouting the sunken portion of the patio or by removing and replacing it. The patio remains functional despite this condition. However, the raised edges of the concrete can be a trip hazard for some people. Repairs should be made as necessary.

The wooden dividers separating the concrete patio sections will eventually deteriorate to a condition where the gaps would be a trip hazard. Replacement with mortar is recommended.

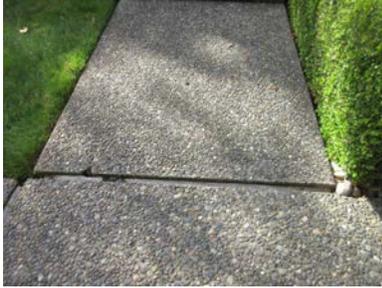
2.6 WALKWAY

The wooden dividers separating the concrete walkway sections have deteriorated to a point where the gaps are a trip hazard. Replacement with mortar is recommended.

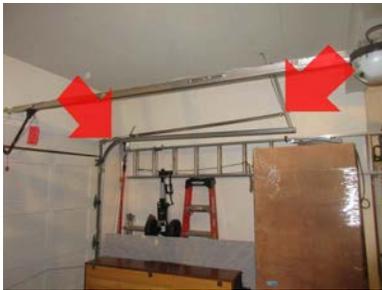
Safeties are cables run through the center of the garage door springs that prevent broken springs from becoming projectiles that can cause injury. There are no safeties installed. The installation of safeties is recommended.

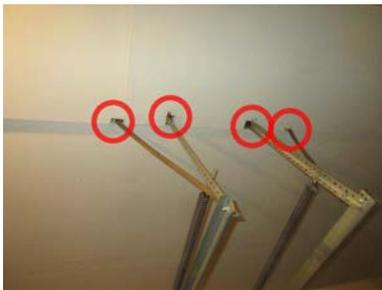
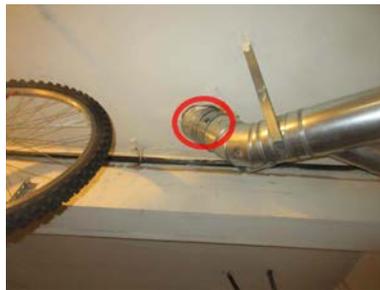
6.4 FIRE SEPARATION

There are voids in the fire resistive barrier between the living space and garage that will allow flames to penetrate. The gypsum barrier slows the spread of a fire from the garage to the structure and/or living space. Patching the voids with a fire retardant caulk is recommended.

6.4 FIRE SEPERATION: Voids in gypsum will be caulked as recommended.

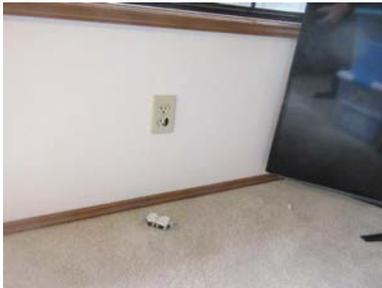
Testing revealed open grounds (ungrounded receptacles) in the master bedroom. Open grounds are a potential hazard and could damage some electronic equipment. All receptacles with open grounds should be repaired in accordance with applicable electrical codes.

A receptacle in the master bedroom is damaged leaving live components exposed to small children. This is a shock hazard. The damaged receptacle should be replaced.

There are several loose receptacles throughout the home. This is a potential shock and a fire hazard. All loose receptacles should be repaired as necessary.

7.2 RECEPTACLES: Damaged receptacle replaced with new in master bedroom. Loose receptacles throughout home all tighten.

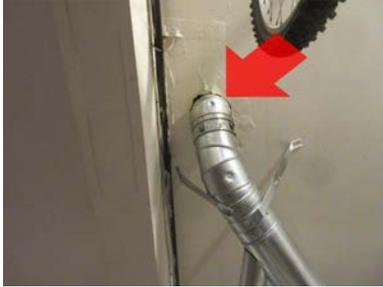
The furnace type B vent is in contact with combustible materials in the garage and attic. This is a fire hazard. A minimum clearance of 1" is required between the type B vent and the combustible material. Repairs are recommended.

8.10 VENT: 1" clearance to be created in garage between vent and sheetrock as recommended.

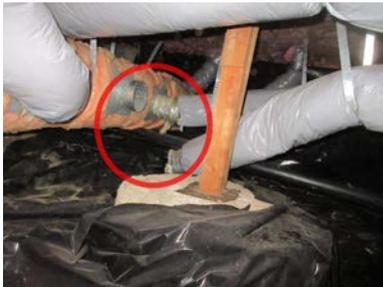
8.13 DUCTS

The heating duct in the crawlspace under the laundry/living area is detached. It should be reattached and secured in accordance with the manufacturer's specifications.

8.13 DUCTS: Heating duct in crawlspace reattached and secured to manufacture's specifications.

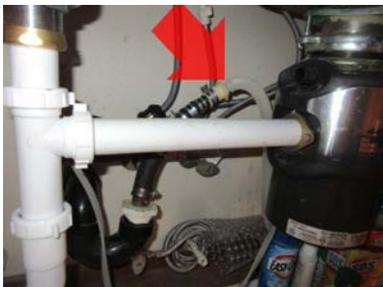
The dishwasher drain lacks an air gap. The dishwasher will function without one, but there is a risk of contamination of the inside of the dishwasher by waste water. The installation of an air gap is recommended.

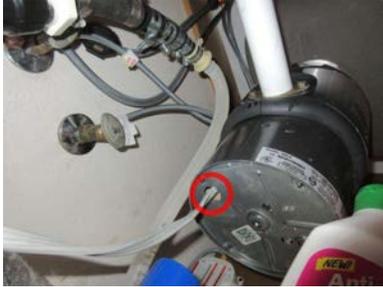
10.12 GARBAGE DISPOSAL

The cord is not clamped where it enters the disposal. This could damage the wires or cause a ground fault. The cord should be clamped in accordance with industry standards.

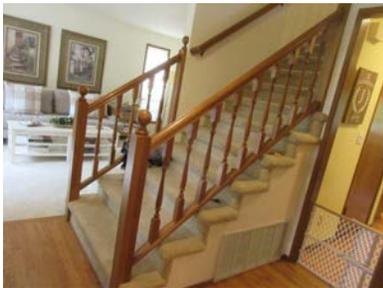
14.2 STAIRS

The stair railing baluster spacing is too wide. This is a hazard for small children. The baluster spacing should be reduced as a safety upgrade. Current standards require that a 4" sphere not pass through the railing.

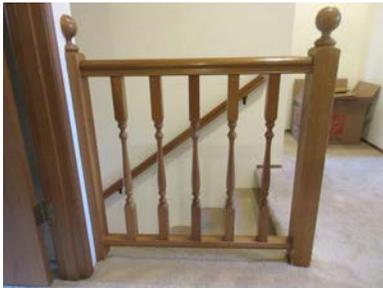
14.3 GUARD RAILINGS

The spacing between the balusters is too wide. This is a hazard to small children. The balusters should be spaced close enough together so that a 4" sphere cannot pass through. Upgrading the guard railing is recommended if small children are present.

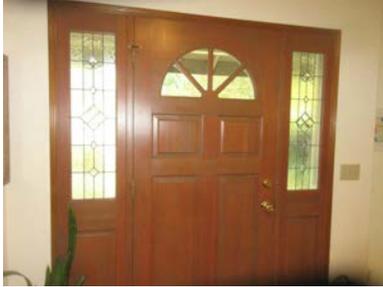
There is condensation or mineral deposits between the panes of glass in 4 of the insulated glass windows. This indicates failed seals. The glass assemblies should be replaced, which is the only method for correcting this deficiency.

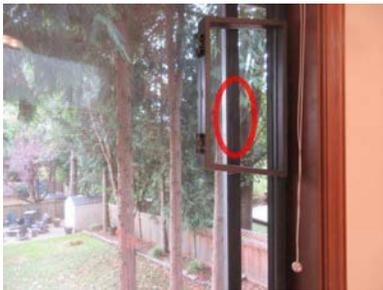
The latch/locking mechanism for one of the south facing windows does not secure the window closed. We recommend repairs as necessary to restore the windows proper operation.

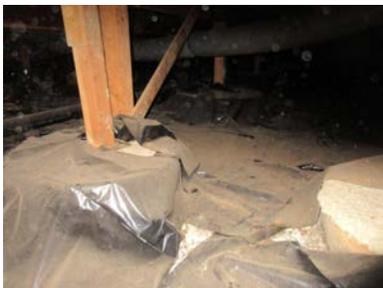
The support post concrete piers are covered with the plastic vapor retarder. This allows the transmission of water vapor from the soil up and into the floor framing. The plastic vapor retarder should be removed from the pier so that it covers at least 85% of the entire surface of the soil only.

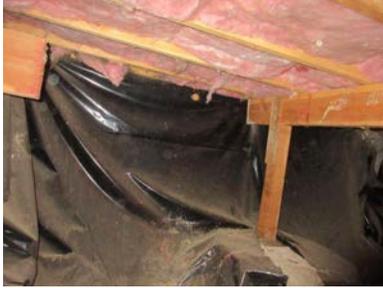
The foundation walls are covered with the plastic vapor retarder. This allows the transmission of water vapor from the soil up and into the exterior wall framing. The plastic vapor retarder should be removed from the foundation so that it covers at least 85% of the entire surface of the soil only.

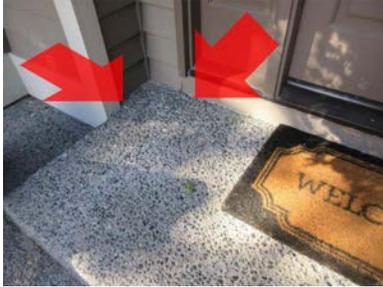
3.2 PEST CONTROL

Untreated wood in direct contact with concrete was observed along the entry stoop. Untreated wood should be raised 1-2" above the concrete. Treating the wood with a preservative sometimes will prevent wood destroy organism damage.

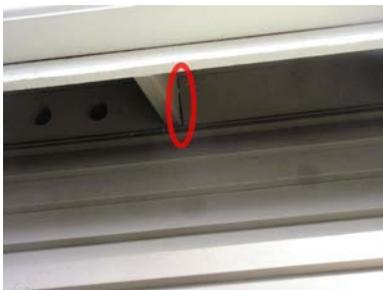
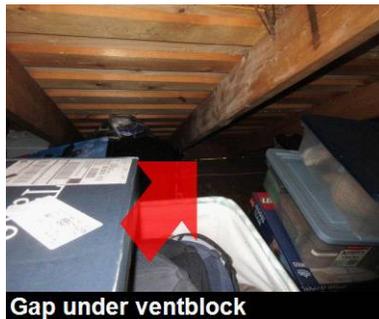
3.3 SOFFITS AND OVERHANGS

There are large gaps over 1/4" in size adjacent/under the soffit vent blocks. These gaps allow insects and rodents to enter the attic. Covering the gaps with screening, a strip of wood and/or caulking is recommended.

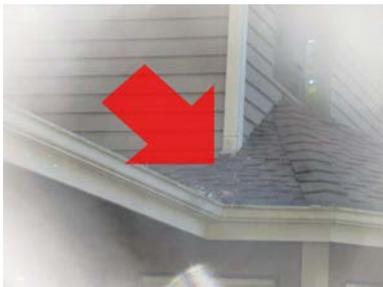
3.4 GUTTERS AND DOWNSPOUTS

There is a build-up of organic debris inside the gutters. Proper maintenance of gutters and downspouts is essential and should be performed routinely in order to prevent clogging. Maintenance consists primarily of keeping leaves and other organic debris out of the system. Failure to clean the gutters will result in water splash on the building when they overflow. Gutters can be damaged under the weight of the water and organic matter inside the gutter. Gutters should be cleaned as necessary to maintain a free flow of water into the downspouts.

Downspouts draining directly onto the asphalt shingle surface causes excessive wear of the roofing material. Downspout extensions to the lower gutters should be installed to prevent excessive wear and tear of the roofing.

3.4 GUTTERS & DOWNSPOUTS: To be cleaned as recommended.

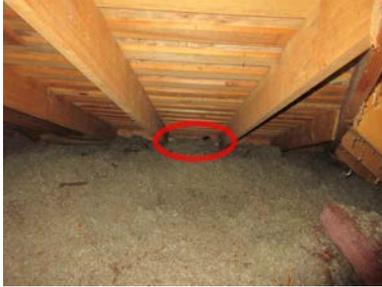
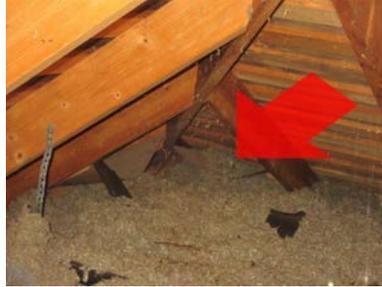
5.2 VENTILATION

Wind baffles locations are compromised in some areas of the attic. The proper placement of wind baffles in front of all soffit vents is recommended.

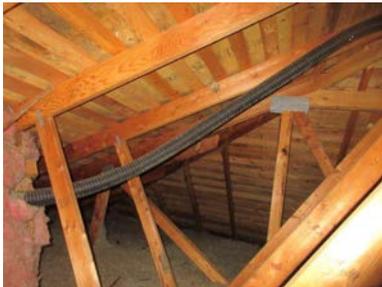
5.3 MECHANICAL VENTILATION SYSTEMS

Flexible plastic duct is used to direct air from the vent fan to the exterior. This type of material is unreliable. Replacing the plastic duct with 4" smooth-wall sheet metal duct is recommended.

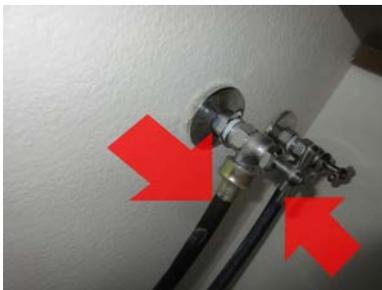
High pressure (steel braided) washer line connections is recommended.

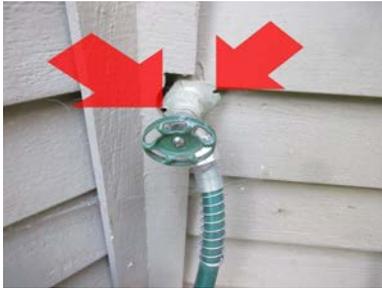
The hose bibb on the rear of the house is loose. This could result in damage to the water pipe and leakage. The bibb should be securely fastened to the wall.

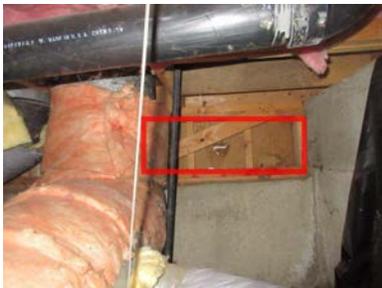
Shear panels are plywood or OSB panels that are mechanically fastened to both vertical and horizontal framing members in critical structural areas of the building. They prevent lateral movement of the structure during an earthquake. Shear panels are often visible in the crawlspace on cripple walls between the first floor and foundation. They may also be installed on interior walls that are covered with drywall. An examination of the crawlspace revealed the absence of shear panels on the cripple walls. The installation of shear panels on the cripple walls is recommended as an upgrade.

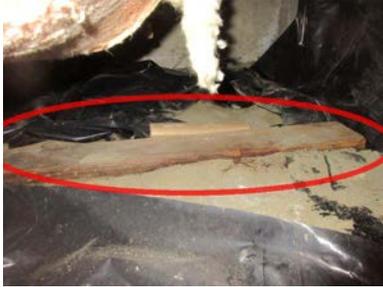
Scrap-wood and other cellulose debris was observed on the crawl floor. This wood debris creates conducive conditions for wood boring insects. The removal of all cellulose debris is recommended.

Cellulose forms were left in place on the pier footings. This cellulose is conducive to the infestation of various wood destroying organisms. The removal of the cellulose is recommended.

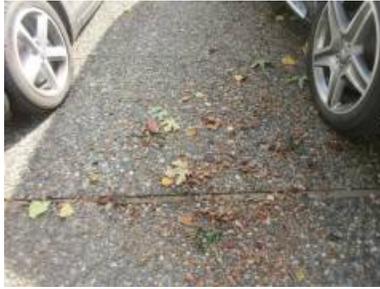
2.4 DRIVEWAY

One or more of the wooden dividers separating the concrete driveway sections were infested by wood destroying organisms and have deteriorated to a point where they are becoming a trip hazard. Replacement with mortar is recommended.

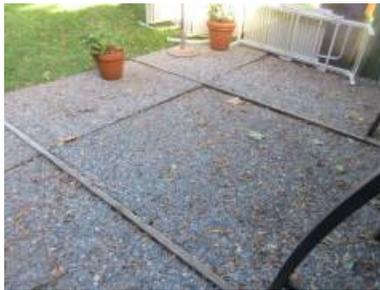
2.5 PATIO

The wooden dividers separating the concrete patio sections will eventually deteriorate to a condition where the gaps would be a trip hazard. Replacement with mortar is recommended.

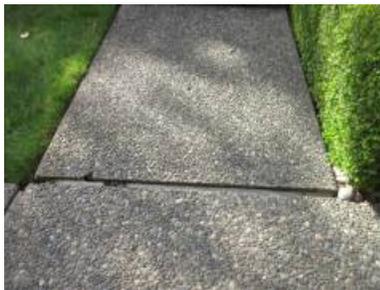
2.6 WALKWAY

Many legal and public works departments have defined a trip hazard as an irregularity in a walking surface exceeding one inch (1") in height. All walking surfaces should maintain, free of a vertical surface change of 3/4" or more, in the interest of public and personal safety.

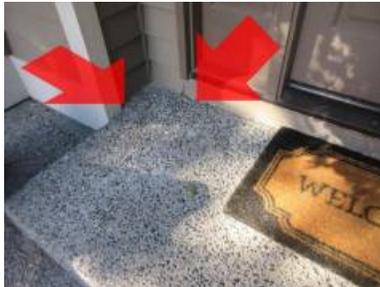
Untreated wood in direct contact with concrete was observed along the entry stoop. Untreated wood should be raised 1-2" above the concrete. Treating the wood with a preservative sometimes will prevent wood destroy organism damage.

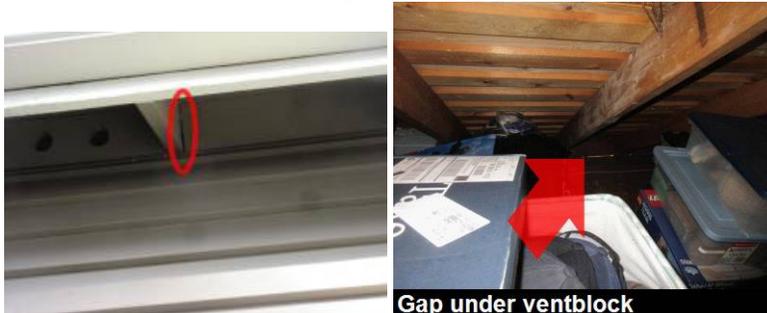
3.3 SOFFITS AND OVERHANGS

There are large gaps over 1/4" in size adjacent/under the soffit vent blocks. These gaps allow insects and rodents to enter the attic. Covering the gaps with screening, a strip of wood and/or caulking is recommended.

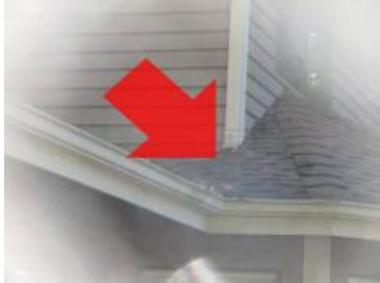
3.4 GUTTERS AND DOWNSPOUTS

Downspouts draining directly onto the asphalt shingle surface causes excessive wear of the roofing material. Downspout extensions to the lower gutters should be installed to prevent excessive wear and tear of the roofing.

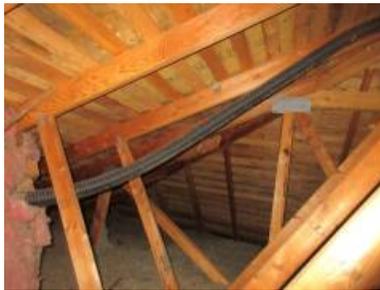
5.3 MECHANICAL VENTILATION SYSTEMS

Flexible plastic duct is used to direct air from the vent fan to the exterior. This type of material is unreliable. Replacing the plastic duct with 4" smooth-wall sheet metal duct is recommended.

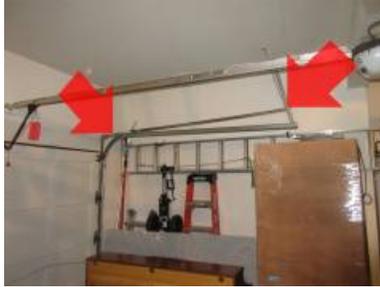
Safeties are cables run through the center of the garage door springs that prevent broken springs from becoming projectiles that can cause injury. There are no safeties installed. The installation of safeties is recommended.

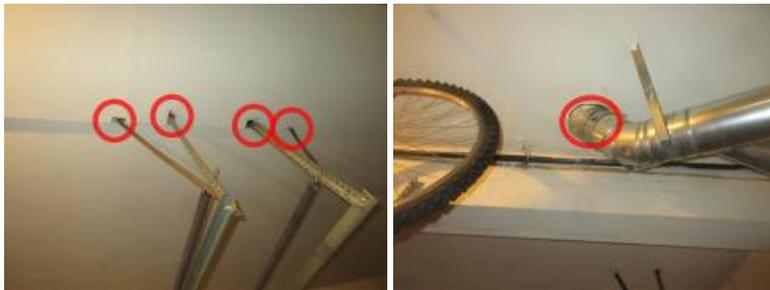
There are voids in the fire resistive barrier between the living space and garage that will allow flames to penetrate. The gypsum barrier slows the spread of a fire from the garage to the structure and/or living space. Patching the voids with a fire retardant caulk is recommended.

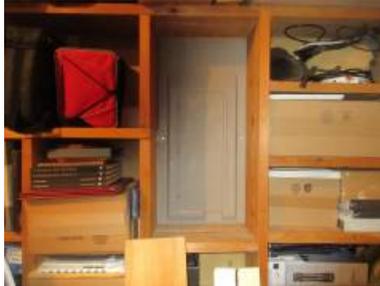
Access to the electrical panel is blocked by shelving. Shelves should be removed or modified so that there is a 30" wide by 36" deep by 7' tall clearance in front of the panel.

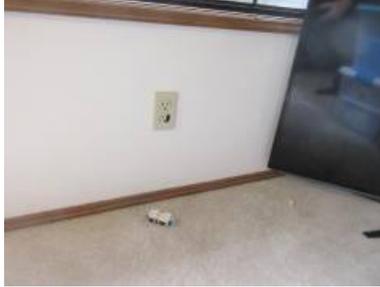
There are several loose receptacles throughout the home. This is a potential shock and a fire hazard. All loose receptacles should be repaired as necessary.

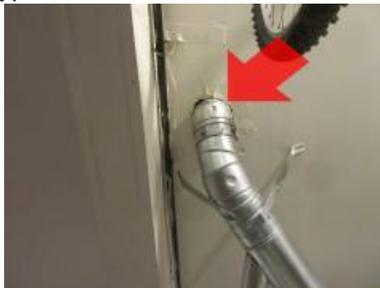
The furnace type B vent is in contact with combustible materials in the garage and attic. This is a fire hazard. A minimum clearance of 1" is required between the type B vent and the combustible material. Repairs are recommended.

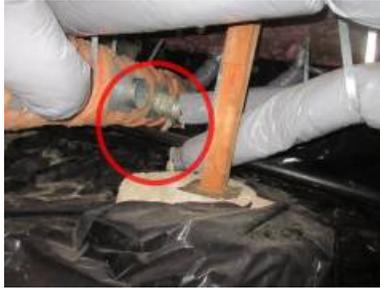
The heating duct in the crawlspace under the laundry/living area is detached. It should be reattached and secured in accordance with the manufacturer's specifications.

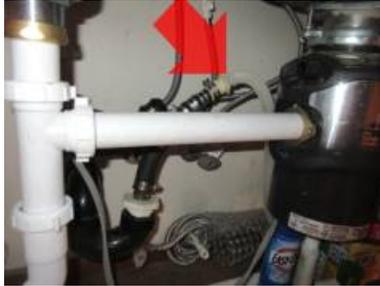
The dishwasher drain lacks an air gap. The dishwasher will function without one, but there is a risk of contamination of the inside of the dishwasher by waste water. The installation of an air gap is recommended.

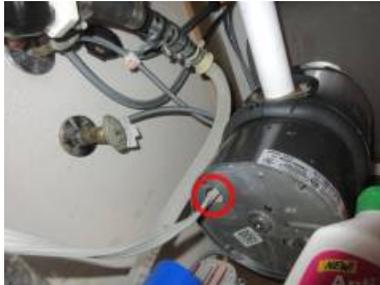
The cord is not clamped where it enters the disposal. This could damage the wires or cause a ground fault. The cord should be clamped in accordance with industry standards.

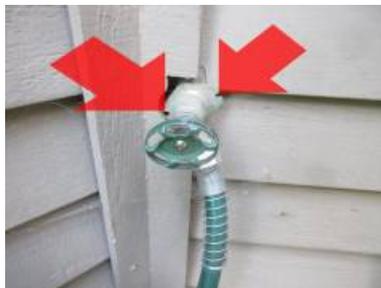
The hose bibb on the rear of the house is loose. This could result in damage to the water pipe and leakage. The bibb should be securely fastened to the wall.

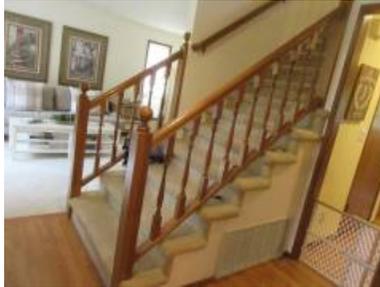
The stair railing baluster spacing is too wide. This is a hazard for small children. The baluster spacing should be reduced as a safety upgrade. Current standards require that a 4" sphere not pass through the railing.

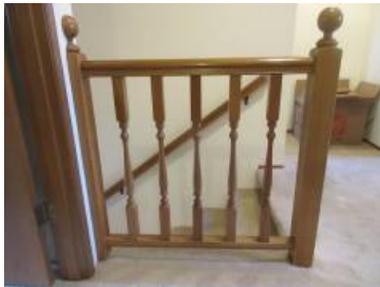
14.3 GUARD RAILINGS

The spacing between the balusters is too wide. This is a hazard to small children. The balusters should be spaced close enough together so that a 4" sphere cannot pass through. Upgrading the guard railing is recommended if small children are present.

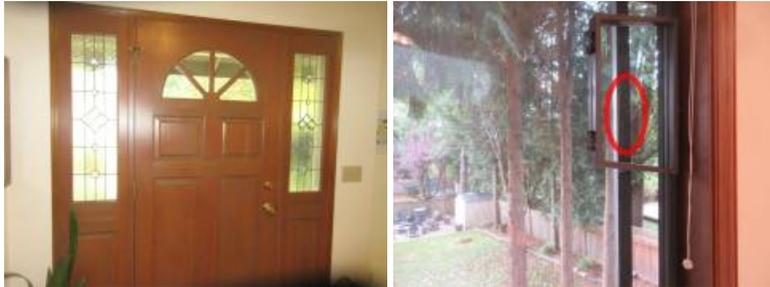
The latch/locking mechanism for one of the south facing windows does not secure the window closed. We recommend repairs as necessary to restore the windows proper operation.
