NOTICE TO BUYER: SELLER-PROCURED INSPECTION REPORT

March 24, 2021

Re: 13715 180th Ave. NE
Redmond, WA.

At your request, a visual inspection of the above referenced property was conducted on 03/22/2021. We have inspected the major structural components, plumbing, heating and electrical systems for signs of significant non-performance, excessive or unusual wear and general state of repair.

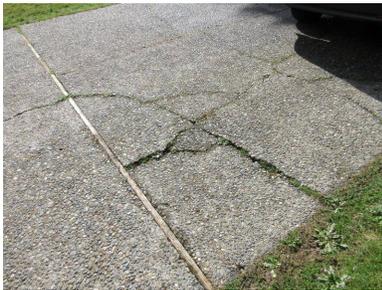
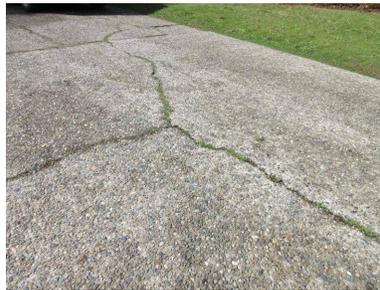
The driveway has cracked and settled differentially. This was probably caused by inadequate preparation of the soil prior to the placement of the concrete. This condition can be repaired by pressure grouting the sunken portion of the driveway or by removing and replacing it. The driveway remains functional despite this condition.

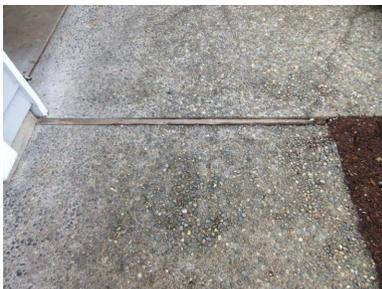
The wooden divider(s) separating the concrete walkway sections were infested by wood destroying organisms and have deteriorated to a point where they are becoming a trip hazard. Replacement with mortar is recommended.

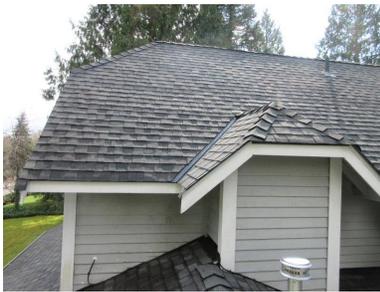
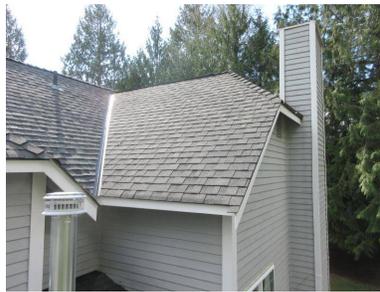
3.4 GUTTERS AND DOWNSPOUTS

Gutters are missing from the upper roof runoff of the building. Gutters should be installed to prevent water splash on the siding and saturated soils adjacent building components.

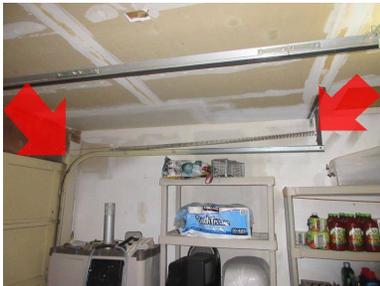
The north garage door was inoperative. Repairs are recommended.

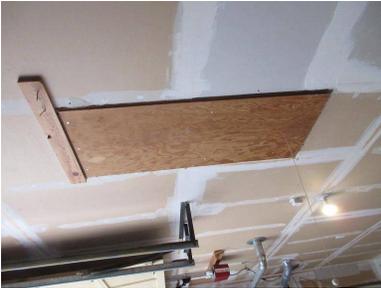
The pull down ladder is a breach in the fire resistive barrier in the garage. This is a safety concern. The gypsum barrier on the ceiling slows the spread of a fire from the garage to the attic. The installation of a layer of 5/8" gypsum type X board over the 1/4" plywood is recommended.

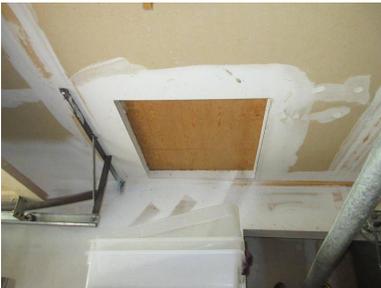
The cover for the attic access is a breach in the fire resistive barrier in the garage. This is a safety concern. The gypsum barrier on the ceiling slows the spread of a fire from the garage to the attic. The installation of a layer of 5/8" gypsum type X board over the exposed wood is recommended.

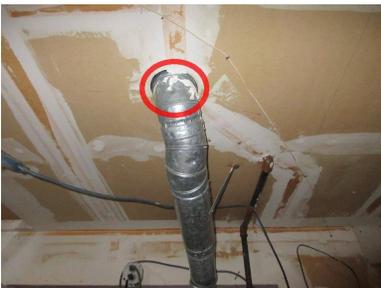
The installation of a furnace vent thimble is recommended to prevent flames to spread to the structure.

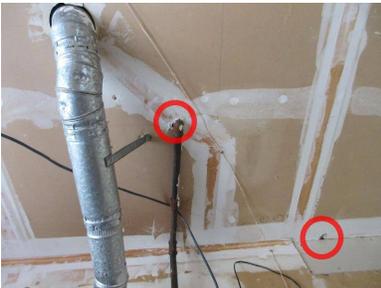
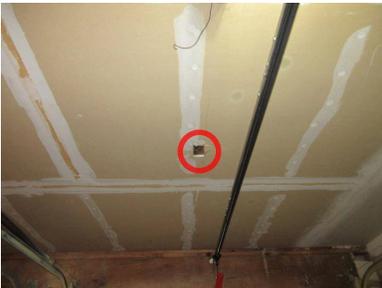
There are voids in the fire resistive barrier between the living space and garage that will allow flames to penetrate. The gypsum barrier slows the spread of a fire from the garage to the structure and/or living space. Patching the voids with a fire retardant caulk is recommended.

- 5.4** – Bird screening added to voids in attic above garage.
- 6.2** – Safety cables installed on garage door springs.
- 6.4** – Voids in the fire barrier have been corrected.
- 7.10** – Loose wiring and junction boxes in attic have been secured.
- 7.12** – Loose receptacles have been corrected.
- 7.13** – GFCI outlets have been corrected.
- 8.10** – Clearance to B vent have been corrected.
- 10.1** – Kitchen backsplash has been caulked
- 11.9 & 11.13** – Drain stops have been corrected
- 11.15** – Tub spout has been corrected.

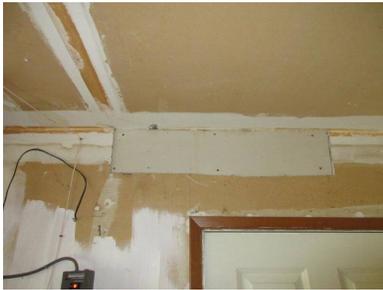
Several of the joints are not taped. Consideration should be given to "fire taping" the drywall as a safety upgrade.

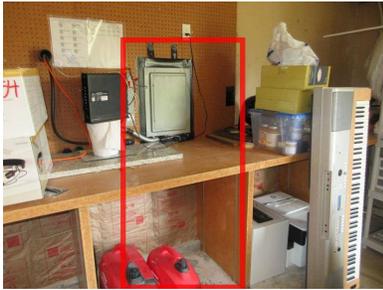
7.3 SERVICE PANEL LOCATION

The service panel is located in the garage. Access to the electrical panel is blocked by shelving. Shelves should be removed or modified so that there is a 30" wide by 36" deep by 7' tall clearance in front of the panel.

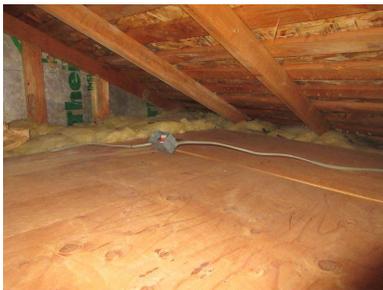
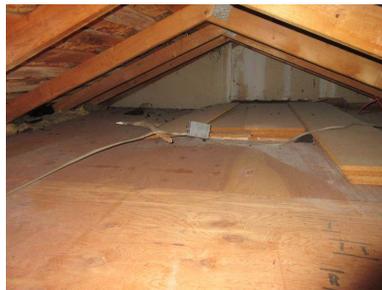
7.10 WIRING

Loose electrical cables were observed in the garage attic. Loose cables are vulnerable to damage. All loose cables should be secured at 4' intervals using approved cable staples.

Loose junction boxes were observed in the garage attic. This is a hazard. The junction boxes should be attached and secured to the framing. Loose cables are vulnerable to damage. All loose cables should be secured at 4' intervals using approved cable staples.

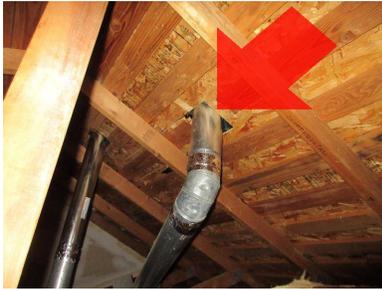
The furnace vent connector is too close to a combustible material. This is a hazard. A minimum clearance of 6" is required between the single wall vent connector and the combustible material. The double wall type B vent requires only 1" of clearance. Repairs are recommended.

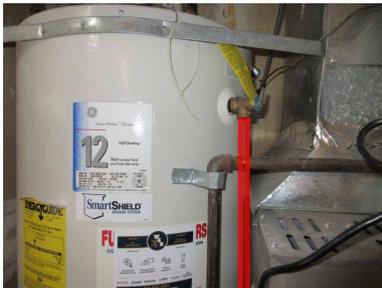
The pressure relief valve lacks a drain pipe. This is a scald hazard. The installation of a 3/4" copper, CPVC plastic or galvanized steel drain pipe is recommended. Ideally, the drain should be routed to the exterior. However, running the pipe straight down to the floor eliminates the scald hazard.

- 9.3, 9.5, 9.11 & 9.13** – Seller will install a new water heater to code.
- 12.2** – Seller will install smooth wall dryer vent ducting to exterior and repair drywall.

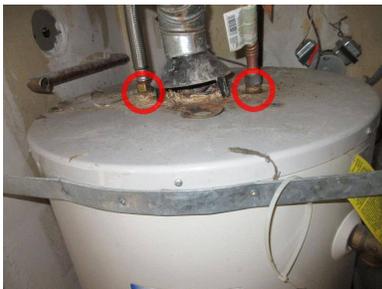
9.5 WATER CONNECTIONS AT TANK

The nipples sticking out of the top of the water heater are corroded and may start to leak. The nipples should be monitored for leakage and replaced as necessary. Installing brass nipples will eliminate the corrosion that occurs when two dissimilar metals are joined together in the presence of water.

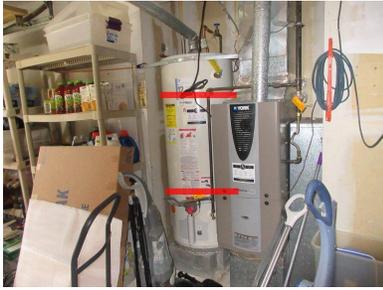
9.11 SEISMIC RESTRAINT

The seismic restraint for the water heater was minimal. Proper strapping is recommended to adequately secure the tank and provide potable water in the event of an earthquake.

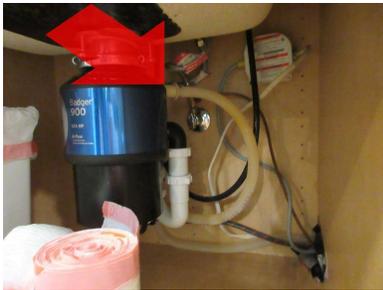
The dishwasher drain lacks an air gap. The dishwasher will function without one, but there is a risk of contamination of the inside of the dishwasher by waste water. The installation of an air gap or connection to the Johnson Tee that is installed in the kitchen wall. This air gap protects the dishwasher from contamination caused by a backflow of waste water.

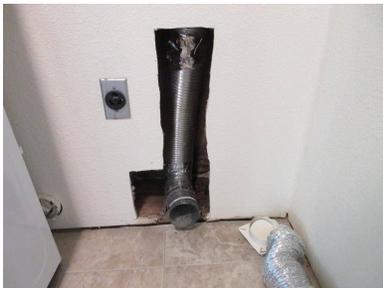
Improper material has been used for the dryer vent duct. This material tends to clog with lint and will lengthen the drying time for clothes. A new duct system should be installed that complies with present building standards. Present standards for dryer vents require a 4 inch, smooth wall duct, no longer than 35 feet, with a hooded damper at the exterior termination. A flexible duct (6 ft max) can only be used between the dryer and floor or wall inlet.

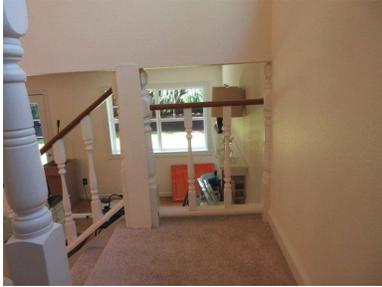
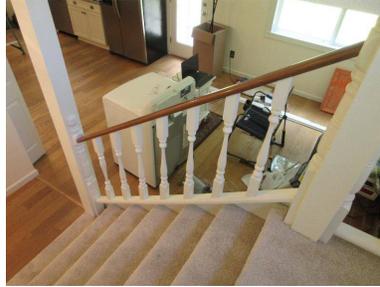
The stair railing baluster spacing is too wide. This is a hazard for small children. The baluster spacing should be reduced as a safety upgrade. Current standards require that a 4" sphere not pass through the railing.

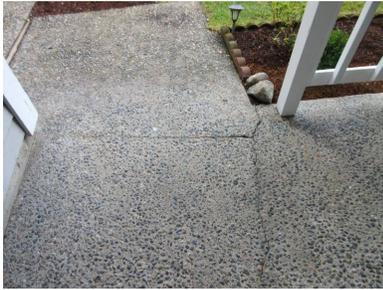
Minor cracks observed in the concrete surface of the walkway can be sealed to minimize moisture entry and further settlement of the concrete.

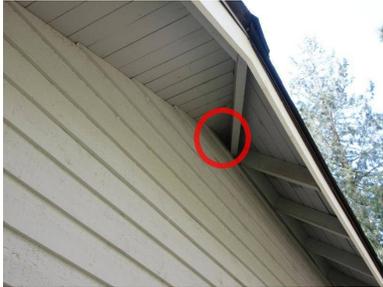
There are openings at the intersection between the overhang and the roof through which birds and rodents can enter into the attic. These openings should be covered with wood, wire mesh or filled with aerosol foam.

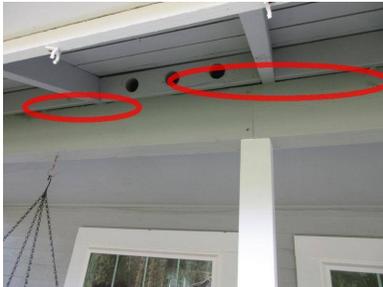
There are large gaps over 1/4" in size adjacent the soffit vent blocks. These gaps allow insects and rodents to enter the attic. Covering the gaps with screening, a strip of wood and/or caulking is recommended.

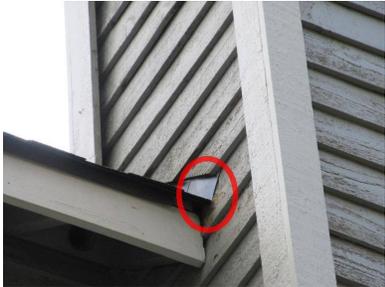
There is no kick out flashing at the roof edge to wall intersection. This will allow water to enter the wall behind the siding. The installation of a kick-out flashing is recommended.

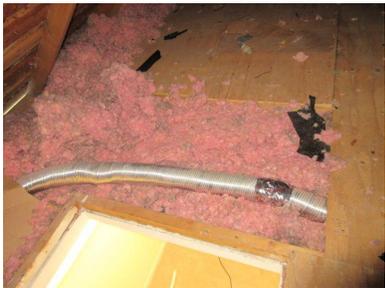
Flexible plastic duct is used to direct air from the vent fan to the exterior. This type of material is unreliable. Replacing the plastic duct with 4" smooth-wall sheet metal duct is recommended.

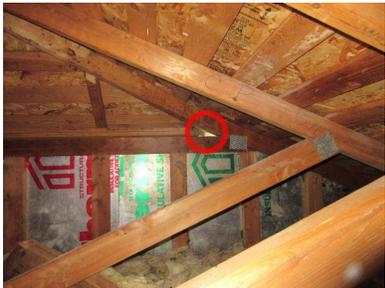
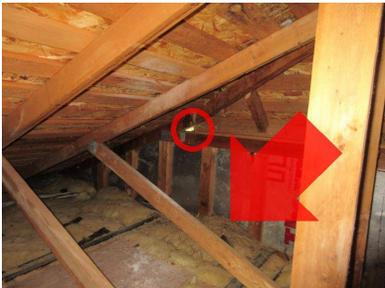
5.4 PEST CONTROL

There is a birds nest in the attic. We recommend sealing holes and gaps using wire mesh, caulking, wood or aerosol foam to prevent further activity.

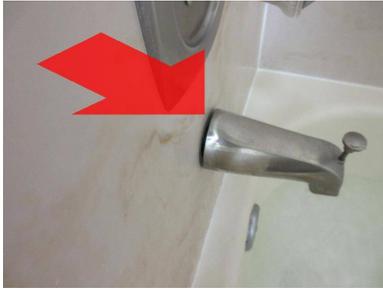
The tub spout is not mounted flush to the wall. This can result in leaks. The spout should be made flush to the

wall in accordance with industry standards.

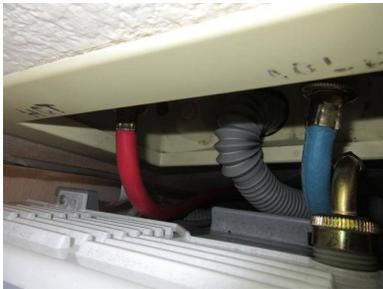
Upgrading the washer connections to high pressure (steel braided) lines is recommended.

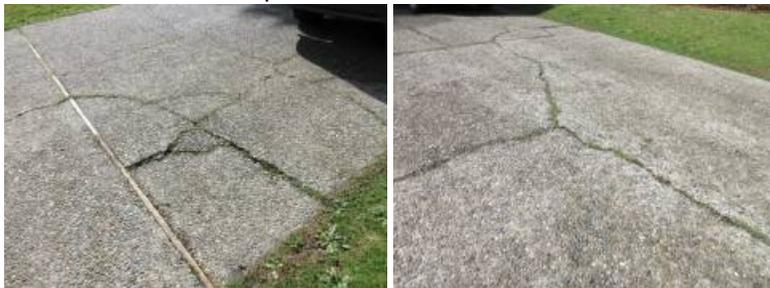
The driveway has cracked and settled differentially. This was probably caused by inadequate preparation of the soil prior to the placement of the concrete. This condition can be repaired by pressure grouting the sunken portion of the driveway or by removing and replacing it. The driveway remains functional despite this condition.

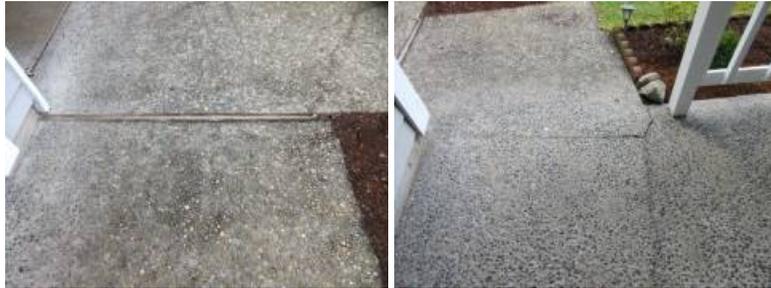
Minor cracks observed in the concrete surface of the walkway can be sealed to minimize moisture entry and further settlement of the concrete.

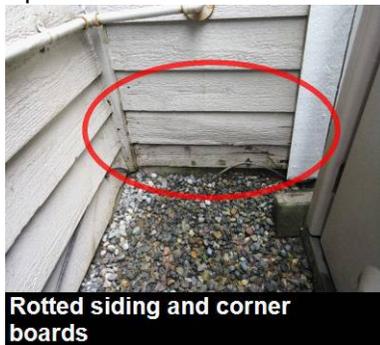
The bottom of the fireplace chase walls at the north side are rotted where they have had chronic contact with moisture. Rot damaged material should be repaired and protected from chronic contact with moisture.

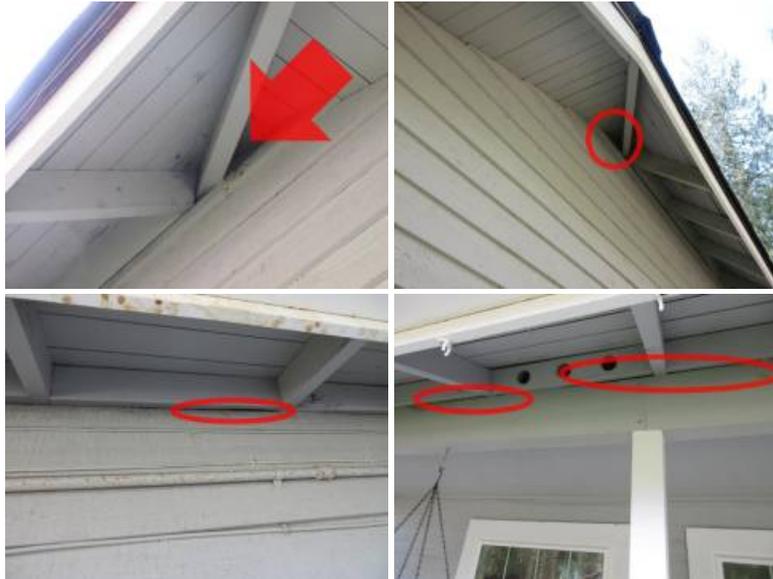
There are large gaps over 1/4" in size adjacent the soffit vent blocks. These gaps allow insects and rodents to enter the attic. Covering the gaps with screening, a strip of wood and/or caulking is recommended.

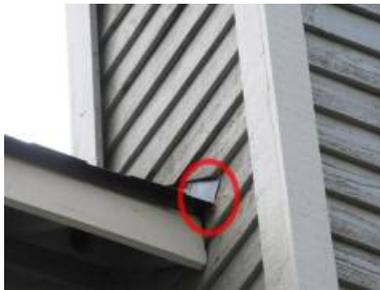
There is no kick out flashing at the roof edge to wall intersection. This will allow water to enter the wall behind the siding. The installation of a kick-out flashing is recommended.

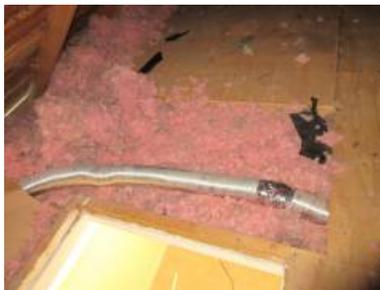
Flexible plastic duct is used to direct air from the vent fan to the exterior. This type of material is unreliable. Replacing the plastic duct with 4" smooth-wall sheet metal duct is recommended.

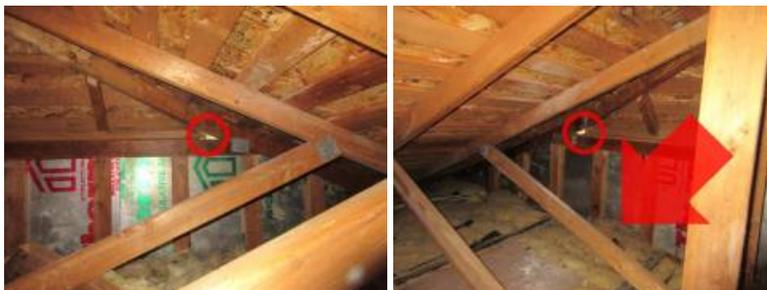
There is a birds nest in the attic. We recommend sealing holes and gaps using wire mesh, caulking, wood or aerosol foam to prevent further activity.

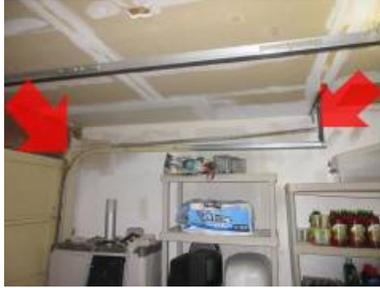
The north garage door was inoperative. Repairs are recommended.

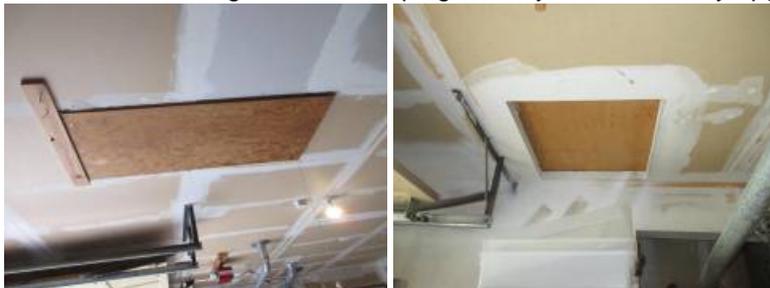
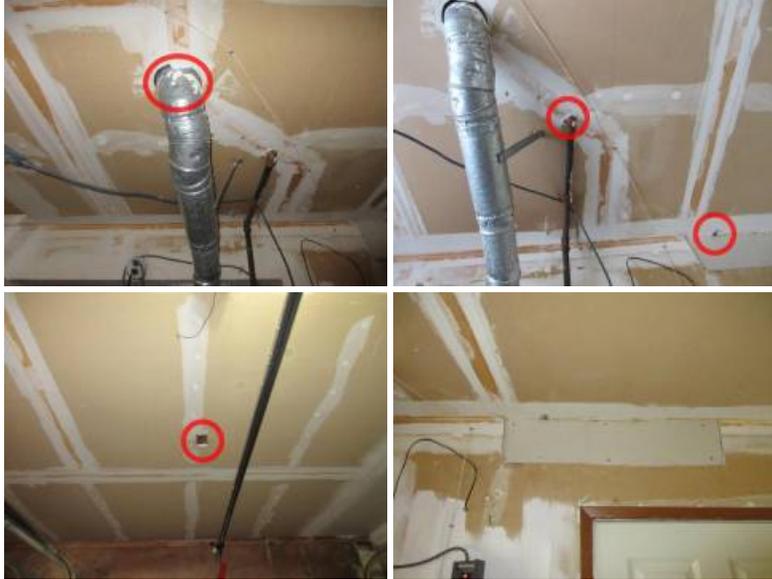
Several of the joints are not taped. Consideration should be given to "fire taping" the drywall as a safety upgrade.

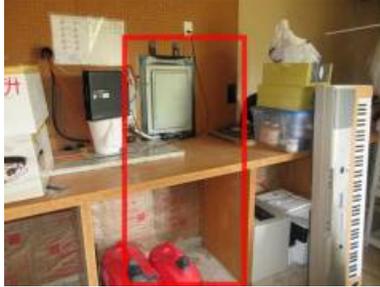
The service panel is located in the garage. Access to the electrical panel is blocked by shelving. Shelves should be removed or modified so that there is a 30" wide by 36" deep by 7' tall clearance in front of the panel.

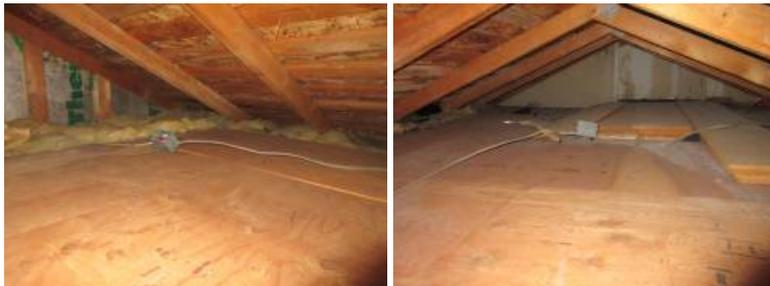
Loose junction boxes were observed in the garage attic. This is a hazard. The junction boxes should be attached and secured to the framing. Loose cables are vulnerable to damage. All loose cables should be secured at 4' intervals using approved cable staples.

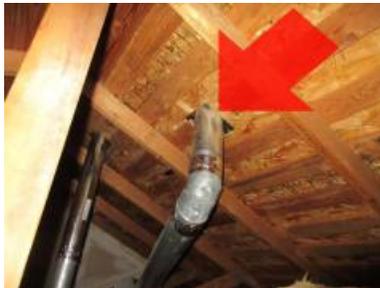
The furnace vent connector is too close to a combustible material. This is a hazard. A minimum clearance of 6" is required between the single wall vent connector and the combustible material. The double wall type B vent requires only 1" of clearance. Repairs are recommended.

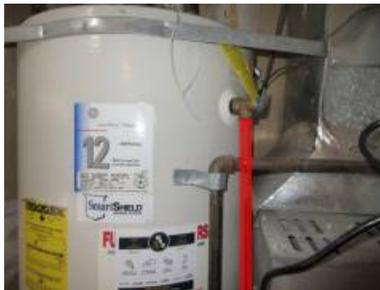
The pressure relief valve lacks a drain pipe. This is a scald hazard. The installation of a 3/4" copper, CPVC plastic or galvanized steel drain pipe is recommended. Ideally, the drain should be routed to the exterior. However, running the pipe straight down to the floor eliminates the scald hazard.

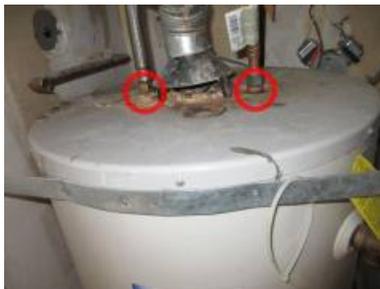
The nipples sticking out of the top of the water heater are corroded and may start to leak. The nipples should be monitored for leakage and replaced as necessary. Installing brass nipples will eliminate the corrosion that occurs when two dissimilar metals are joined together in the presence of water.

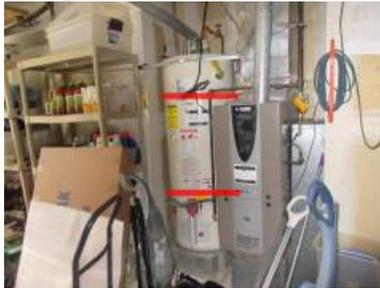
The seismic restraint for the water heater was minimal. Proper strapping is recommended to adequately secure the tank and provide potable water in the event of an earthquake.

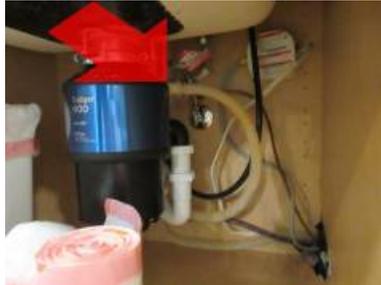
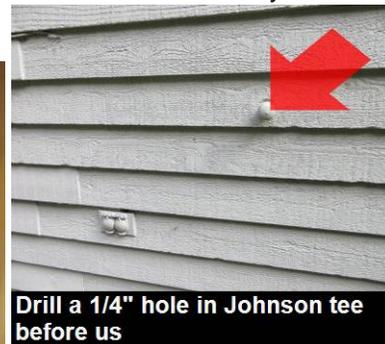
The dishwasher drain lacks an air gap. The dishwasher will function without one, but there is a risk of contamination of the inside of the dishwasher by waste water. The installation of an air gap is recommended or connection to the Johnson Tee that is installed in the kitchen wall. This air gap protects the dishwasher from contamination caused by a backflow of waste water.

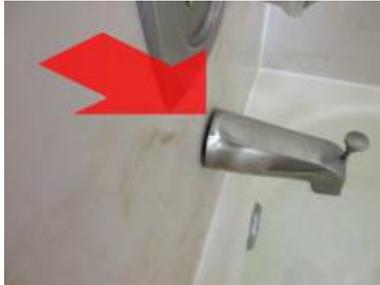
The tub spout is not mounted flush to the wall. This can result in leaks. The spout should be made flush to the wall in accordance with industry standards.

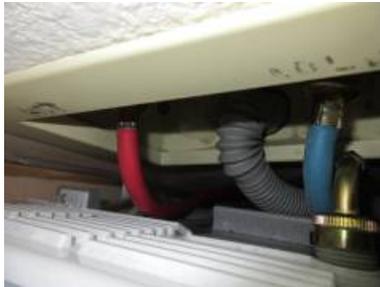
Upgrading the washer connections to high pressure (steel braided) lines is recommended.

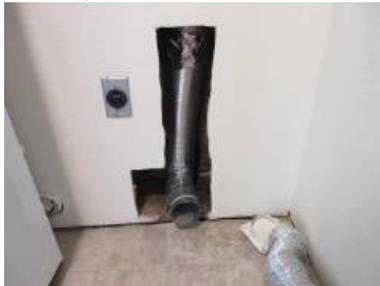
12.2 DRYER VENT

Improper material has been used for the dryer vent duct. This material tends to clog with lint and will lengthen the drying time for clothes. A new duct system should be installed that complies with present building standards. Present standards for dryer vents require a 4 inch, smooth wall duct, no longer than 35 feet, with a hooded damper at the exterior termination. A flexible duct (6 ft max) can only be used between the dryer and floor or wall inlet.

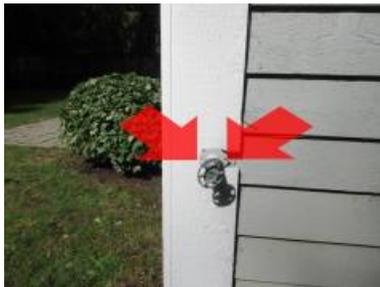
The hose bibb on the rear of the house is loose. This could result in damage to the water pipe and leakage. The bibb should be securely fastened to the wall.

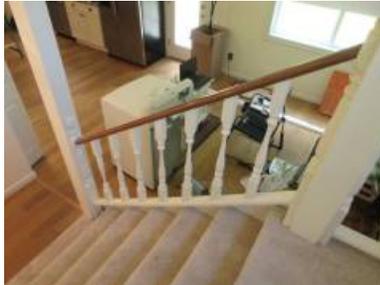
The stair railing baluster spacing is too wide. This is a hazard for small children. The baluster spacing should be reduced as a safety upgrade. Current standards require that a 4" sphere not pass through the railing.

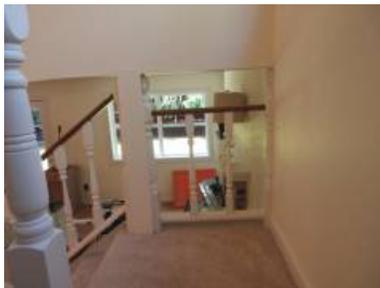
14.3 GUARD RAILINGS

The spacing between the balusters is too wide. This is a hazard to small children. The balusters should be spaced close enough together so that a 4" sphere cannot pass through. Upgrading the guard railing is recommended if small children are present.

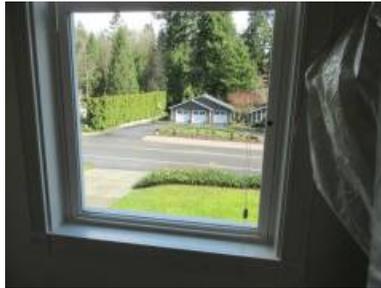
The lift assist mechanism for the window in the bedroom room is in need of repair. The window should not be used until repairs are completed.
