NOTICE TO BUYER: SELLER-PROCURED INSPECTION REPORT

19718 222nd Ave NE, Woodinville, WA 98077

February 12, 2021

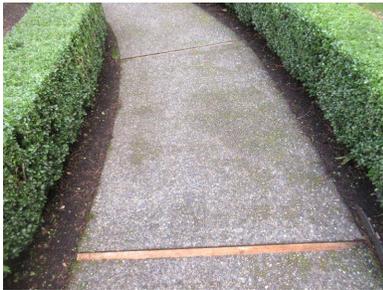
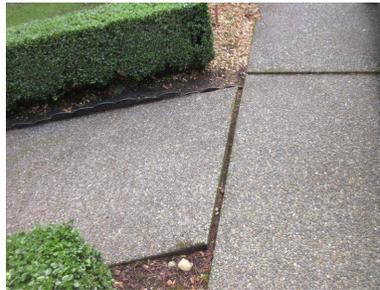
The wooden dividers separating the concrete walkway sections have deteriorated to a point where the gaps are a trip hazard. Replacement with mortar is recommended.

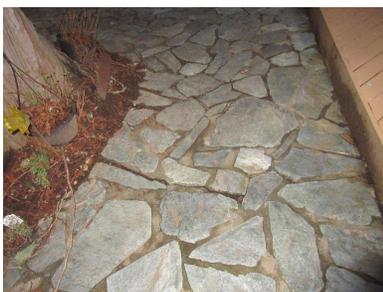
The walking surface was not even and trip hazards were present. We recommend all walking surfaces be maintained free of trip hazards.

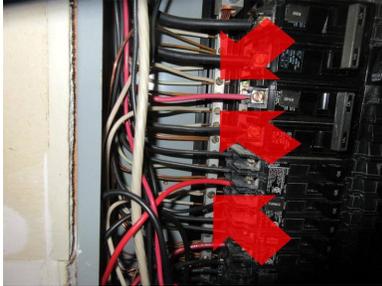
Several of the neutral wires are double tapped on the buss bar. Double tapping means that two conductors share a single terminal. Double tapped terminals can loosen and overheat and therefore are not permitted unless the terminal is specifically listed for multiple wires. This defect is easily repaired by connecting the two wires to a "pig tail", securing them with a wire cap, and then inserting the pig tail conductor under the terminal.

- 6.3 – New Genie garage door sensors have been installed in the far garage door. The door sensors and opener are now fully functional**
- 7.8 – The four neutral wires that were double tapped on the buss bar of the electrical panel have been re-wired with a “pig tail” so that only one conductor is inserted in the terminal for each of these**

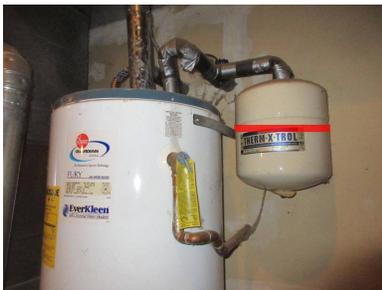
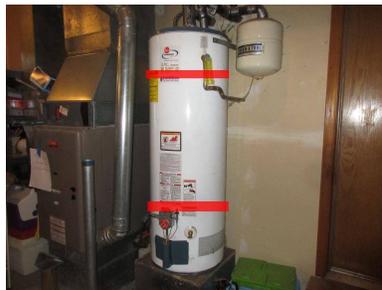
The expansion tank is not adequately secured to the wall. This could result in damage to the water pipe and leakage during an earth quake. A seismic restraint should be installed to secure the expansion tank.

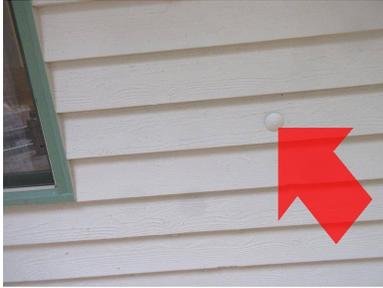
An air gap called a Johnson Tee is installed in the kitchen wall. This air gap protects the dishwasher from contamination caused by a backflow of waste water. The cap protruding on the exterior wall opposite the dishwasher is not drilled. This renders the air gap non-functional. Drilling a 1/4" hole in the end of the cap will

restore its function. The remaining visible portions of the Johnson Tee were properly installed and functioning as intended.

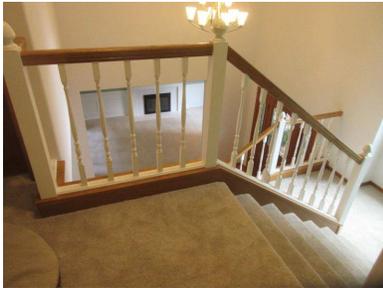
The stair railing baluster spacing is too wide. This is a hazard for small children. The baluster spacing should be reduced as a safety upgrade. Current standards require that a 4" sphere not pass through the railing.

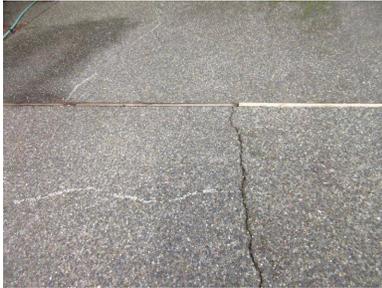
One or more of the wooden dividers separating the concrete driveway sections were infested by wood destroying organisms and have deteriorated to a point where they are becoming a trip hazard. Replacement with mortar is recommended.

Cracks were observed in the concrete surface of the driveway. Minor cracks can be sealed to minimize moisture entry and further settlement of the concrete. Minor cracks are common and do not affect the serviceability of the concrete.

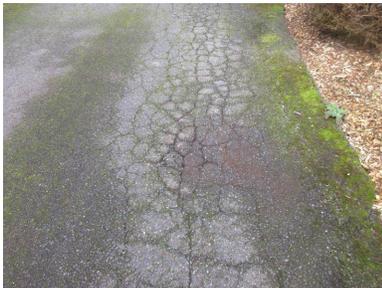
Seal coating the surface of the asphalt is recommended to maximize the service life of the paving. Asphalt sealers are available at most home improvement stores.

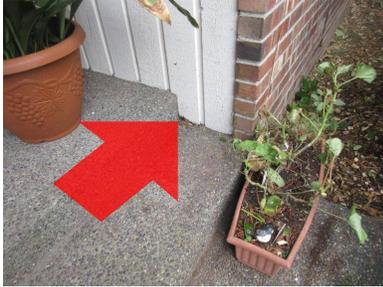
Untreated wood in direct contact with concrete was observed along the front stoop. Untreated wood should be raised 1-2" above the concrete. Treating the wood with a preservative sometimes will prevent wood destroy organism damage.

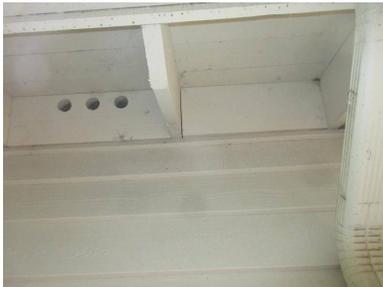
There are large gaps over 1/4" in size adjacent the soffit vent blocks. These gaps allow insects and rodents to enter the attic. Covering the gaps with screening, a strip of wood and/or caulking is recommended.

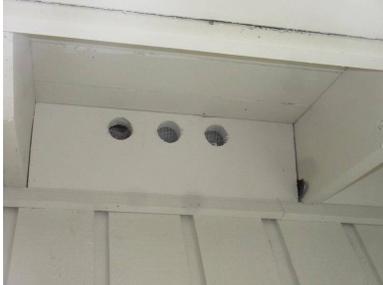
There is a damaged vent screen on the front of the house. The vent screen should be repaired to prevent insect, bird and rodent entry.

- 3.3 – Repair the folded vent screen on the front of the house coming into the garage**
- 3.6 – Edges of the deck will be treated with a spray-fungicide to destroy rot fungi**
- 4.5 – On March 1st, 2021 Ed’s Chimney Service and Repair will be back out to acid-wash the bricks on both chimneys and apply liquid sealer to further prevent water leakage**
- 11.4 – Caulk shower edge at the wood floor in the downstairs bathroom**
- 13.2 – Confirm that main shutoff valve for water is in the box in the southeast corner of the front yard near the street**

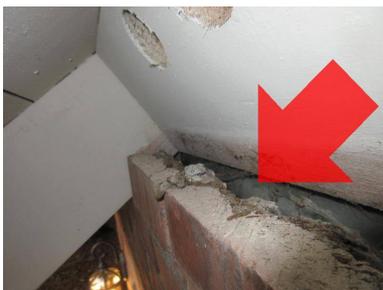
There are openings at the intersection between the overhang and the brick facade through which birds and rodents can enter into the attic. These openings should be covered with wood, wire mesh or filled with aerosol foam.

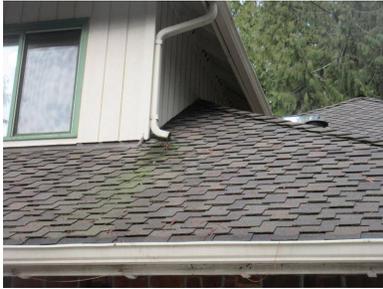
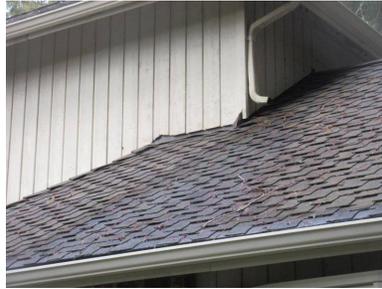
Downspouts draining directly onto the asphalt shingle surface causes excessive wear of the roofing material. Downspout extensions to the lower gutters should be installed to prevent excessive wear and tear of the

roofing.

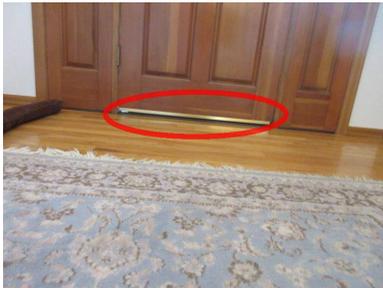
The front door is not adequately weather stripped with a threshold. This allows cold air to infiltrate under the door. The installation of threshold's on all of the exterior doors is recommended.

- 3.8 – Weatherstripping has been replaced at the bottom of the front door, to fit the full length of the door**
- 4.5 – On February 26th, 2021 chimney repair company Ed’s Chimney Service and Repair replaced the cement caps on the top of both chimneys and adjusted the flashing around both chimneys to prevent water leakage**

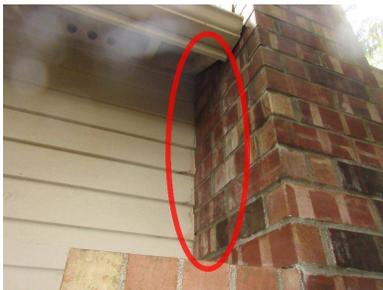
Metal flashings are used to seal around chimneys, vents and roof to wall intersections. Flashings are improperly installed adjacent the chimney. This is allowing leakage to occur. Repairs to the flashings is recommended.

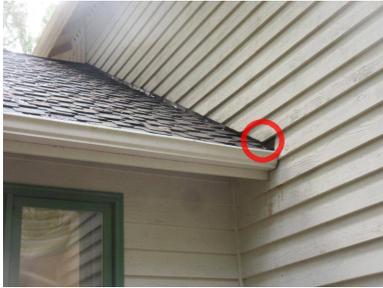
The kick out flashing at the roof edge to wall intersection above the gutter is too small. This will allow water to enter the wall behind the siding. The installation of a larger kick-out flashing is recommended.

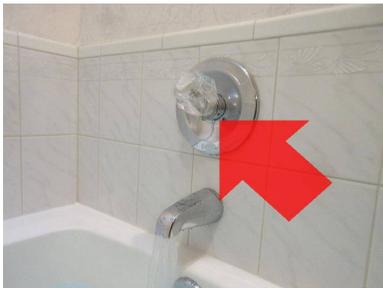
The bathtub faucet valve stem is leaking. This usually occurs in older faucets. Leaking faucets should be rebuilt or replaced.

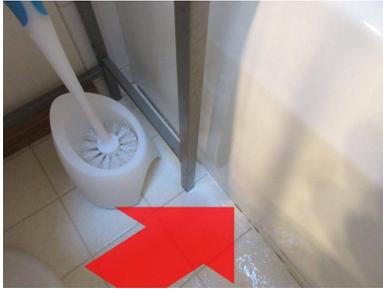
The caulking is cracked at the intersection between the tub/shower and floor. This can lead to water damage

to the flooring and substrate. Caulking this area with a flexible caulk is recommended.

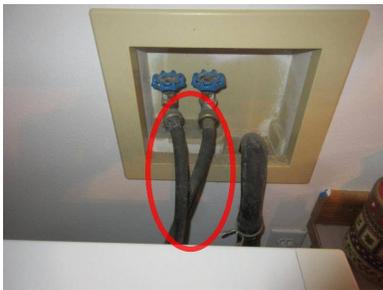
Upgrading the washer connections to high pressure (steel braided) lines is recommended.

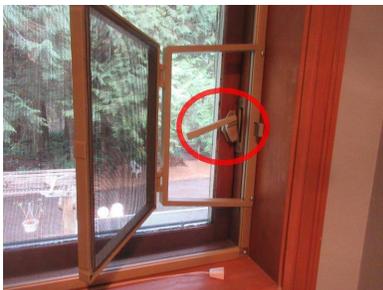
The latch/locking mechanism for one of the windows does not secure the window closed. We recommend repairs as necessary to restore the windows proper operation.

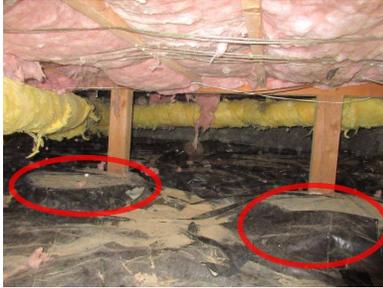
The support post concrete piers are covered with the plastic vapor retarder. This allows the transmission of water vapor from the soil up and into the floor framing. The plastic vapor retarder should be removed from the pier so that it covers at least 85% of the entire surface of the soil only.

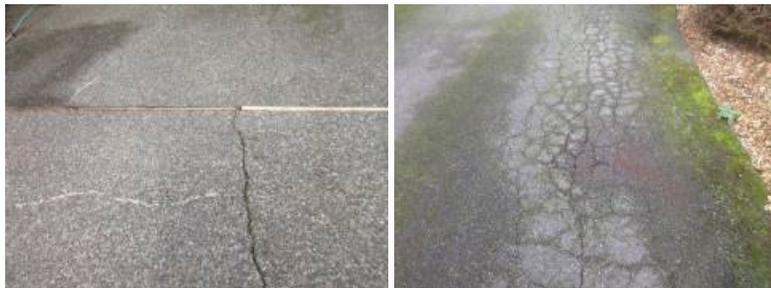
The driveway is paved with asphalt paving mix. The driveway is properly installed and is performing its intended function. Seal coating the surface of the asphalt is recommended to maximize the service life of the paving. Asphalt sealers are available at most home improvement stores.

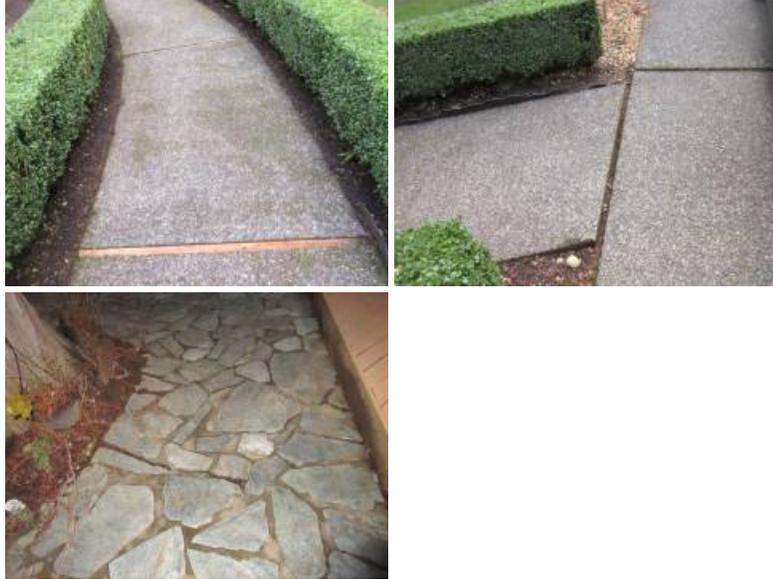
The walking surface was not even and trip hazards were present. We recommend all walking surfaces be maintained free of trip hazards.

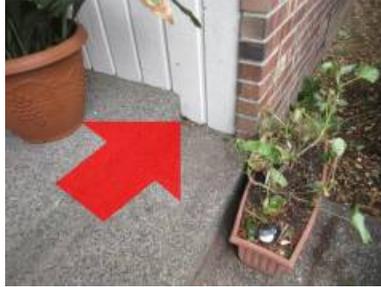
Rot damage was observed in wood that has been in contact with the front stoop. Wood rot commonly referred to as "Dry Rot" occurs when untreated wood is allowed to retain moisture for extended periods of time. Wood rot is caused by fungi which grow in the cell structure and spread like a root system through the wood. Fungi can also develop from spores which are present in the soil and are transferred through the air. Rotted wood creates an environment that is conducive to various types of wood boring insects (e.g. carpenter ants, moisture ants, dampwood termites, etc.) Wood rot can be prevented by keeping the wood dry, or if this is not possible, such as in the case of outdoor wood, by using pressure treated wood, by treating exposed wood with semi-transparent stain and/or wood preservative, and by keeping untreated wood out of and 6" above the soil.

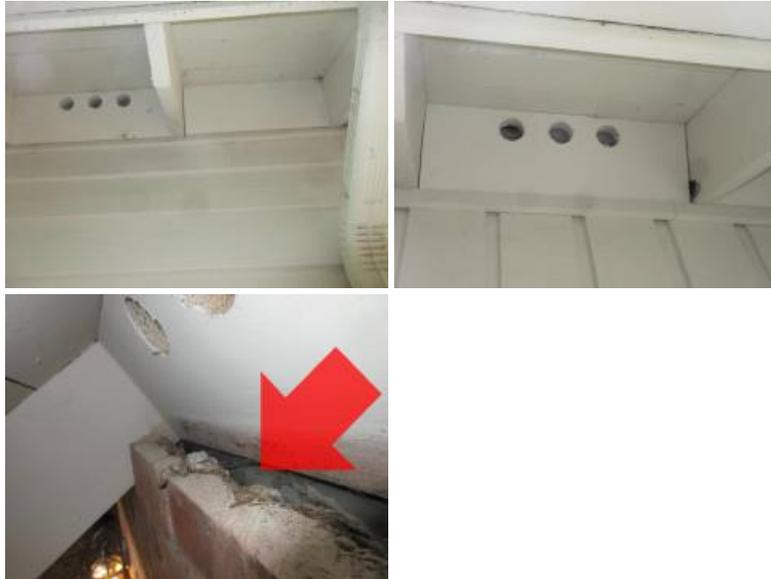
There are openings at the intersection between the overhang and the brick facade through which birds and rodents can enter into the attic. These openings should be covered with wood, wire mesh or filled with aerosol foam.

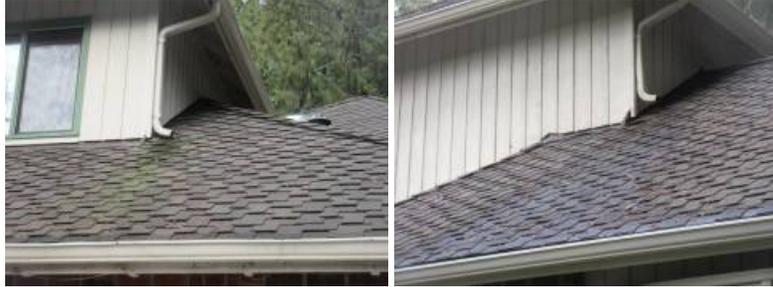
Downspouts draining directly onto the asphalt shingle surface causes excessive wear of the roofing material. Downspout extensions to the lower gutters should be installed to prevent excessive wear and tear of the roofing.

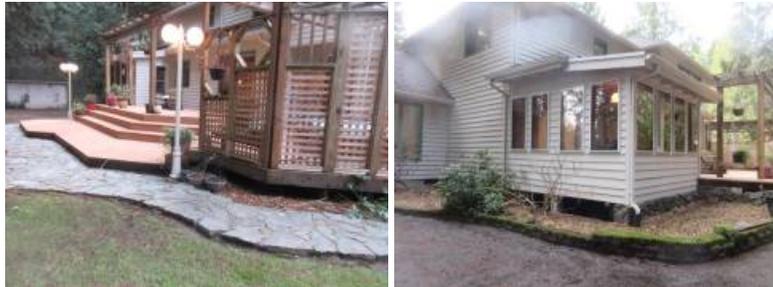
The proximity of the room extension to the ground prevented an inspection of the floor framing. The visible portions of the room extension are in good condition.

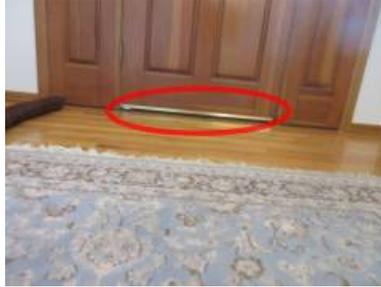
Wood doors are undesirable for use at any location that has chronic exposure to rainfall or water splash. Consideration should be given to upgrading the exposed wood doors to aluminum or vinyl clad doors.

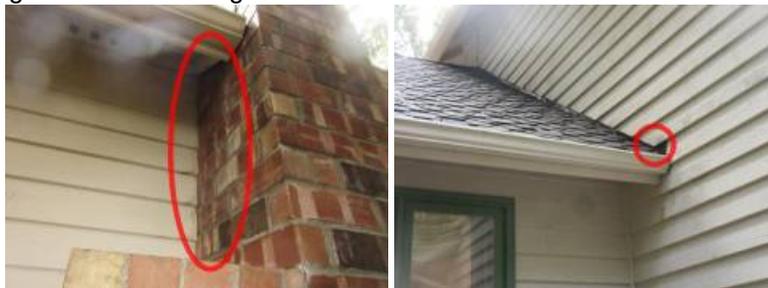
The kick out flashing at the roof edge to wall intersection above the gutter is too small. This will allow water to enter the wall behind the siding. The installation of a larger kick-out flashing is recommended.

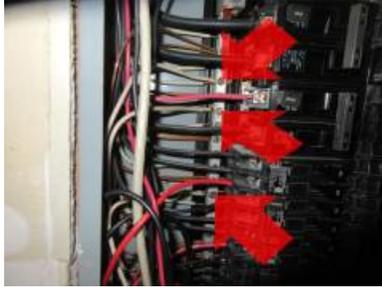
Several of the neutral wires are double tapped on the buss bar. Double tapping means that two conductors share a single terminal. Double tapped terminals can loosen and overheat and therefore are not permitted unless the terminal is specifically listed for multiple wires. This defect is easily repaired by connecting the two wires to a "pig tail", securing them with a wire cap, and then inserting the pig tail conductor under the terminal.

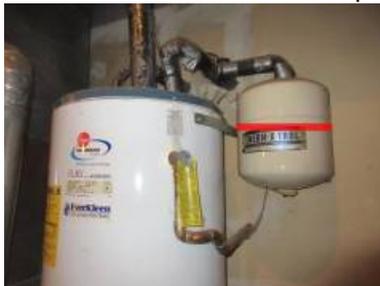
The expansion tank is not adequately secured to the wall. This could result in damage to the water pipe and leakage during an earth quake. A seismic restraint should be installed to secure the expansion tank.

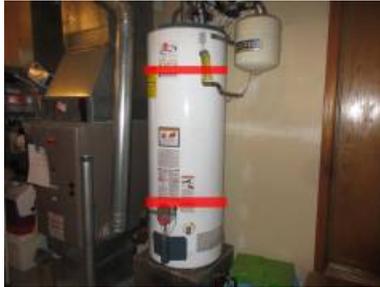
The seismic restraint for the water heater was minimal. Proper strapping is recommended to adequately secure the tank and provide potable water in the event of an earthquake.

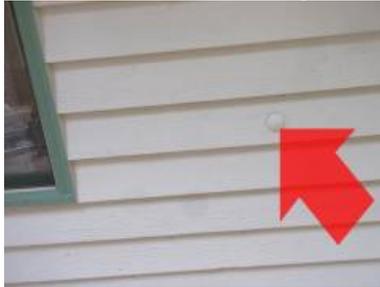
An air gap called a Johnson Tee is installed in the kitchen wall. This air gap protects the dishwasher from contamination caused by a backflow of waste water. The cap protruding on the exterior wall opposite the dishwasher is not drilled. This renders the air gap non-functional. Drilling a 1/4" hole in the end of the cap will restore its function. The remaining visible portions of the Johnson Tee were properly installed and functioning as intended.

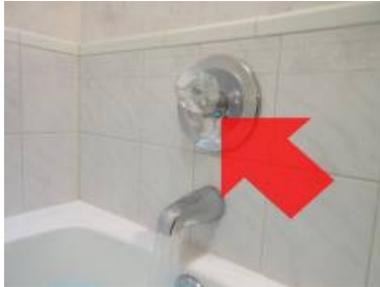
The bathtub faucet valve stem is leaking. This usually occurs in older faucets. Leaking faucets should be rebuilt or replaced.

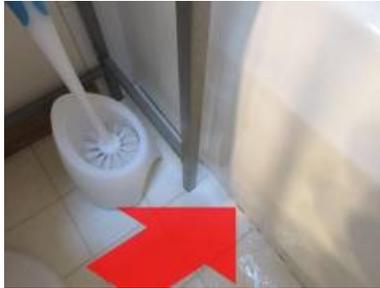
The caulking is cracked at the intersection between the tub/shower and floor. This can lead to water damage to the flooring and substrate. Caulking this area with a flexible caulk is recommended.

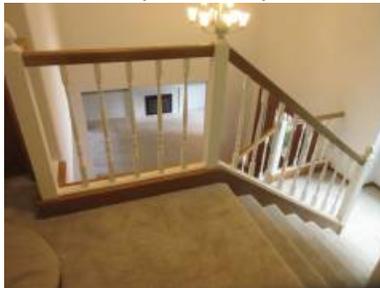
The stair railing baluster spacing is too wide. This is a hazard for small children. The baluster spacing should be reduced as a safety upgrade. Current standards require that a 4" sphere not pass through the railing.

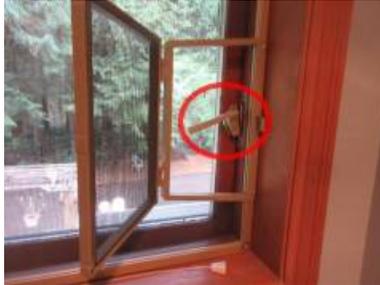
The latch/locking mechanism for one of the windows does not secure the window closed. We recommend repairs as necessary to restore the windows proper operation.

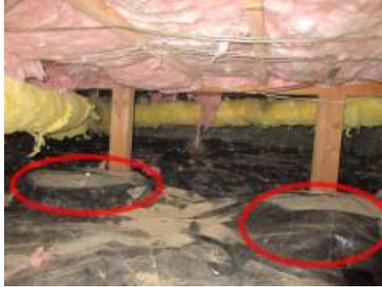
The support post concrete piers are covered with the plastic vapor retarder. This allows the transmission of water vapor from the soil up and into the floor framing. The plastic vapor retarder should be removed from the pier so that it covers at least 85% of the entire surface of the soil only.
