NOTICE TO BUYER: SELLER-PROCURED INSPECTION REPORT

Lee Weng
11427 NE 117th Street
Kirkland, WA 98034

11427 NE 117th St. Unit #45
Kirkland WA.

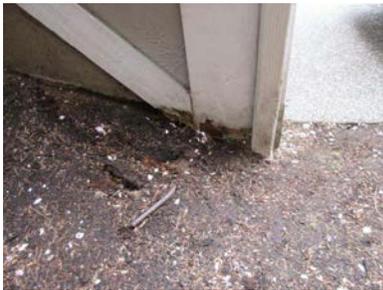
3.1 PRIMARY EXTERIOR WALL CLADDING

The trim boards and siding are rotted where they have been in contact with the soil at the northeast corner of the building. The rot damaged siding and trim should be replaced and proper earth to wood clearances maintained.

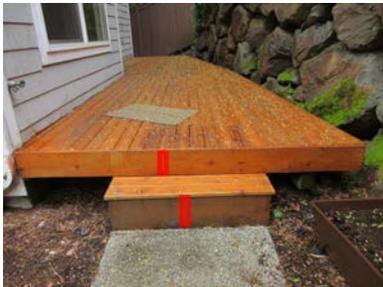
3.9 STAIRS

The deck steps are non-conforming due to the variable and/or excessive rise. Deck stair/step design standards require that step risers do not exceed 8" and that the variation in rise not exceed 3/8" in order to reduce falls from tripping. To increase the margin of safety, consideration should be given to reconfiguring the steps so that rise and run do not vary by more than 3/8". If this proves to be too impractical or expensive, then we recommend exercising caution when using these steps.

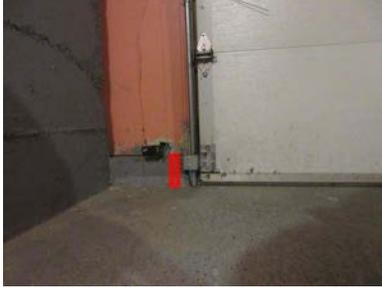
6.3 GARAGE DOOR OPENER

The Photo-eye beam was installed to high above the floor of the garage to adequately offer protection for small children and/or pets. We recommend that the photo-eye be lowered to within 4-6" of the floor.

6.3 – Garage Door Opener – adjusted photo-eye beam per recommendation to 6” from ground

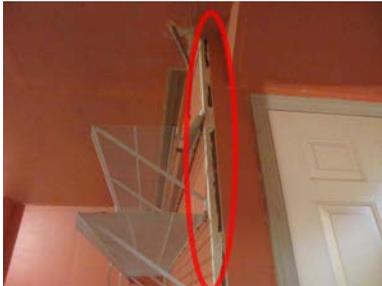
6.4 FIRE SEPARATION

The fire resistive barrier between the garage and the living space is properly installed and in good condition, however, the corner joint is not taped. Consideration should be given to "fire taping" the drywall as a safety upgrade.

6.4 – Taped the corner joint as recommended

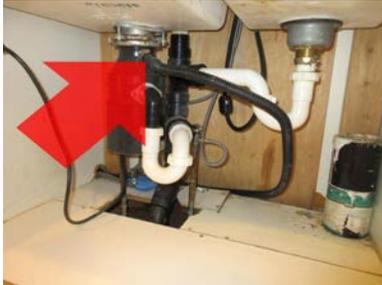
10.8 AIR GAP

The dishwasher drain lacks an air gap. The dishwasher will function without one, but there is a risk of contamination of the inside of the dishwasher by waste water. The installation of an air gap is recommended.

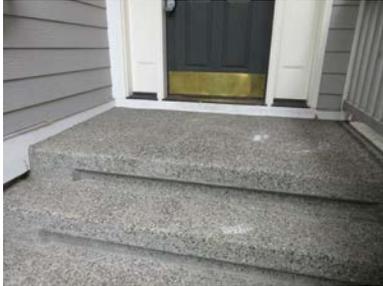
Untreated wood in direct contact with concrete was observed along the entry stoop. Untreated wood should

be raised 1-2" above the concrete. Treating the wood with a preservative sometimes will prevent wood destroy organism damage.

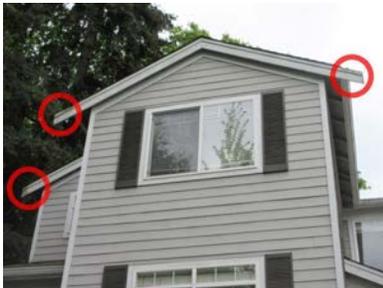
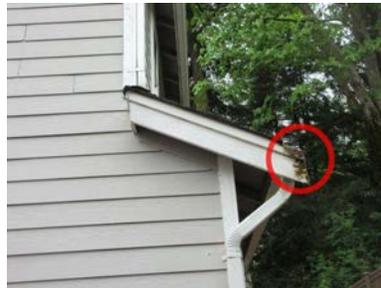
3.3 SOFFITS AND OVERHANGS

The ends of the barge boards are exposed to the weather and are vulnerable to rot damage. To prevent damage to the barge board ends, they should be covered with roofing material or flashing.

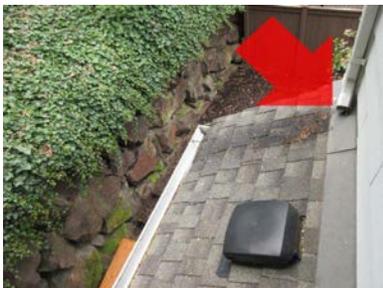
3.4 GUTTERS AND DOWNSPOUTS

Downspouts draining directly onto the asphalt shingle surface causes excessive wear of the roofing material. Downspout extensions to the lower gutters should be installed to prevent excessive wear and tear of the roofing.

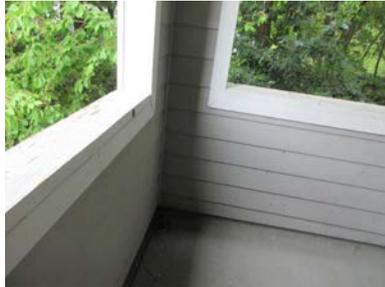
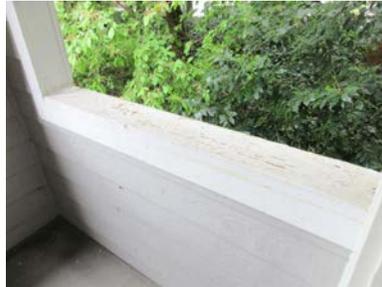
3.8 DECK RAILINGS

A wooden cap has been installed over the top of the enclosed deck railing. This is an unreliable construction detail that will often allow water intrusion into the enclosed railing. The flat surface causes accelerated deterioration of the wood. The installation of a metal cap on the railing is recommended.

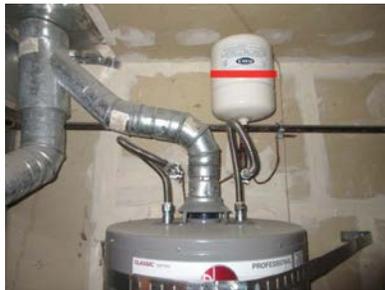
9.6 EXPANSION TANK

The expansion tank is not adequately secured to the wall. This could result in damage to the water pipe and leakage during an earth quake. A seismic restraint should be installed to secure the expansion tank.

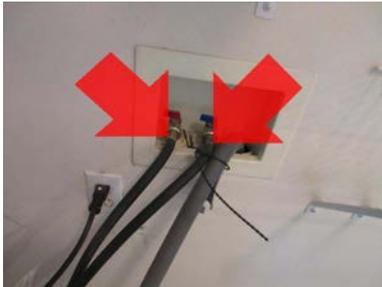
12.3 APPLIANCES

Upgrading the washer connections to high pressure (steel braided) lines is recommended.

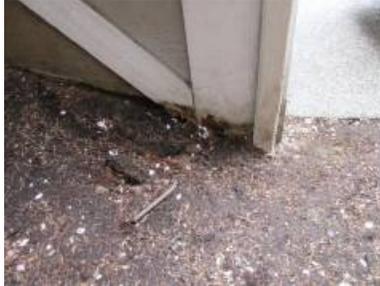
The trim boards and siding are rotted where they have been in contact with the soil at the northeast corner of the building. The rot damaged siding and trim should be replaced and proper earth to wood clearances maintained.

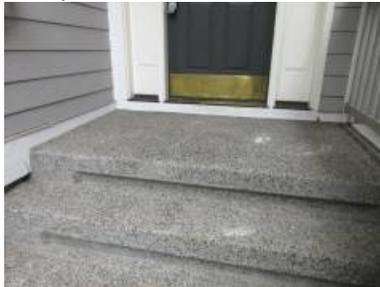
3.2 PEST CONTROL

Untreated wood in direct contact with concrete was observed along the entry stoop. Untreated wood should be raised 1-2" above the concrete. Treating the wood with a preservative sometimes will prevent wood destroy organism damage.

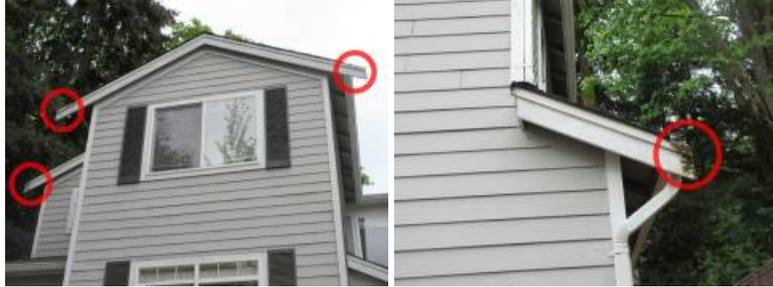
3.3 SOFFITS AND OVERHANGS

The ends of the barge boards are exposed to the weather and are vulnerable to rot damage. To prevent damage to the barge board ends, they should be covered with roofing material or flashing.

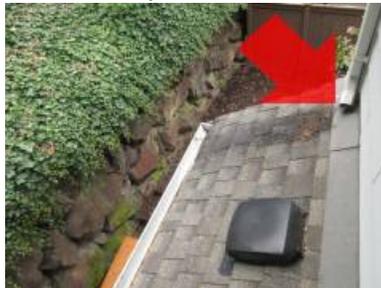
3.4 GUTTERS AND DOWNSPOUTS

Downspouts draining directly onto the asphalt shingle surface causes excessive wear of the roofing material. Downspout extensions to the lower gutters should be installed to prevent excessive wear and tear of the roofing.

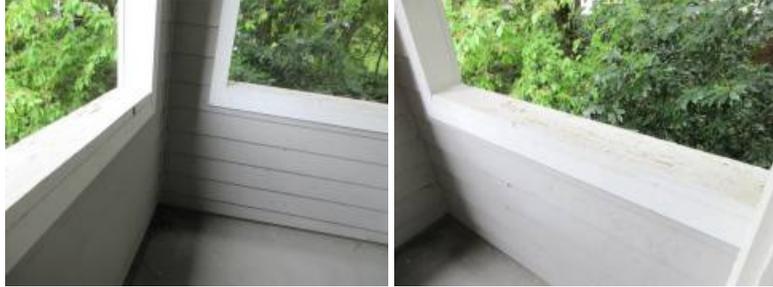
3.8 DECK RAILINGS

A wooden cap has been installed over the top of the enclosed deck railing. This is an unreliable construction detail that will often allow water intrusion into the enclosed railing. The flat surface causes accelerated deterioration of the wood. The installation of a metal cap on the railing is recommended.

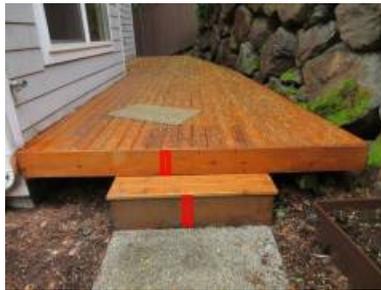
3.9 STAIRS

The deck steps are non-conforming due to the variable and/or excessive rise. Deck stair/step design standards require that step risers do not exceed 8" and that the variation in rise not exceed 3/8" in order to reduce falls from tripping. To increase the margin of safety, consideration should be given to reconfiguring the steps so that rise and run do not vary by more than 3/8". If this proves to be too impractical or expensive, then we recommend exercising caution when using these steps.

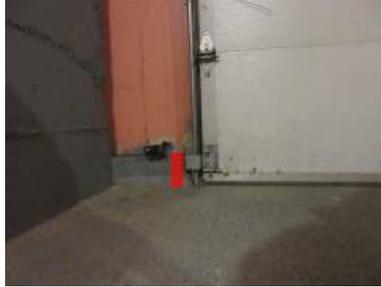
The Photo-eye beam was installed to high above the floor of the garage to adequately offer protection for small children and/or pets. We recommend that the photo-eye be lowered to within 4-6" of the floor.

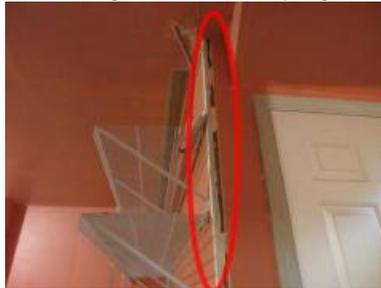
6.4 FIRE SEPARATION

The fire resistive barrier between the garage and the living space is properly installed and in good condition, however, the corner joint is not taped. Consideration should be given to "fire taping" the drywall as a safety upgrade.

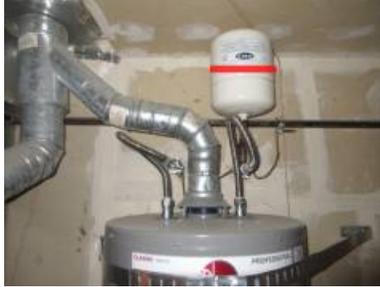
The expansion tank is not adequately secured to the wall. This could result in damage to the water pipe and leakage during an earth quake. A seismic restraint should be installed to secure the expansion tank.

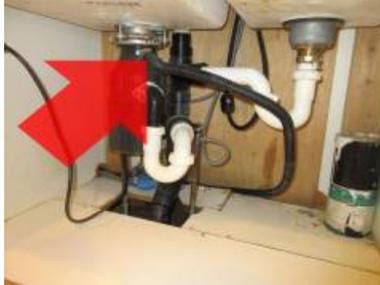
10.8 AIR GAP

The dishwasher drain lacks an air gap. The dishwasher will function without one, but there is a risk of contamination of the inside of the dishwasher by waste water. The installation of an air gap is recommended.

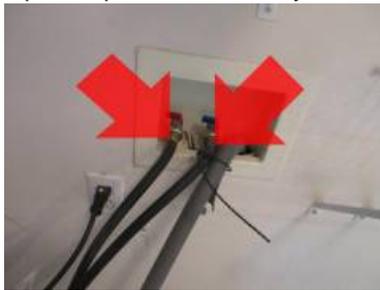
Upgrading the washer connections to high pressure (steel braided) lines is recommended.
