NOTICE TO BUYER: SELLER-PROCURED INSPECTION REPORT

13116 175th Ave NE

Redmond, WA 98052

At your request, a visual inspection of the above referenced property was conducted on 04/23/2021. We have inspected the major structural components, plumbing, heating and electrical systems for signs of significant non-performance, excessive or unusual wear and general state of repair.

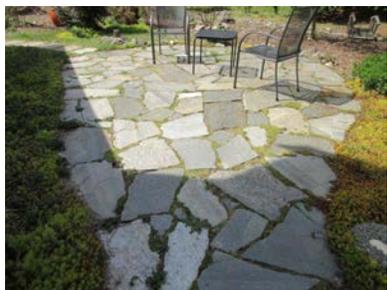
2.5 PATIO

The walking surface of the patio was not even and trip hazards were present. We recommend all walking surfaces be maintained free of trip hazards.

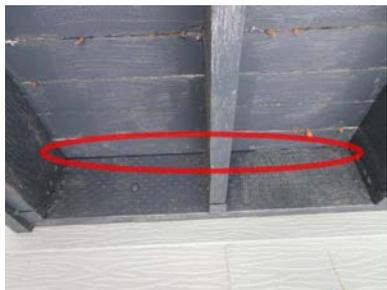
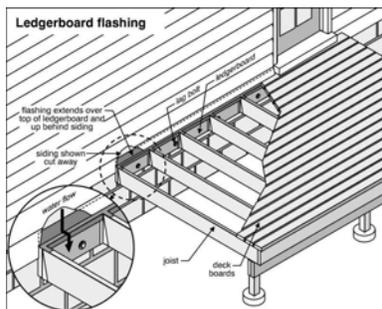
3.6 DECK

There is no flashing at the intersection between the deck and house. This will allow water to enter behind the siding. The installation of flashing in this area is recommended.

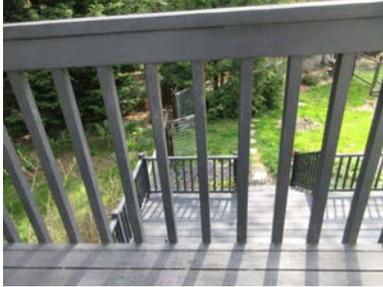
3.7 DECK RAILINGS

The spacing between the balusters is too wide. This is a hazard to small children. The balusters should be spaced close enough together so that a 4" sphere cannot pass through. Upgrading the deck railing is recommended if small children are present.

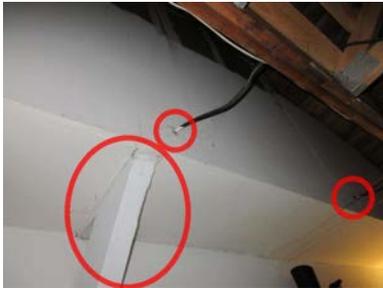
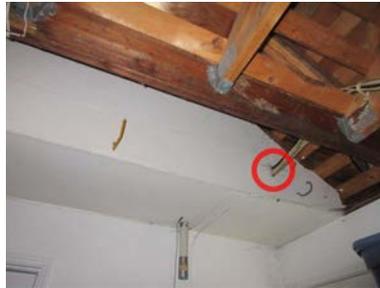
ATTACHED GARAGE 6.4 FIRE SEPARATION

There are voids in the fire resistive barrier between the living space and garage that will allow flames to penetrate. The gypsum barrier slows the spread of a fire from the garage to the structure and/or living space. Patching the voids with a fire retardant caulk is recommended.

6.4 – Filled voids in the fire resistive barrier between living space and garage with fire retardant caulk

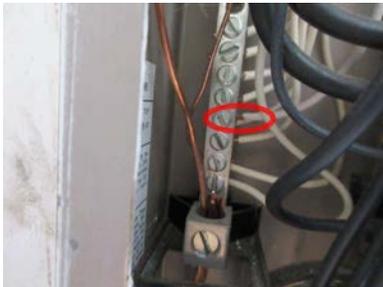
7.8 SERVICE PANEL

One of the neutral wires is double tapped on the buss bar. Double tapping means that two conductors share a single terminal. Double tapped terminals can loosen and overheat and therefore are not permitted unless the terminal is specifically listed for multiple wires. This defect is easily repaired by connecting the two wires to a "pig tail", securing them with a wire cap, and then inserting the pig tail conductor under the terminal.

7.8 – Seller repair the double-tapping of one of the neutral wires by connecting the two wires to a pig tail, secure with a wire cap and then insert the pig tail conductor under the terminal

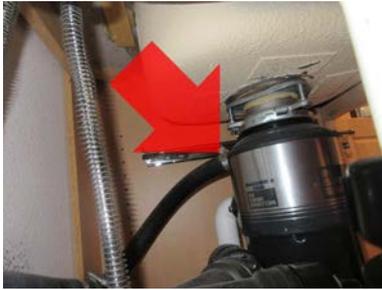
10.8 AIR GAP

The dishwasher drain lacks an air gap. The dishwasher will function without one, but there is a risk of contamination of the inside of the dishwasher by waste water. The installation of an air gap is recommended.

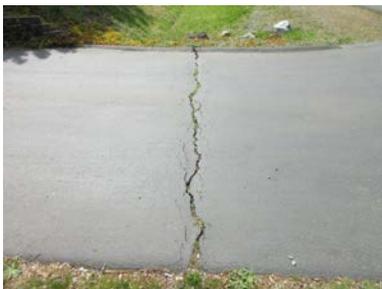
A large crack and settling was observed in the asphalt surface of the driveway. The crack can be sealed to minimize moisture entry and further settlement of the asphalt.

2.4 – Sealed large crack in the asphalt driveway

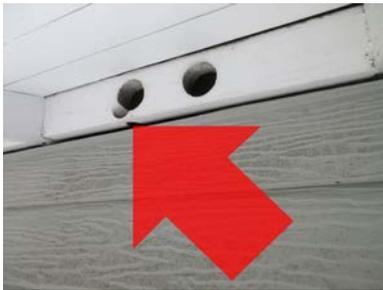
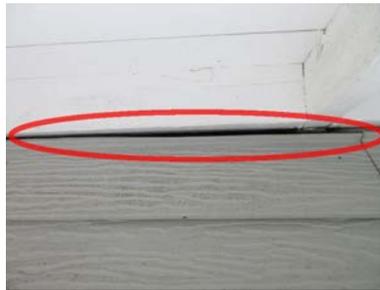
3.3 SOFFITS AND OVERHANGS

There are large gaps over 1/4" in size adjacent the soffit vent blocks. These gaps allow insects and rodents to enter the attic. Covering the gaps with screening, a strip of wood and/or caulking is recommended.

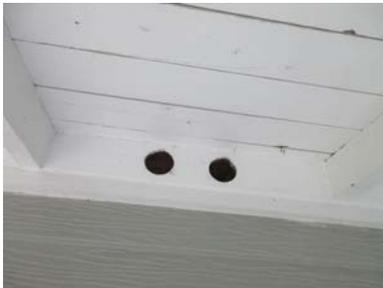
Several vents are covered with steel wool. This blocks the flow of air. Better ventilation can be achieved by installing 1/4" wire mesh over the vents.

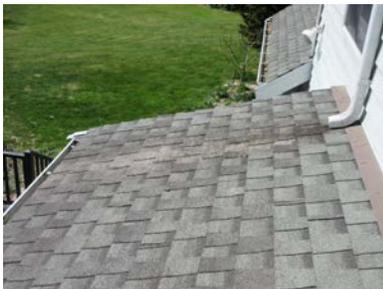
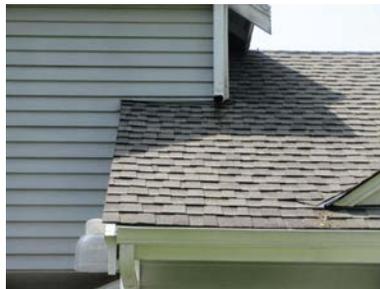
3.4 GUTTERS AND DOWNSPOUTS

Downspouts draining directly onto the asphalt shingle surface causes excessive wear of the roofing material. Downspout extensions to the lower gutters should be installed to prevent excessive wear and tear of the roofing.

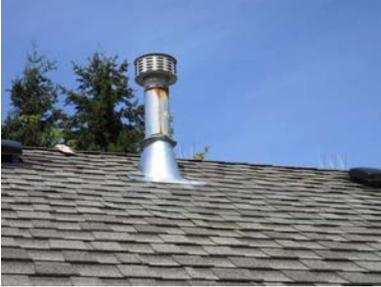
4.5 GAS APPLIANCE VENTS

The gas appliance vent is corroded above the roof line. Cleaning and painting the vent will prolong its service life.

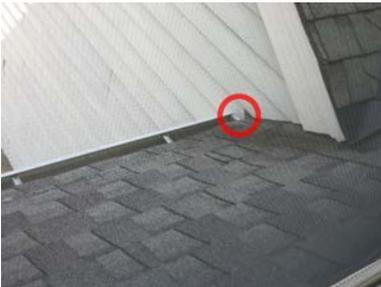
4.6 FLASHINGS

There is no kick out flashing at the roof edge to wall intersection above the gutter. This will allow water to enter the wall behind the siding. The installation of a kick-out flashing is recommended.

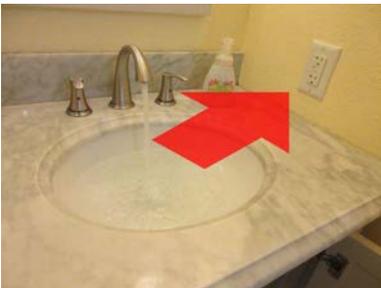
10.1 COUNTERTOPS

The backsplash is not caulked. This allows water to enter the gap between the back splash and counter and it is difficult to clean. Caulking should be installed at this location.

The side backsplash is missing. The installation of a full backsplash is recommended.

10.1 – Caulked kitchen counter backsplash

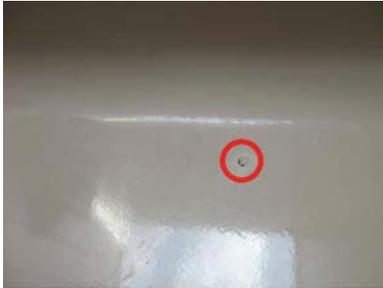
11.25 BATHTUB

The surface of the bathtub is chipped. This defect is primarily cosmetic and therefore repairs are optional. Chips can be touched up with appliance repair touch-up paint available at most home improvement centers. condition.

11.25 – Fixed chip in master bedroom bathtub

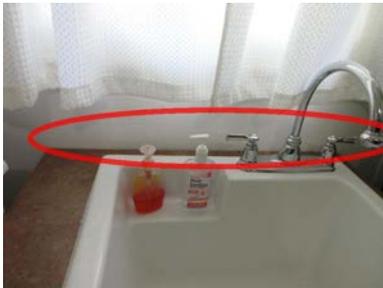
12.2 COUNTERTOP

The backsplash is missing. The installation of a backsplash is recommended.

The backsplash is not caulked. This allows water to enter the gap between the back splash and counter and it is difficult to clean. Caulking should be installed at this location.

12.2 – Installed laundry room sink backsplash

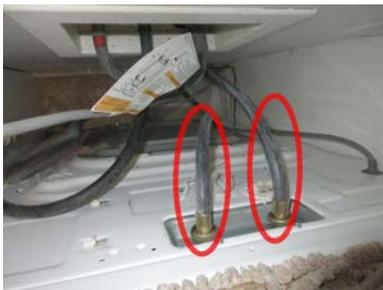
12.7 APPLIANCES

Upgrading the washer connections to high pressure (steel braided) lines is recommended.

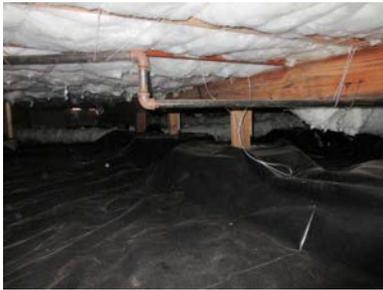
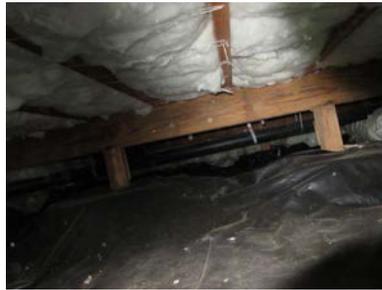
19.4 VAPOR RETARDER

The support post concrete piers are covered with the plastic vapor retarder. This allows the transmission of water vapor from the soil up and into the floor framing. The plastic vapor retarder should be removed from the pier so that it covers at least 85% of the entire surface of the soil only.

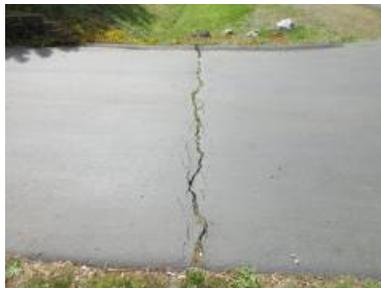
A large crack and settling was observed in the asphalt surface of the driveway. The crack can be sealed to minimize moisture entry and further settlement of the asphalt.

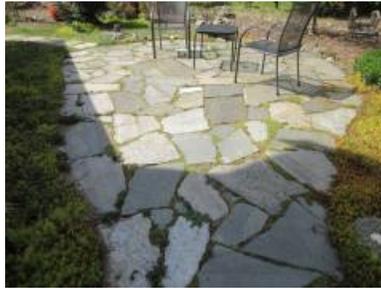
2.5 PATIO

The walking surface of the patio was not even and trip hazards were present. We recommend all walking surfaces be maintained free of trip hazards.

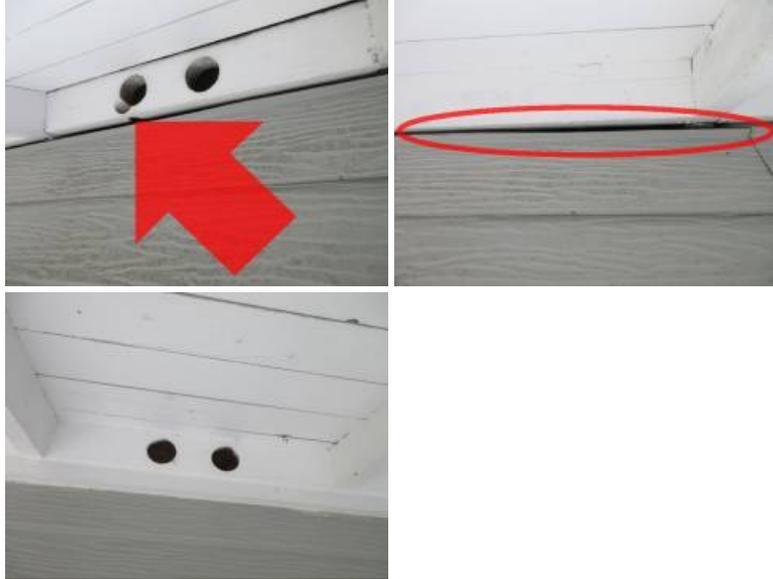
There are large gaps over 1/4" in size adjacent the soffit vent blocks. These gaps allow insects and rodents to enter the attic. Covering the gaps with screening, a strip of wood and/or caulking is recommended.

Several vents are covered with steel wool. This blocks the flow of air. Better ventilation can be achieved by installing 1/4" wire mesh over the vents.

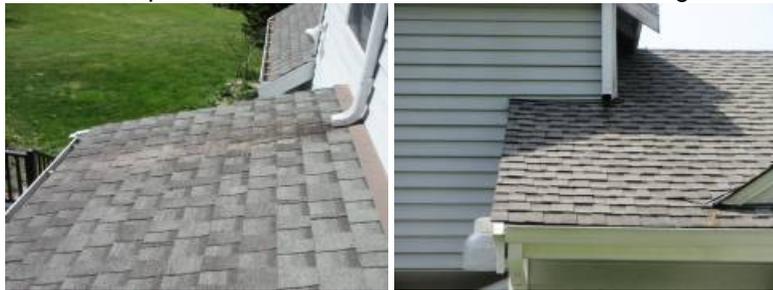
3.4 GUTTERS AND DOWNSPOUTS

Downspouts draining directly onto the asphalt shingle surface causes excessive wear of the roofing material. Downspout extensions to the lower gutters should be installed to prevent excessive wear and tear of the roofing.

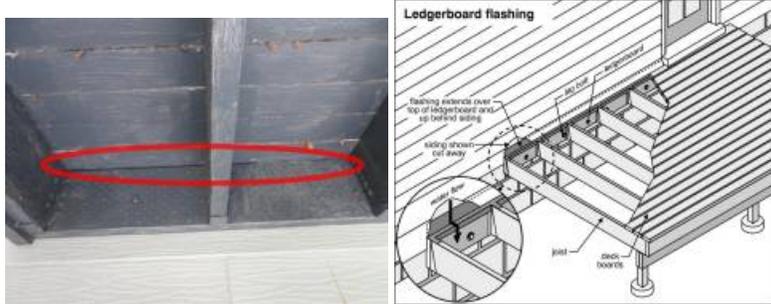
There is no flashing at the intersection between the deck and house. This will allow water to enter behind the siding. The installation of flashing in this area is recommended.

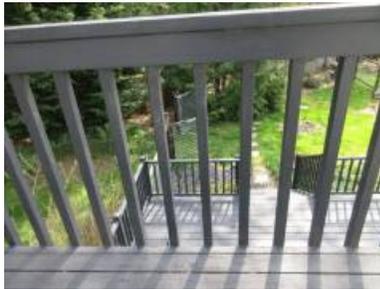
3.7 DECK RAILINGS

The spacing between the balusters is too wide. This is a hazard to small children. The balusters should be spaced close enough together so that a 4" sphere cannot pass through. Upgrading the deck railing is recommended if small children are present.

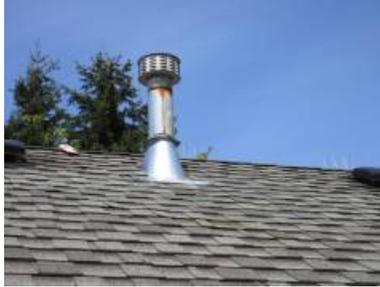
4.5 GAS APPLIANCE VENTS

The gas appliance vent is corroded above the roof line. Cleaning and painting the vent will prolong its service life.

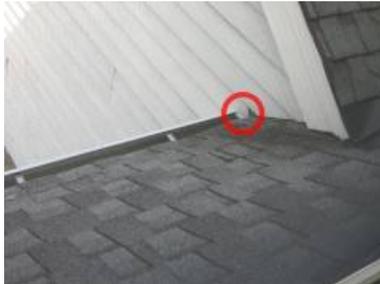
4.6 FLASHINGS

There is no kick out flashing at the roof edge to wall intersection above the gutter. This will allow water to enter the wall behind the siding. The installation of a kick-out flashing is recommended.

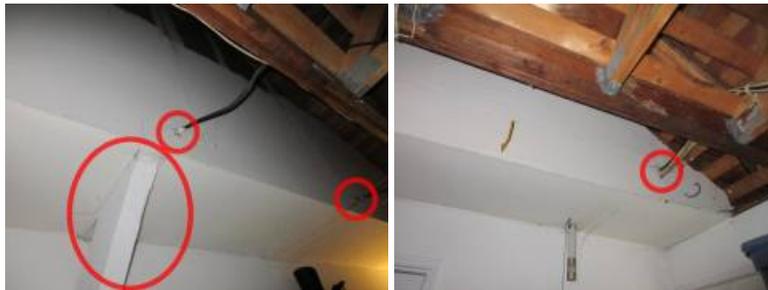
6.4 FIRE SEPARATION

There are voids in the fire resistive barrier between the living space and garage that will allow flames to penetrate. The gypsum barrier slows the spread of a fire from the garage to the structure and/or living space. Patching the voids with a fire retardant caulk is recommended.

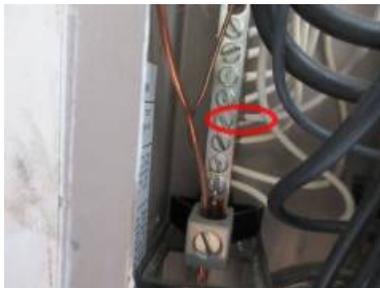
One of the neutral wires is double tapped on the buss bar. Double tapping means that two conductors share a single terminal. Double tapped terminals can loosen and overheat and therefore are not permitted unless the terminal is specifically listed for multiple wires. This defect is easily repaired by connecting the two wires to a "pig tail", securing them with a wire cap, and then inserting the pig tail conductor under the terminal.

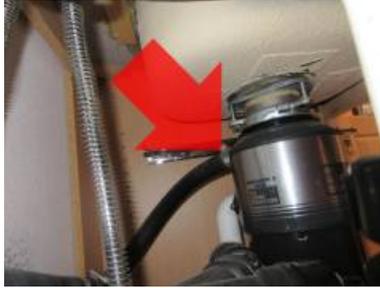
10.8 AIR GAP

The dishwasher drain lacks an air gap. The dishwasher will function without one, but there is a risk of contamination of the inside of the dishwasher by waste water. The installation of an air gap is recommended.

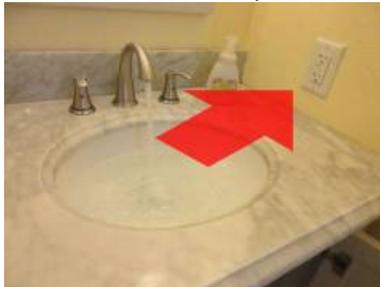
The side backsplash is missing. The installation of a full backsplash is recommended.

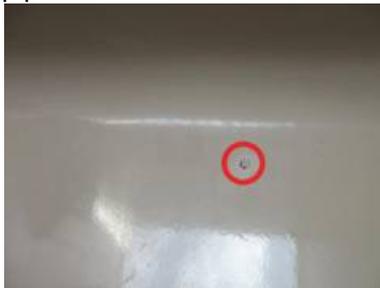
The surface of the bathtub is chipped. This defect is primarily cosmetic and therefore repairs are optional. Chips can be touched up with appliance repair touch-up paint available at most home improvement centers. condition.

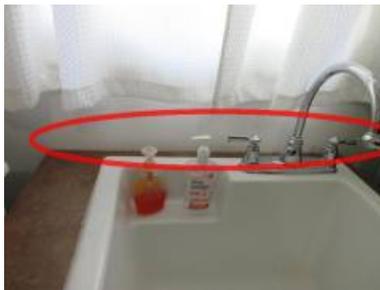
The backsplash is missing. The installation of a backsplash is recommended.

The backsplash is not caulked. This allows water to enter the gap between the back splash and counter and it is difficult to clean. Caulking should be installed at this location.

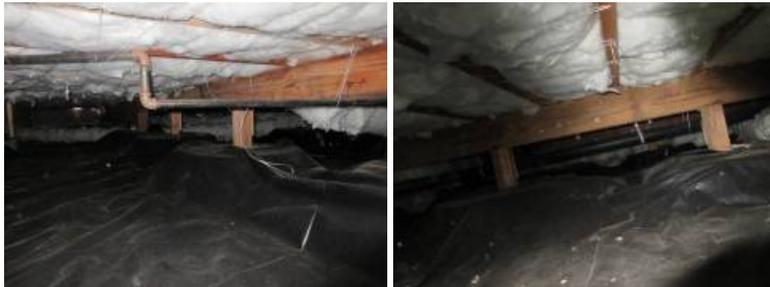
The support post concrete piers are covered with the plastic vapor retarder. This allows the transmission of water vapor from the soil up and into the floor framing. The plastic vapor retarder should be removed from the pier so that it covers at least 85% of the entire surface of the soil only.
