NOTICE TO BUYER: SELLER-PROCURED INSPECTION REPORT

The following notice is given with respect to the Purchase and Sale Agreement dated _____ between _____ (“Buyer”) and **Nicholas Banks** **Stephanie Banks** (“Seller”) concerning **27929 NE 147th Cir** **Duvall** **WA 98019** (“the Property”).

Inspection Cover Letter

27929 NE 147th Circle
Duvall WA.

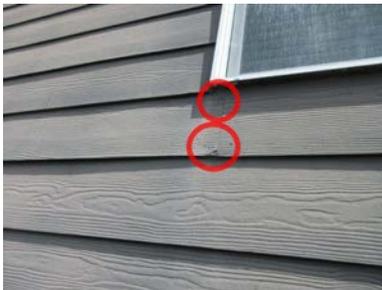
Localized areas of peeling paint were noted on trim boards. Paint protects the wood from cupping, checking, warping and rot. These areas should be scraped, primed and repainted.

Siding nails that have damaged the surface overlay need to be caulked. Caulking prevents water intrusion of the siding. Consideration should be given to caulking the siding as necessary. Exterior caulking is recommended.

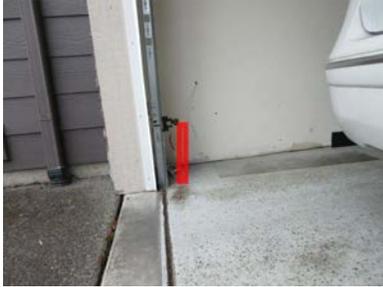
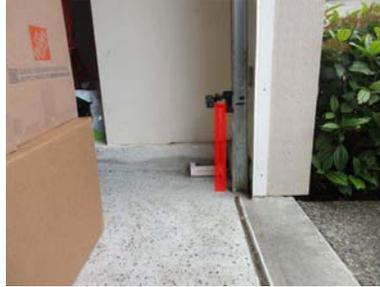
The Photo-eye beam was installed to high above the floor of the garage to adequately offer protection for small children and/or pets. We recommend that the photo-eye be lowered to within 4-6" of the floor.

6.3 GARAGE DOOR OPENER

The photo-eye was moved down to the required height.

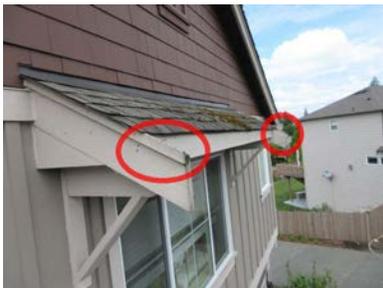
3.4 SOFFITS AND OVERHANGS

The ends of the barge boards are exposed to the weather and are vulnerable to rot damage. To prevent damage to the barge board ends, they should be covered with roofing material or flashing.

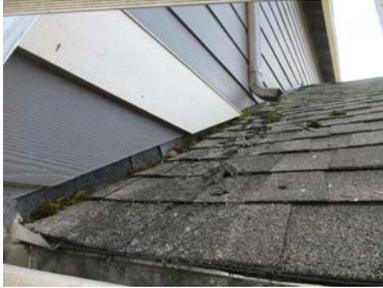
3.5 GUTTERS AND DOWNSPOUTS

Downspouts draining directly onto the asphalt shingle surface causes excessive wear of the roofing material.

Downspout extensions to the lower gutters should be installed to prevent excessive wear and tear of the roofing.

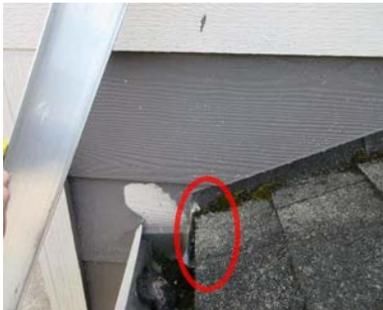
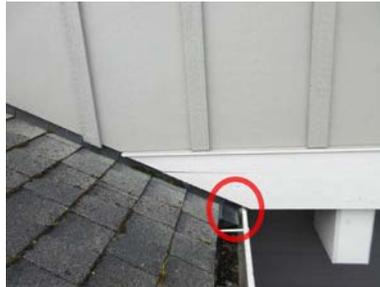
4.4 FLASHINGS

There are inadequate or no kick out flashings at the roof edge to wall intersections above the gutters. This will allow water to enter the wall behind the siding. The installation of kick-out flashings is recommended.

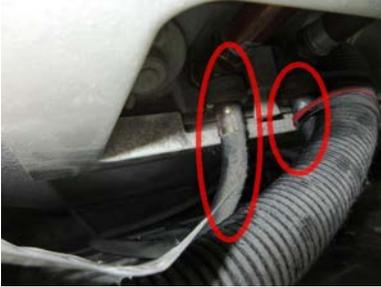
13.3 APPLIANCES

Upgrading the washer connections to high pressure (steel braided) lines is recommended.

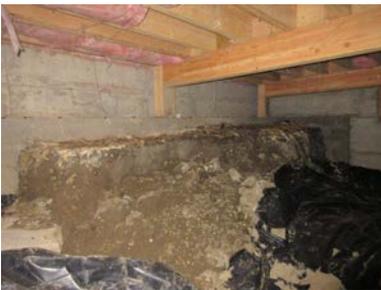
Some of the soil under the house is not covered with a polyethylene plastic vapor retarder. This component is typically referred to as a "vapor barrier". While not a true vapor barrier, it does reduce the transmission of water vapor from the soil to the air. The vapor retarder should be maintained so that it covers at least 85% of the entire surface of the soil.

20.4 VAPOR RETARDER

The vapor barrier was pulled back to cover all the possible surface area.

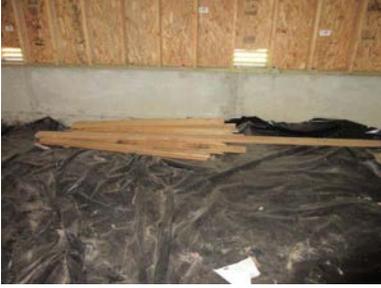
Scrap-wood and other cellulose debris was observed on the crawl floor. This wood debris creates conducive conditions for wood boring insects. The removal of all cellulose debris is recommended.

20.5 PEST CONTROL

The scrap-wood was picked up off the crawl floor.

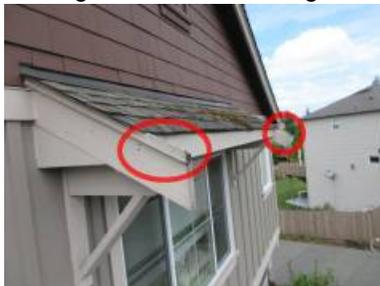
The ends of the barge boards are exposed to the weather and are vulnerable to rot damage. To prevent damage to the barge board ends, they should be covered with roofing material or flashing.

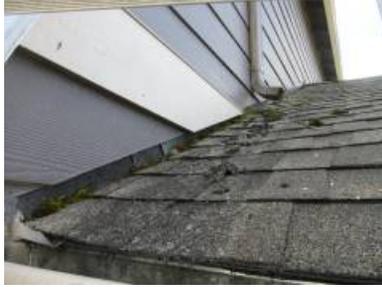
3.5 GUTTERS AND DOWNSPOUTS

Downspouts draining directly onto the asphalt shingle surface causes excessive wear of the roofing material. Downspout extensions to the lower gutters should be installed to prevent excessive wear and tear of the roofing.

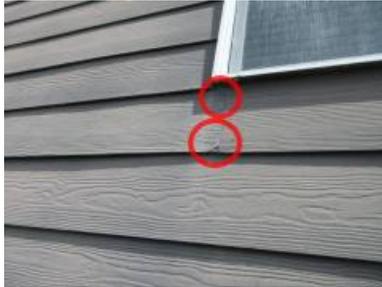
3.6 PAINT

The paint is weathered from age and exposure. Repainting the house will be required in the near future.

Localized areas of peeling paint were noted on trim boards. Paint protects the wood from cupping, checking, warping and rot. These areas should be scraped, primed and repainted.

Siding nails that have damaged the surface overlay need to be caulked. Caulking prevents water intrusion of the siding. Consideration should be given to caulking the siding as necessary. Exterior caulking is recommended.

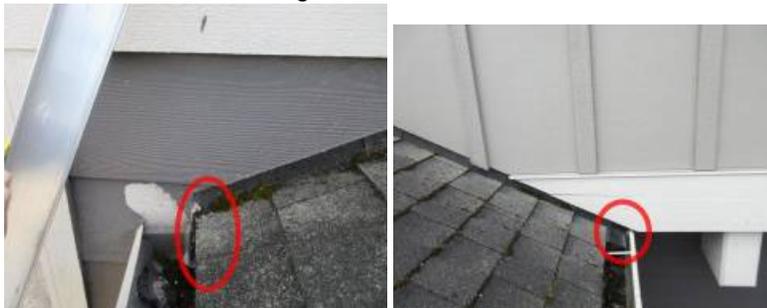
There are inadequate or no kick out flashings at the roof edge to wall intersections above the gutters. This will allow water to enter the wall behind the siding. The installation of kick-out flashings is recommended.

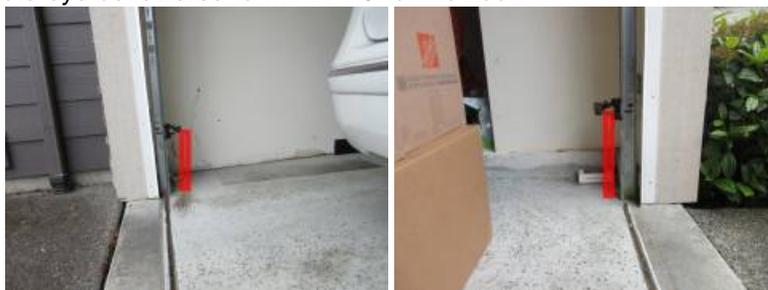
The Photo-eye beam was installed to high above the floor of the garage to adequately offer protection for small children and/or pets. We recommend that the photo-eye be lowered to within 4-6" of the floor.

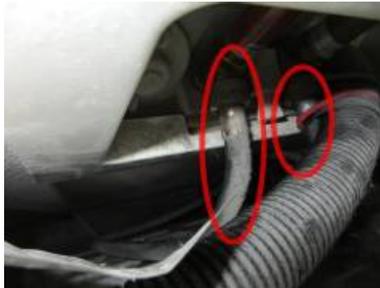
Upgrading the washer connections to high pressure (steel braided) lines is recommended.

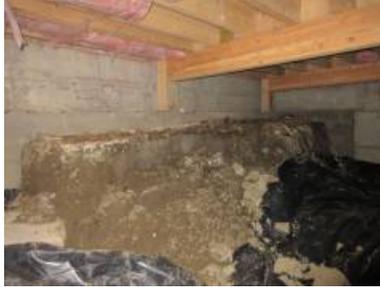
20.4 VAPOR RETARDER

Some of the soil under the house is not covered with a polyethylene plastic vapor retarder. This component is typically referred to as a "vapor barrier". While not a true vapor barrier, it does reduce the transmission of water vapor from the soil to the air. The vapor retarder should be maintained so that it covers at least 85% of the entire surface of the soil.

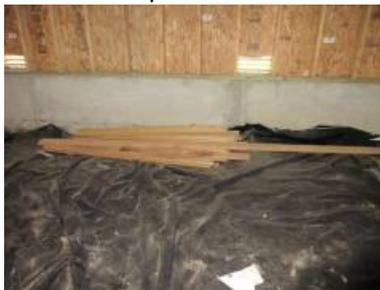
20.5 PEST CONTROL

Scrap-wood and other cellulose debris was observed on the crawl floor. This wood debris creates conducive conditions for wood boring insects. The removal of all cellulose debris is recommended.
