NOTICE TO BUYER: SELLER-PROCURED INSPECTION REPORT

July 28, 2021

Re: 13702 178th Ave. NE
Redmond, WA.

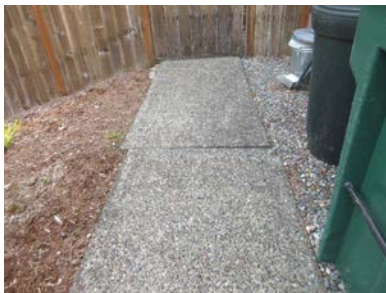
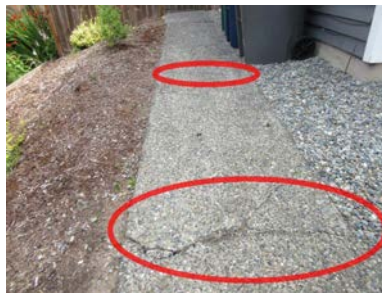
The walkway has cracked and settled differentially. This was probably caused by inadequate preparation of the soil prior to the placement of the concrete. This condition can be repaired by pressure grouting the sunken portion of the walkway or by removing and replacing it. Grinding down the raised edges of the concrete will also mitigate the hazard. The walkway remains functional despite this condition. However, the raised edges of the concrete can be a trip hazard for some people. Repairs should be made as necessary.

Cracks were observed in the concrete surface of the walkway. Minor cracks can be sealed to minimize moisture entry and further settlement of the concrete.

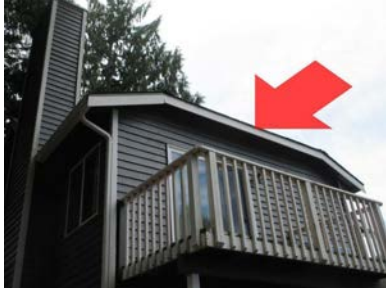
3.4 GUTTERS AND DOWNSPOUTS

The gutters are missing on the north side of the building. Missing gutters should be replaced to prevent water splash on the siding.

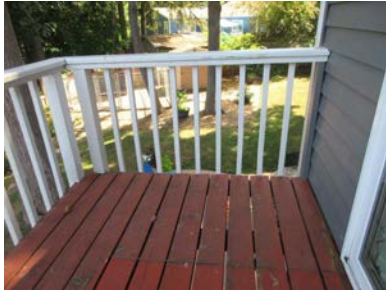
3.7 DECK RAILINGS

The spacing between the balusters is too wide. This is a hazard to small children. The balusters should be spaced close enough together so that a 4" sphere cannot pass through. Upgrading the deck railing is recommended if small children are present.

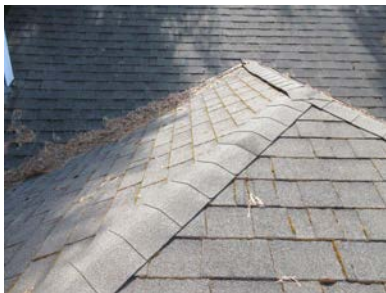
4.7 MAINTENANCE AND REPAIRS

The roof is in need of routine maintenance. The surface should be blown off or washed with a high volume low pressure garden hose to remove moss and organic debris. Performing this maintenance will improve the appearance and increase the life expectancy of the roof.

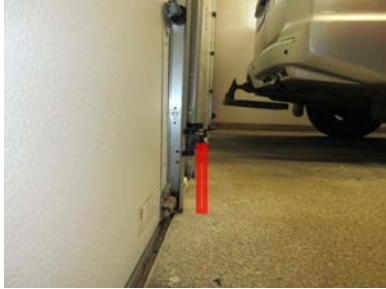
The Photo-eye beams were installed too high above the floor of the garage to adequately offer protection for small children and/or pets. We recommend that the photo-eyes be lowered to within 4-6" of the floor.

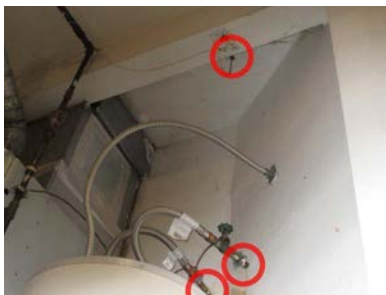
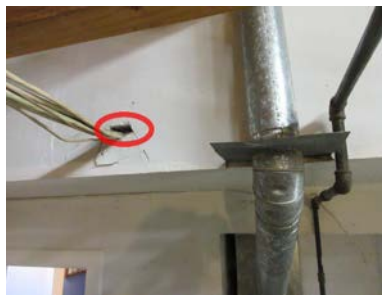
6.4 FIRE SEPARATION

There are voids in the fire resistive barrier between the living space and garage that will allow flames to penetrate. The gypsum barrier slows the spread of a fire from the garage to the structure and/or living space. Patching the voids with a fire retardant caulk is recommended.

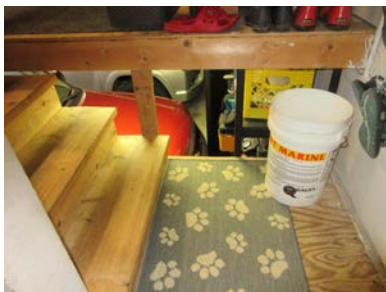
The stair landing spacing is too wide. This is a hazard for small children. The baluster spacing should be reduced as a safety upgrade. Current standards require that a 4" sphere not pass through the railing.

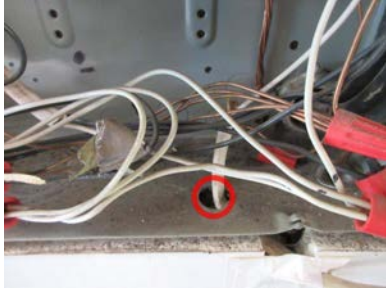
There are openings in the panel box where knock-outs have been removed. Missing knock-outs should be replaced with snap in metal plugs.

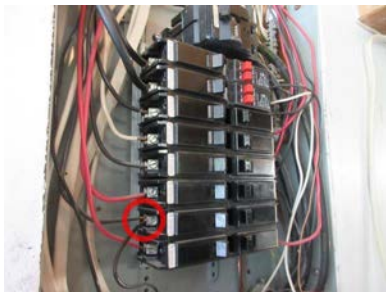
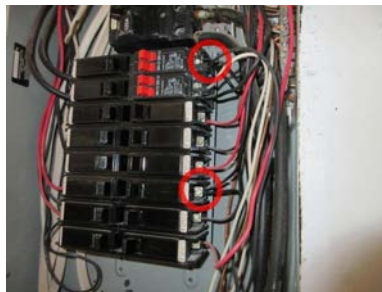
7.9 OVER CURRENT PROTECTION

Several of the circuits are double tapped. Double tapping means that two conductors share a single terminal. Double tapped terminals can loosen and overheat and therefore are not permitted unless the terminal is specifically listed for multiple wires. This defect is easily repaired by connecting the two wires to a "pig tail", securing them with a wire cap, and then inserting the pig tail conductor under the terminal.

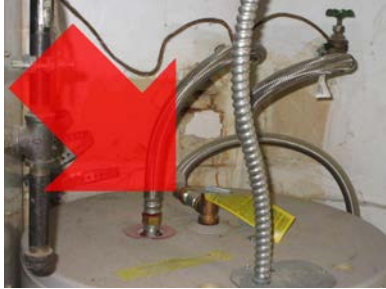
The pressure relief valve drain pipe has a reverse slope which traps water in the pipe. This can result in failure of the pressure relief valve. The drain pipe should be reconfigured so that it slopes 1/4" per foot to the drain outlet. If this is not possible or practical, a small (1/16") drain hole can be drilled in the bottom of the pipe at the lowest point.

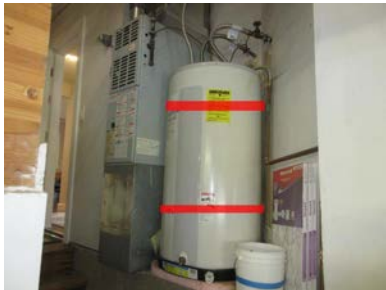
9.6 SEISMIC RESTRAINT

The water heater is not secured to the wall. A seismic restraint should be installed to secure the water heater and prevent it from falling over during an earthquake. This prevents the gas and water lines from rupturing.

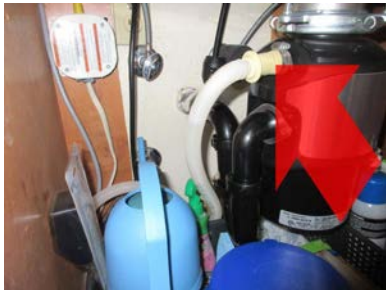
The dishwasher drain lacks an air gap. The dishwasher will function without one, but there is a risk of contamination of the inside of the dishwasher by waste water. The installation of an air gap is recommended.

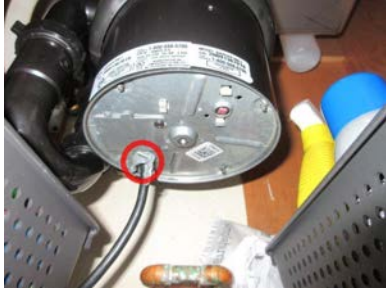
The cord is not clamped where it enters the disposal. This could damage the wires or cause a ground fault. The cord should be clamped in accordance with industry standards.

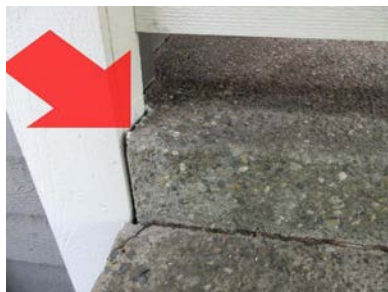
Untreated wood in direct contact with concrete was observed along the front porch. Untreated wood should be raised 1-2" above the concrete. Treating the wood with a preservative sometimes will prevent wood destroy organism damage.

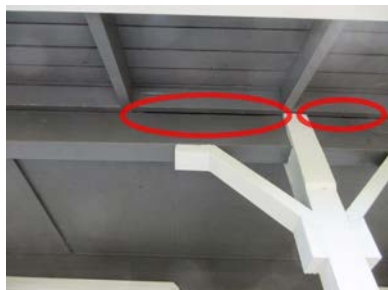
3.3 SOFFITS AND OVERHANGS

There are large gaps over 1/4" in size adjacent the soffit vent blocks. These gaps allow insects and rodents to enter the attic. Covering the gaps with screening, a strip of wood and/or caulking is recommended.

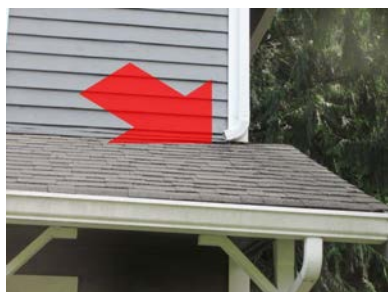
3.4 GUTTERS AND DOWNSPOUTS

Downspouts draining directly onto the asphalt shingle surface causes excessive wear of the roofing material. Downspout extensions to the lower gutters should be installed to prevent excessive wear and tear of the roofing.

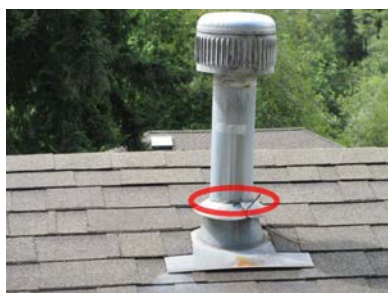
4.5 GAS APPLIANCE VENTS

The storm collar is not sealed. This is allowing leakage to occur. Sealing the storm collar is recommended.

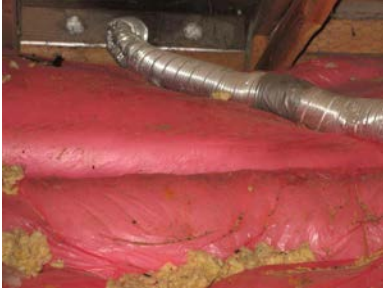
Flexible plastic duct is used to direct air from the vent fan to the exterior. This type of material is unreliable. Replacing the plastic duct with 4" smooth-wall sheet metal duct is recommended.

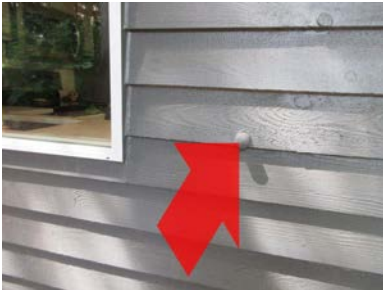
The cap protruding on the exterior wall opposite the dishwasher is not drilled. This air gap protects the dishwasher from contamination caused by a backflow of waste water when in use. Drilling a 1/4" hole in the end of the cap will restore its function when connected to the dishwasher waste line.

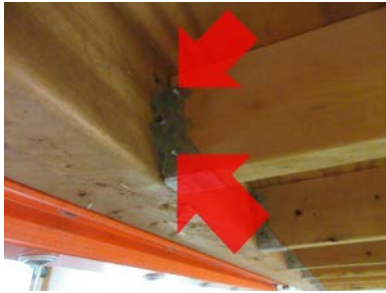
The garage storage loft support brackets are not secured with the specified fasteners recommended. The installation of 16d common nails or designed screws for the framing brackets is recommended.

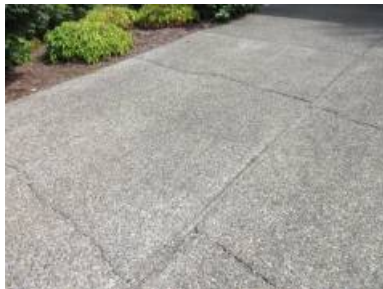
Cracks were observed in the concrete surface of the driveway. Minor cracks can be sealed to minimize moisture entry and further settlement of the concrete. Minor cracks are common and do not affect the serviceability of the concrete.

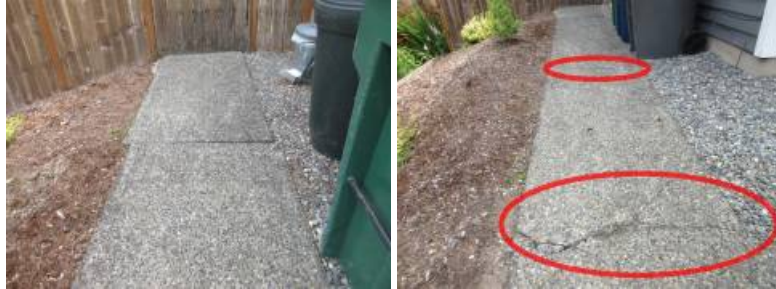
Cracks were observed in the concrete surface of the walkway. Minor cracks can be sealed to minimize moisture entry and further settlement of the concrete.

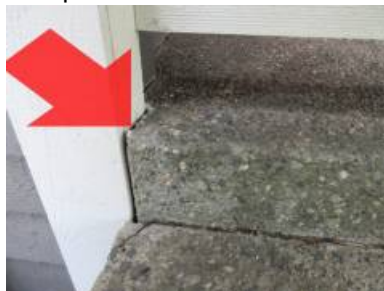
Untreated wood in direct contact with concrete was observed along the front porch. Untreated wood should be raised 1-2" above the concrete. Treating the wood with a preservative sometimes will prevent wood destroy organism damage.

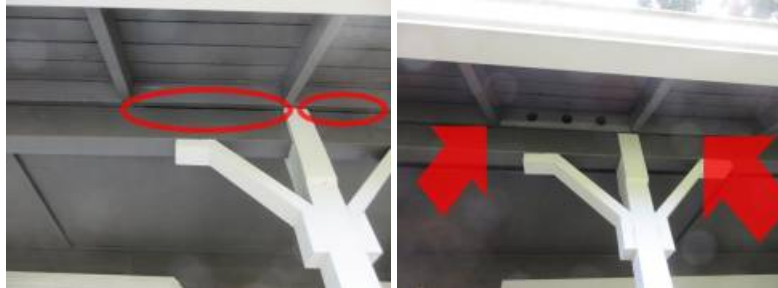
3.3 SOFFITS AND OVERHANGS

There are large gaps over 1/4" in size adjacent the soffit vent blocks. These gaps allow insects and rodents to enter the attic. Covering the gaps with screening, a strip of wood and/or caulking is recommended.

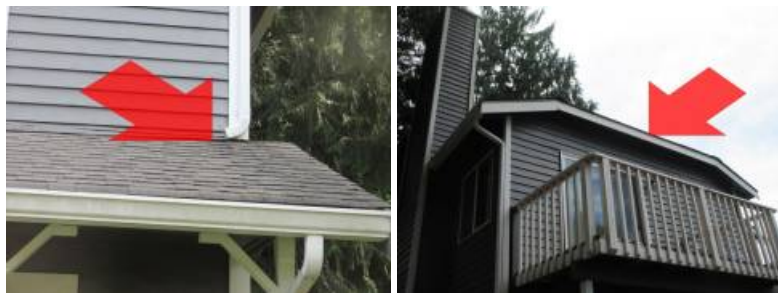
The gutters are missing on the north side of the building. Missing gutters should be replaced to prevent water splash on the siding.

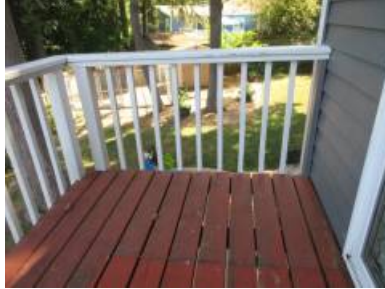
The spacing between the balusters is too wide. This is a hazard to small children. The balusters should be spaced close enough together so that a 4" sphere cannot pass through. Upgrading the deck railing is recommended if small children are present.

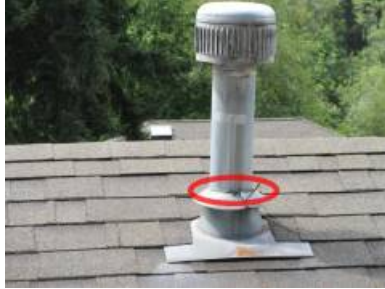
The storm collar is not sealed. This is allowing leakage to occur. Sealing the storm collar is recommended.

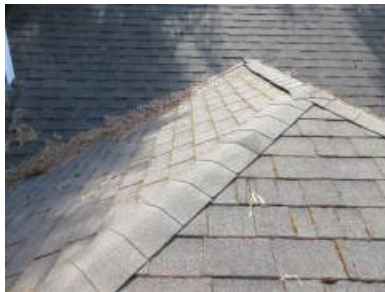
4.7 MAINTENANCE AND REPAIRS

The roof is in need of routine maintenance. The surface should be blown off or washed with a high volume low pressure garden hose to remove moss and organic debris. Performing this maintenance will improve the appearance and increase the life expectancy of the roof.

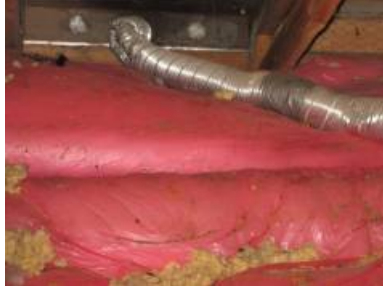
Flexible plastic duct is used to direct air from the vent fan to the exterior. This type of material is unreliable. Replacing the plastic duct with 4" smooth-wall sheet metal duct is recommended.

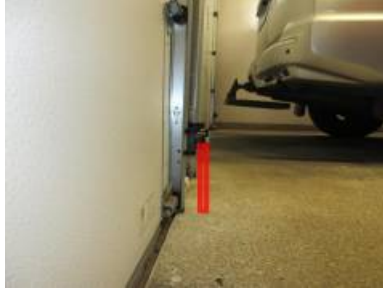
The Photo-eye beams were installed to high above the floor of the garage to adequately offer protection for small children and/or pets. We recommend that the photo-eyes be lowered to within 4-6" of the floor.

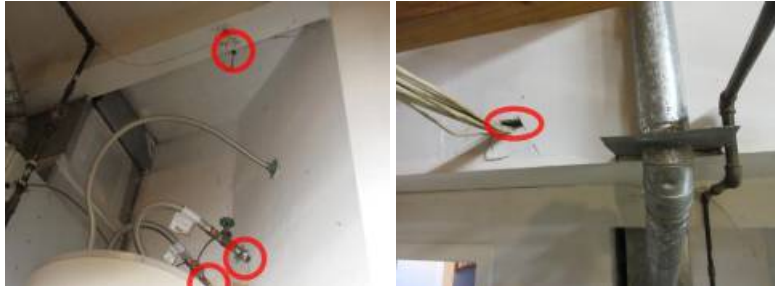
6.4 FIRE SEPARATION

There are voids in the fire resistive barrier between the living space and garage that will allow flames to penetrate. The gypsum barrier slows the spread of a fire from the garage to the structure and/or living space. Patching the voids with a fire retardant caulk is recommended.

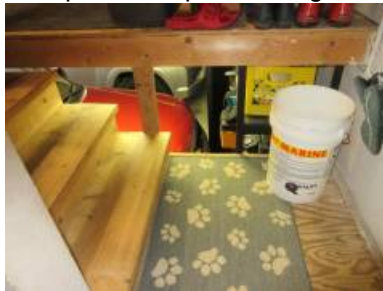
The stair landing spacing is too wide. This is a hazard for small children. The baluster spacing should be reduced as a safety upgrade. Current standards require that a 4" sphere not pass through the railing.

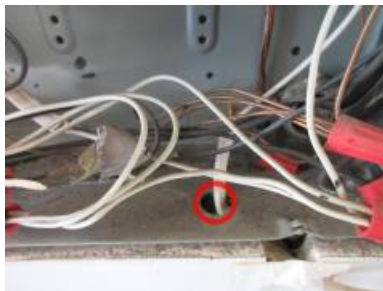
There are openings in the panel box where knock-outs have been removed. Missing knock-outs should be replaced with snap in metal plugs.

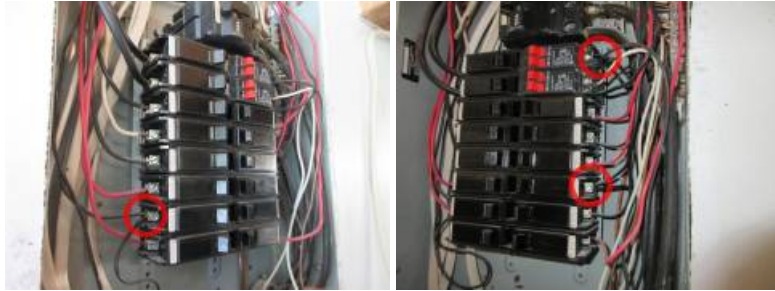
7.9 OVER CURRENT PROTECTION

Several of the circuits are double tapped. Double tapping means that two conductors share a single terminal. Double tapped terminals can loosen and overheat and therefore are not permitted unless the terminal is specifically listed for multiple wires. This defect is easily repaired by connecting the two wires to a "pig tail", securing them with a wire cap, and then inserting the pig tail conductor under the terminal.

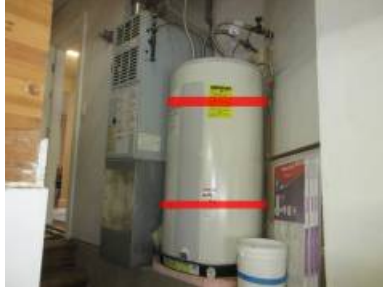
The water heater is not secured to the wall. A seismic restraint should be installed to secure the water heater and prevent it from falling over during an earthquake. This prevents the gas and water lines from rupturing.

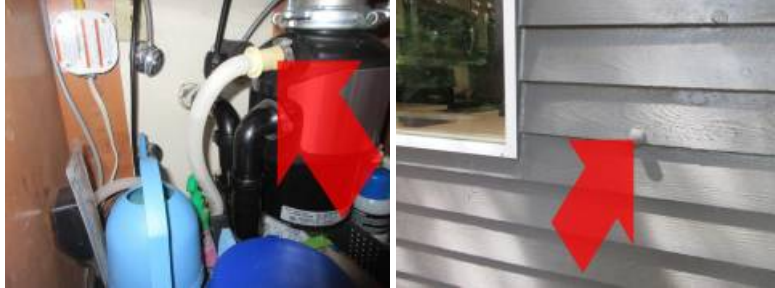
The cap protruding on the exterior wall opposite the dishwasher is not drilled. This air gap protects the dishwasher from contamination caused by a backflow of waste water when in use. Drilling a 1/4" hole in the end of the cap will restore its function when connected to the dishwasher waste line.

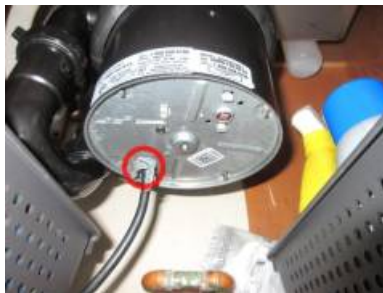
The cord is not clamped where it enters the disposal. This could damage the wires or cause a ground fault. The cord should be clamped in accordance with industry standards.

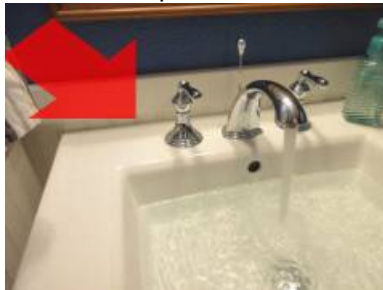
The backsplash is missing. The installation of a backsplash is recommended.

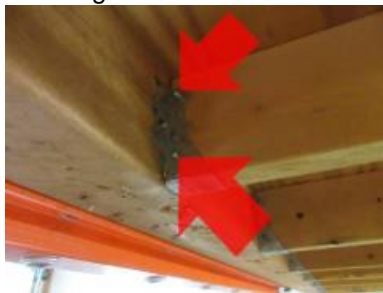
The garage storage loft support brackets are not secured with the specified fasteners recommended. The installation of 16d common nails or designed screws for the framing brackets is recommended.
