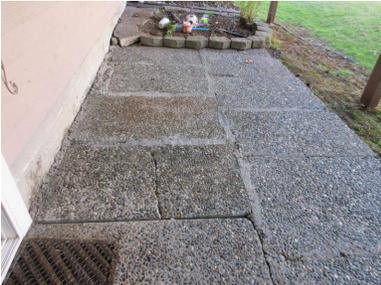
2.5 PATIO

The patio has settled differentially. This was probably caused by inadequate preparation of the soil prior to the placement of the concrete sections. This condition can be repaired by pressure grouting the sunken sections of the patio or by removing and replacing them. The patio remains functional despite this condition. However, the raised edges of the concrete can be a trip hazard for some people. Repairs should be made as necessary. Minor cracks can be sealed to minimize moisture entry and further settlement of the concrete sections.

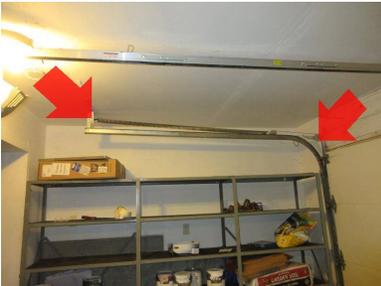
Safeties are cables run through the center of the garage door springs that prevent broken springs from becoming projectiles that can cause injury. There are no safeties installed. The installation of safeties is recommended.

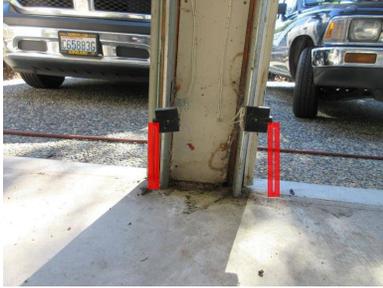
The Photo-eye beam was installed too high above the floor of the garage to adequately offer protection for small children and/or pets. We recommend that the photo-eye be lowered to within 4-6" of the floor.

6.3 GARAGE DOOR OPENER (Sensors) – The sensors are moved to 6” from the floor.

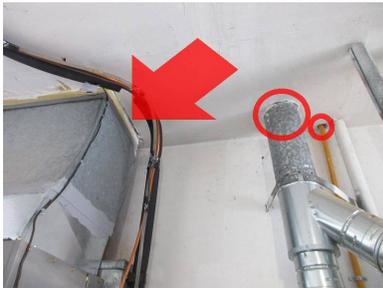
There are voids in the fire resistive barrier between the living space and garage that will allow flames to penetrate. The gypsum barrier slows the spread of a fire from the garage to the structure and/or living space. Patching the voids with a fire retardant caulk is recommended.

6.4 FIRE SEPARATION - Patched the voids with a fire retardant caulk.

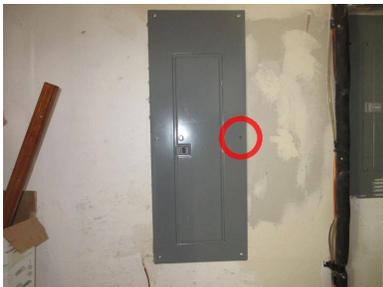
Screws that secure the panel cover to the panel box are missing. This is a potential hazard. Missing screws should be replaced with the original style blunt end screws.

7.8 SERVICE PANEL – Replaced the missing screws

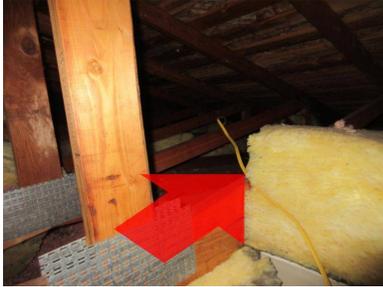
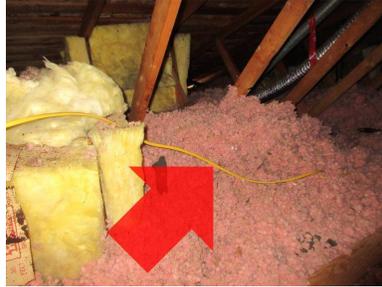
Loose electrical cables were observed in the attic. Loose cables are vulnerable to damage. All loose cables should be secured at 4' intervals using approved cable staples.

7.10 WIRING – Secured all loose cables at 4' intervals using approved cable staples.

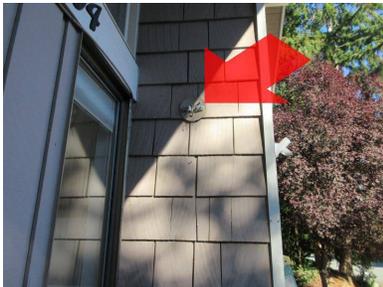
The exterior luminaire at the front porch is missing. A luminaire should be installed to provide proper lighting in this area.

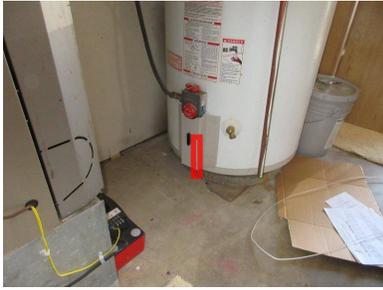
The water heater is not elevated above the garage floor in accordance with industry standards. This is a hazard. Elevating the water heater so that the burner is at least 18" above the garage floor prevents ignition of gasoline fumes.

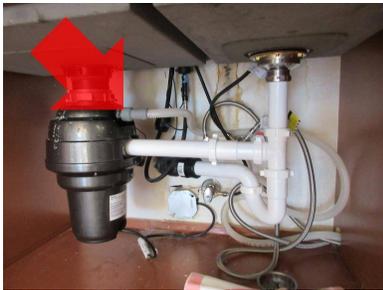
The dishwasher drain lacks an air gap. The dishwasher will function without one, but there is a risk of contamination of the inside of the dishwasher by waste water. The installation of an air gap or connection to the existing Johnson Tee that is installed in the kitchen wall. This air gap or Johnson Tee protects the dishwasher from contamination caused by a backflow of waste water.

11.8 AIR GAP – Replaced

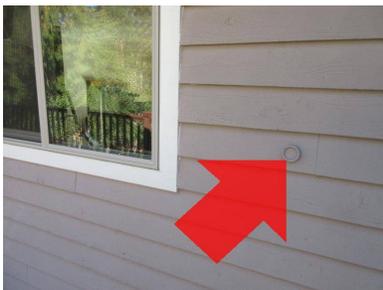
The cap protruding on the exterior wall opposite the dishwasher is not drilled. This air gap protects the dishwasher from contamination caused by a backflow of waste water when in use. Drilling a 1/4" hole in the end of the cap will restore its function when connected to the dishwasher waste line.

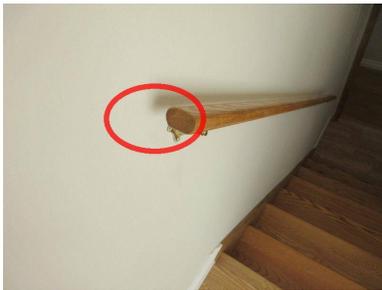
The railing ends in the stairwell does not return to the wall. This is a safety hazard. The installation of a continuous handrail should be considered as a safety upgrade.

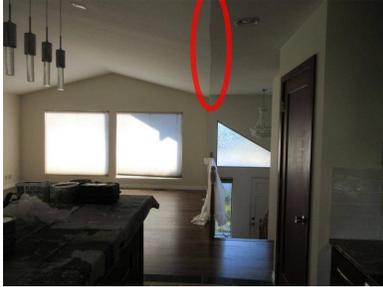
15.5 WALLS AND CEILINGS

There are notable signs of sagging at the hallway and vaulted ceiling juncture. Cracks in drywall that have been repaired and reoccur several months after the repairs have been completed are typically due to flexing of the wood framing. Installing post supports, modifying ceiling framing or applying strong ties to the framing connections would help minimize further movement.

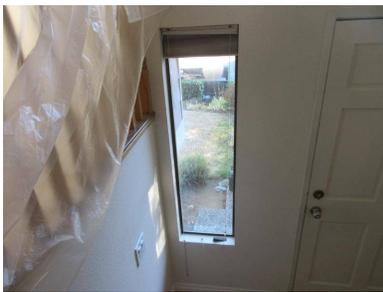
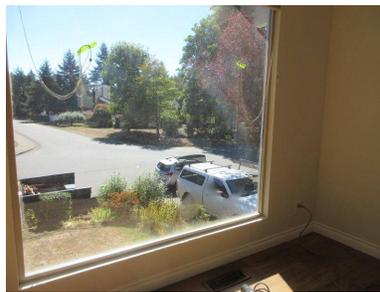
There is condensation or mineral deposits between the panes of glass in several of the insulated glass windows. This indicates failed seals. The glass assemblies should be replaced, which is the only method for correcting this deficiency.

15.8 WINDOWS – The living windows will be replaced by November 10th, 2021 (the delay is due to availability of glass from the supplier)

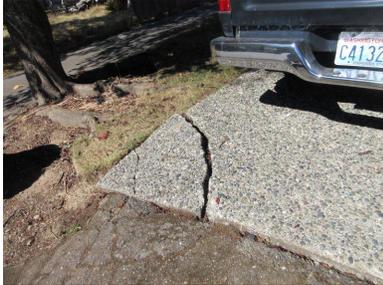
The driveway has cracked and settled differentially. This was probably caused by inadequate preparation of the soil prior to the placement of the concrete. This condition can be repaired by pressure grouting the sunken portion of the driveway or by removing and replacing it. The driveway remains functional despite this condition.

Cracks were observed in the concrete surface of the driveway. Minor cracks can be sealed to minimize moisture entry and further settlement of the concrete. Minor cracks are common and do not affect the serviceability of the concrete.

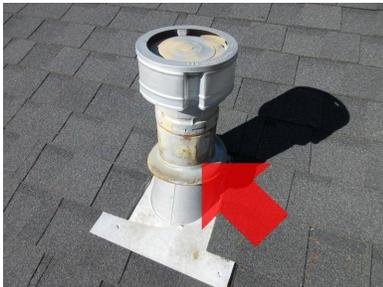
The storm collar is not sealed. This is allowing leakage to occur. Sealing the storm collar is recommended.

4.5 GAS APPLIANCE VENTS – Repaired

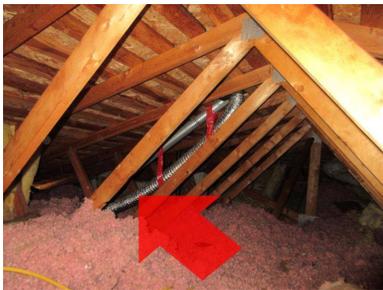
Flexible plastic duct is used to direct air from the vent fan to the exterior. This type of material is unreliable. Replacing the plastic duct with 4" smooth-wall sheet metal duct is recommended.

5.3 MECHANICAL VENTILATION SYSTEMS - Replaced the plastic duct with 4" aluminum duct.

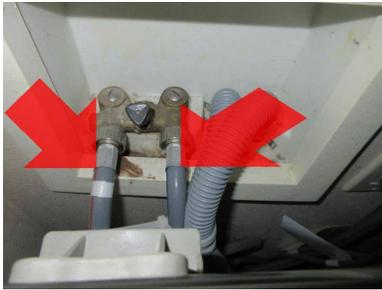
High pressure (steel braided) washer line connections is recommended.

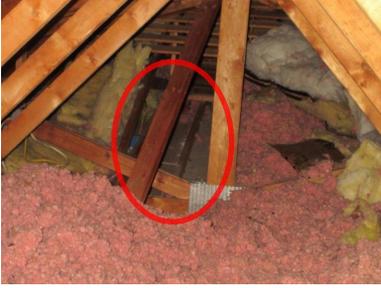
There is a large thermal bypass in the attic over the kitchen/dining and living areas. A thermal bypass is an opening between an insulated and uninsulated part of the house through which heated air can escape. As air is heated, it rises and pulls cool air in to the space to replace it. This condition will result in significant heat loss. Sealing up all thermal bypass routes is recommended.

18.1 ATTIC INSULATION – Repaired

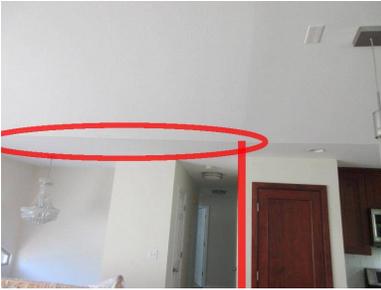
19.8 CEILING

There are notable signs of sagging at the hallway and vaulted ceiling juncture. Installing post supports, modifying ceiling framing or applying strong ties to the framing connections would help minimize further movement.

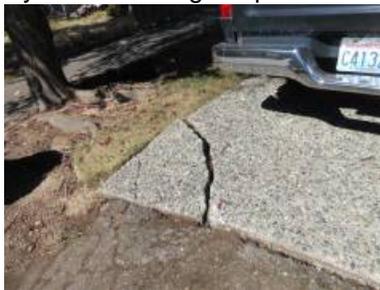
One or more of the wooden dividers separating the concrete driveway sections were infested by wood destroying organisms and have deteriorated to a point where they are becoming a trip hazard. Replacement with mortar is recommended.

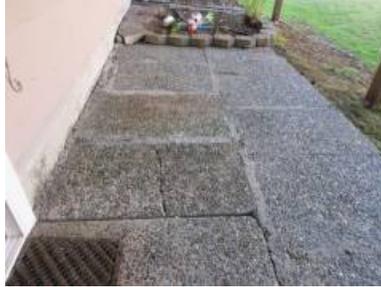
2.5 PATIO

The patio has settled differentially. This was probably caused by inadequate preparation of the soil prior to the placement of the concrete sections. This condition can be repaired by pressure grouting the sunken sections of the patio or by removing and replacing them. The patio remains functional despite this condition. However, the raised edges of the concrete can be a trip hazard for some people. Repairs should be made as necessary. Minor cracks can be sealed to minimize moisture entry and further settlement of the concrete sections.

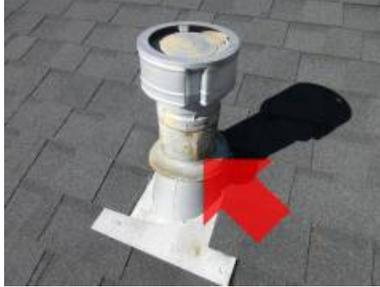
The storm collar is not sealed. This is allowing leakage to occur. Sealing the storm collar is recommended.

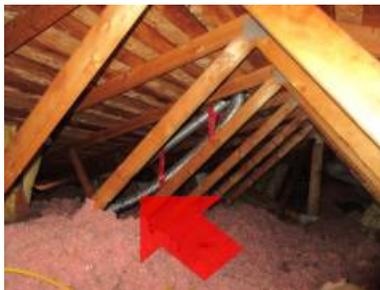
Flexible plastic duct is used to direct air from the vent fan to the exterior. This type of material is unreliable. Replacing the plastic duct with 4" smooth-wall sheet metal duct is recommended.

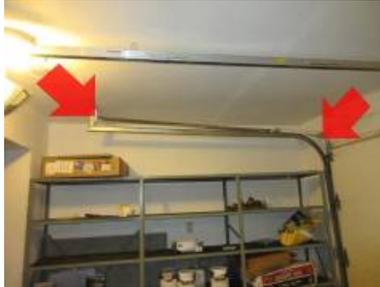
Safeties are cables run through the center of the garage door springs that prevent broken springs from becoming projectiles that can cause injury. There are no safeties installed. The installation of safeties is recommended.

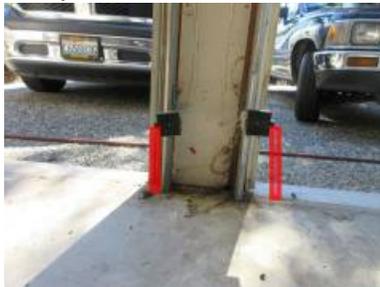
6.3 GARAGE DOOR OPENER

The Photo-eye beam was installed too high above the floor of the garage to adequately offer protection for small children and/or pets. We recommend that the photo-eye be lowered to within 4-6" of the floor.

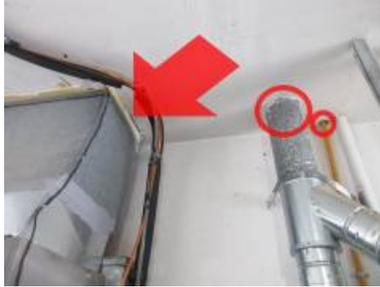
6.4 FIRE SEPARATION

There are voids in the fire resistive barrier between the living space and garage that will allow flames to penetrate. The gypsum barrier slows the spread of a fire from the garage to the structure and/or living space. Patching the voids with a fire retardant caulk is recommended.

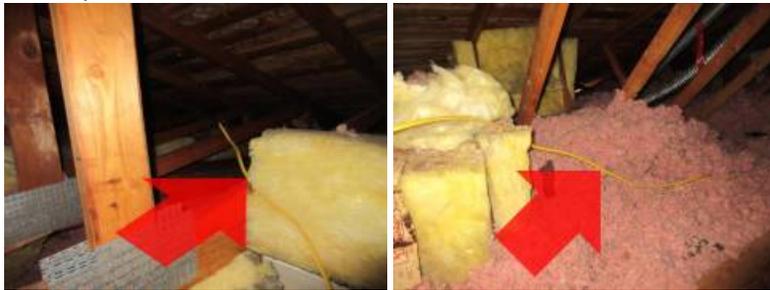
Loose electrical cables were observed in the attic. Loose cables are vulnerable to damage. All loose cables should be secured at 4' intervals using approved cable staples.

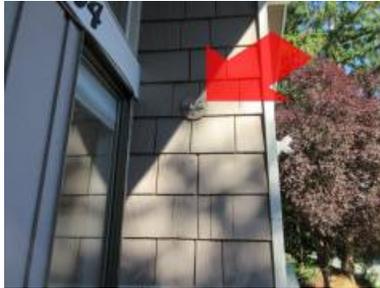
The exterior luminaire at the front porch is missing. A luminaire should be installed to provide proper lighting in this area.

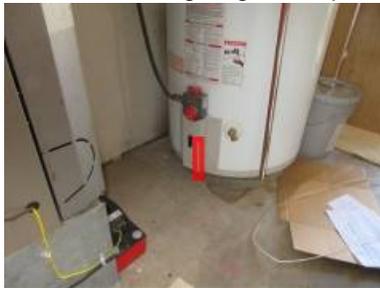
The water heater is not elevated above the garage floor in accordance with industry standards. This is a hazard. Elevating the water heater so that the burner is at least 18" above the garage floor prevents ignition of gasoline fumes.

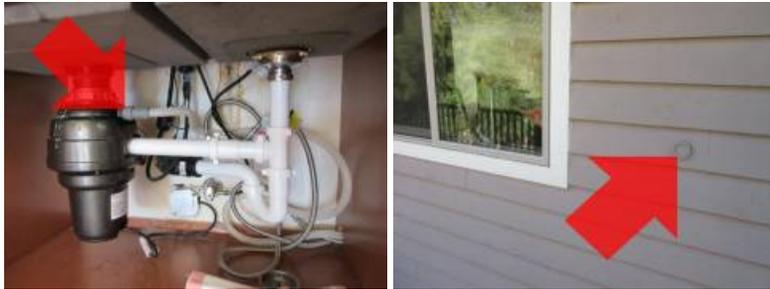
The cap protruding on the exterior wall opposite the dishwasher is not drilled. This air gap protects the dishwasher from contamination caused by a backflow of waste water when in use. Drilling a 1/4" hole in the end of the cap will restore its function when connected to the dishwasher waste line.

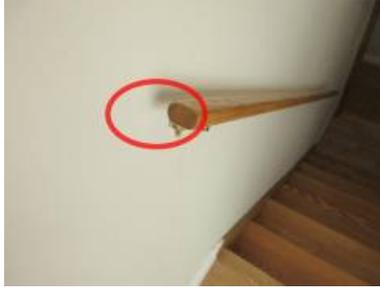
The railing ends in the stairwell does not return to the wall. This is a safety hazard. The installation of a continuous handrail should be considered as a safety upgrade.

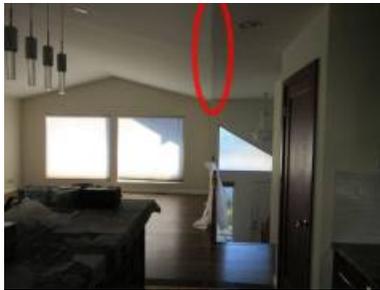
There are minor cracks in the walls and/or ceilings. This is a common condition with this type of construction and does not indicate a structural deficiency. Minor cracks can be repaired or painted over during routine maintenance. Minor cracks in drywall that reoccur several months after the repairs have been completed is due to seasonal movement of the structure caused by changes in humidity.

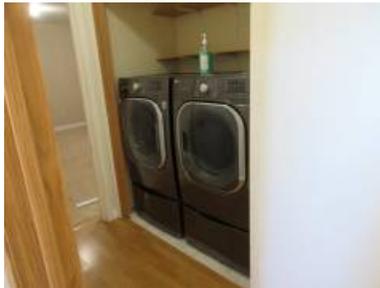
Closet doors are missing in the hallway.

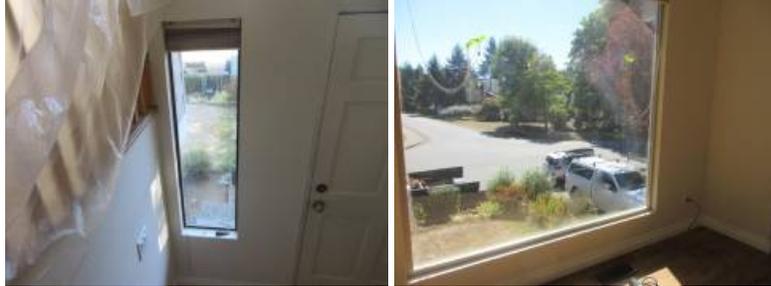
There is condensation or mineral deposits between the panes of glass in several of the insulated glass windows. This indicates failed seals. The glass assemblies should be replaced, which is the only method for correcting this deficiency.

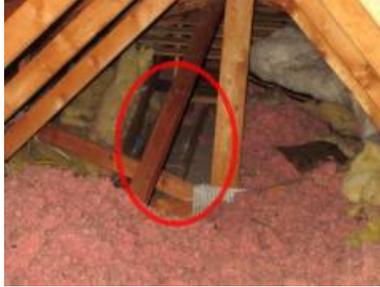
There is a large thermal bypass in the attic over the kitchen/dining and living areas. A thermal bypass is an opening between an insulated and uninsulated part of the house through which heated air can escape. As air is heated, it rises and pulls cool air in to the space to replace it. This condition will result in significant heat loss. Sealing up all thermal bypass routes is recommended.

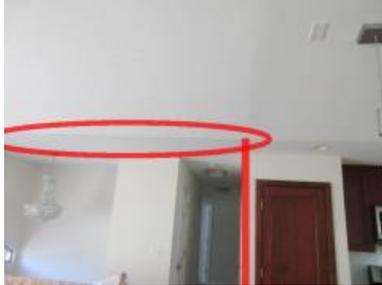
There are notable signs of sagging at the hallway and vaulted ceiling juncture. Installing post supports, modifying ceiling framing or applying strong ties to the framing connections would help minimize further movement.
