NOTICE TO BUYER: SELLER-PROCURED INSPECTION REPORT

**Ms. Frances Dunkin
17421 NE 140th Pl.
Redmond, WA.**

**Re: 17421 NE 140th Pl.
Redmond, WA.**

At your request, a visual inspection of the above referenced property was conducted on 09/21/2021. We have inspected the major structural components, plumbing, heating and electrical systems for signs of significant non-performance, excessive or unusual wear and general state of repair.

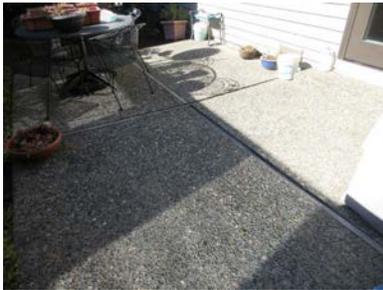
2.5 PATIO

The wooden dividers separating the concrete patio sections have deteriorated to a point where the gaps are a trip hazard. Replacement with mortar is recommended.

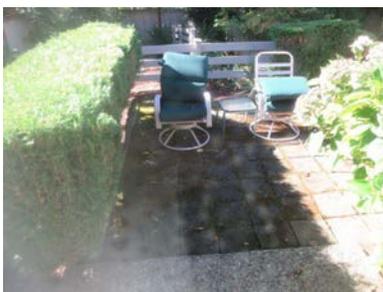
The walking surface was not even and trip hazards were present. We recommend all walking surfaces be maintained free of trip hazards.

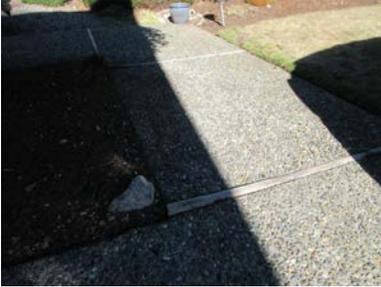
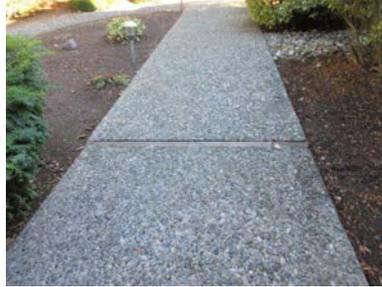
2.6 WALKWAY

One or more of the wooden dividers separating the concrete walkway sections were infested by wood destroying organisms and have deteriorated to a point where they are becoming a trip hazard. Replacement with mortar is recommended.

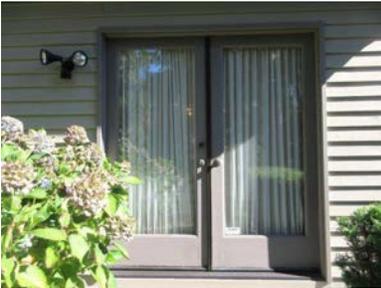
3.7 EXTERIOR DOORS

The rear patio doors are stuck and are inoperative. Repairs should be made as necessary.

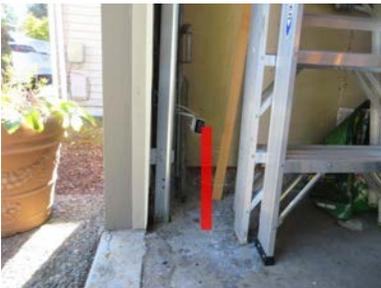
One of the Photo-eye beams were installed to high above the floor of the garage to adequately offer protection for small children and/or pets. We recommend that the photo-eye be lowered to within 4-6" of the floor.

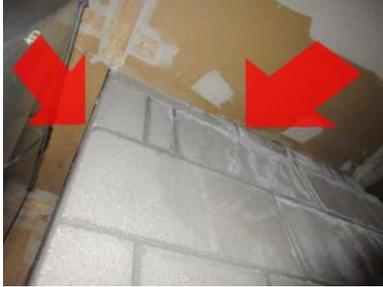
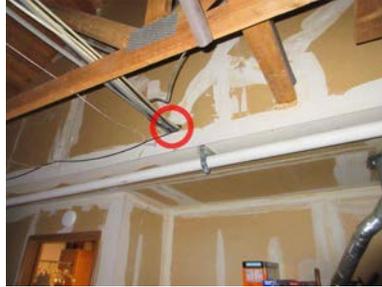
6.4 FIRE SEPARATION

There are voids in the fire resistive barrier between the living space and garage that will allow flames to penetrate. The gypsum barrier slows the spread of a fire from the garage to the structure and/or living space. Patching the voids with a fire retardant caulk is recommended.

- 6.4 Fire Separation - spray fire-resistant foam into gaps
- 19.5 Pest Control - Traps set and monitored and prior to closing intrusion points sealed off

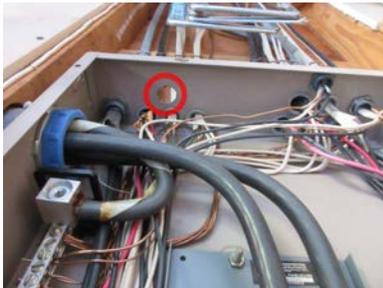
There are openings in the panel box where knock-outs have been removed. Missing knock-outs should be replaced with snap in metal plugs.

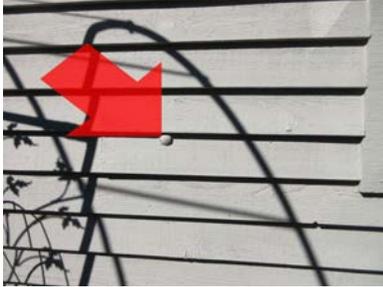
The cap protruding on the exterior wall opposite the dishwasher is not drilled. This air gap protects the dishwasher from contamination caused by a backflow of waste water when in use. Drilling a 1/4" hole in the end of the cap will restore its function when connected to the dishwasher waste line.

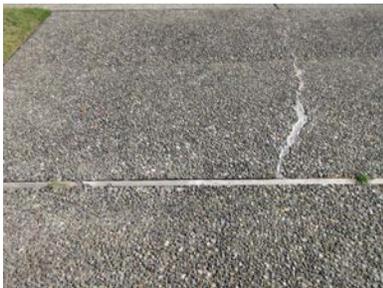
One or more of the wooden dividers separating the concrete driveway sections were infested by wood destroying organisms and have deteriorated to a point where they are becoming a trip hazard. Replacement with mortar is recommended.

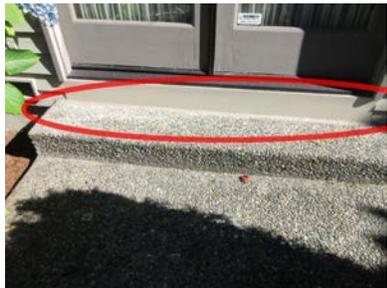
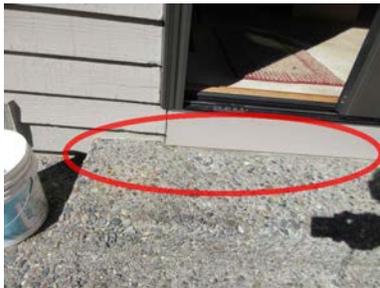
3.2 PEST CONTROL

Untreated wood in direct contact with concrete was observed along the patio stoop. Untreated wood should

be raised 1-2" above the concrete. Treating the wood with a preservative sometimes will prevent wood destroy organism damage.

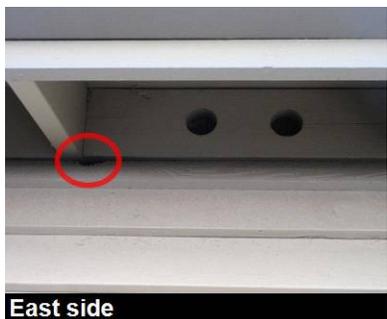
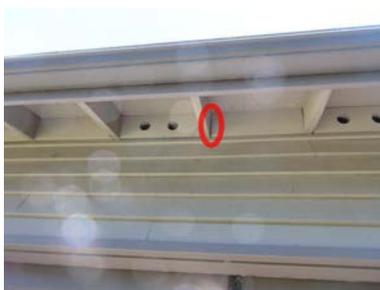
3.3 SOFFITS AND OVERHANGS

There are large gaps over 1/4" in size adjacent the soffit vent blocks. These gaps allow insects and rodents to enter the attic. Covering the gaps with screening, a strip of wood and/or caulking is recommended.

East side

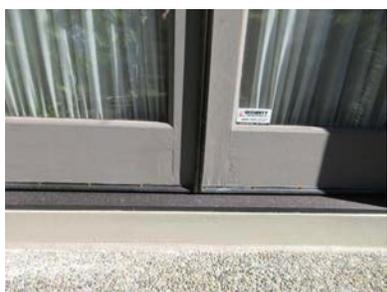
3.7 EXTERIOR DOORS

Wood doors are undesirable for use at any location that has chronic exposure to rainfall or water splash. Consideration should be given to upgrading the exposed wood doors to aluminum or vinyl clad doors.

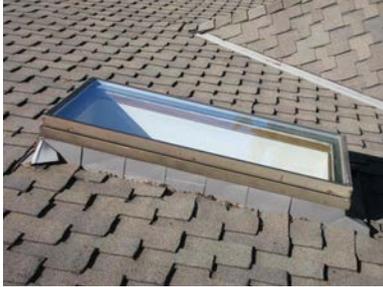
4.3 SKYLIGHTS

The north skylight is not secured to the roof. Skylights can get blown off roofs during high winds if they are not secured. Fastening the skylight to the curb with four plated or stainless screws is recommended.

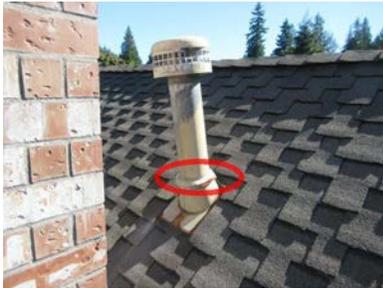
4.5 GAS APPLIANCE VENTS

The storm collar is not sealed. This is allowing leakage to occur. Sealing the storm collar is recommended.

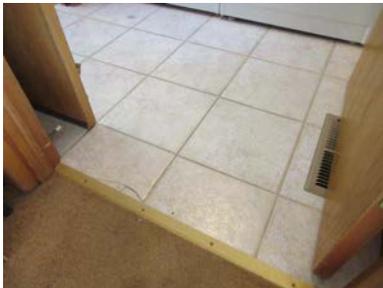
There are cracks in one of the ceramic tiles. This is usually caused by deflection at the floor transition. Shoring up the transition would help to reduce further cracking.

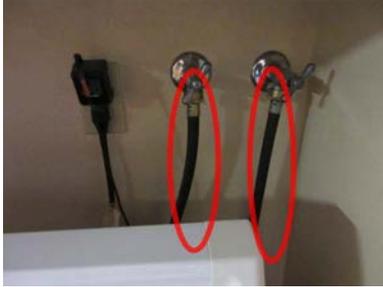
12.2 APPLIANCES

High pressure (steel braided) washer line connections is recommended.

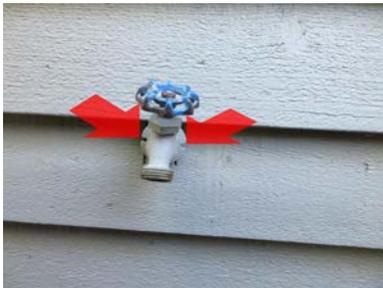
13.9 HOSE BIBBS AND EXTERIOR SUPPLY PIPES

The hose bibb on the front of the house is loose. This could result in damage to the water pipe and leakage. The bibb should be securely fastened to the wall.

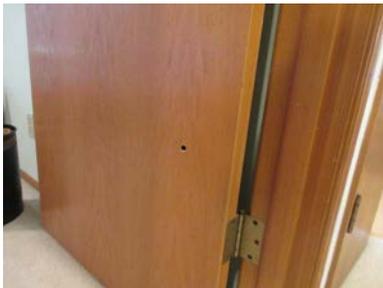
14.3 DOORS

There is a hole in one of the bedroom doors. Repair or replacement of the door is recommended for better appearance.

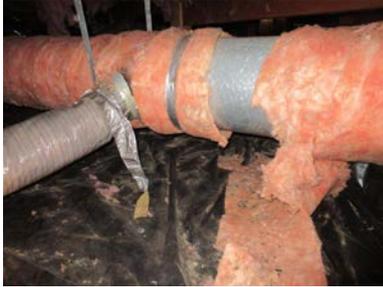
Some of the duct insulation is missing or has fallen off the ducts. This increases the amount of heat loss. The installation of new duct insulation is recommended in areas where insulation is damaged or missing.

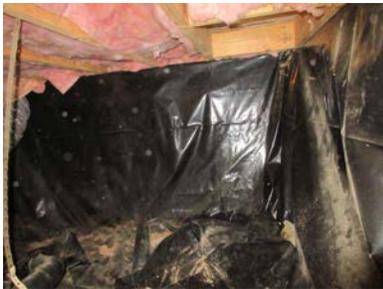
19.4 VAPOR RETARDER

The foundation walls are covered with the plastic vapor retarder. This allows the transmission of water vapor from the soil up and into the exterior wall framing. The plastic vapor retarder should be removed from the foundation.

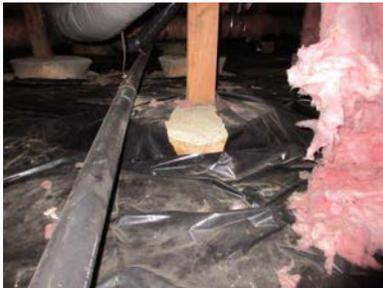
The support post concrete piers are covered with the plastic vapor retarder. This allows the transmission of water vapor from the soil up and into the floor framing. The plastic vapor retarder should be removed from the piers.

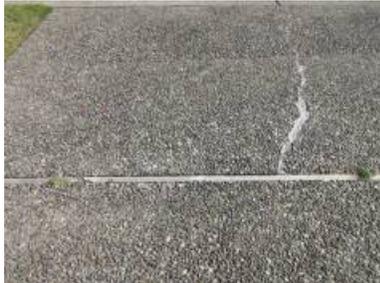
One or more of the wooden dividers separating the concrete driveway sections were infested by wood destroying organisms and have deteriorated to a point where they are becoming a trip hazard. Replacement with mortar is recommended.

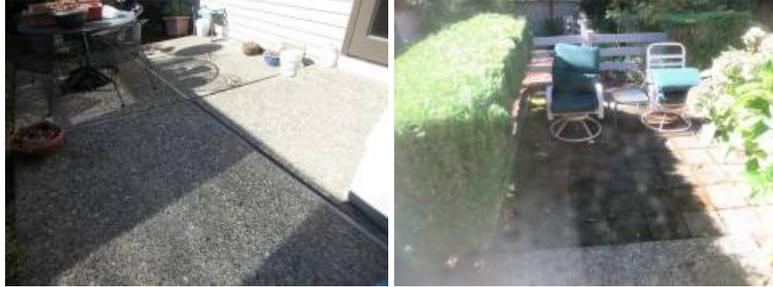
2.5 PATIO

The wooden dividers separating the concrete patio sections have deteriorated to a point where the gaps are a trip hazard. Replacement with mortar is recommended.

The walking surface was not even and trip hazards were present. We recommend all walking surfaces be maintained free of trip hazards.

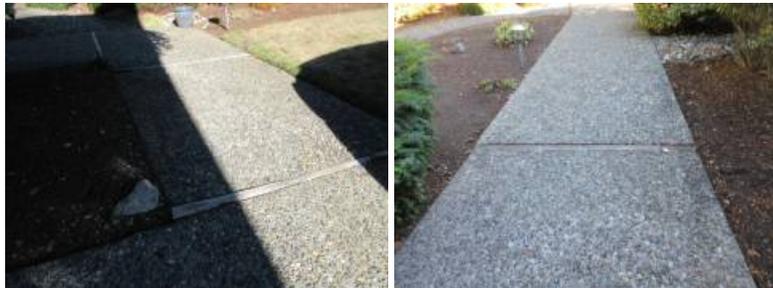
2.6 WALKWAY

One or more of the wooden dividers separating the concrete walkway sections were infested by wood destroying organisms and have deteriorated to a point where they are becoming a trip hazard. Replacement with mortar is recommended.

Many legal and public works departments have defined a trip hazard as an irregularity in a walking surface exceeding one inch (1") in height. All walking surfaces should maintain, free of a vertical surface change of 3/4" or more, in the interest of public and personal safety.

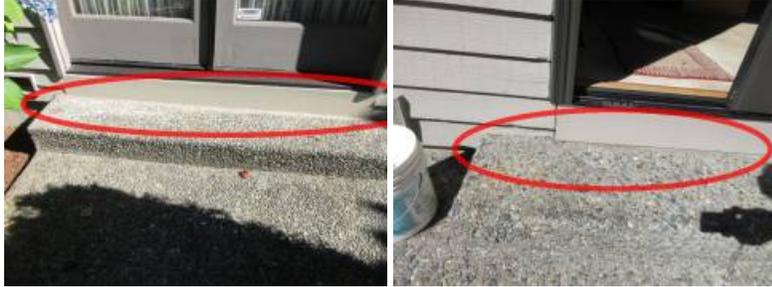
Untreated wood in direct contact with concrete was observed along the patio stoop. Untreated wood should be raised 1-2" above the concrete. Treating the wood with a preservative sometimes will prevent wood destroy organism damage.

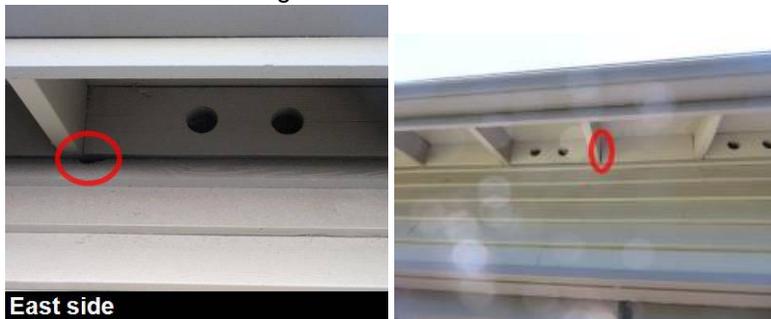
3.3 SOFFITS AND OVERHANGS

There are large gaps over 1/4" in size adjacent the soffit vent blocks. These gaps allow insects and rodents to enter the attic. Covering the gaps with screening, a strip of wood and/or caulking is recommended.

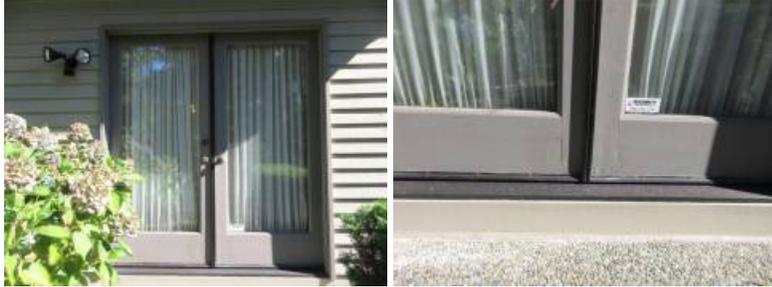
Wood doors are undesirable for use at any location that has chronic exposure to rainfall or water splash. Consideration should be given to upgrading the exposed wood doors to aluminum or vinyl clad doors.

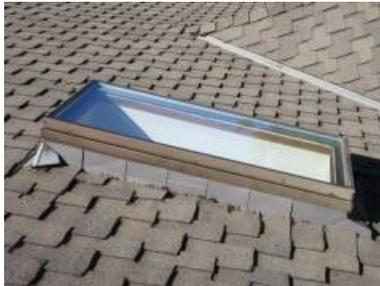
The north skylight is not secured to the roof. Skylights can get blown off roofs during high winds if they are not secured. Fastening the skylight to the curb with four plated or stainless screws is recommended.

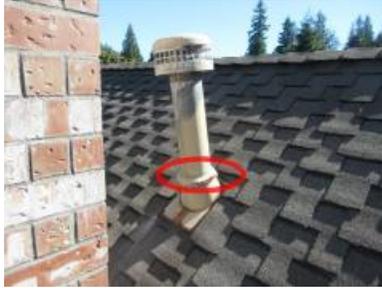
The storm collar is not sealed. This is allowing leakage to occur. Sealing the storm collar is recommended.

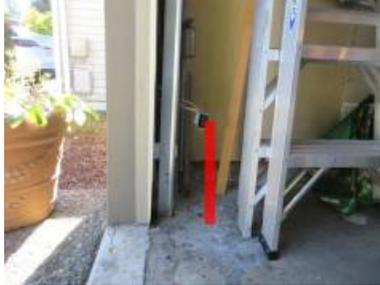
One of the Photo-eye beams were installed to high above the floor of the garage to adequately offer protection for small children and/or pets. We recommend that the photo-eye be lowered to within 4-6" of the floor.

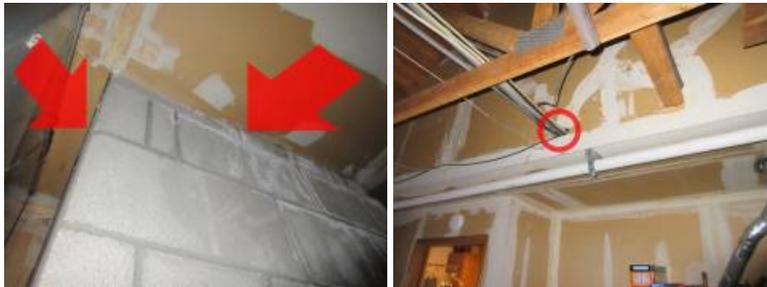
6.4 FIRE SEPARATION

There are voids in the fire resistive barrier between the living space and garage that will allow flames to penetrate. The gypsum barrier slows the spread of a fire from the garage to the structure and/or living space. Patching the voids with a fire retardant caulk is recommended.

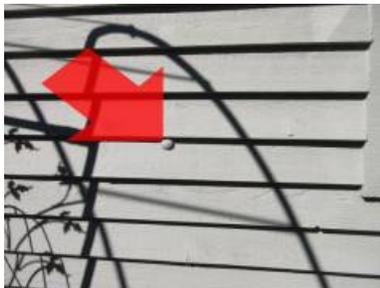
The cap protruding on the exterior wall opposite the dishwasher is not drilled. This air gap protects the dishwasher from contamination caused by a backflow of waste water when in use. Drilling a 1/4" hole in the end of the cap will restore its function when connected to the dishwasher waste line.

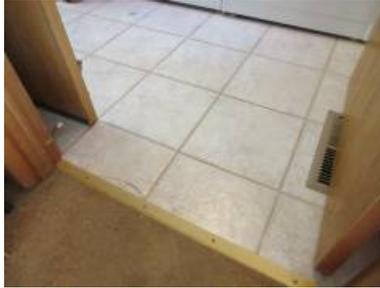
There are cracks in one of the ceramic tiles. This is usually caused by deflection at the floor transition. Shoring up the transition would help to reduce further cracking.

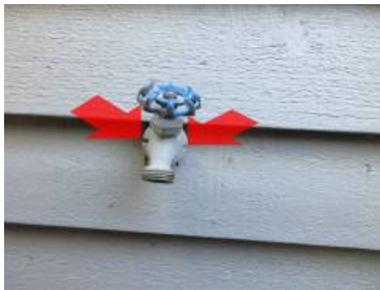
The hose bibb on the front of the house is loose. This could result in damage to the water pipe and leakage. The bibb should be securely fastened to the wall.

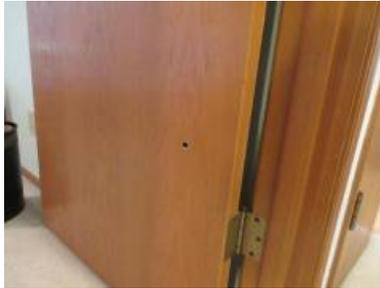
There is a hole in one of the bedroom doors. Repair or replacement of the door is recommended for better appearance.

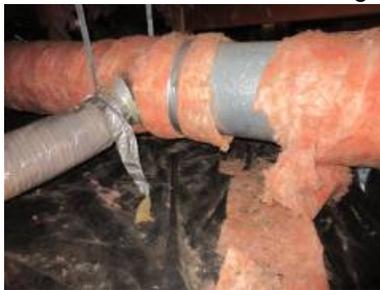
Some of the duct insulation is missing or has fallen off the ducts. This increases the amount of heat loss. The installation of new duct insulation is recommended in areas where insulation is damaged or missing.

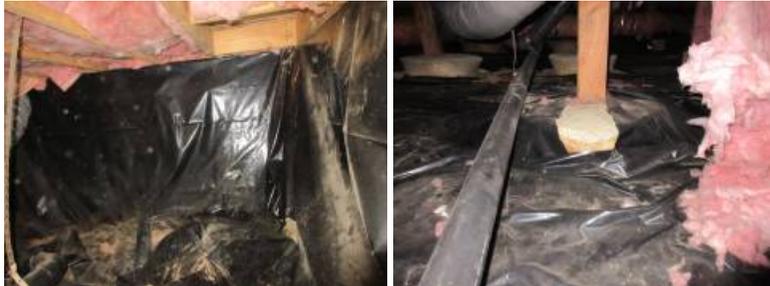
The support post concrete piers are covered with the plastic vapor retarder. This allows the transmission of water vapor from the soil up and into the floor framing. The plastic vapor retarder should be removed from the piers.
