TIME OF SALE OSS INSPECTION REPORT: TOS

Application No: 108633

13500 171ST AVE NE
KING COUNTY, WA

Inspection Date: 02/24/2022

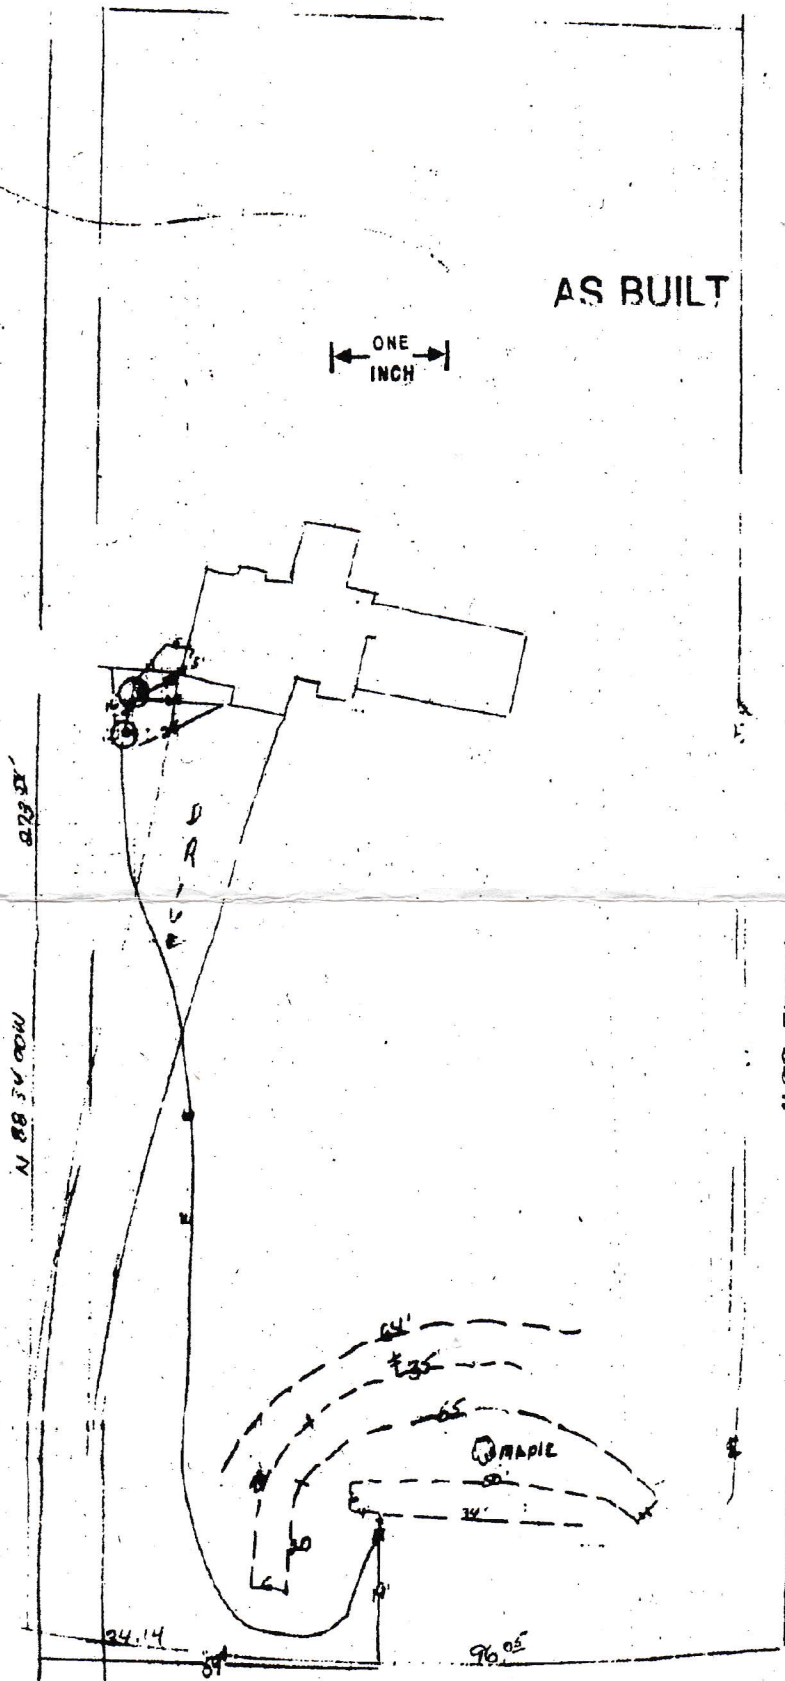
AS BUILT

"AS BUILT 12-14-85"
 1000 GAL SEPTIC TANK
 300 FT DRAINFIELD
 600 GAL PUMP TANK
 W/OSP33M HYDRA-MATIC
 SET TO PUMP 135 GPM
 RECYCLE ALUMINUM BAN
 IN TANK PERMIT #33209
