NOTICE TO BUYER: SELLER-PROCURED INSPECTION REPORT

February 10, 2022

Re: 16943 NE 118th Way
Redmond, WA.

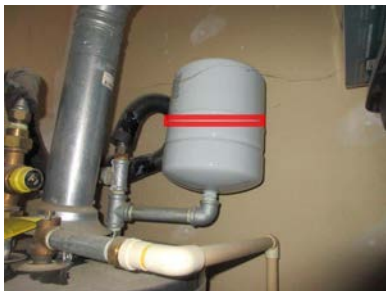
10.6 EXPANSION TANK

The expansion tank is not adequately secured to the wall. As code requirements start to call for engineered expansion tank supports we recommend the installation of seismic restraints to secure the expansion tank instead of allowing it to simply depend on piping connections that could result in damage to the water pipe and leakage during an earthquake.

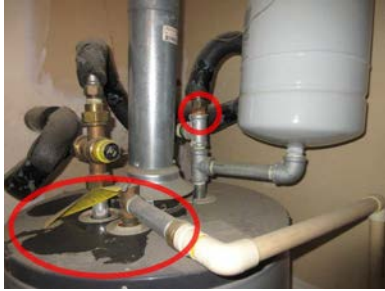
10.14 GENERAL COMMENTS

The water heater is leaking. The services of a qualified plumbing contractor should be retained to replace the water heater.

- 10.5 Water connections at tank – Water heater connections to be replaced by closing.
- 10.14 General comments – Water heater to be replaced by closing.
- 14.9 Hose bibbs and exterior supply pipes – to be repaired by closing.

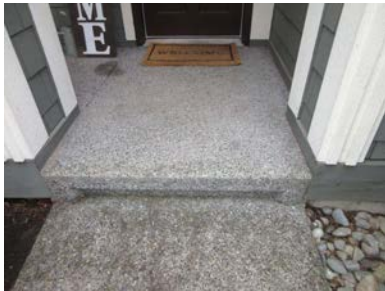
3.3 PEST CONTROL

Untreated wood in direct contact with concrete was observed along the front porch stoop. Untreated wood should be raised 1-2" above the concrete. Treating the wood with a preservative sometimes will prevent wood destroy organism damage.

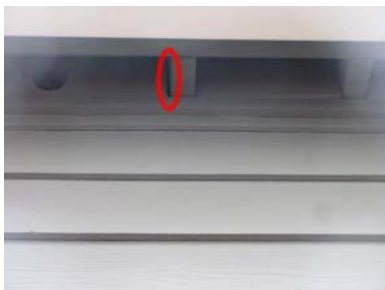
3.4 SOFFITS AND OVERHANGS

Gaps over 1/4" in size adjacent the soffit vent blocks will allow insects and rodents to enter the attic. Covering any gaps with screening, a strip of wood and/or caulking is recommended.

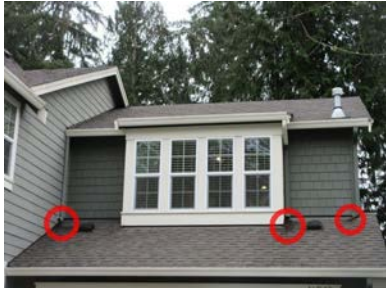
3.5 GUTTERS AND DOWNSPOUTS

Downspouts draining directly onto the asphalt shingle surface causes excessive wear of the roofing material. Downspout extensions to the lower gutters should be installed to prevent excessive wear and tear of the roofing.

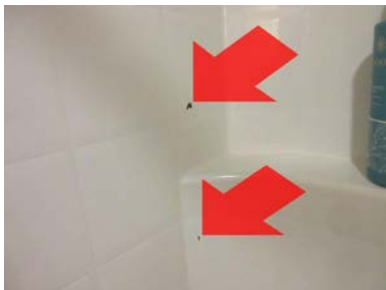
12.14 TUB WALLS

The surface of the shower/tub wall is chipped. This defect is primarily cosmetic and therefore repairs are optional. Chips can be touched up with appliance repair touch-up paint available at most home improvement centers.

- 7.13 GFCI receptacles – Redundant GFCI receptacles replaced with standard receptacles.
- 9.2 Condenser – Repaired.
- 12.7 Faucet fixture – Repaired.
- 12.14 Tub walls – Cleaned debris, no damage to the tub wall.
- 12.28 Glass enclosure – Repaired.
- 12.33 Faucet fixture – Repaired.
- 20.5 Pest control – Preventative patch applied.

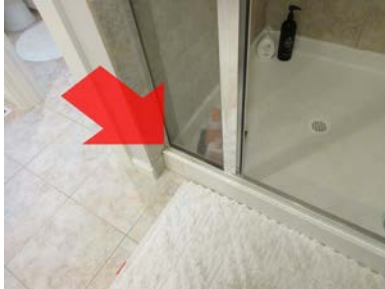
12.28 GLASS ENCLOSURE

The glass enclosure has been leaking at the lower corner. Minor wall trim damage was visible. Resealing or repairing the enclosure is recommended as preventive maintenance.

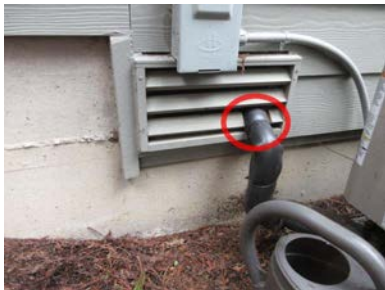
20.5 PEST CONTROL

One of the crawlspace vent screens is damaged on the southwest corner of the house. This will allow rodent entry into the crawlspace. The damaged screen should be repaired.

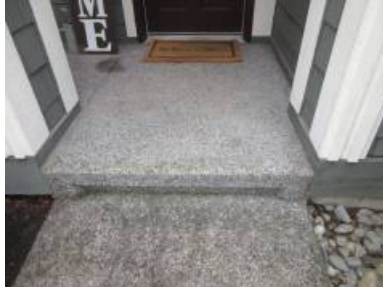
Untreated wood in direct contact with concrete was observed along the front porch stoop. Untreated wood should be raised 1-2" above the concrete. Treating the wood with a preservative sometimes will prevent wood destroy organism damage.

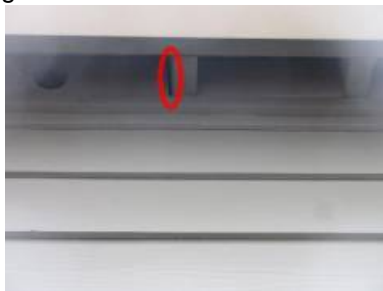
3.4 SOFFITS AND OVERHANGS

Gaps over 1/4" in size adjacent the soffit vent blocks will allow insects and rodents to enter the attic. Covering any gaps with screening, a strip of wood and/or caulking is recommended.

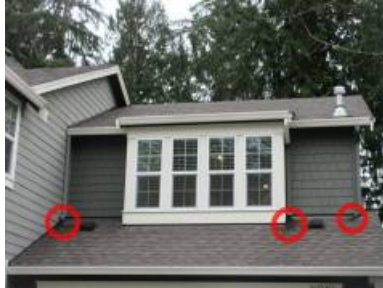
3.5 GUTTERS AND DOWNSPOUTS

Downspouts draining directly onto the asphalt shingle surface causes excessive wear of the roofing material. Downspout extensions to the lower gutters should be installed to prevent excessive wear and tear of the roofing.

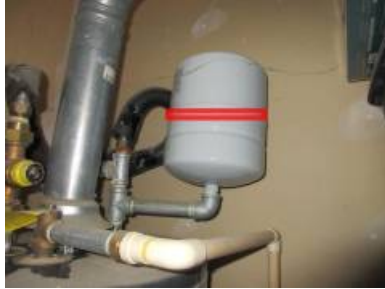
10.6 EXPANSION TANK

The expansion tank is not adequately secured to the wall. As code requirements start to call for engineered expansion tank supports we recommend the installation of seismic restraints to secure the expansion tank instead of allowing it to simply depend on piping connections that could result in damage to the water pipe and leakage during an earthquake.

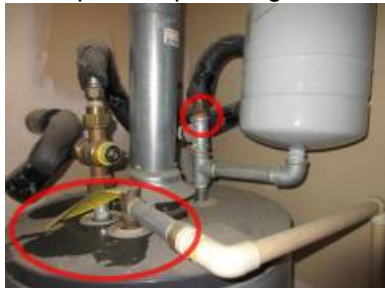
10.14 GENERAL COMMENTS

The water heater is leaking. The services of a qualified plumbing contractor should be retained to replace the water heater.

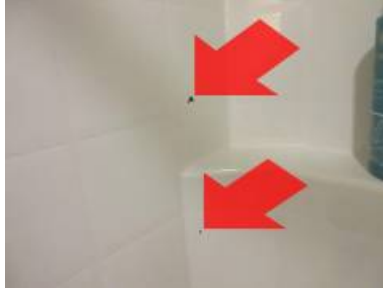
12.14 TUB WALLS

The surface of the shower/tub wall is chipped. This defect is primarily cosmetic and therefore repairs are optional. Chips can be touched up with appliance repair touch-up paint available at most home improvement centers.

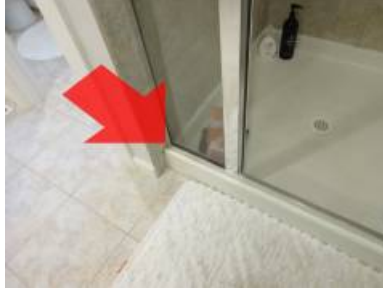
The glass enclosure has been leaking at the lower corner. Minor wall trim damage was visible. Resealing or repairing the enclosure is recommended as preventive maintenance.
