NOTICE TO BUYER: SELLER-PROCURED INSPECTION REPORT

Joe & Jody Shmait
17230 NE 132nd Place
Redmond, WA 98052

At your request, a visual inspection of the above referenced property was conducted on 03/22/2022. We have inspected the major structural components, plumbing, heating and electrical systems for signs of significant non-performance, excessive or unusual wear and general state of repair.

17230 NE 132nd Pl.
Redmond WA.

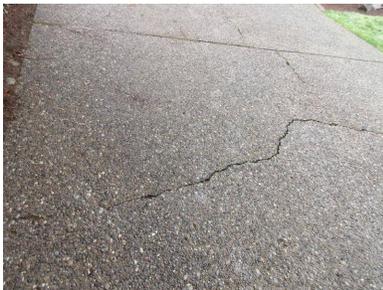
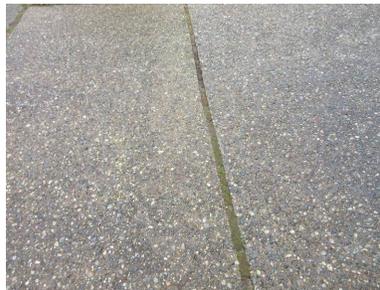
The driveway has cracked and settled differentially. This was probably caused by inadequate preparation of the soil prior to the placement of the concrete. This condition can be repaired by pressure grouting the sunken portion of the driveway or by removing and replacing it. The driveway remains functional despite this condition.

The wooden divider separating the concrete driveway sections has deteriorated to a point where it is a trip hazard. Replacement with mortar is recommended.

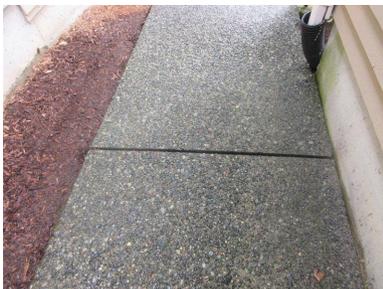
2.5 WALKWAY

One or more of the wooden dividers separating the concrete walkway sections were infested by wood destroying organisms and have deteriorated to a point where they are becoming a trip hazard. Replacement with mortar is recommended.

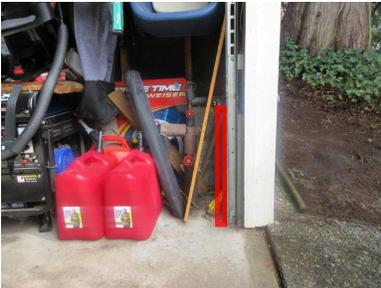
6.3 GARAGE DOOR OPENER

The Photo-eye beam was installed to high above the floor of the garage to adequately offer protection for small children and/or pets. We recommend that the photo-eye be lowered to within 4-6" of the floor.

- 6.3 GARAGE DOOR SENSORS - Photo beam sensors are 6" above floor and are operating per specifications
- 6.4 FIRE SEPARATION - Voids in the fire resistive barrier have been filled with fire retardant foam.

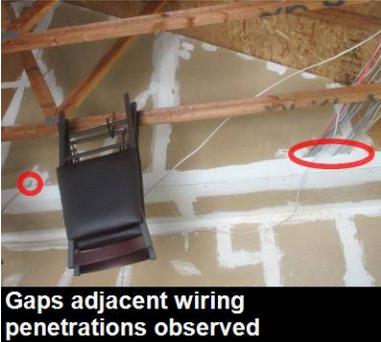
6.4 FIRE SEPARATION

There are voids in the fire resistive barrier between the living space and garage that will allow flames to penetrate. The gypsum barrier slows the spread of a fire from the garage to the structure and/or living space. Patching the voids with a fire retardant caulk is recommended.

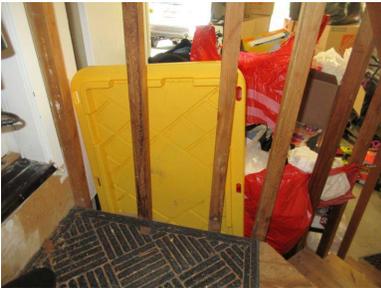
6.6 STAIRS

The stair landing railing baluster spacing is too wide. This is a hazard for small children. The baluster spacing should be reduced as a safety upgrade. Current standards require that a 4" sphere not pass through the railing.

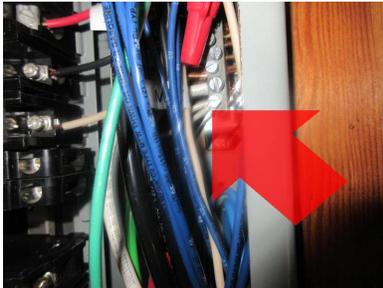
One of the neutral wires is double tapped on the buss bar. Double tapping means that two conductors share a single terminal. Double tapped terminals can loosen and overheat and therefore are not permitted unless the terminal is specifically listed for multiple wires. This defect is easily repaired by connecting the two wires to a "pig tail", securing them with a wire cap, and then inserting the pig tail conductor under the terminal.

- 7.8 OVER CURRENT PROTECTION – The defect was repaired by removing one of the wires from the double tap and reconnecting it to an open terminal.
- 7.8 SERVICE PANEL SCREW – The missing screw was replaced.

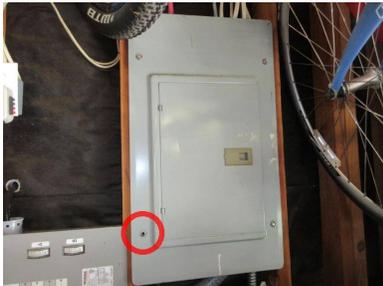
Screws that secure the panel cover to the panel box are missing. This is a potential hazard. Missing screws should be replaced with the original style blunt end screws.

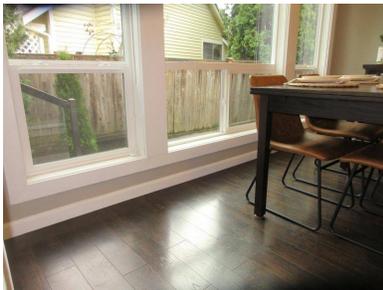
14.5 WINDOWS

The lower window glass is not labeled as tempered safety glass. The existing glass is nonconforming by current building standards and would be hazardous if broken. The installation of safety glass is recommended as a safety upgrade for all windows less than 18" from the walking surface.

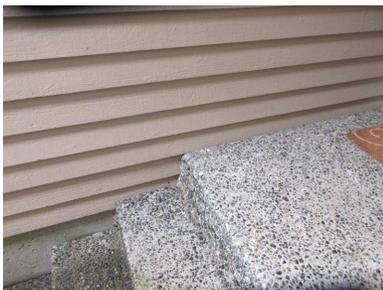
3.3 PEST CONTROL

Untreated wood in direct contact with concrete was observed along the porch stoop. Untreated wood should be raised 1-2" above the concrete. Treating the wood with a preservative sometimes will prevent wood destroy organism damage.

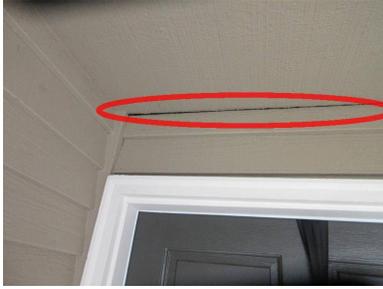
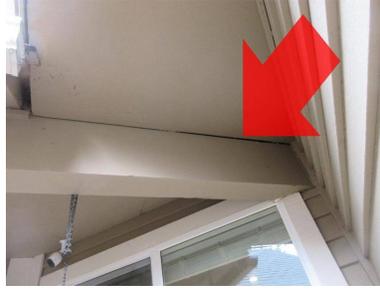
3.4 SOFFITS AND OVERHANGS

Gaps over 1/4" in size adjacent the soffits will allow insects and rodents to enter the attic. Covering any gaps

with screening, a strip of wood and/or caulking is recommended.

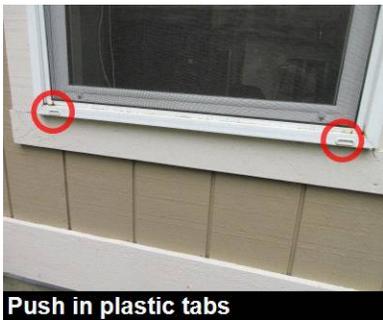
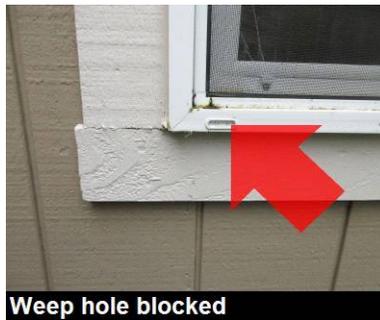
Weep hole tabs were not removed from several windows. These tabs should be removed to allow for positive drainage and to prevent moss build up on window frames.

- 3.10 EXTERIOR WINDOWS – Weep hole tabs have been removed.
- 10.9 OVEN – Oven breaker was replaced with a new 40 amp double pole breaker by electrician.

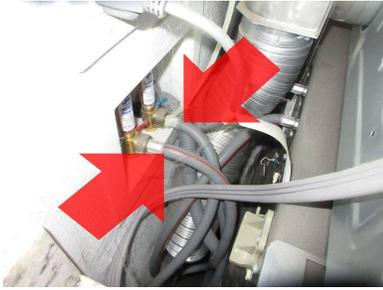
12.8 APPLIANCES

Upgrading the washer connections to high pressure (steel braided) lines is recommended.

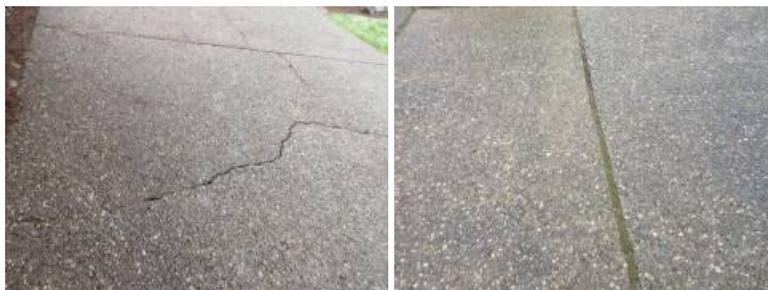
The driveway has cracked and settled differentially. This was probably caused by inadequate preparation of the soil prior to the placement of the concrete. This condition can be repaired by pressure grouting the sunken portion of the driveway or by removing and replacing it. The driveway remains functional despite this condition.

The wooden divider separating the concrete driveway sections has deteriorated to a point where it is a trip hazard. Replacement with mortar is recommended.

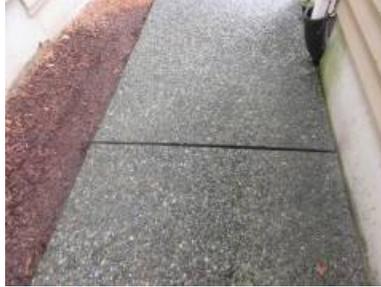
2.5 WALKWAY

One or more of the wooden dividers separating the concrete walkway sections were infested by wood destroying organisms and have deteriorated to a point where they are becoming a trip hazard. Replacement with mortar is recommended.

Many legal and public works departments have defined a trip hazard as an irregularity in a walking surface exceeding one inch (1") in height. All walking surfaces should maintain, free of a vertical surface change of 3/4" or more, in the interest of public and personal safety.

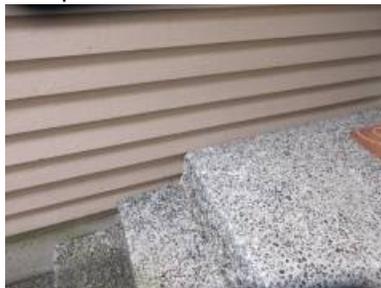
Untreated wood in direct contact with concrete was observed along the porch stoop. Untreated wood should be raised 1-2" above the concrete. Treating the wood with a preservative sometimes will prevent wood destroy organism damage.

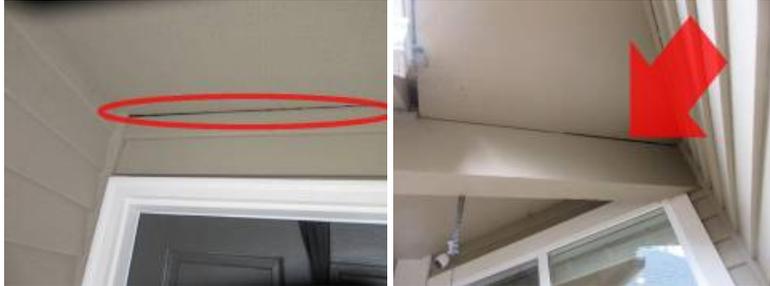
3.4 SOFFITS AND OVERHANGS

Gaps over 1/4" in size adjacent the soffits will allow insects and rodents to enter the attic. Covering any gaps with screening, a strip of wood and/or caulking is recommended.

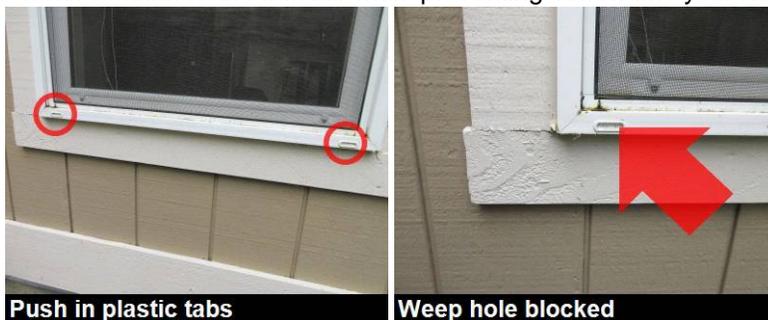
Weep hole tabs were not removed from several windows. These tabs should be removed to allow for positive drainage and to prevent moss build up on window frames.

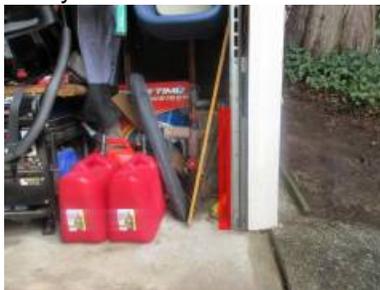
The Photo-eye beam was installed to high above the floor of the garage to adequately offer protection for small children and/or pets. We recommend that the photo-eye be lowered to within 4-6" of the floor.

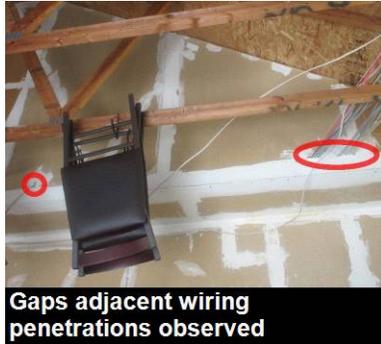
6.4 FIRE SEPARATION

There are voids in the fire resistive barrier between the living space and garage that will allow flames to penetrate. The gypsum barrier slows the spread of a fire from the garage to the structure and/or living space. Patching the voids with a fire retardant caulk is recommended.

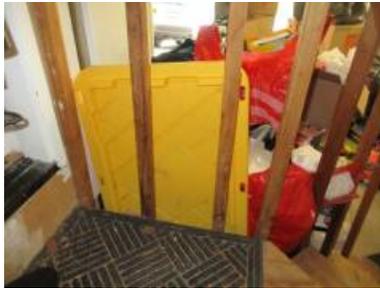
The stair landing railing baluster spacing is too wide. This is a hazard for small children. The baluster spacing should be reduced as a safety upgrade. Current standards require that a 4" sphere not pass through the railing.

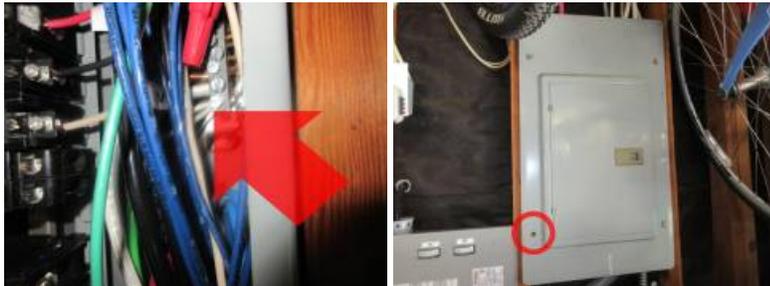
One of the neutral wires is double tapped on the buss bar. Double tapping means that two conductors share a single terminal. Double tapped terminals can loosen and overheat and therefore are not permitted unless the terminal is specifically listed for multiple wires. This defect is easily repaired by connecting the two wires to a "pig tail", securing them with a wire cap, and then inserting the pig tail conductor under the terminal.

Screws that secure the panel cover to the panel box are missing. This is a potential hazard. Missing screws should be replaced with the original style blunt end screws.

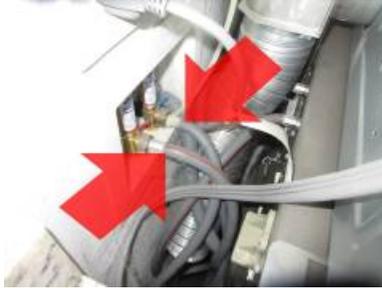
Upgrading the washer connections to high pressure (steel braided) lines is recommended.

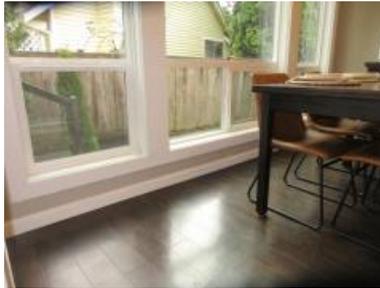
The lower window glass is not labeled as tempered safety glass. The existing glass is nonconforming by current building standards and would be hazardous if broken. The installation of safety glass is recommended as a safety upgrade for all windows less than 18" from the walking surface.
