TIME OF SALE OSS INSPECTION REPORT: TOS

Application No: 109213

12503 179TH AVE NE
KING COUNTY, WA

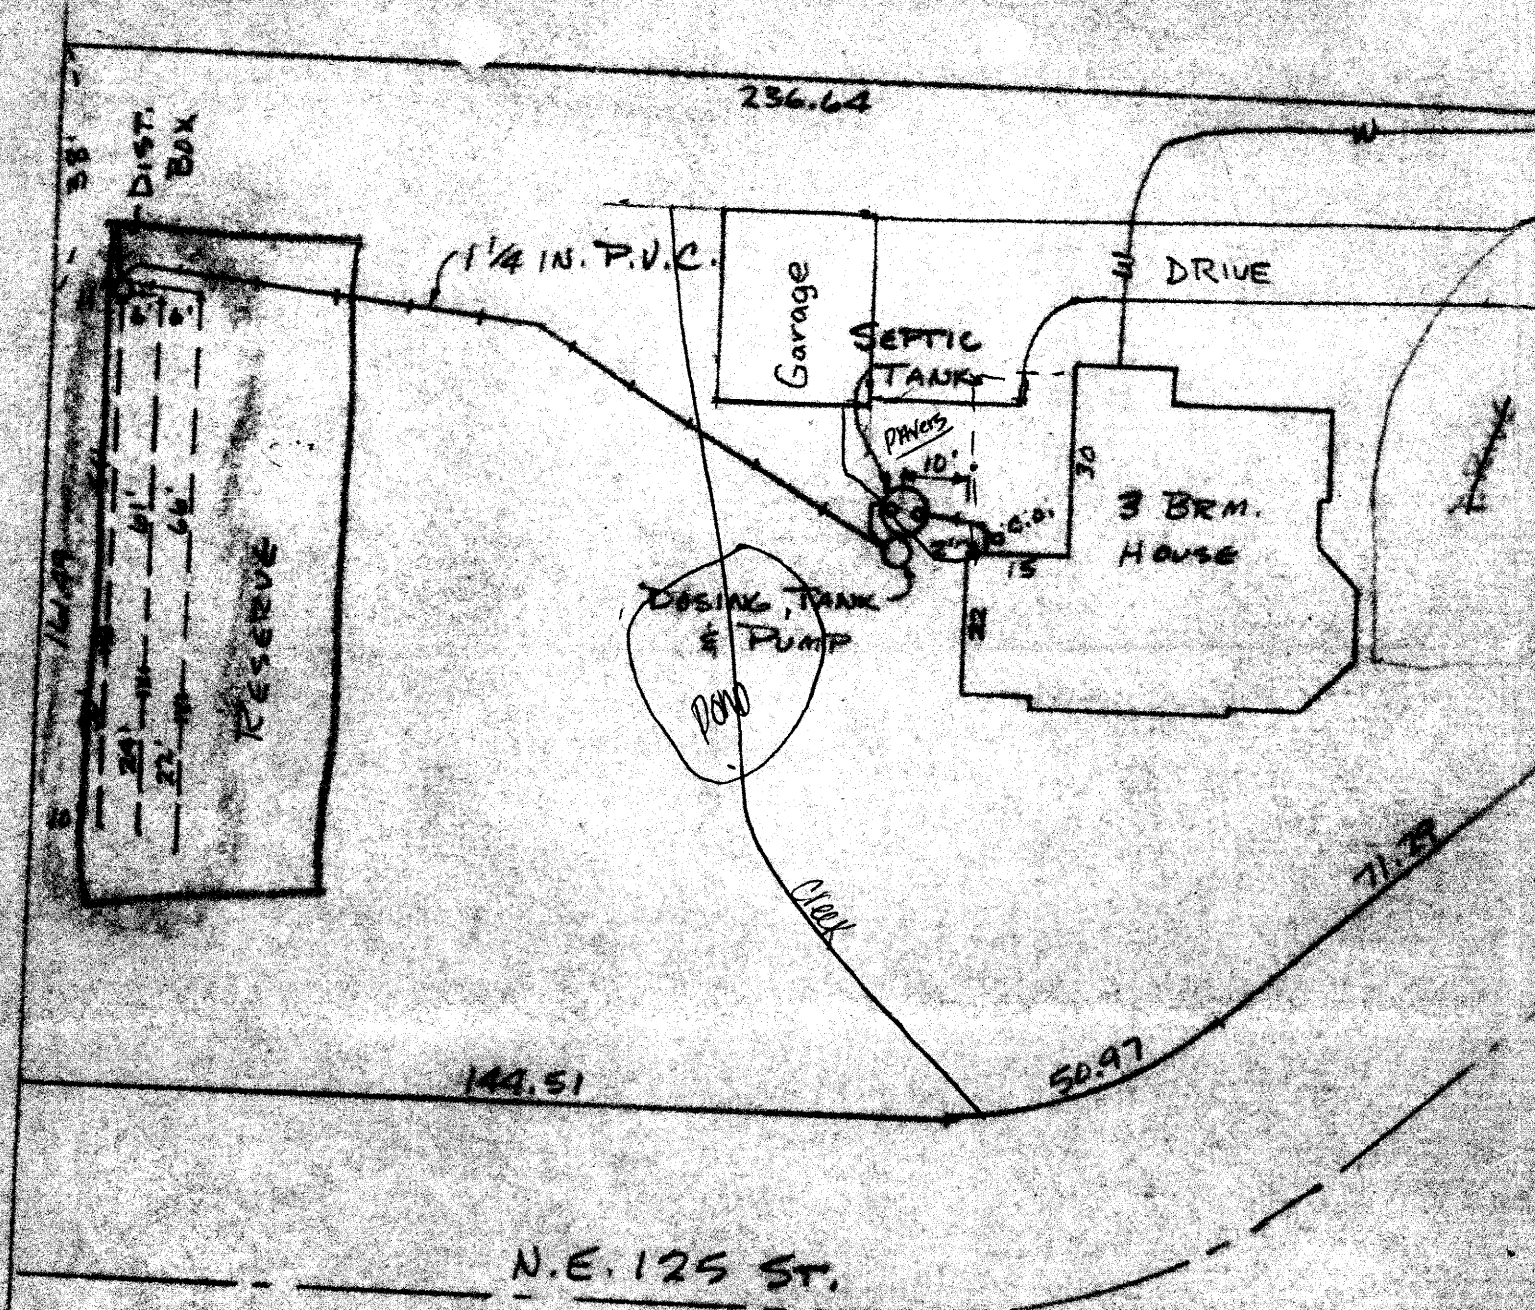
MODIFICATION: DRIVEWAY, PAVEMENT, SEPTIC TANK, POND, CREEK

REVIEWER - 4/18/2022 - Updated site drawing indicates pond and creek are less than 100 feet from the septic system. Current codes do not allow septic systems within one hundred feet of surface water due to risk of contamination from inadequately treated sewage.

SEPTIC TANK PUMPED
PUMP TANK PUMPED
LOAD TEST PERFORMED - 150 GAL = NO RUN-BACK OBSERVED
THERE ARE REMOVABLE PAVERS OVER TANKS CREATING AN ENCROACHMENT
SYSTEM APPEARS TO BE FUNCTIONING PROPERLY AT TIME OF INSPECTION
Modified drawing to reflect driveway and pavers over tank

REVIEWER - 4/18/2022 - Application on hold for maintainer to update drawing.
