**NOTICE TO BUYER: SELLER-PROCURED INSPECTION REPORT**

**David P Walsh & Nicola Thornton-Walsh**  
**18356 NE 143<sup>rd</sup> PL**  
**Woodinville, WA, 98072**

**Per the seller, the following items listed on the pre-sale inspection summary dated (03/26/2022), are being corrected by the seller as part of preparation for sale in good faith.**

At your request, a visual inspection of the above referenced property was conducted on 03/24/2022. We have inspected the major structural components, plumbing, heating and electrical systems for signs of significant non-performance, excessive or unusual wear and general state of repair.

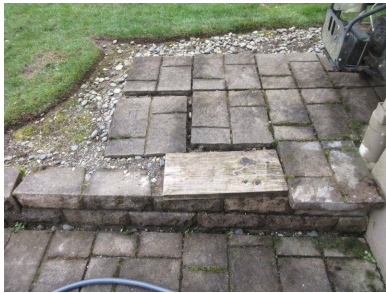
The walkway pavers adjacent the patio have settled differentially. This was probably caused by inadequate preparation of the soil prior to the placement of the masonry. This condition can be repaired by removing and replacing them. The walkway remains functional despite this condition. However, the raised edges of the concrete pavers can be a trip hazard for some people. Repairs should be made as necessary.

- 2.6 Patio walkway - repaired

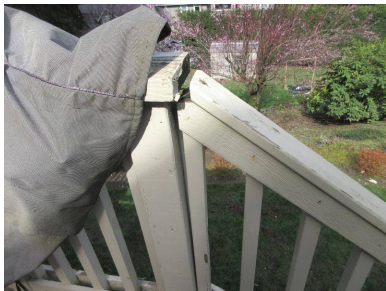
##### 3.10 STAIRS

The handrail along the stairs is loose. This is a hazard. Securing the handrail along the stairs is recommended.

- 3.10 Stairs – Stair handrail secured (new deck and stairs recommended)
- 6.4 Fire Separation – Fire sealant applied around pipes. Exposed wood covered.

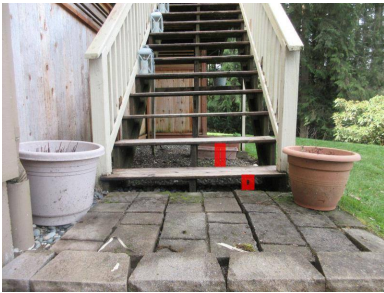
The stairs are non-conforming due to the variable and/or excessive rise. Stair design standards require that stair risers do not exceed 8" and that the variation in rise not exceed 3/8" in order to reduce falls from tripping.

To increase the margin of safety, consideration should be given to reconfiguring the stairs so that rise and run do not vary by more than  $\frac{3}{8}$ ". If this proves to be too impractical or expensive, then we recommend exercising caution when using these stairs.

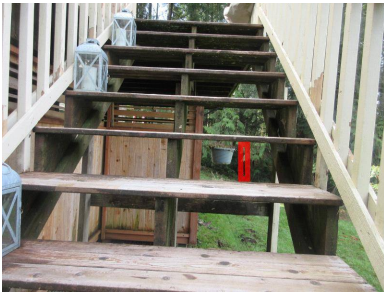
The stair rise spacing is too wide. This is a hazard for small children. The spacing should be reduced as a safety upgrade. Current standards require that a 4" sphere not pass through the opening.

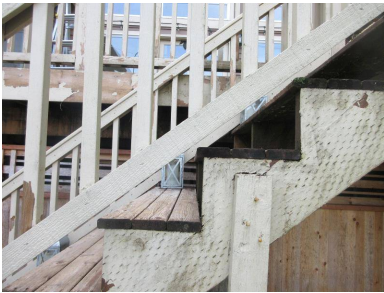
The spacing under stair railing is too wide. This is a hazard for small children. The spacing should be reduced as a safety upgrade. Current standards require that a 4" sphere not pass under the railing.

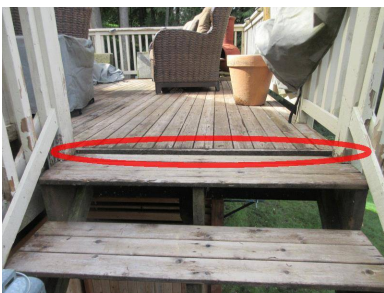
The uneven surface at the top of the steps is a potential trip hazard. Consideration should be given to modifying the deck surface to mitigate the hazard.

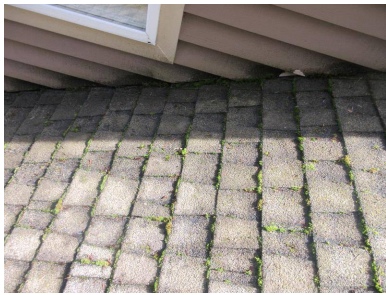
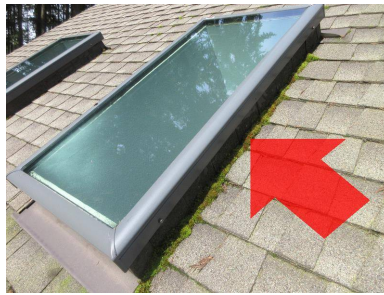
#### 4.5 MAINTENANCE AND REPAIRS

The roof is in need of maintenance. The surface should be blown off or washed with a high volume low pressure garden hose to remove moss and organic debris.

- 4.5/ 19.10 Roof and sheathing– Will be replaced. See attached Rock Roofing Estimate. Seller will add optional Ridge Venting and TPO membrane
- 5.2/5.3 Attic - Will be treated along with roof and extra ventilation installed
- 15.7 Windows – Kitchen and great room windows have been ordered and will be installed prior to closing
- 3.5 Building exterior – gaps will be caulked
- 20.5 Crawlspace – Scrap wood will be removed prior to closing

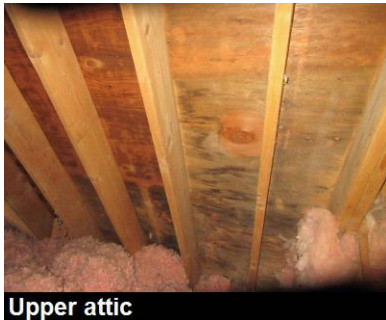
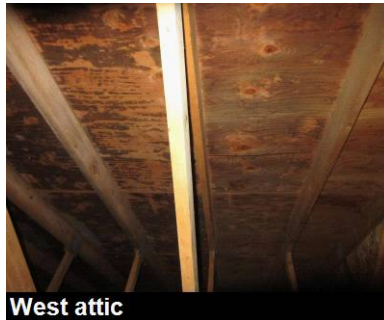
#### 4.6 GENERAL COMMENTS

The roof is nearing the end of its service life. Significant wear, deterioration, and evidence of saturation of the sheathing was observed from within the attic. The need for replacement should be anticipated within 1-3 years.

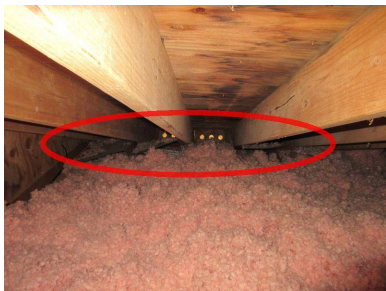
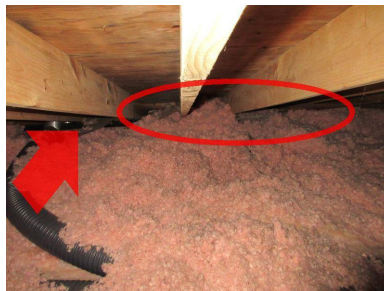
#### 5.2 VENTILATION

The attic space is only minimally vented. The installation of some additional attic ventilation is recommended. Vents should be evenly divided between the eaves and ridge, whenever possible.

Wind baffles are compromised in some areas of the attic and insulation has bypassed at several locations. Clearing away the insulation from the vent block openings and the proper placement of wind baffles in front of all soffit vents is recommended.

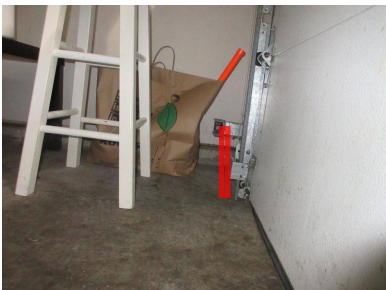
The Photo-eye beam was installed too high above the floor of the garage to adequately offer protection for small children and/or pets. We recommend that the photo-eye be lowered to within 4-6" of the floor.

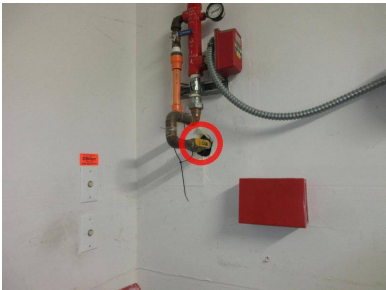
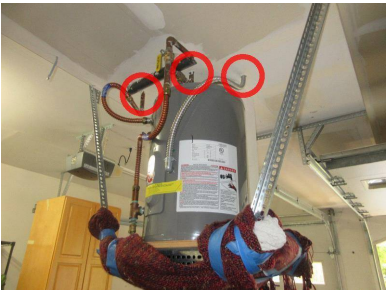
**6.4 FIRE SEPARATION**

There are voids in the fire resistive barrier between the living space and garage that will allow flames to penetrate. The gypsum barrier slows the spread of a fire from the garage to the structure and/or living space. Patching the voids with a fire retardant caulk is recommended.

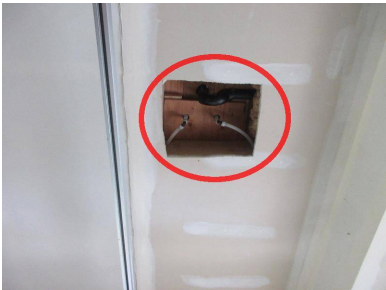
The exposed wood is a breach in the fire resistive barrier in the garage. Patching the void with a fire retardant caulk or repairs to the missing piece 5/8" gypsum type X board over the exposed wood is recommended.

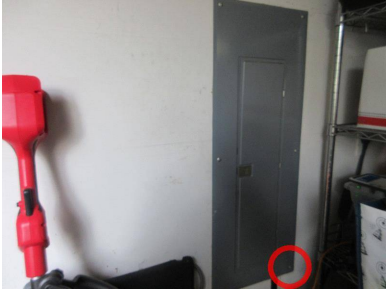
**7.9 SERVICE PANEL**

Screws that secure the panel cover to the panel box are missing. This is a potential hazard. Missing screws should be replaced with the original style blunt end screws.

- 7.9 Electrical system – Repaired
- 7.13 Receptacles – Repaired
- 10.19 Water Heater – Two Seismic straps installed
- 11.12 Hot Water Dispenser – Unplugged when inspection occurred. Plugged in and operating normally.

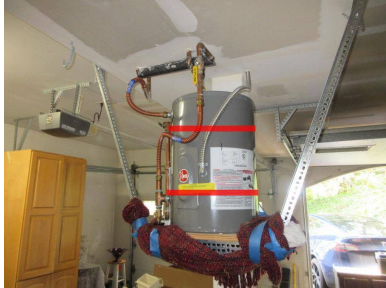
The water heater is not secured to the wall. A seismic restraint should be installed to secure the water heater and prevent it from falling over during an earthquake. This prevents the gas and water lines from rupturing.

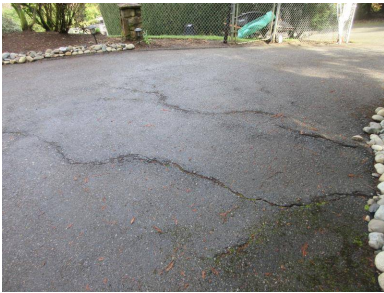
There is minor tree root damage visible in the asphalt driveway. The damage is not affecting the function of the driveway. Seal coating the surface of the asphalt is recommended to maximize the service life of the paving. Asphalt sealers are available at most home improvement stores.

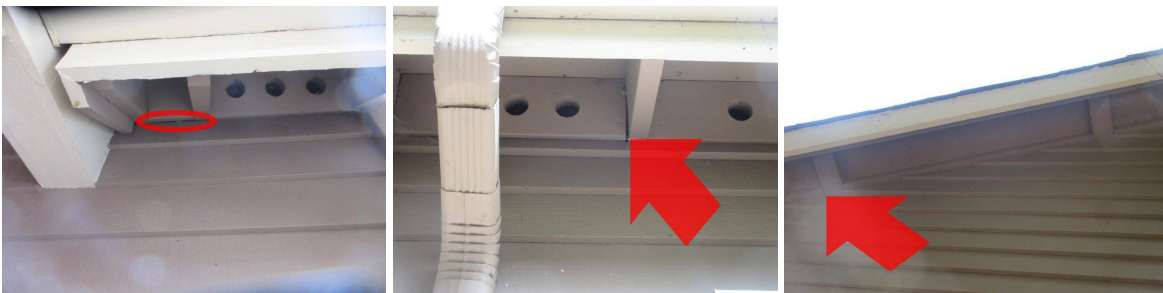
There are large gaps over 1/4" in size adjacent the soffit vent blocks. These gaps allow insects and rodents to enter the attic. Covering the gaps with screening, a strip of wood and/or caulking is recommended.

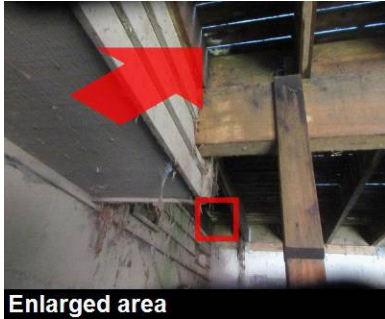
#### **3.8 DECK**

Numerous areas of rot damaged wood and rot fungi was observed in the deck boards. Rot weakens the wood and can result in catastrophic failure of the structure. Replacement of all rotted wood is recommended.

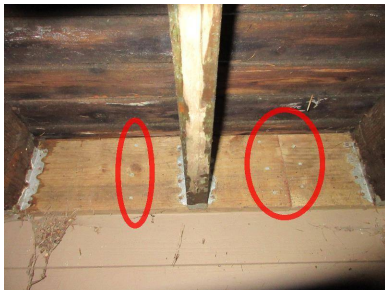
The deck is not adequately secured to the building. The installation of lag bolts through the ledger board into the wall is recommended.

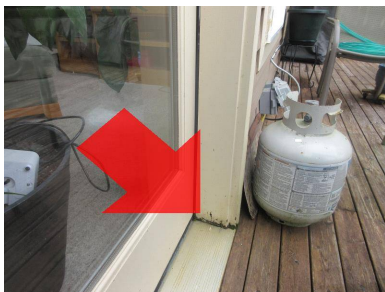
### 3.12 EXTERIOR DOORS

The bottom(s) of the deck door jambs are rotted. The door jambs are not a structural component, therefore, this is an aesthetic concern only. Replacement of the damaged door jambs for better appearance is recommended.

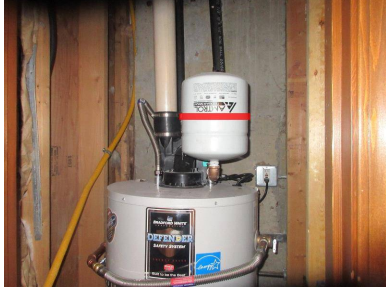
The expansion tank is not adequately secured to the wall. As code requirements start to call for engineered expansion tank supports we recommend the installation of seismic restraints to secure the expansion tank instead of allowing it to simply depend on piping connections that could result in damage to the water pipe and leakage during an earthquake.

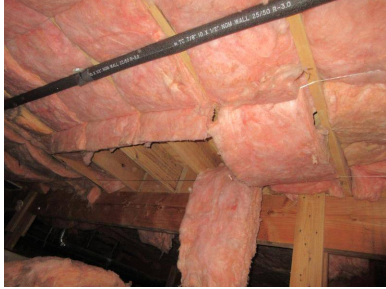
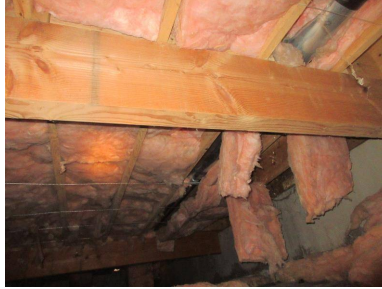
Some of the insulation batts were not properly secured and have falling down. The fallen batts should be reinstalled and secured.

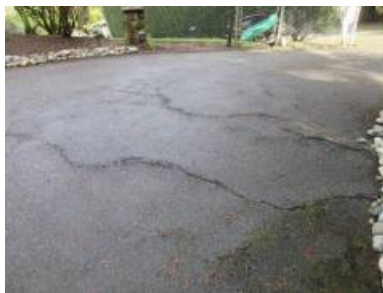
There is minor tree root damage visible in the asphalt driveway. The damage is not affecting the function of the driveway. Seal coating the surface of the asphalt is recommended to maximize the service life of the paving. Asphalt sealers are available at most home improvement stores.

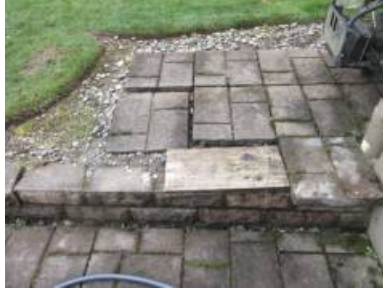
Many legal and public works departments have defined a trip hazard as an irregularity in a walking surface exceeding one inch (1") in height. All walking surfaces should maintain, free of a vertical surface change of 3/4" or more, in the interest of public and personal safety.

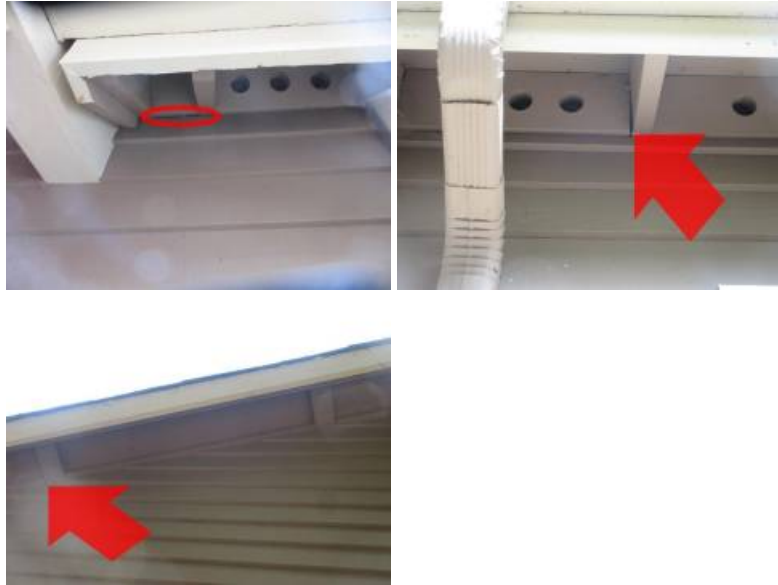
There are large gaps over 1/4" in size adjacent the soffit vent blocks. These gaps allow insects and rodents to enter the attic. Covering the gaps with screening, a strip of wood and/or caulking is recommended.

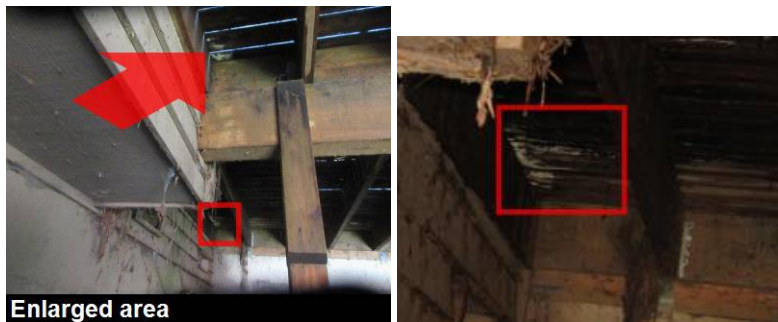
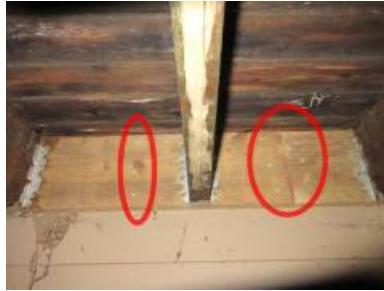
Enlarged area

The deck is not adequately secured to the building. The installation of lag bolts through the ledger board into the wall is recommended.

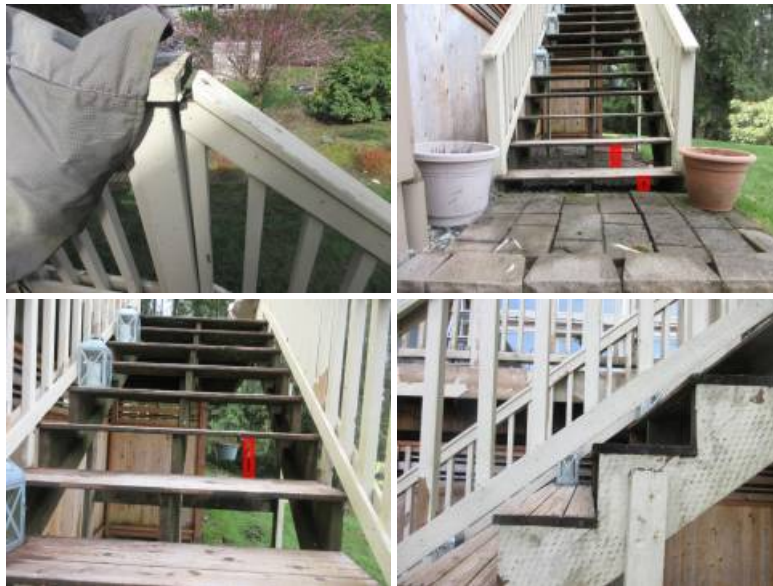
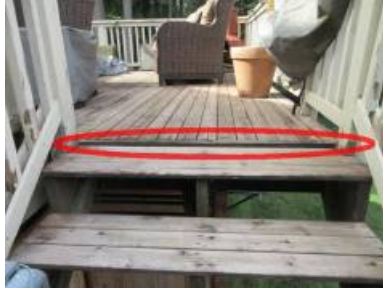
The uneven surface at the top of the steps is a potential trip hazard. Consideration should be given to modifying the deck surface to mitigate the hazard.

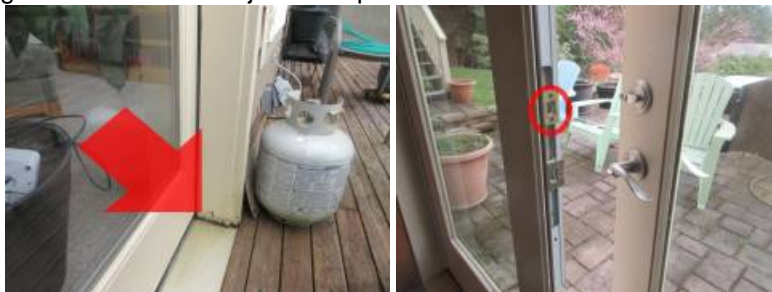
The patio entry door latch is in need of minor adjustment and/or repair. Door hardware should be adjusted or replaced as necessary to restore full function. Sticking doors should be adjusted or planed.

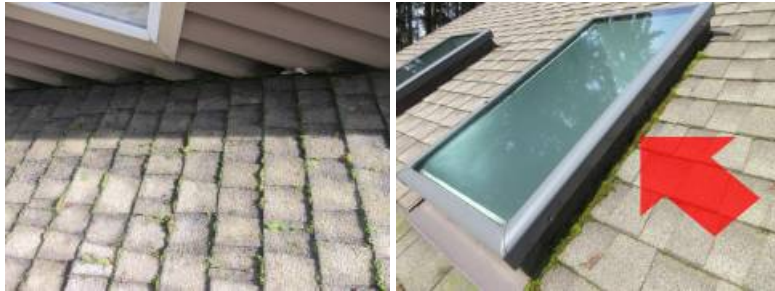
Moss growth once established acts like a sponge, soaking up and storing rainwater. Some of that water then wicks up under the shingles through capillary action and soaks into and through the roof underlayment, which is typically 15- or 30-pound felt. Eventually, it saturates the roof sheathing below.

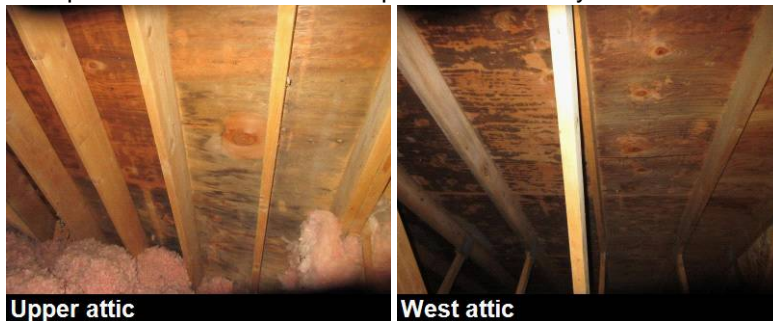
#### 4.6 GENERAL COMMENTS

The roof is nearing the end of its service life. Significant wear, deterioration, and evidence of saturation of the sheathing was observed from within the attic. The need for replacement should be anticipated within 1-3 years.

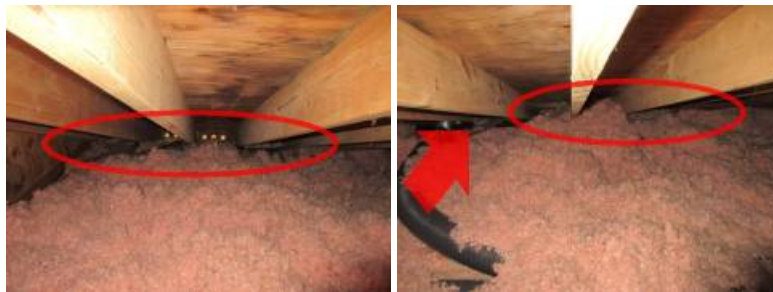
Wind baffles prevent wind from blowing through the soffit vents and pushing the insulation away from the vent opening. The absence of wind baffles will often result in the exposure of large areas of the ceiling to cold temperatures. Wind baffles also prevent insulation from blocking the vents.

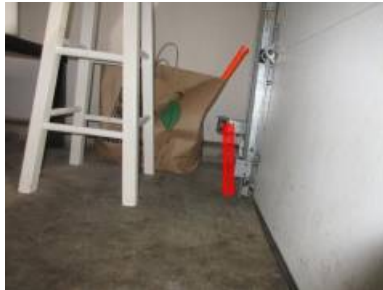
The Photo-eye beam was installed too high above the floor of the garage to adequately offer protection for small children and/or pets. We recommend that the photo-eye be lowered to within 4-6" of the floor.

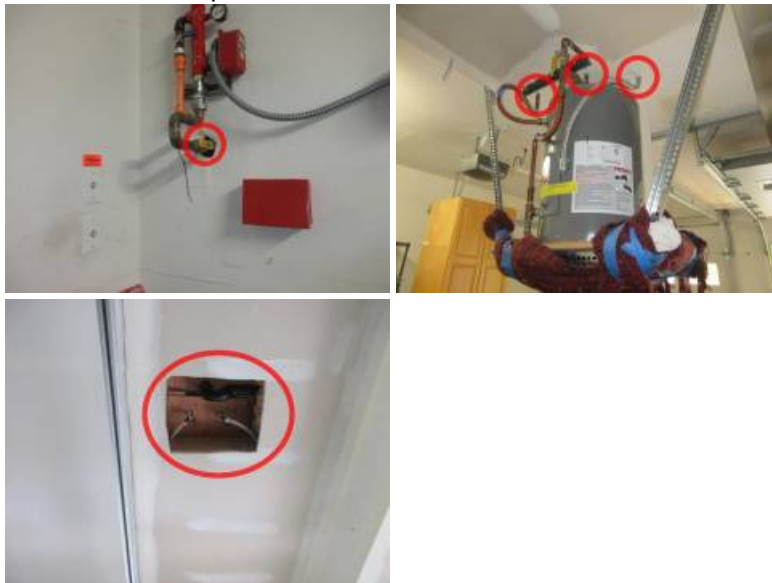
The exposed wood is a breach in the fire resistive barrier in the garage. Patching the void with a fire retardant caulk or repairs to the missing piece 5/8" gypsum type X board over the exposed wood is recommended.

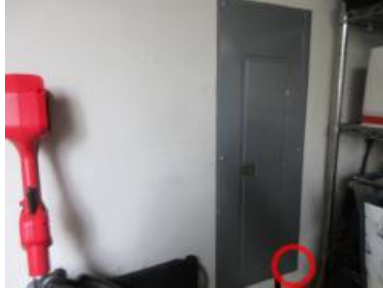
Screws that secure the panel cover to the panel box are missing. This is a potential hazard. Missing screws should be replaced with the original style blunt end screws.

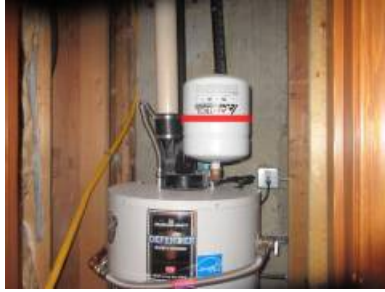
depend on piping connections that could result in damage to the water pipe and leakage during an earthquake.

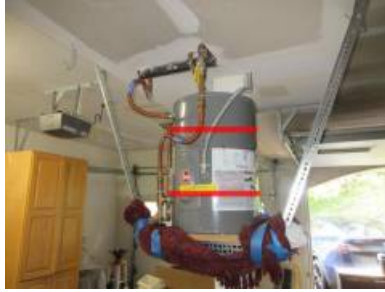
from falling over during an earthquake. This prevents the gas and water lines from rupturing.

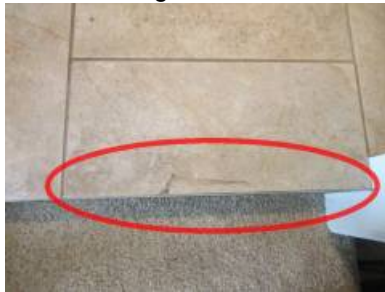
There are cracks in some of the ceramic tile. This is usually caused by impact or deflection in the floor. Shoring up the floors edge underneath would help to reduce further cracking.

- 7.16 Luminaries – Bulbs replaced, all operational.
- 11.3 Kitchen Flooring – Tiles repaired
- 12.8 Countertop – Repaired.
- 12.15 Main floor bathroom Sink – Repaired.

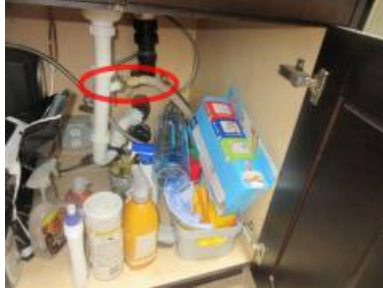
The island dishwasher drain lacks an air gap. The dishwasher will function without one, but there is a risk of contamination of the inside of the dishwasher by waste water. The installation of an air gap is recommended.

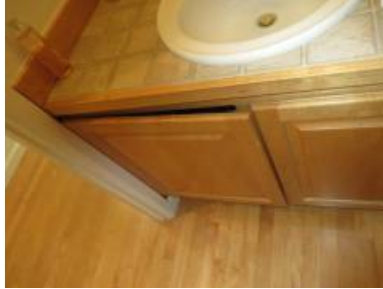
The cabinet is properly installed and in good condition, however, the doors are mis-aligned. These doors have adjustable hinges that make door realignment a simple operation.

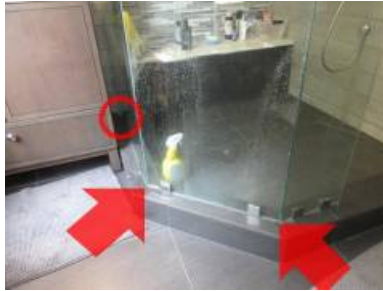
The glass enclosure has been leaking at the lower corners. No damage was visible, but resealing or repairing the enclosure is recommended as preventive maintenance.

- 12.18 Hallway bathroom Cabinets – Repaired.
- 12.19 Hallway bathroom – caulked
- 12.35 Master bath Glass Enclosure – caulked
- 12.38 Guest bath Sink – Repaired.

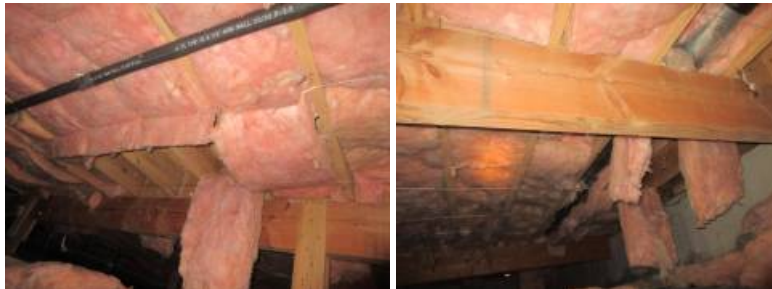
Some of the insulation batts were not properly secured and have falling down. The fallen batts should be reinstalled and secured.
